MINES BRANCH INVESTIGATION REPORT IR 66-22

**EXAMINATION OF METAL
COMPOSITE USED IN THE
MANUFACTURE OF SAFES**

Mines Branch Investigation Report IR 66-22

SUMMARY OF RESULTS

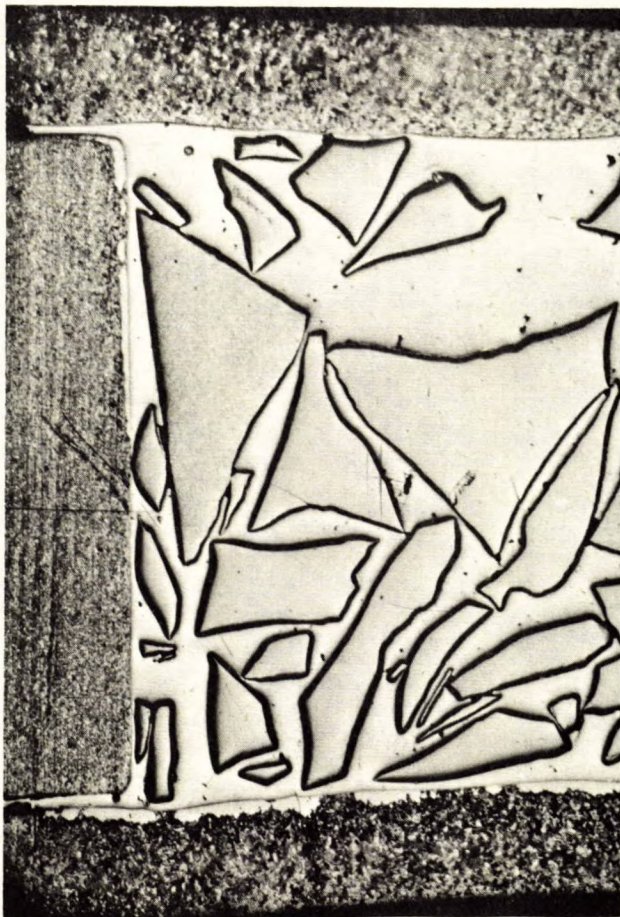
Figure 6.
Detail of the hole
closure, X8.

The manner in which the hole in the plate has been contrived substantiates the above deduction, since it is seen in Figure 6, that a steel cylinder has been inserted between the top and bottom surfaces to form the wall of the hole. In addition, it may be noted that the steel insert has been brazed into position by brazing alloy from the inside seeping into the joint.

In spite of the fact that the appearance of the sample (Figure 2) closely resembles an end section of rolled plate, it is obvious that this method of manufacture must be rejected when consideration is given to the placement of the steel cylinder between the steel surfaces at the hole. The absence of corner welds further excluded a picture frame type of assembly. That the component could have been made by joining together two identical cups (as suggested by the butt welded steel joints) is unlikely since the hole closure itself is in one piece. With the exclusion of these possible methods of manufacture then, it is considered that a reasonable reconstruction of the manufacturing operations might be as follows:
