**COMPARATIVE EVALUATION OF MINE-SHAFT WIRE-ROPE
NDT INSTRUMENTS: A SEARCH FOR, AND ANALYSIS OF,
BACKGROUND INFORMATION —CONTRIBUTION TO THE
CANADA/USBM/ONTARIO MOL JOINT R&D PROGRAM**

L.B. Geller and J.E. Udd

**MINING RESEARCH LABORATORIES
DIVISION REPORT MRL 88-78 (TR)**

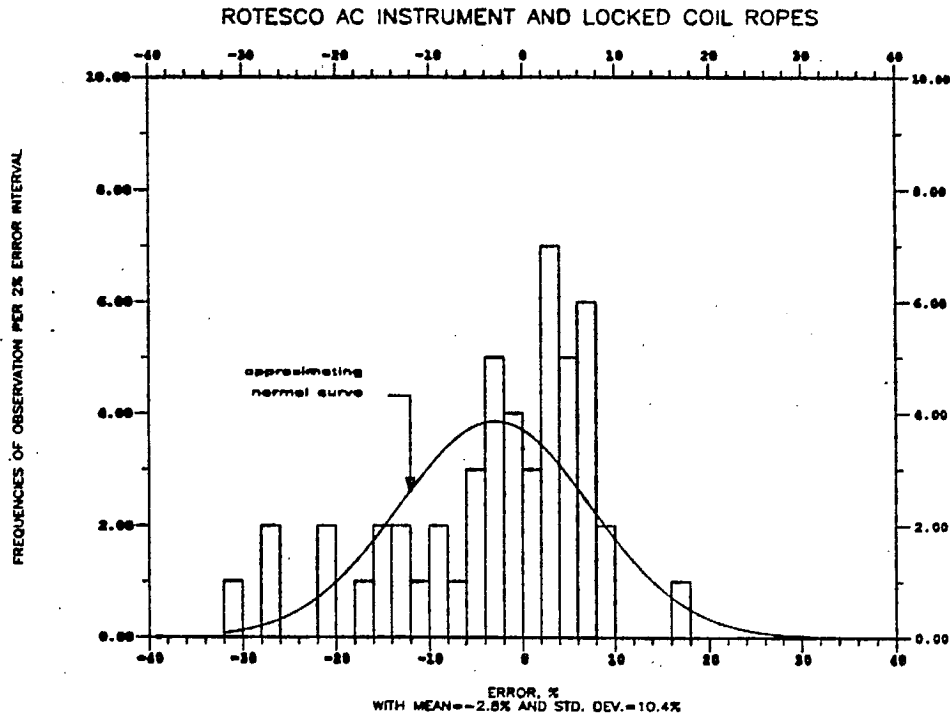
Fig. 4 — Error% vs frequencies of observation (50 altogether), and the approximating normal curve — locked coil ropes and Rotesco AC instrument

The actual values obtaining are listed in Table 1. The corresponding histograms and approximating normal curves (i.e., the curves that correspond to a population that has a normal distribution, with the same \bar{X} and S values as the actual sample) are shown in Figures 4 to 10, inclusive. The curves clearly indicate that Ontario's $\pm 4\%$ Performance Requirement (Appendix A) is far from being satisfied.

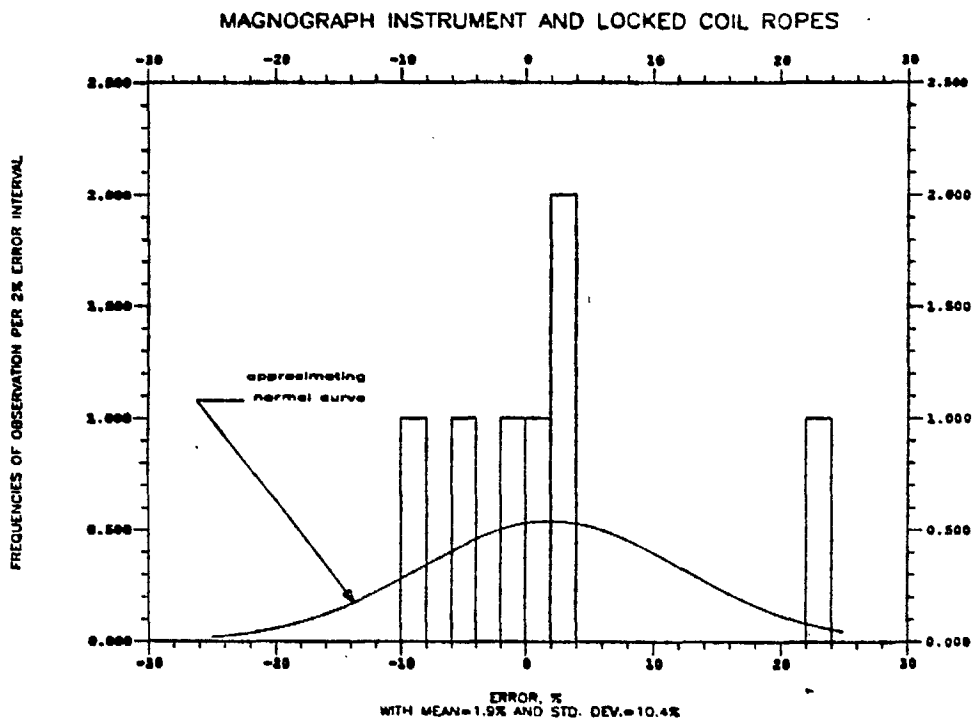
Fig. 6 — Error% vs frequencies of observation (7 altogether), and the approximating normal curve — locked coil ropes and Magnograph instrument

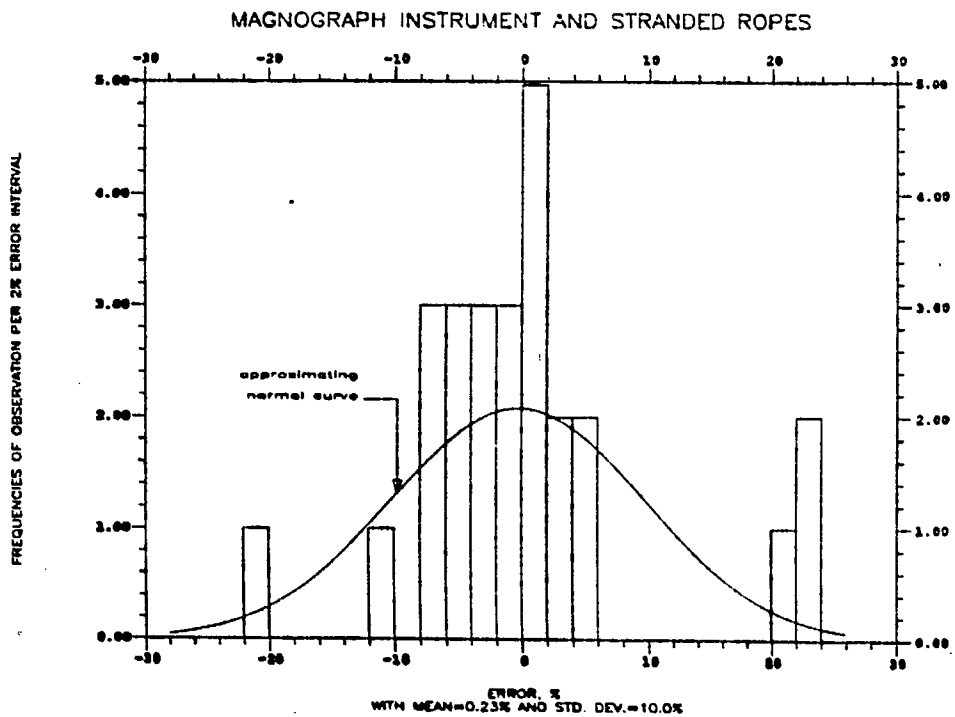
Fig. 10 — Error% vs frequencies of observation (26 altogether), and the approximating normal curve — stranded ropes and Magnograph instrument
