STABILITY OF SURFACE CROWN PILLARS
IN SHEARED TERRAINS WITH WEAK
HANGING WALL AND FOOT WALL

MRL 88-99 (OP, J)

OCTOBER 1988

Presented at the CANMET Seminar, Timmins, Ontario,
November 22, 23, 1988: "CANMET, Partners with the
Ontario Mining Industry". Inclusion in the
Seminar Proceedings.

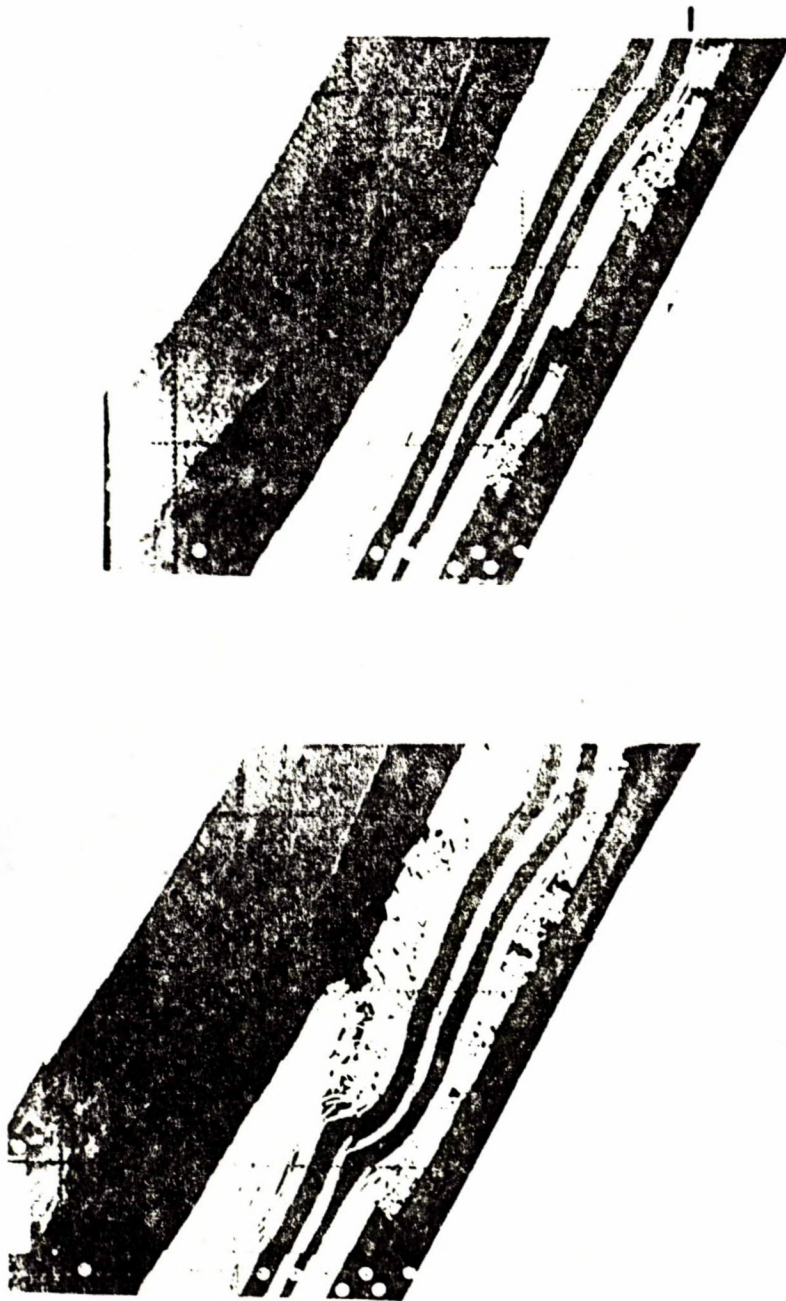
Figure 8. Results of a base friction test on a mine scale model with schist; a) to b) shows the progression of the failure mechanism with motion of the driving basal sandpaper (5).

There are several varieties of physical models. The base friction model, figure 8, is used widely to reproduce the effects of gravity in 2-D models of rock excavations. The body force of gravity is simulated by the drag of a sand belt moving along the underside of the model.
