Evaluation of EM rope testers: joint Canada/US work
paper for ASNT conf., Oct. 8-12, 1990, Seattle, WA
L.B. Geller, D. Poffenroth, J.E. Udd, and D. Hutchinson

MRL report #90-052 (OP)

EVALUATION OF EM ROPE TESTERS: JOINT CANADA/US WORK

For presentation at the ASNT Oct. 8-12, 1990, Seattle, WA, Conference
on "NDT for Today's Application"

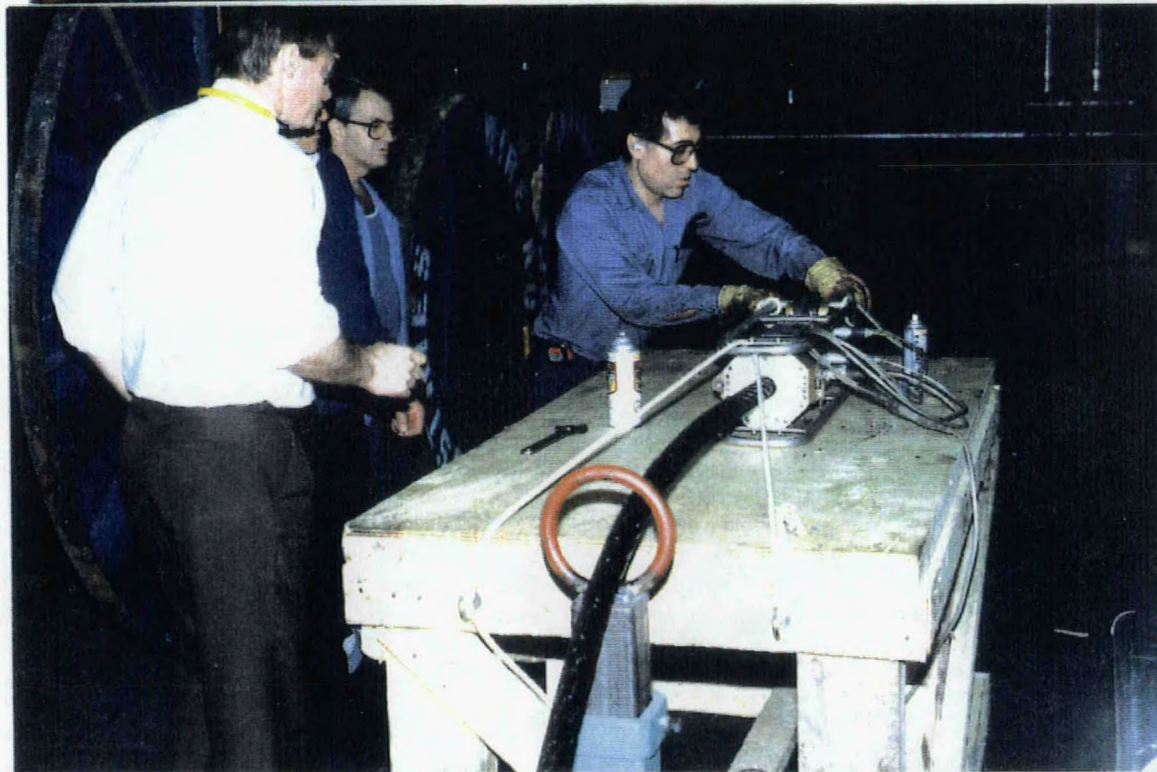
(a) view from rope inlet-end

(b) side view: LMA-250 at right, Magnograph at left
of picture; rope moving from right to left

Fig. 1 — General views of test-procedure

(c) view from rope outlet-end

tests. The other instruments, with their powerful permanent magnets, were then tested together. After carefully testing for their polarities, they were appropriately aligned in series on a wooden table. General views of the test procedure are presented in Figure 1. Complete details of both the in situ and shop-floor tests are provided elsewhere (1, 2, 3).

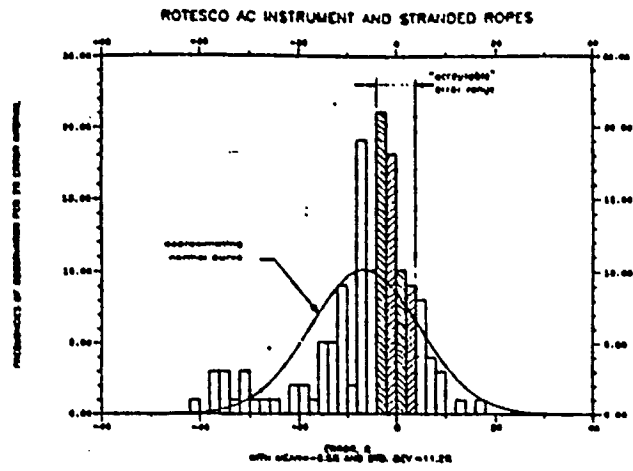
Fig. 2a — Error% vs frequencies of observation (144 altogether), and the approximating normal curve — stranded ropes and Rotesco AC Instrument

Fig. 2b — Error% vs frequencies of observation (34 altogether), and the approximating normal curve — stranded ropes and Rotesco graph instrument

Fig. 2c — Error% vs frequencies of observation (26 altogether), and the approximating normal curve — stranded ropes and Magnograph instrument

Fig. 2 (after ref. 2) — Error% vs frequencies of observation and the approximating normal curve — stranded ropes

As discussed in detail elsewhere (1, 2, 3), an excessive number of EM instrument-based loss-of-breaking-strength (LBS) estimates are outside the $\pm 4.0\%$ benchmark parameter of Ontario's "Performance Requirements of EM Mine Shaft Rope Testing Devices". This is illustrated in the error distribution bell-curves, and in the cumulative DT vs NDT test-result diagrams of Figures 2 to 5. One could, perhaps, question: (a) our choice of the $\pm 4.0\%$ benchmark parameter, and (b) our reasons for restricting the analysis of the DT/NDT data pairs to those that were obtained from the worst rope sections only — while ignoring the large number available from other rope sections. In reply we state that: (a) we were unaware of any other benchmark parameter we could have used instead, and (b) the accuracy of the LBS estimates for the worst rope sections is the vital one; that for the better rope segments is of somewhat less importance.

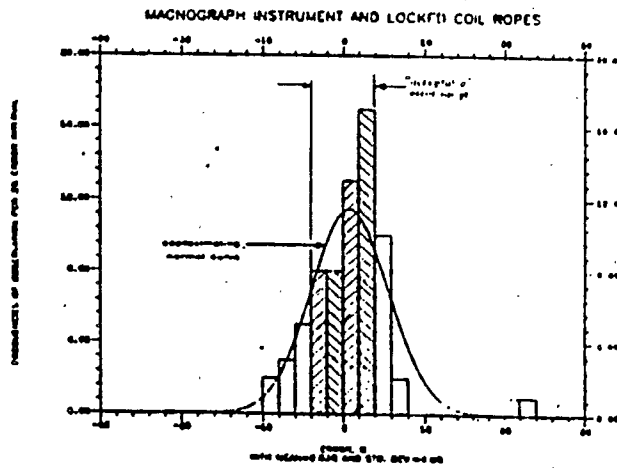
Fig. 3a — Error% vs frequencies of observation (113 altogether), and the approximating normal curve — locked coil ropes and Rotesco AC Instrument

Fig. 3b — Error% vs frequencies of observation (51 altogether), and the approximating normal curve — locked coil ropes and Rotesograph Instrument

Fig. 3c — Error% vs frequencies of observation (69 altogether), and the approximating normal curve — locked coil ropes and Magnograph Instrument

Fig. 3 (after ref. 2) — Error% vs frequencies of observation and the approximating normal curve — locked-coil ropes

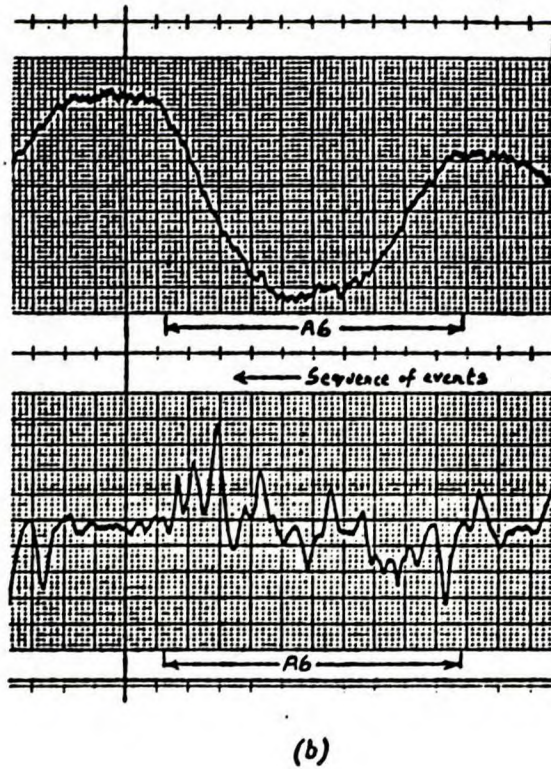
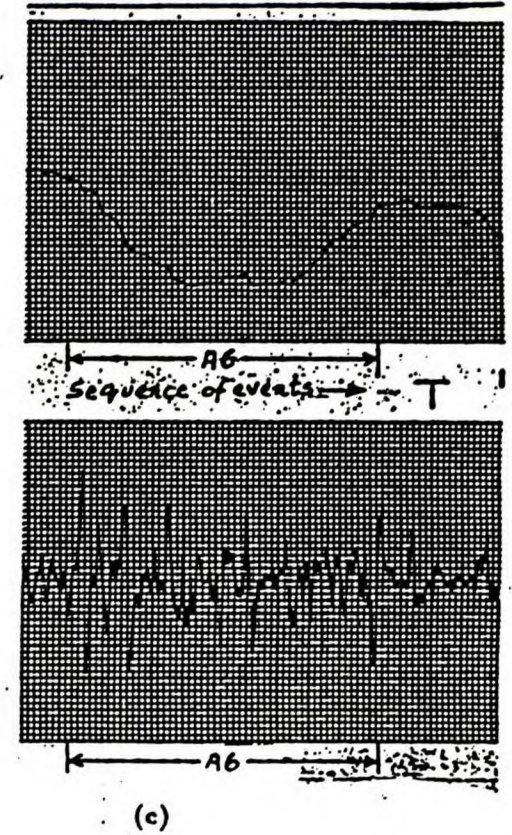
Fig. 6 (after ref. 5) — Rope 'A', April, 1989, testing with (a) Rotoscograph, (b) Magnograph, and (c) LMA-250 instruments; defect A6

We found that results were repeatable to a remarkable degree, and consistently so. As an example, we reproduce in Figures 6 to 13 some of the relevant results, discussed in detail in references 5 and 6. The repeatability of the characteristic %LMA traces, generated by the artificial defects designated in ref. 5 by the symbols: A6; A9 and A10; A13 and A14; B13 and B12; as well as B15 (Figures 6 to 10), is quite remarkable,

especially in view of the fact that these were obtained quite independently of each other, with different instruments, at different times, and with different operators. These figures also illustrate the great advantage in having both LMA and LF chart-traces. The two together make it, inter alia, easier to pin-point the exact location of rope defects, and to say whether these are of a positive or negative %LMA nature.
