**Effect of trapped wire-rope debris upon
an EM instrument's LMA chart-trace**

MRL 90-008 (TR)

February, 1990

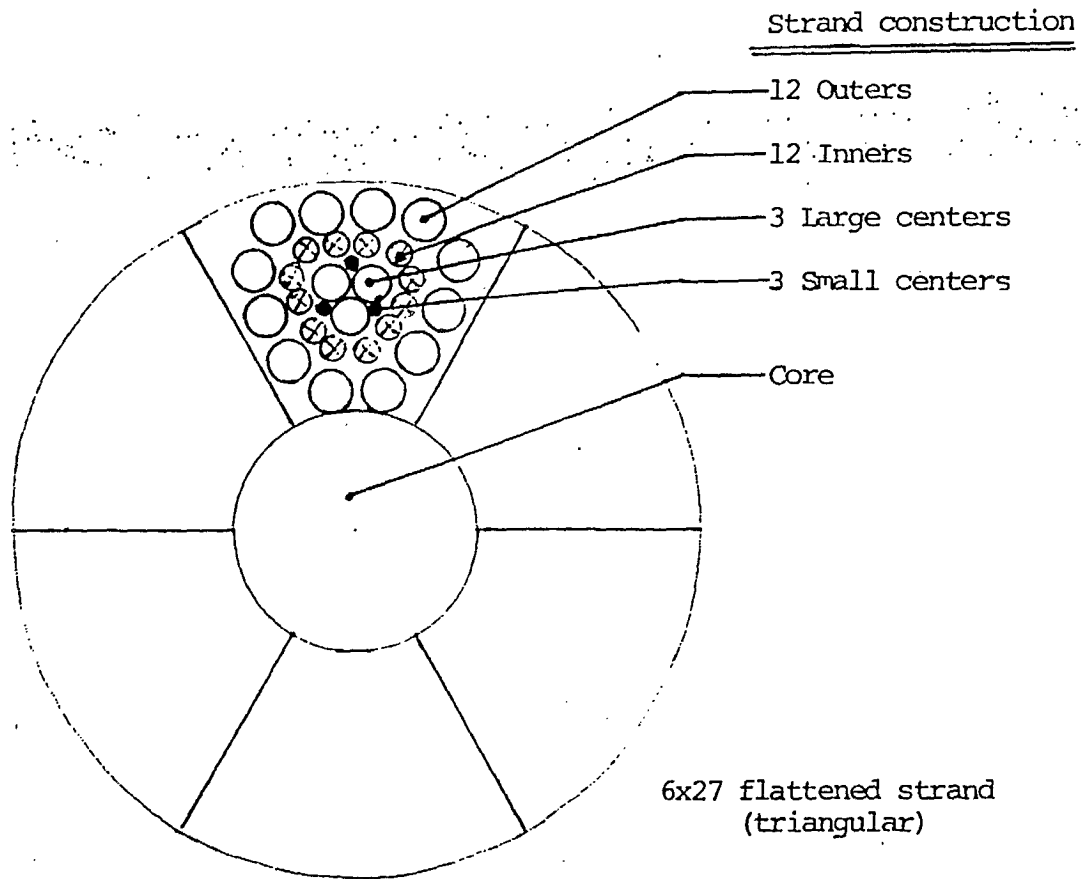
STRAND CONSTRUCTION	IMA (total)
12 Outers	62%
12 Inners	22%
3+3 Centers	16%

Loss of one outer wire = 0,86% IMA
 Loss of one inner wire = 0,31% IMA

Fig. 8 — Construction of test-ropes

In early 1989 two stranded test-ropes were fabricated by Wire Rope Industries Ltd. for CANMET's contracted project (3, 4, 5). The ropes are of $1\frac{3}{4}$ in. 6×27 , flattened strand construction. A sketch of the cross-section of these ropes is shown in Figure 8. Each rope contains artificial defects, intentionally introduced during the

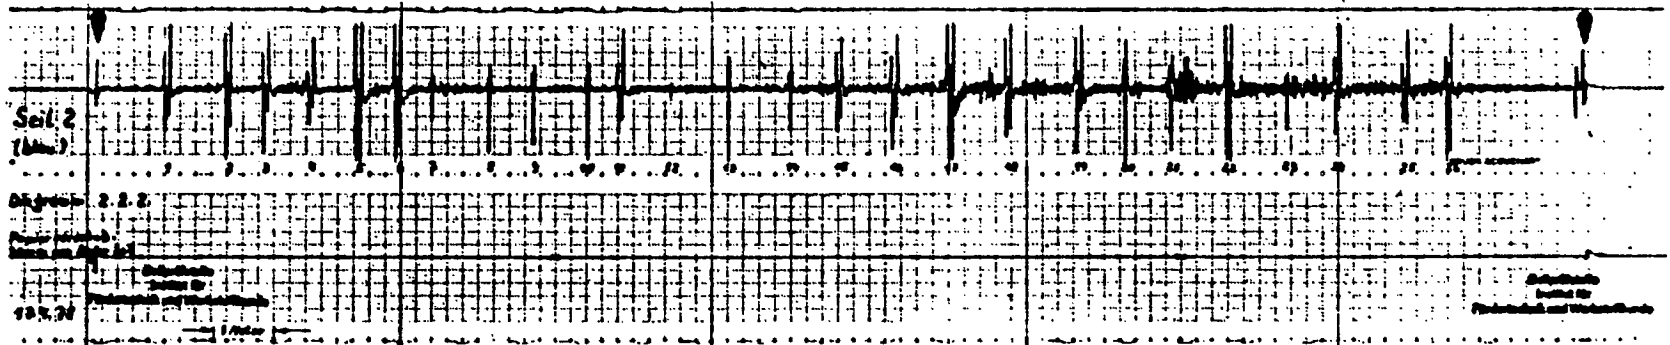
Fig.14 — Copy of WBK chart #2.2.2

Others have arrived at the same conclusion. As an example, Kitzinger and Naud (7) found that with magnetite tightly packed inside a 16 in. long and 0.375 in. I.D. plastic tube, the output of the loss-of-metallic area sensor of their instrument (i.e., of the Magnograph) was less than 3.0% that of a steel rod of the same size. If hematite replaced the magnetite, there was no measurable output. Others (8) examined the LF signals of a range of EM instruments with a number of ropes, including a 42 mm, 1 x 164 full-locked-coil construction with many artificial defects. The latter included filed cavities filled: (a) with magnetic corrosion products, and (b) with non-magnetic corrosion products. The non-magnetic products were located at rope-fault numbers 1, 11, 25, and 26; the magnetic ones at rope-fault numbers 2, 4, 18, and 24. The chart-traces showed little, if any, difference for the two. We reproduce three charts (numbers 2.1.2, 2.2.2, and 2.3.2), as obtained with the German WBK instrument (Figures 13, 14, and 15 to 15b).
