**GEOLOGICAL SURVEY OF CANADA
OPEN FILE 8760**

**High water levels in Big Lake, caused by Hurricane Dorian
(Sept. 7, 2019) and changes to Long Beach, Nova Scotia**

**R.B. Taylor, P. Fraser, V. Kostylev, D.P. Potter, D.L. Forbes, D. Whalen,
A. Robertson, and V. Leys**

2021

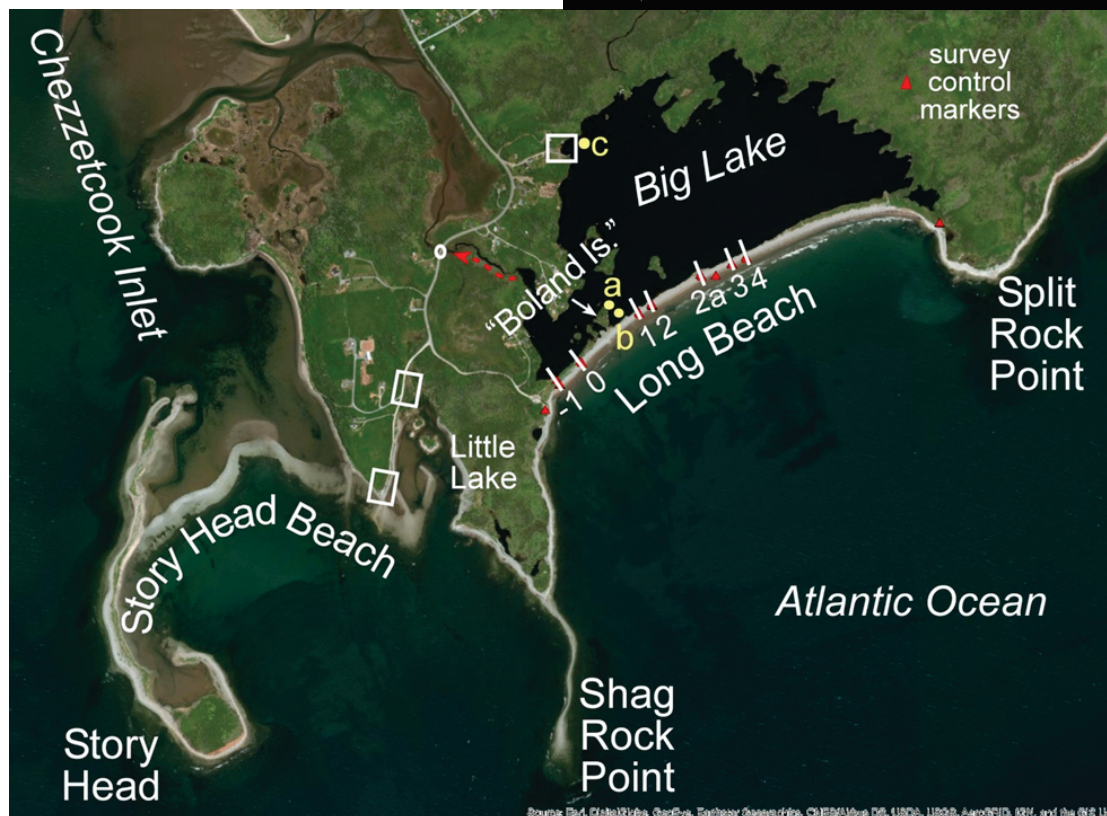
Figure 1. Long Beach, Story Head Beach, and other places mentioned in the text. Also shown are the cross-shore lines (-1, 0, 1, 2, 3, 4-white lines) used to monitor beach changes, the locations of water depth pressure sensors (a, b, c – yellow dots) and the stream channel (red dash line) which drains water from Big Lake toward Chezzetcook Inlet when lake levels exceed 1.4 m (CGVD28). Flood debris lines resulting from Hurricane Dorian were surveyed in three areas outlined by white boxes and specific flood lines are shown in Figure 7 and listed in Table 2. (The base photo is from ESRI Digital Globe 2016).

Long Beach, located east of Halifax along Eastern Shore of Nova Scotia (Fig. 1) forms a 1.4 km long barrier fronting Big Lake. The Geological Survey of Canada Atlantic (GSCA) has been monitoring physical changes and the impacts of storms on the stability of Long Beach since 1985 (Taylor et al. 1995, in prep). Long Beach was selected for study because it represented a specific shore type observed in Atlantic Canada — a high gravel barrier beach (Forbes et al. 1990). Long Beach also provided a contrast to another shore type - a low gravel barrier beach — that had been studied at nearby Story Head Beach, at the mouth of Chezzetcook Inlet, Nova Scotia (Fig. 1). Documenting changes occurring along these two types of barrier beaches contributed to an understanding of gravel beach response to storms and their long-term evolution during a rising sea level (Forbes et al. 1995; Taylor et al. 2014). The GSC contributed background information to CBCL for their study, and have continued to investigate changes at Long Beach and Big Lake as part of their mandate to investigate coastal hazards to Canadians.

Between 1985 and 2011, repetitive surveys were completed at 5 to 7 cross-shore transects (Fig. 1-lines) and along the crest of Long Beach using conventional survey technology (levels, theodolites, paired rods, electronic total station, and real-time kinematic GPS). Surveys were completed on average 3 to 4 times each year, focussing on the impacts of significant storms (Taylor et al. 1997a,b, 2008, 2010, 2013, 2014, in prep). Visual observations of changes at Long Beach were continued by the lead author from 2011 to 2016. GSCA resumed monitoring of Long Beach in 2016 using consumer grade aerial drones, or unpiloted aerial systems (UAS), to collect topographic 'Structure-from 'Motion' (SfM) photogrammetry data. This technique allows for rapid collection of elevation and photogrammetric data for temporal monitoring or following storm events. Elevation data are limited to portions of the barrier that are above water and are not obscured by wave swash.

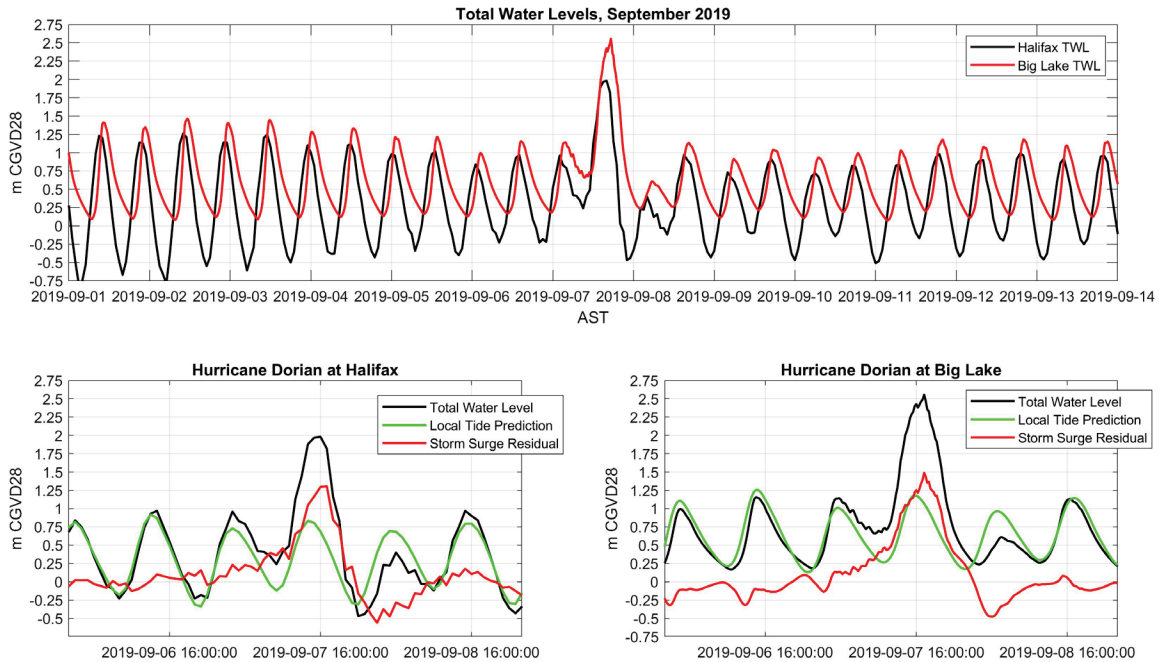
Figure 4. Comparison of water levels filtered to 15- minute interval for Big Lake (Location b, Fig. 1) and tidal station 491 in Halifax Harbour in early September 2019 and during Hurricane Dorian. Note: the tide prediction for Big Lake is based on a tidal analysis of the local tide gauge data.

Water levels (Fig. 4) recorded at tidal station 491 (BIO) on September 7 reached a maximum of 2.83 m (CD) or 2.03 m (CGVD28) at 17:30 ADT (15-minute averaging interval) one hour after predicted high tide and 2.09 m (CGVD28) at 17:24 ADT (1-minute recording interval). The storm surge, which coincided with the highest water, peaked at 1.38 m. Storm surge conditions (>0.6 m) lasted for eight hours. Water levels reached during Hurricane Dorian were similar to those observed during Hurricane Juan in 2003 (2.91 m CD), given the local differences in wind and set-up at the two stations used to obtain the data (Halifax and BIO 491 BIO). Water levels during Hurricane Dorian were slightly higher than those during other storms (January 2010, January 2018, and March 2019; Table 1) when Long Beach was severed temporarily.

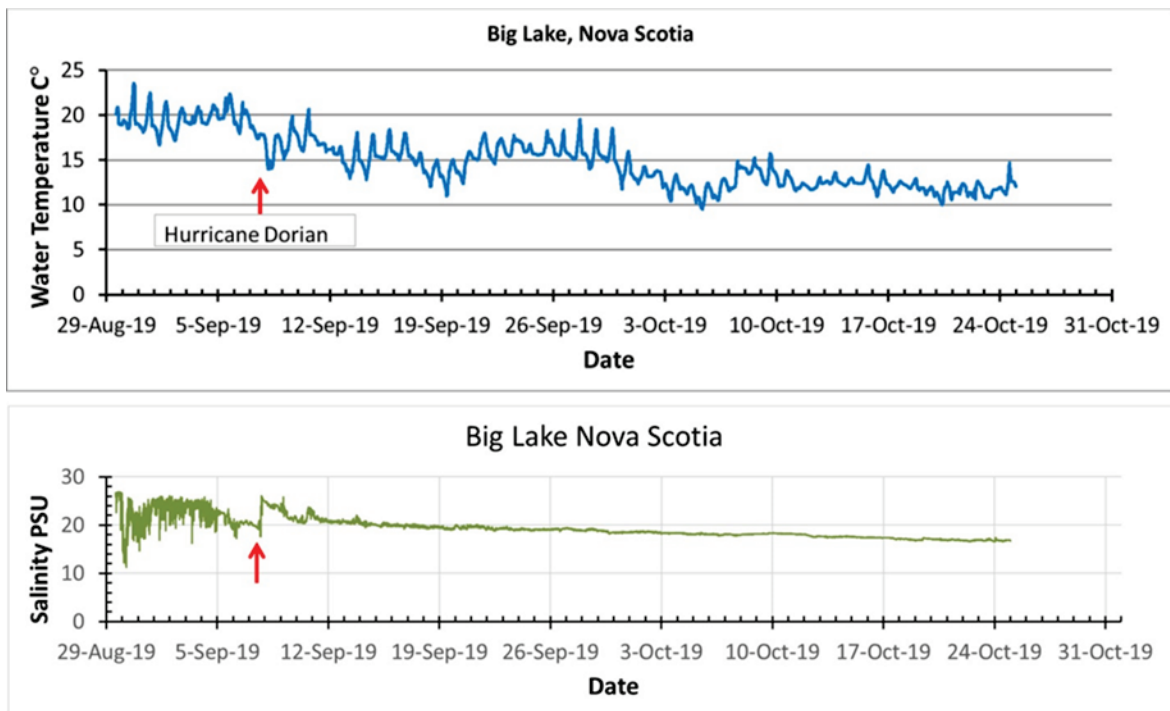
Figure 6. Changes in water temperature and salinity recorded during 2019 at sensor "b" (Fig. 1) in Big Lake. A sharp drop in water temperature and increase in salinity was observed during Hurricane Dorian. It is not clear why the graph of salinity was smoother before and after the hurricane.

Water salinity in Big Lake dipped from 20.0 to 17.6 PSU at 18:34 ADT, then rose sharply to 23.9 PSU by 19:19 ADT, and reached a maximum of 26.1 PSU at 19:39 ADT (Fig. 6). These changes in salinity document the peak of the storm, when the maximum influx of seawater and mixing of Big Lake occurred. The salinity of Big Lake decreased to 16.7 PSU by 25 October 2019.

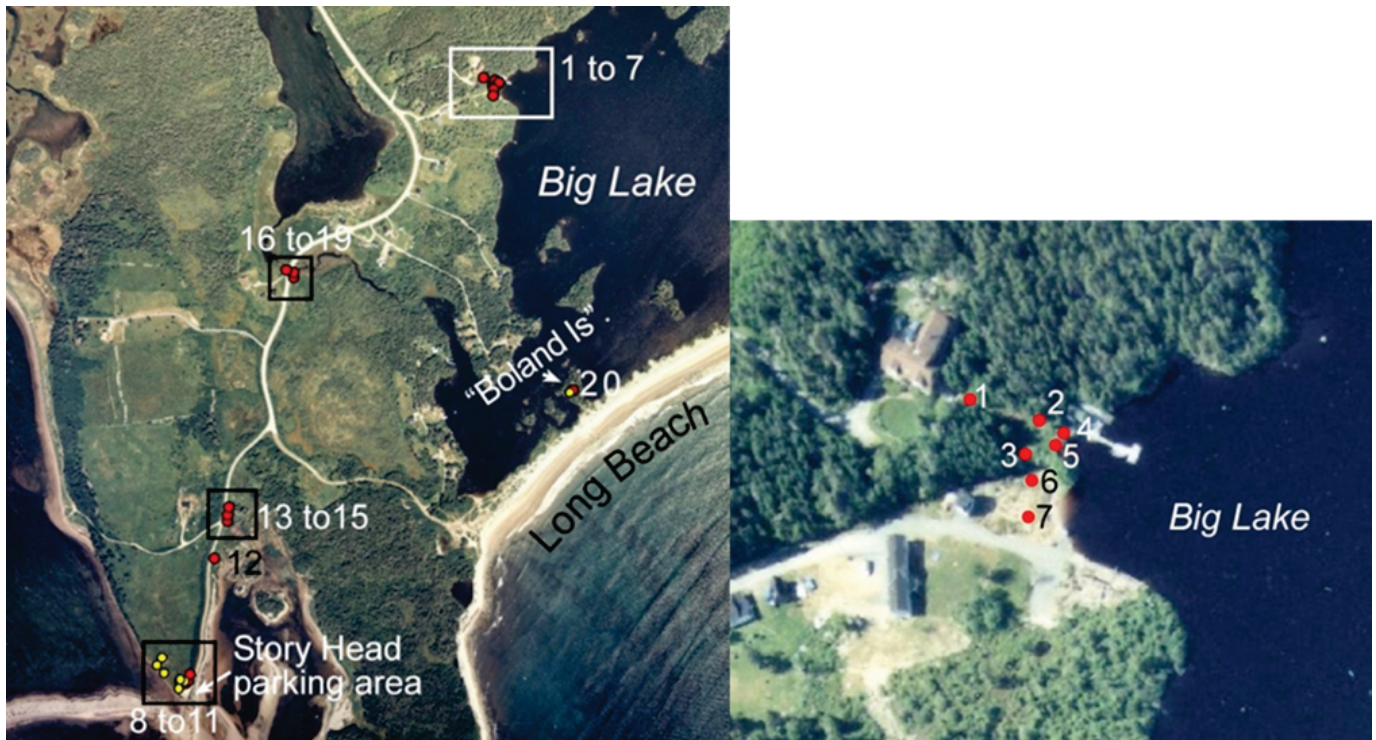
Figure 7. Location of high water levels and storm debris lines surveyed after Hurricane Dorian at Long Beach and the adjacent shores. The geographic coordinates and elevations (CGVD28) of specific points are listed in Table 2. An enlarged map of points 1 to 7 along northwestern shore of Big Lake is provided on the photo to the right.

Debris lines were surveyed to record the extent and elevation of wave run-up and flooding (Fig. 7, Table 2). During the storm, wave run-up extended across all of Long Beach but the magnitude of overwashing and the extent of landward beach migration depended on beach crest elevation, barrier width and whether trees or other shrubs existed along the backshore prior to the storm, e.g. at Line 0 (Figs. 1, 3, 8, 9, 10). Where the crest and backshore were higher than 4 m, i.e. at the western headland and island at the central barrier, waves scoured the slopes and toppled trees (Fig. 9a). Between 3.9 and 4.0 m (CGVD28) elevation, waves extended to the crest and water flowed over it, but with little movement of pebble cobble clasts across the backshore. The lack of backshore change on the higher western barrier is represented by changes at Line -1, (Figs. 1, 3a, 8a, 10). Where the beach crest was less than 3.9 m (Fig. 3a) increased volumes of water overwashed the crest and transported sediment and debris down the back-barrier slope, in many cases into Big Lake (Figs. 8, 9b, 10). For comparison, during Hurricane Juan in 2003, wave run-up commonly reached 2.4 to 2.8 m and a maximum of 3.3 m at the east end.

The only flood level surveyed at Long Beach was on “Boland” Island, (Front cover, Fig. 7) where water level, close to high tide, reached the lower steps of the residence (Susan Boland, pers. comm. 2019). The elevation was 2.48 m (CGVD28), compared with 2.15 m recorded during Hurricane Juan in 2003 (Table 2).

by winds blowing from an east to northeast direction dislodged docks and wharfs along the northern shore of Big Lake (Fig. 11). Along the shore at and adjacent to the Hawkins residence, storm surge combined with wave run-up extended to elevations of 2.4 to 3.0 m (Fig. 7, points 1-7, Table 2).

Farther west along the outer coast, at the east end of Story Head Beach (Fig. 1), wave run-up reached 2.3 to 2.4 m elevation (Fig. 7, Table 2). During Hurricane Juan in 2003, wave run-up at the same location was 0.4 m higher (Table 2) and debris was deposited as high as 3.7 m where waves broke against the shore armour rock. Lower wave run-up at the eastern end of Story Head during Hurricane Dorian was attributed to its location being more sheltered from the strongest winds and waves with an easterly component.

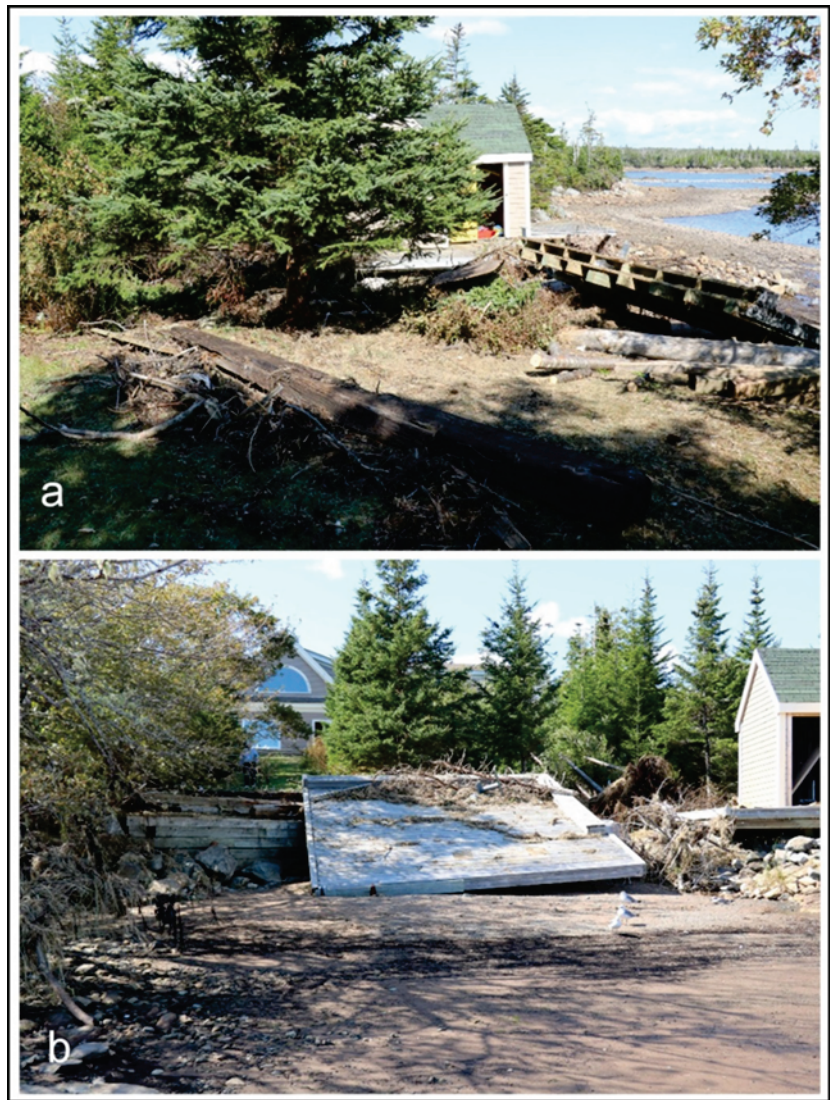
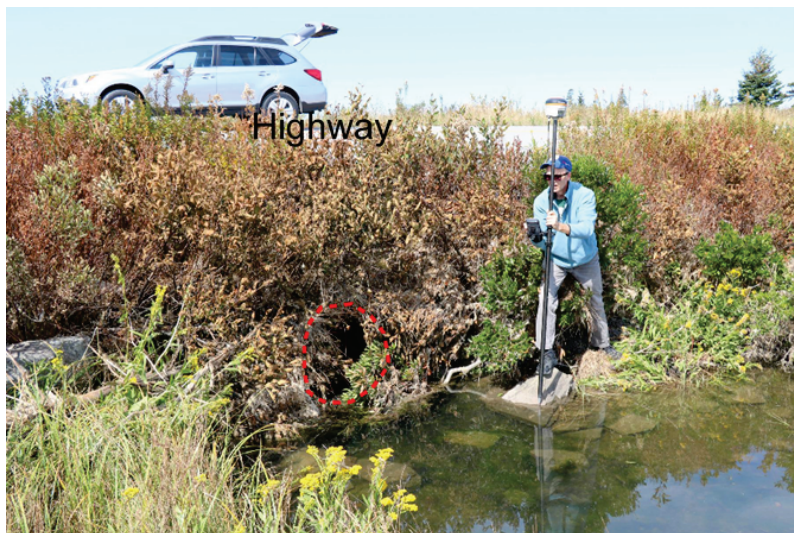
Figure 11. Views of debris lines and damage caused by waves and elevated water level during Hurricane Dorian at the Hawkins property, Big Lake, Nova Scotia (Photographs by R.B. Taylor, 19 Sept. 2019, NRCan photos 2020-857, -858).

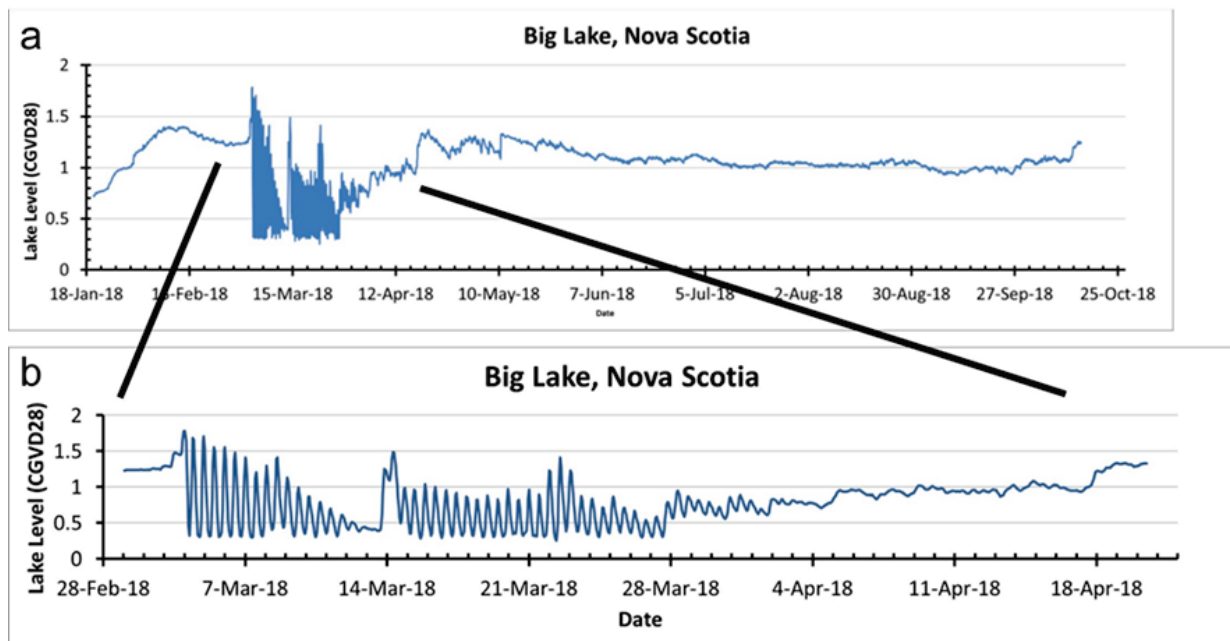
Figure 13. (a) Lake levels recorded in Big Lake from January to October 2018 illustrating the recovery of water levels after temporary inlets (cut through Long Beach) were closed January 18 and April 8, 2018. (b) An enlarged view of the hydrograph highlighting the tidal signal in Big Lake with a temporary inlet and the well-defined truncation in the low tide signal as a function of tidal channel depth.

The hydrograph for Big Lake in 2018 (Fig 13) illustrates lake level recovery after an inlet closed in late January and early April. The hydrograph is much more consistent when the lake is non-tidal. When temporary inlets formed the low tide signal was truncated relative to the inlet channel depth (Fig. 13a, b). The tidal signal on the hydrograph disappeared briefly on March 13 (Fig. 13b) when neap tides were too low to enter the lake and after April 2, when the channel infilled to an elevation of 0.7 m (CGVD28) despite the channel not being physically closed, with water flow not stopping until April 8. The tidal signal became more irregular and disappeared as the lake was recharged and reached its upper level of 1.4 m (CGVD28) (Fig. 13b).

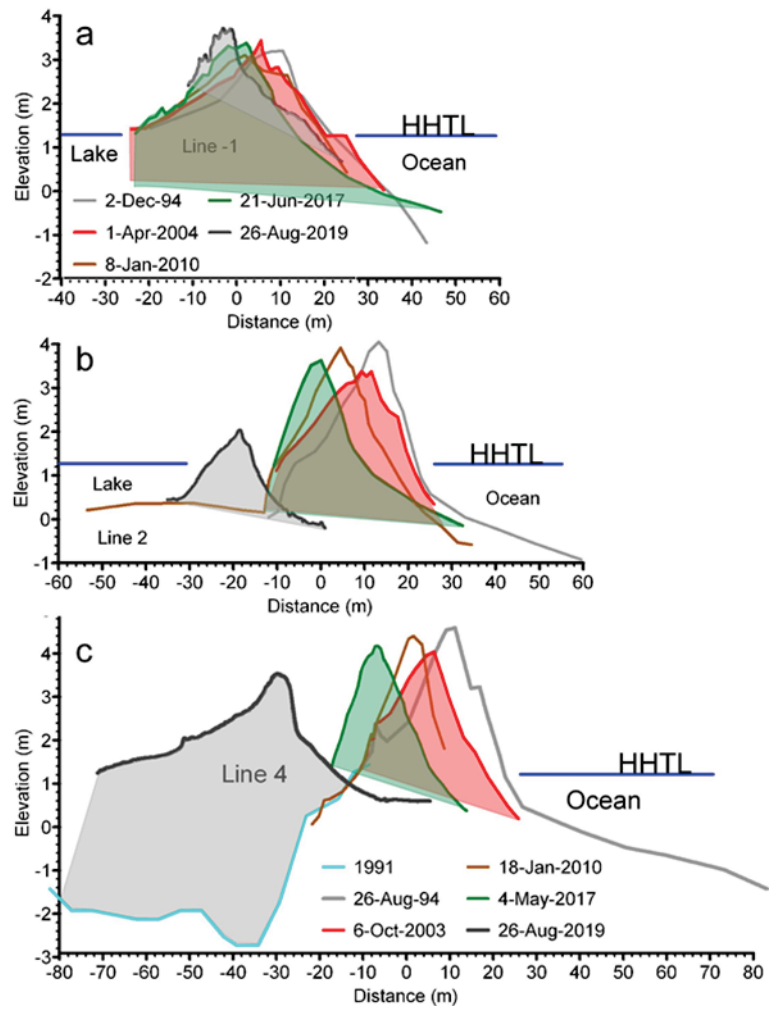
Figure 15. Repetitive cross-shore surveys at three locations between the early 1990s and 2019 illustrate the physical response to wave activity along three parts of Long Beach: (a) Line -1 at the west end, (b) Line 2 at the central barrier, and (c) Line 4 located east of centre (Fig. 1). The graphs illustrate the impact of Hurricane Juan in 2003 (red shade), natural barrier beach recovery and migration by January 2010 when Long beach was first cut and the accelerated barrier migration by 2017 (green shade). Beach changes during Hurricane Dorian (grey shade) illustrate how the beach at Line -1 was able to rebuild across the backshore platform, whereas at Line 4 increased sediment was required to infill Big Lake before the barrier could rebuild. At Line 2 the barrier in 2019 was rebuilding on washover deposits that accumulated in Big Lake because of a previous cut that existed before 1945.

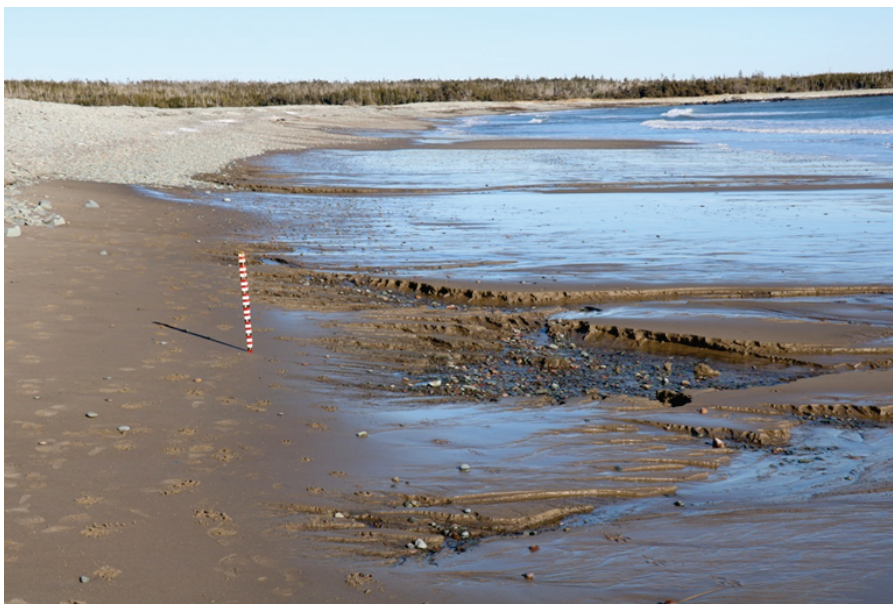
Figure 16. Seepage channels at Line 2a Long Beach where the barrier was cut in January 2010 and in March 2019. Seepage through coarse-clastic barrier beaches is a natural alternative to surface flow through a tidal inlet to maintain water levels in back-barrier water bodies. The larger seepage channels observed at this location (03 Feb. 2019) may have been a precursor to changing conditions that led to a change in drainage from Big Lake (graduated staff marked at 2 cm intervals provides scale). Photograph by R. B. Taylor, NRCan photo 2020-860.
