**A REPORT**  
**ON THE ESTABLISHMENT**  
**OF PRECISE ASTRONOMIC STATIONS**  
**ALONG**  
**THE ALBERTA-NORTHWEST TERRITORIES**  
**BOUNDARY**  
**BETWEEN THE MACKENZIE HIGHWAY AND THE LITTLE BUFFALO R.**  
**SEASON OF 1950**  
**W.D. FORRESTER**  
**GEODETTIC SURVEY OF CANADA**

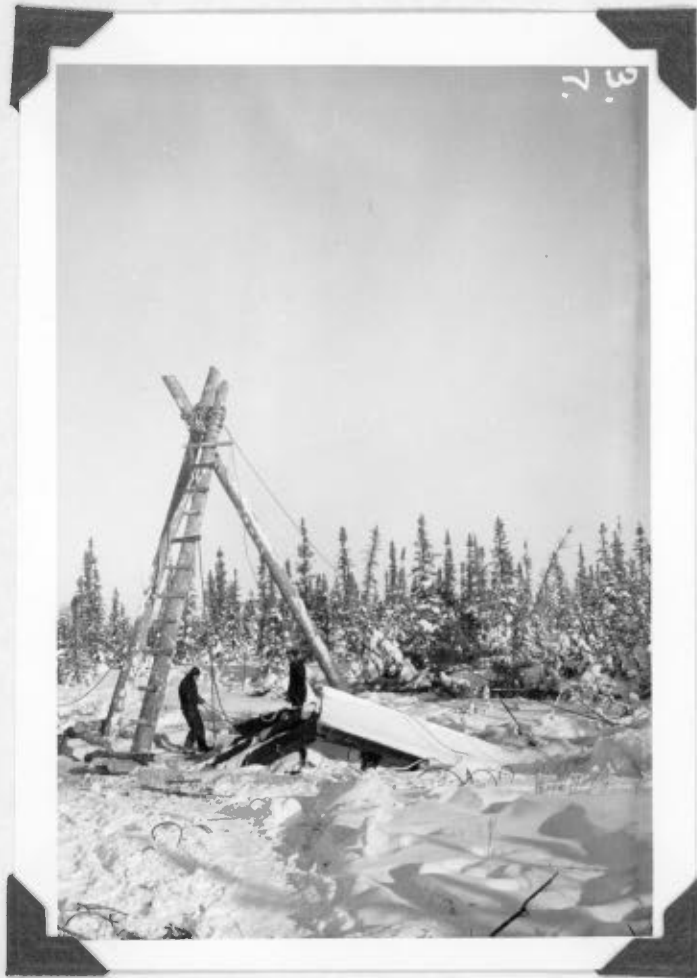
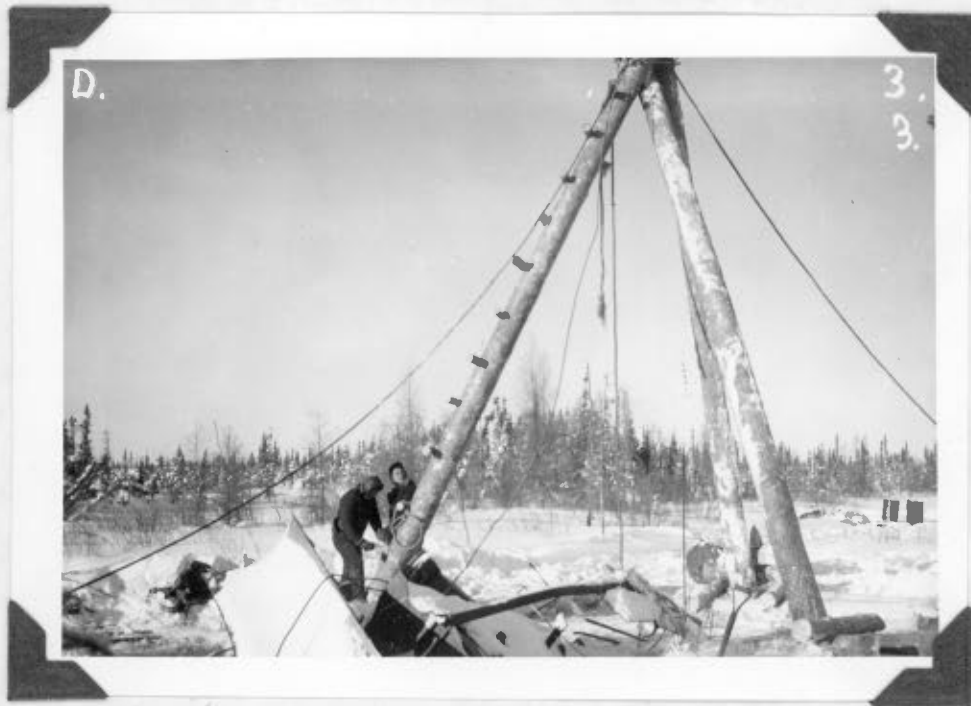
Tripod of 20 ft. timbers erected over TD 18

Another view of tripod over sunken bulldozer

For the next two weeks everyone's attention was focussed on the TD 18. A footing of timbers was frozen in around the cat, a tripod was erected on this footing, and block and tackle was hung from the tripod. It was Dick Bond's intention to hook a cable on to the drawbar at the rear of the cat, and as this drawbar was about 5 feet below the surface of the water, mud, and slush, attempts were made to lower the water level with forestry pumps. These attempts failed only because the pumps were not quite fast enough, however, the water level was lowered by as much as 2 feet for a short while. Meanwhile, the Bombardier had been making several trips to Hay River and two aircraft had also flown from Hay River with more pumps and some "experts" on salvage operations. The experts did much poking at the cat with sticks and much shaking

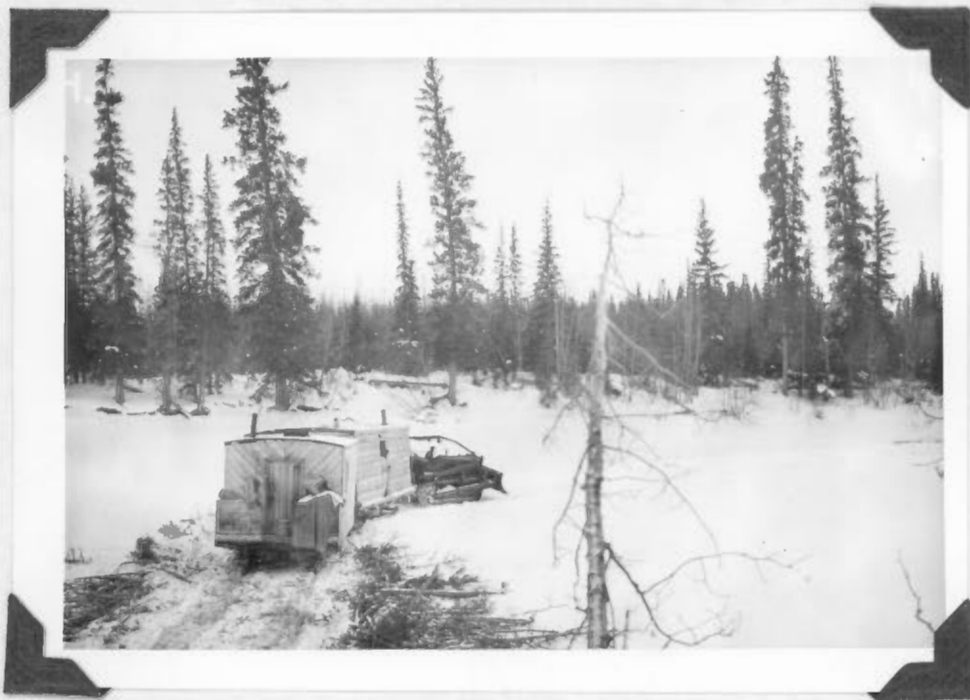
Tractor train crossing Whitesand River. Note ramp of brush and snow down river bank.

The river had been banked on both sides with brush and snow to make approaches, and brush had been pushed by the bulldozer quite far out on the river to cover the weakest looking ice. We passed through the jack-pine that lined both sides of the Whitesand and passed into muskeg country, again with the usual spruce and tamarack. Now and again we encountered a small jack-pine grove; it was important to watch for jack-pine since they always indicate sandy or gravelly soil, which makes an excellent spot for a permanent

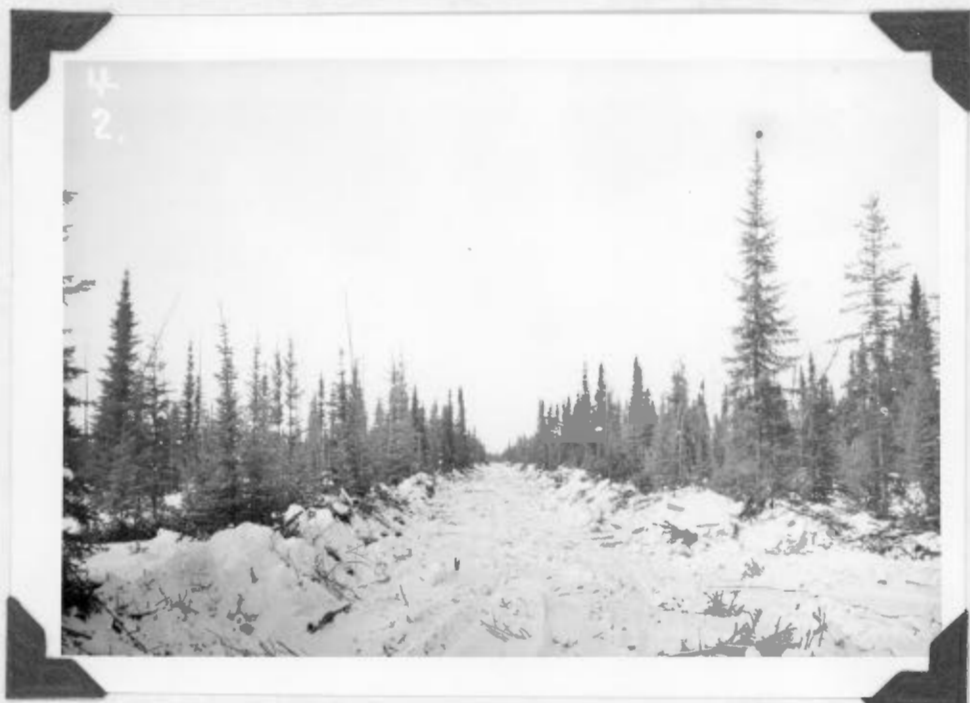
Piece of tractor road through spruce trees near Whitesand River. Road is about 14 feet wide.

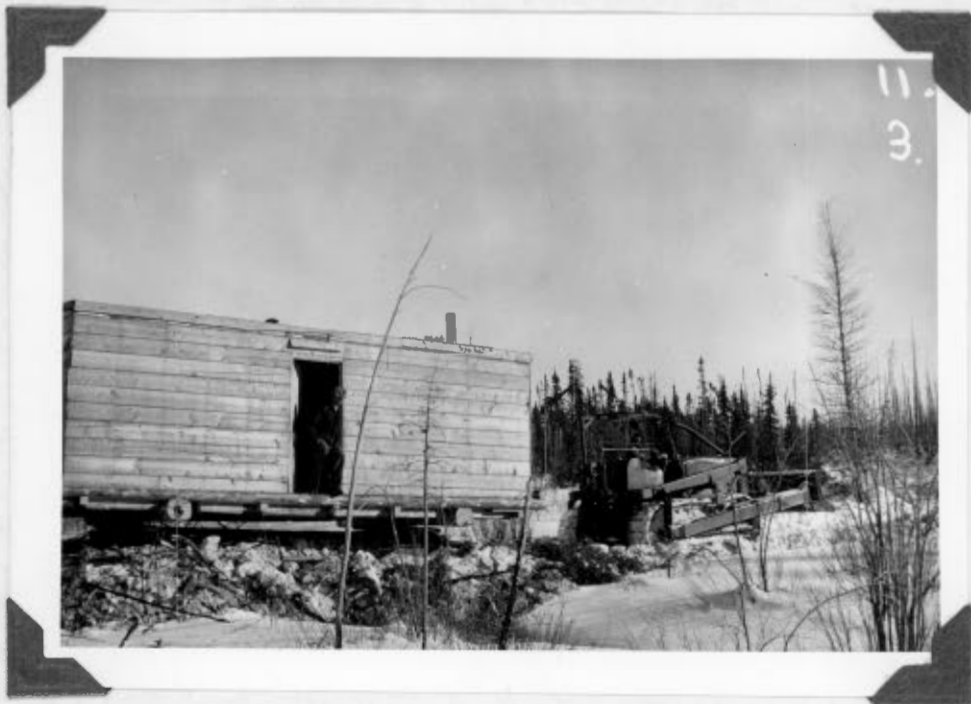
Tractor train crossing unfrozen sulphur stream.  
Note the bridge of brush and snow across stream.

station mark. About 5 miles east of the Whitesand we came to a creek about 50 feet across, which had had to be completely filled in with brush and snow since the ice was hanging, and hence, too dangerous for crossing over. The creek was lined with spruce of as much as a foot in diameter. We moved along behind the bulldozer until March 19, when we reached a suitable spot for the next station, to the east of Buchan Lake. We had been travelling over the same humpy muskeg and through the odd jack-pine grove all the way. Buchan Lake did not have any large growth around it, but seemed to be totally surrounded by muskeg. A stream flowing out of the east end of the lake smelled of sulphur, and had remained unfrozen all winter. We placed our station in a grove of jack-pine 60 feet tall about 3 miles beyond Buchan Lake. There was also an unfrozen stream near here smelling strongly of sulphur.

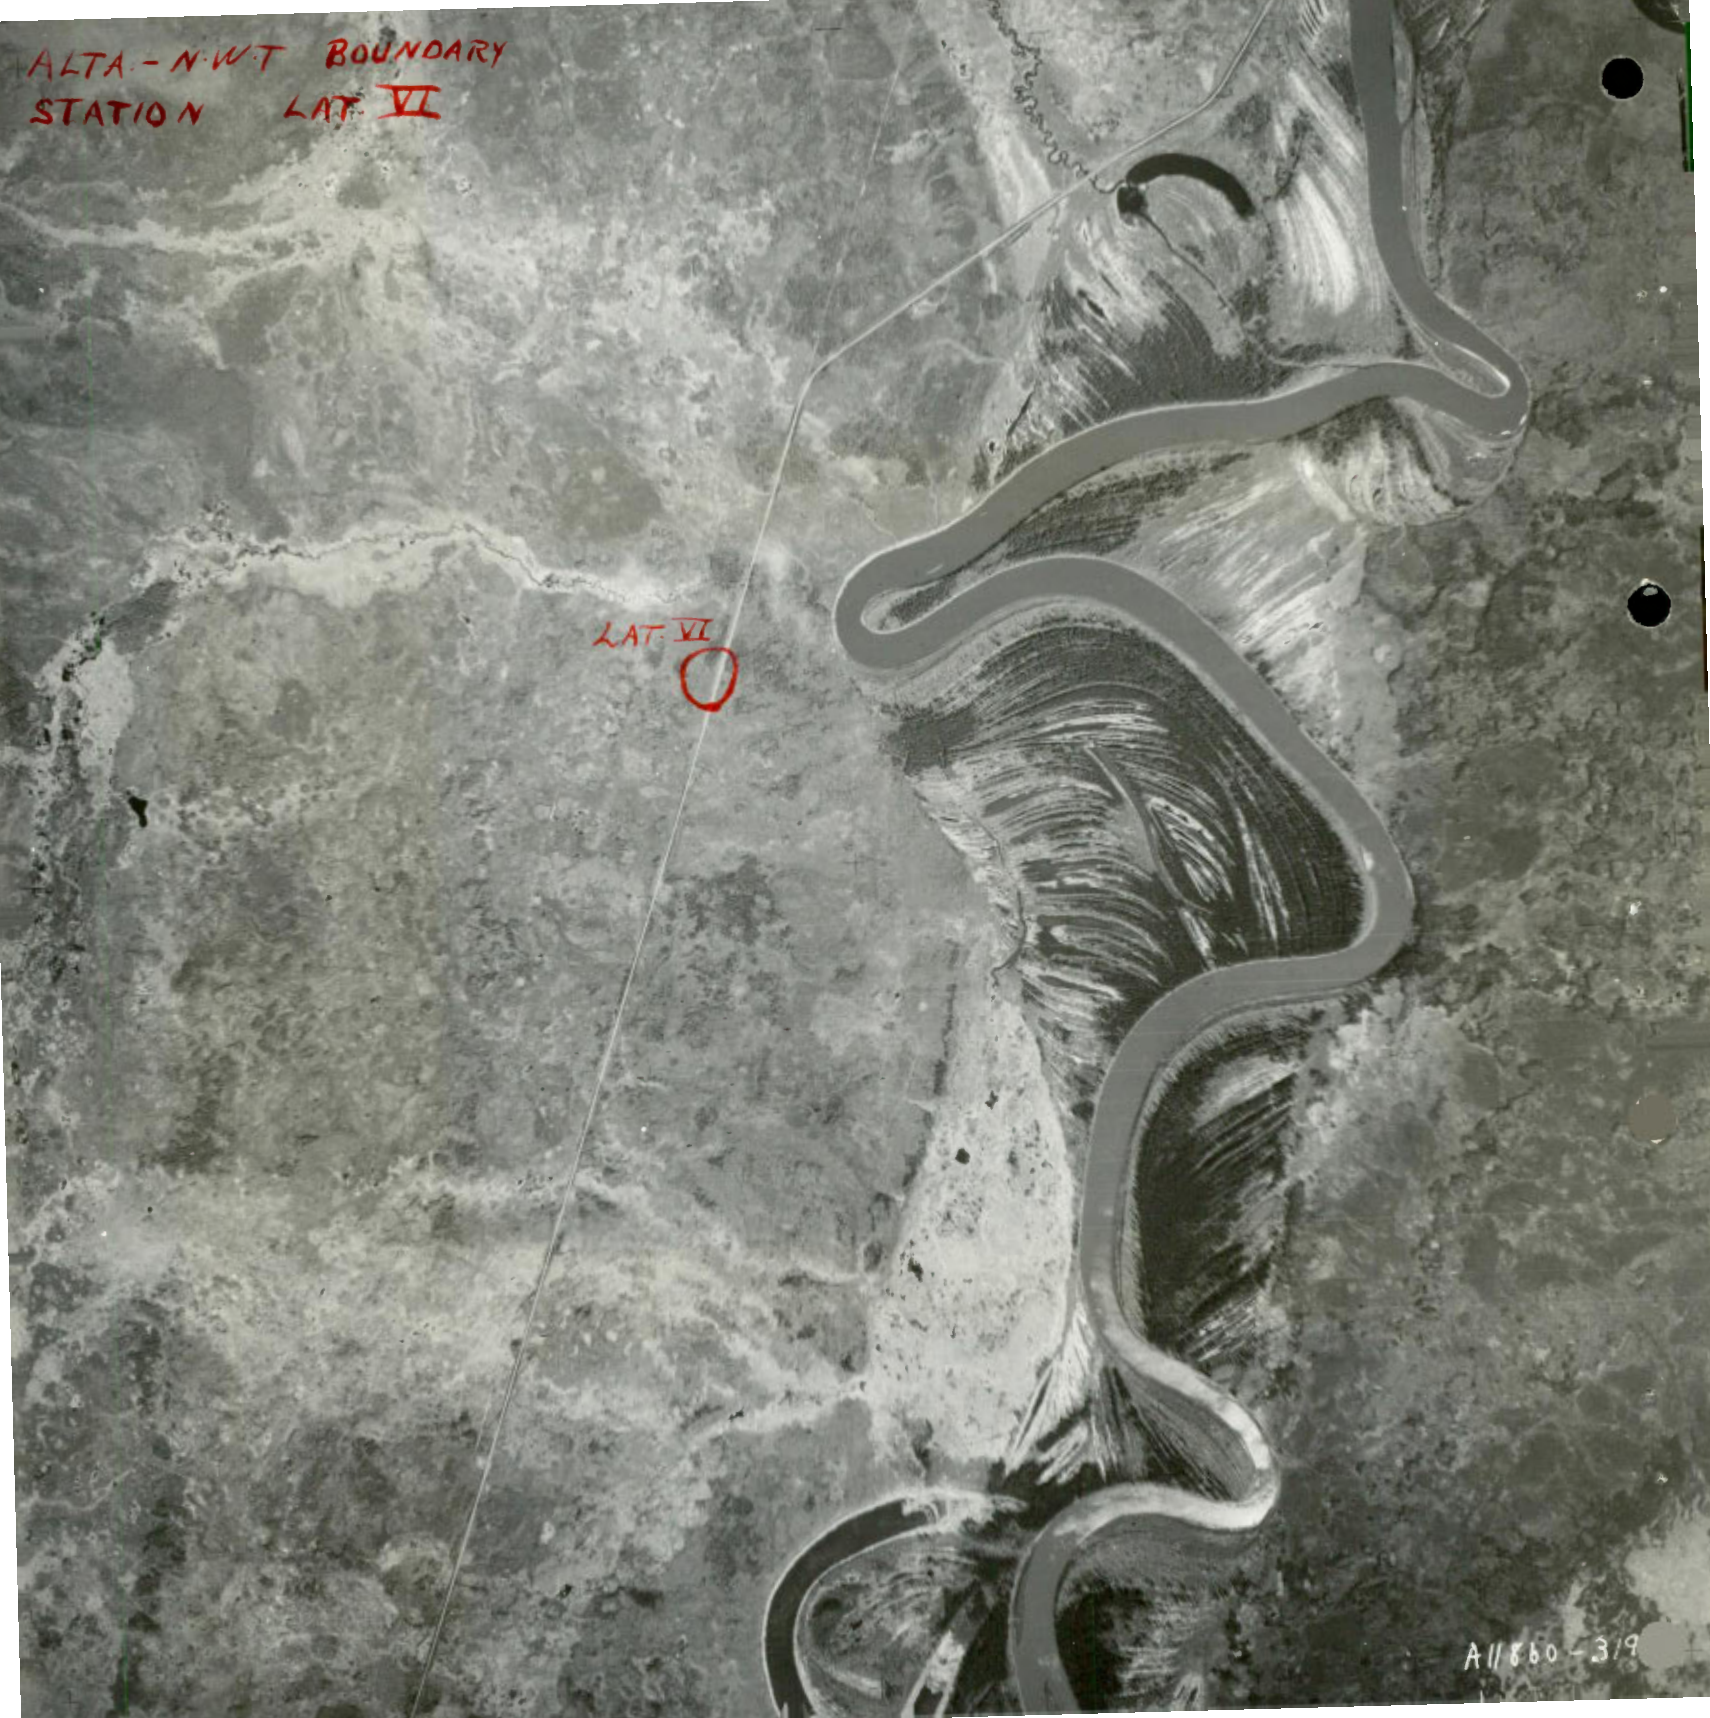
LAT. VI  
○

$\Delta$  - STATION MARKER

BT - BEARING TREE

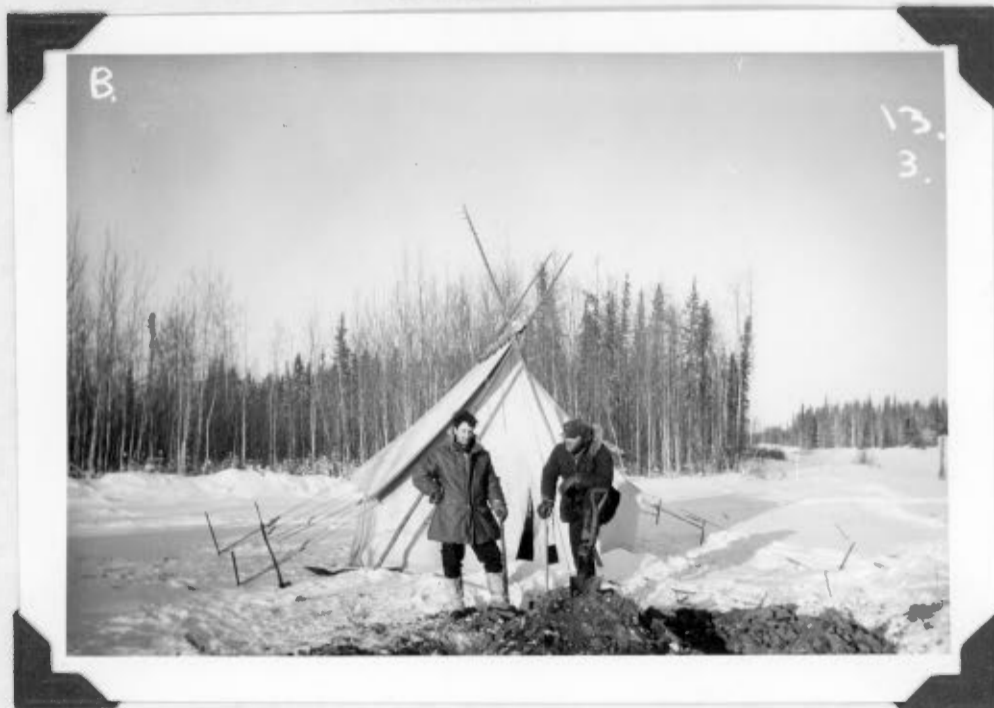
Digging station mark in front of observing tent.

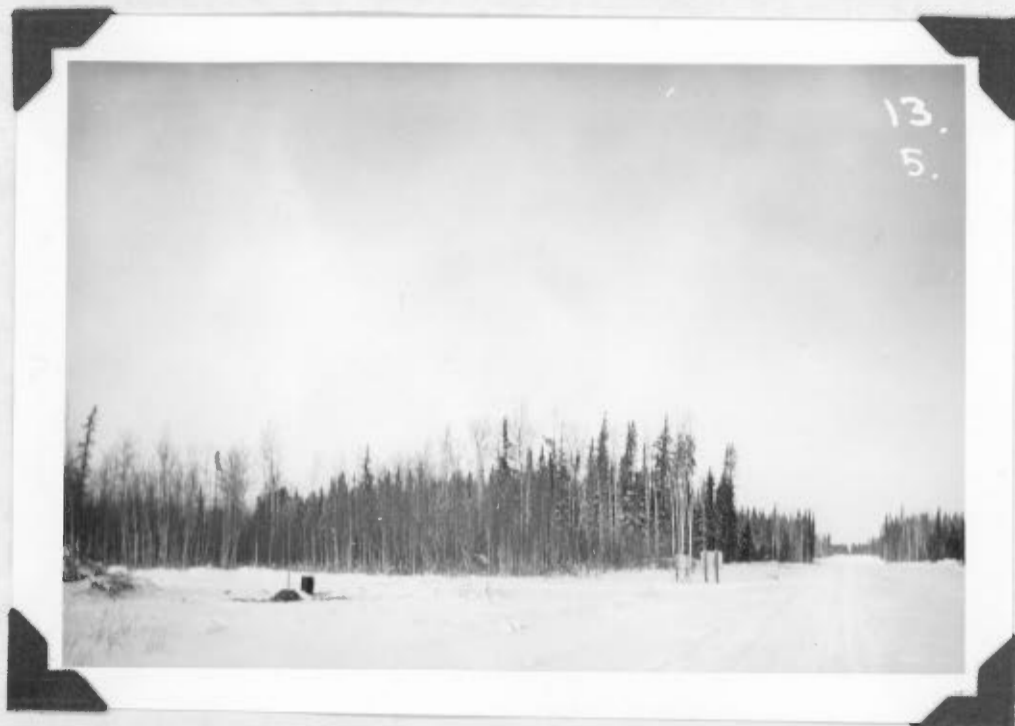
Looking north along Mackenzie Highway, showing station marker at left.

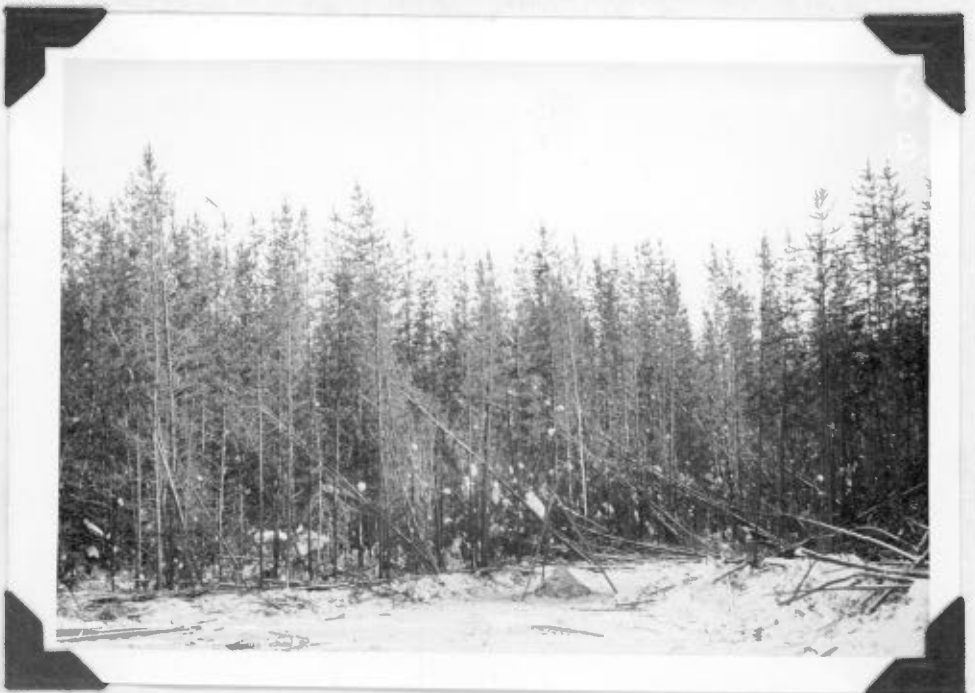
Looking south of east at completed station mark.

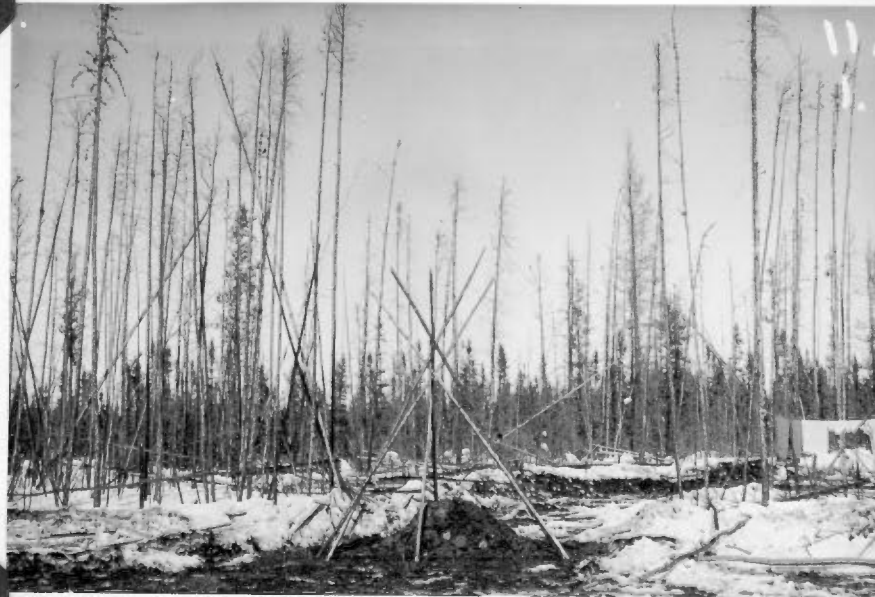
Complete station mark, looking north along loop in trail.

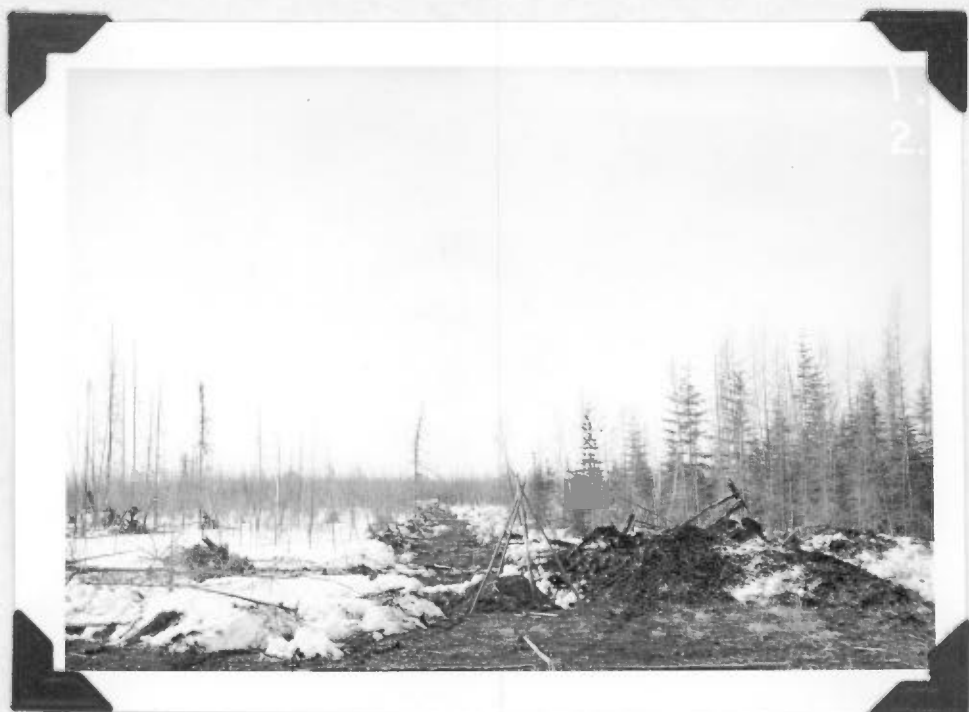
Station marker, looking south along out line.

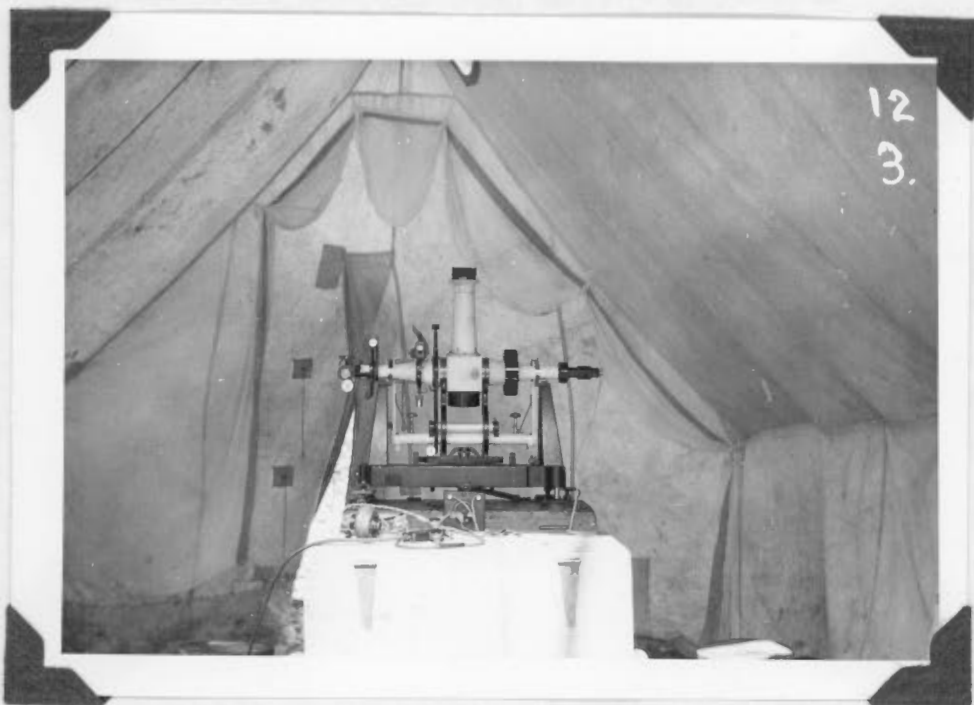
Heyde transit in observing tent. The opening in the roof of the tent shows a little at top of picture.
