RESOLVING AMBIGUITIES IN INTERPRETING
THE THERMAL SIGNATURE OF
ICE AND WATER IN AERIAL
THERMOGRAMS OF FLAT ROOFS

A Project Conducted for the
Canada Centre for Remote Sensing
Contract #195Q23414-8-3000

Philip A. Lapp Ltd
Suite 100
56 Sparks Street
Ottawa, Ontario
K1P 5A9

November 24, 1978

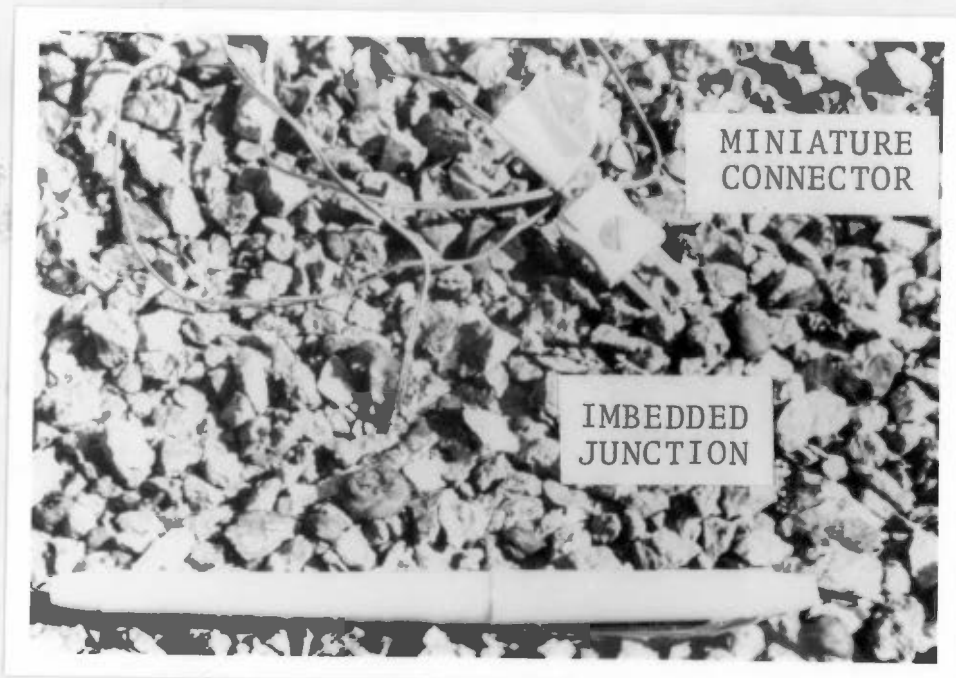
FIG. 3.3 Installation of Thermocouples

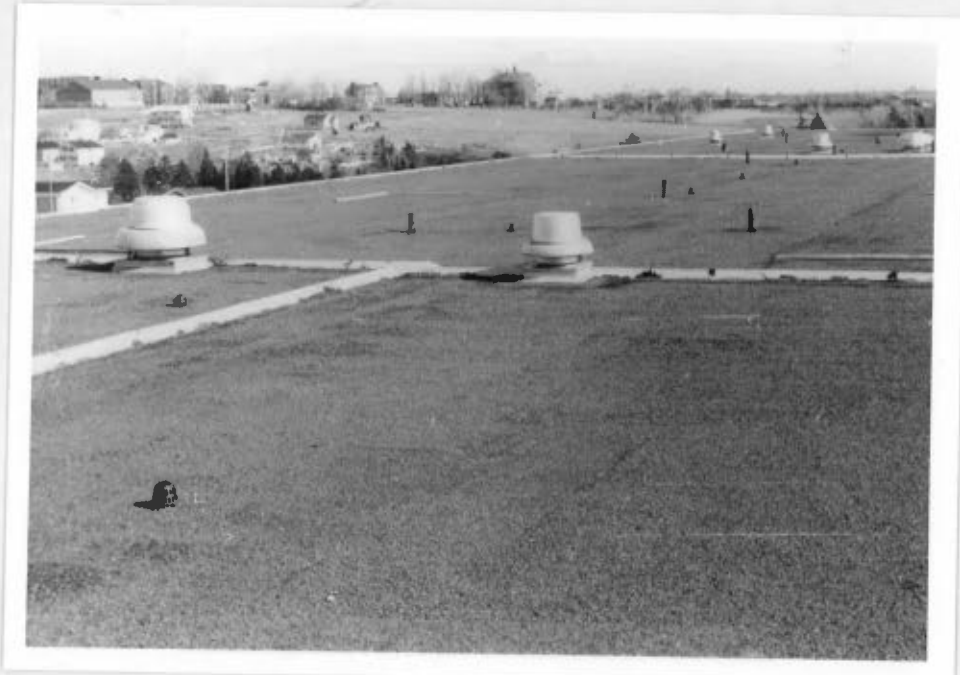
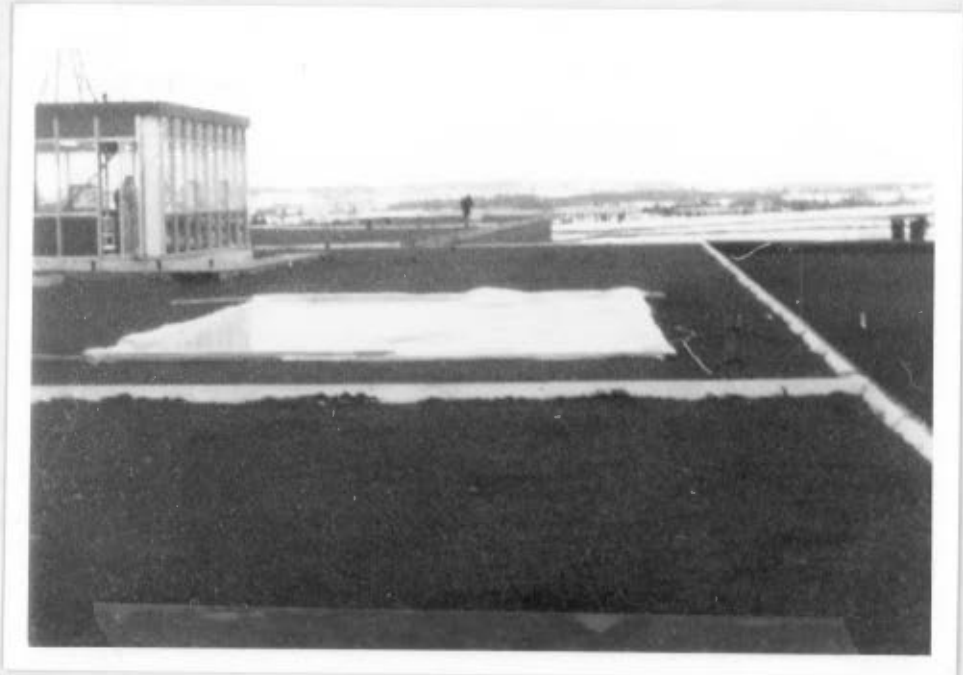
FIG. 3.4 Views of Control Surfaces

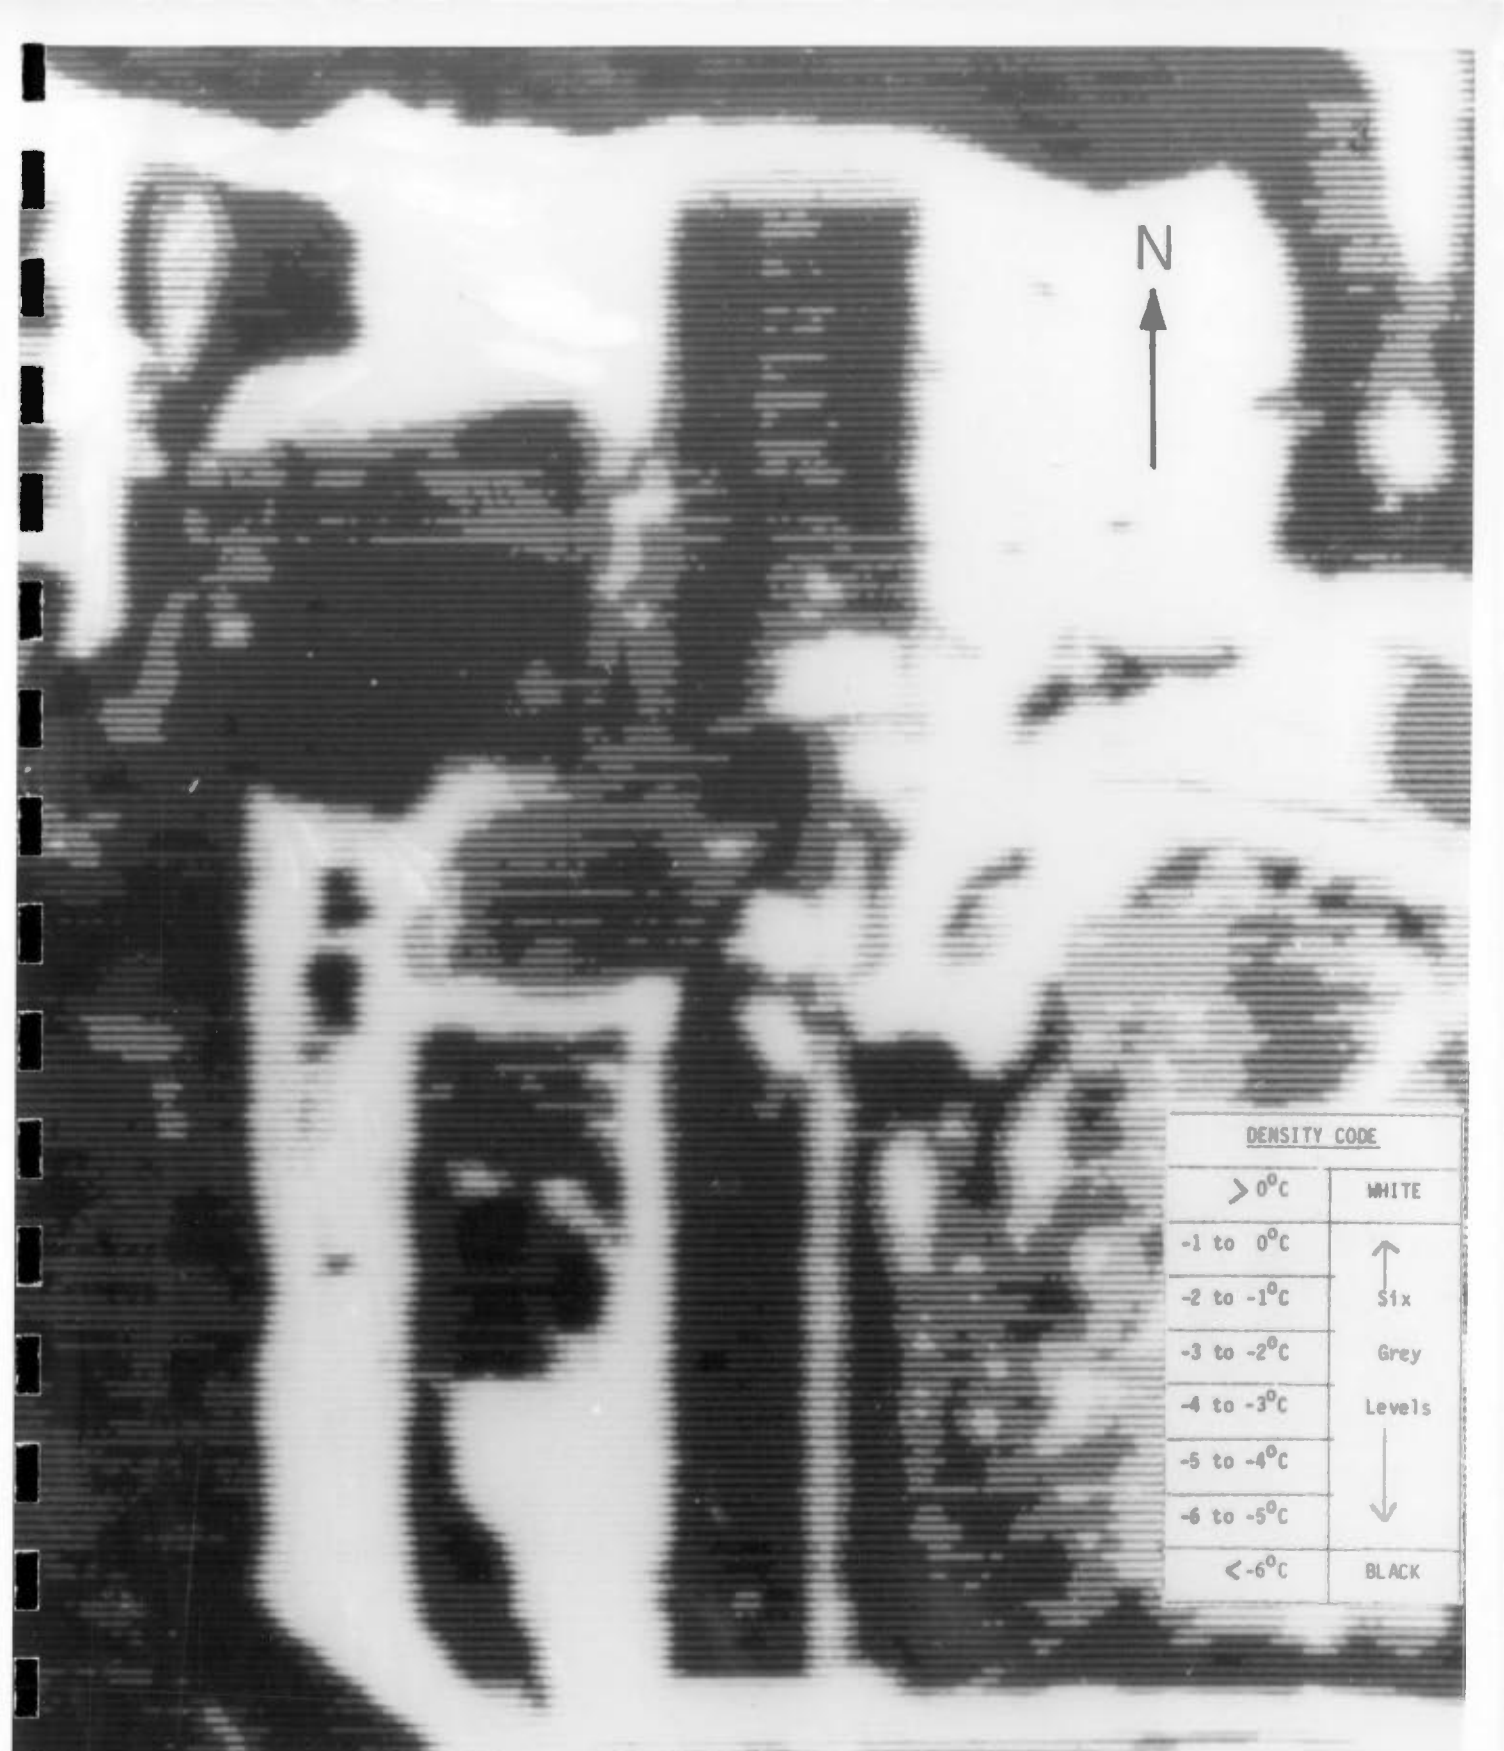
FIG. 4.6: Hollard College Royalty Centre, 11:10 P.M., March 26, 1978. Air temperature, -8.4°C. Wind, 10 kph approximately. Radiative sky temperature, -18°C. Thin overcast at 3.7km.

Part of the temperature vs. density code for the level-slicing used for the thermograms in Figures 4.6 and 4.7 is reproduced below:

In both thermograms, the radiant temperature of the dry portion of the grid falls in the 1st grey level. The radiant temperature is therefore between -6.0°C and -5.3°C . The radiant temperature of the sprayed portion of the grid falls in the second grey level in both thermograms except for a small wedge in Figure 4.7 near the bottom of the grid where the temperature shifts back into the lower band. Neglecting this small part for the moment the radiant temperature of the sprayed section is between -5.0°C and

-4.7°C. Thus the change in contrast from the dry to the sprayed portion indicates a radiant temperature change ranging from a minimum of 0.3 to a maximum of 1.3 degrees (C). Taking a simple average gives 0.8°C. Returning now to the fact that a small wedge of the sprayed section falls into the 1st grey level in Figure 4.6, one concludes that the radiant temperature of the sprayed section must be close to the cross-over temperature of -5°C between the bands, perhaps 5.1°C. The likely maximum temperature spread therefore is 1.1 instead of 1.3 degrees and the average becomes 0.7 degrees. Since the outside is actually 0.23°C cooler, the total change in radiant temperature is estimated to be 0.9°C.

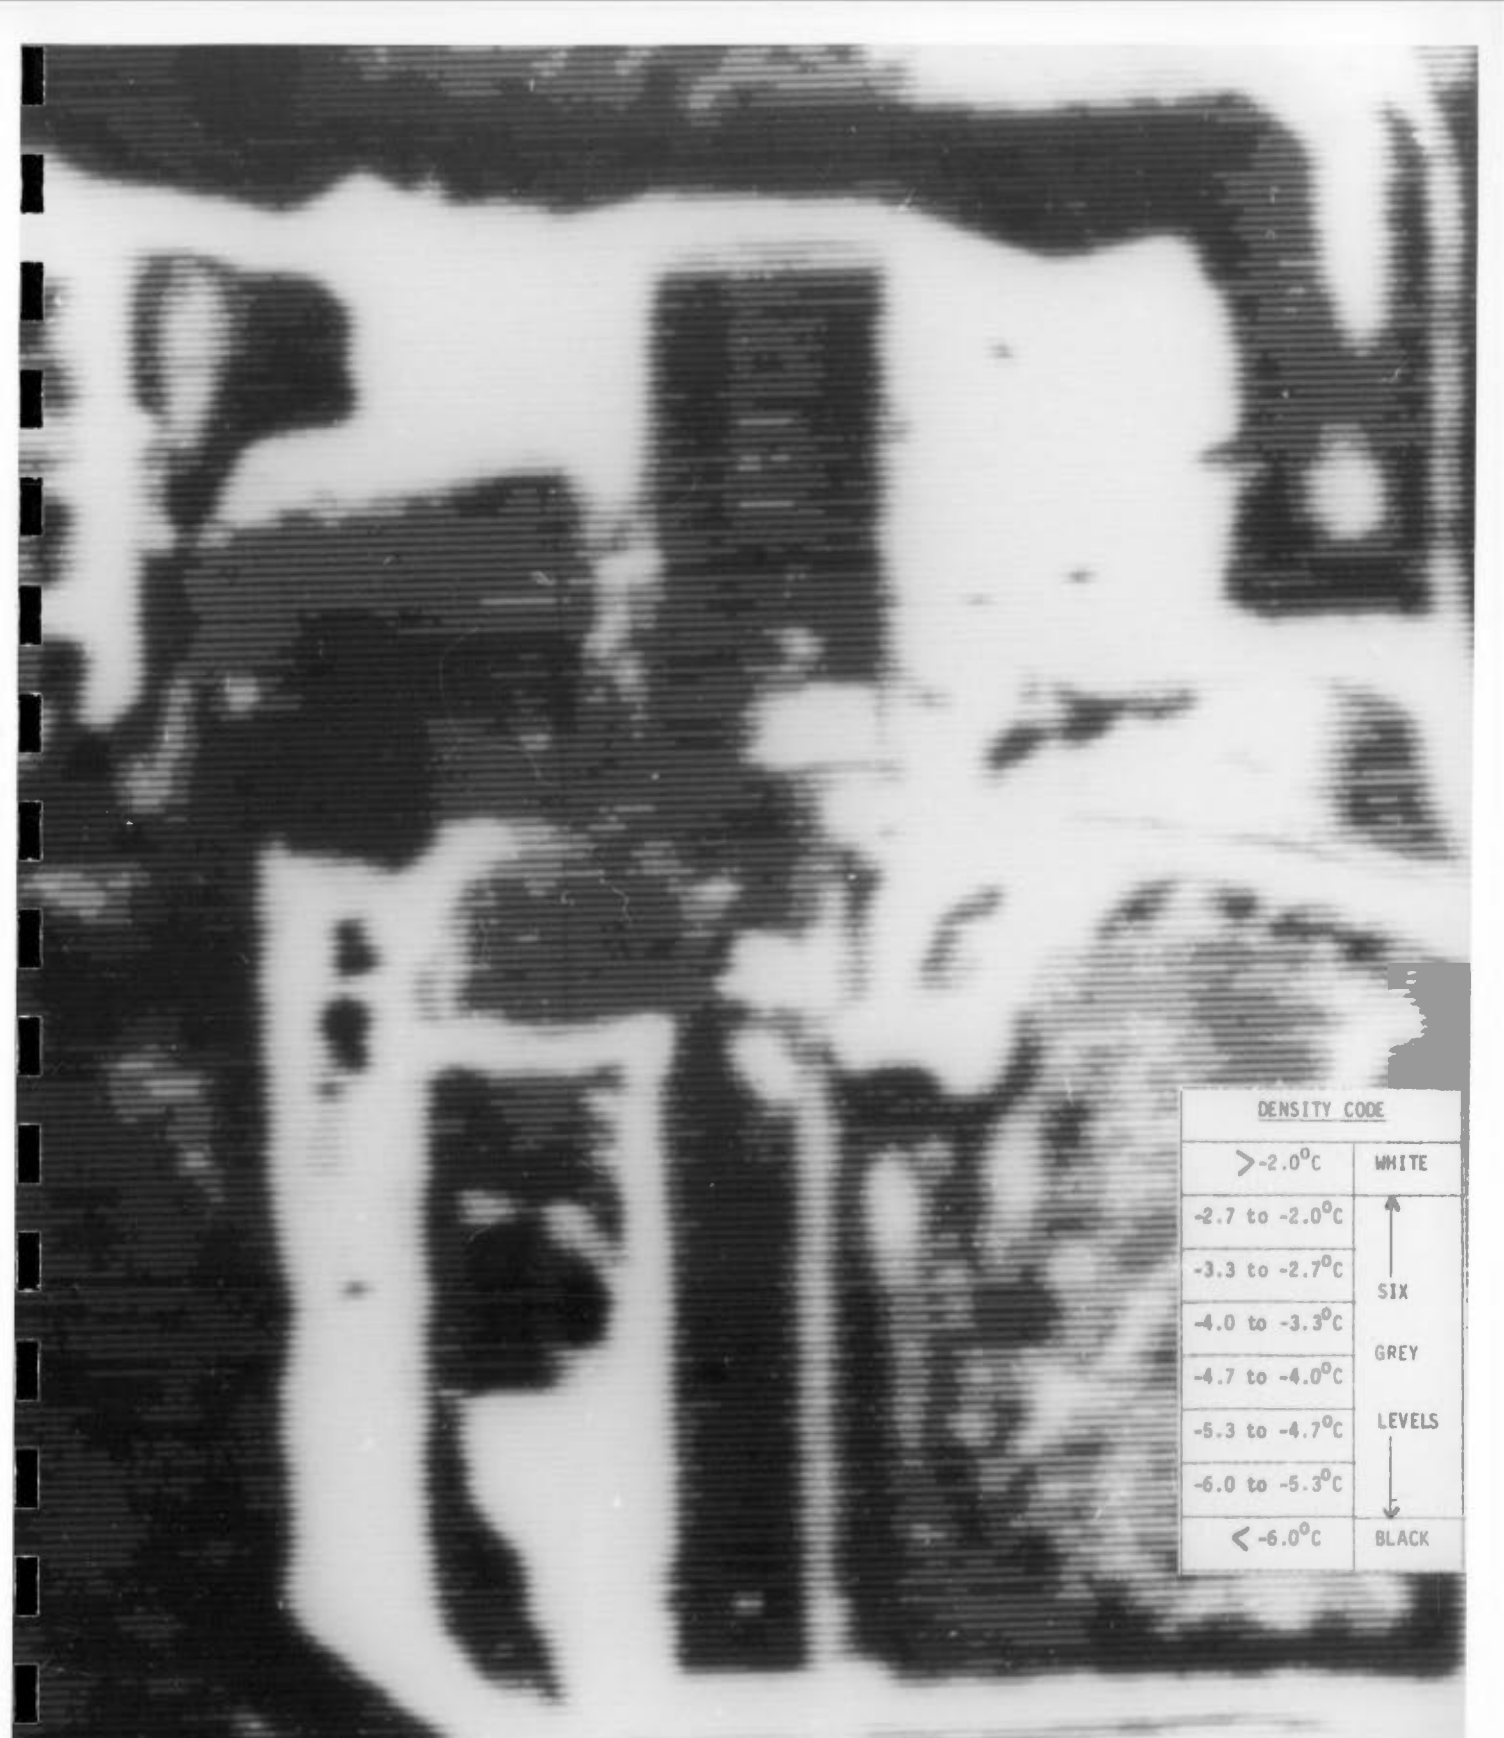
FIG. 4.7: Holland College Royalty Centre, 11:00 P.M., March 26, 1978. Air temperature, -8.4°C. Wind, 10 kph approximately. Radiative sky temperature, -18°C. Thin overcast at 3.7km.

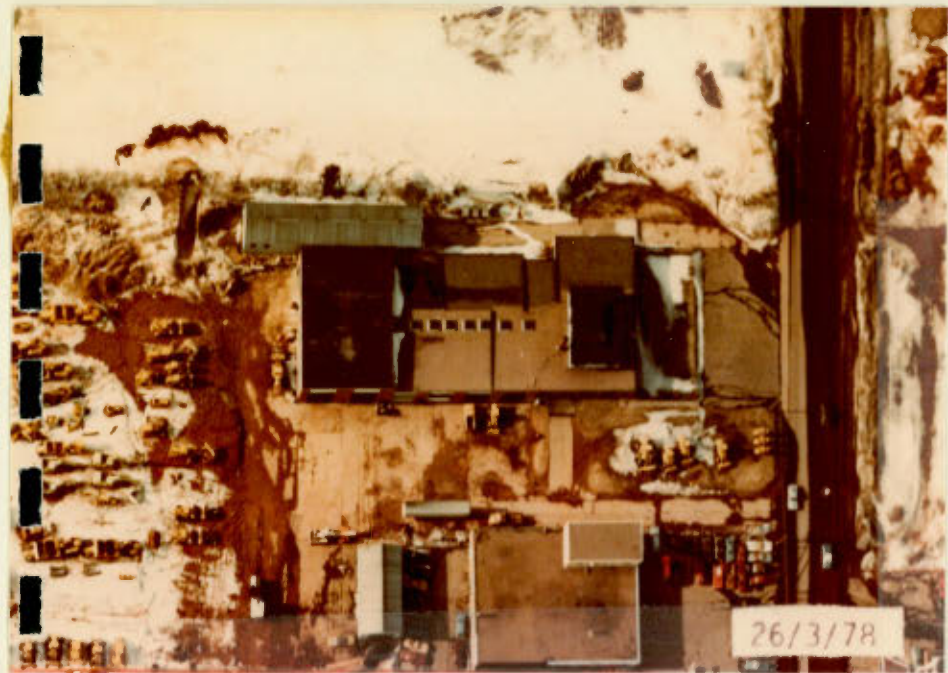
P-2 MAY 8, 1978

The skylights 7, are about 2 metres on a side and conveniently fill one scan line. There are eight skylights, four can be seen in P-3.

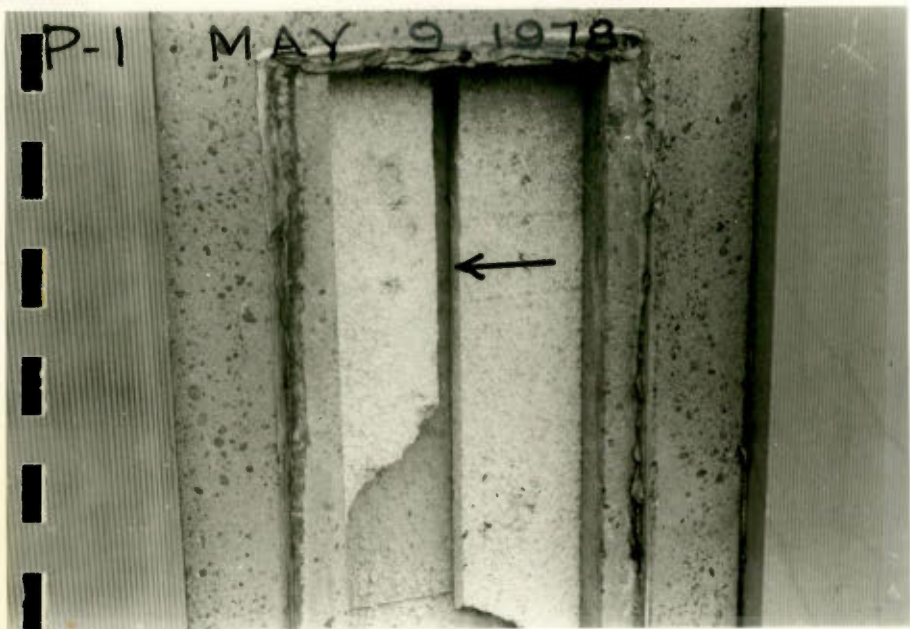
P-1 MAY 9, 1978

The vertical walls of the building are windowless (see P-2). This feature would ordinarily reduce the edge effect considerably but they are poorly insulated (see P-1) with 3 cm. of foam slab, some of which has been installed with a wide gap between the sheets. The broken pieces in P-1 was probably caused by the removal of the facing stone.

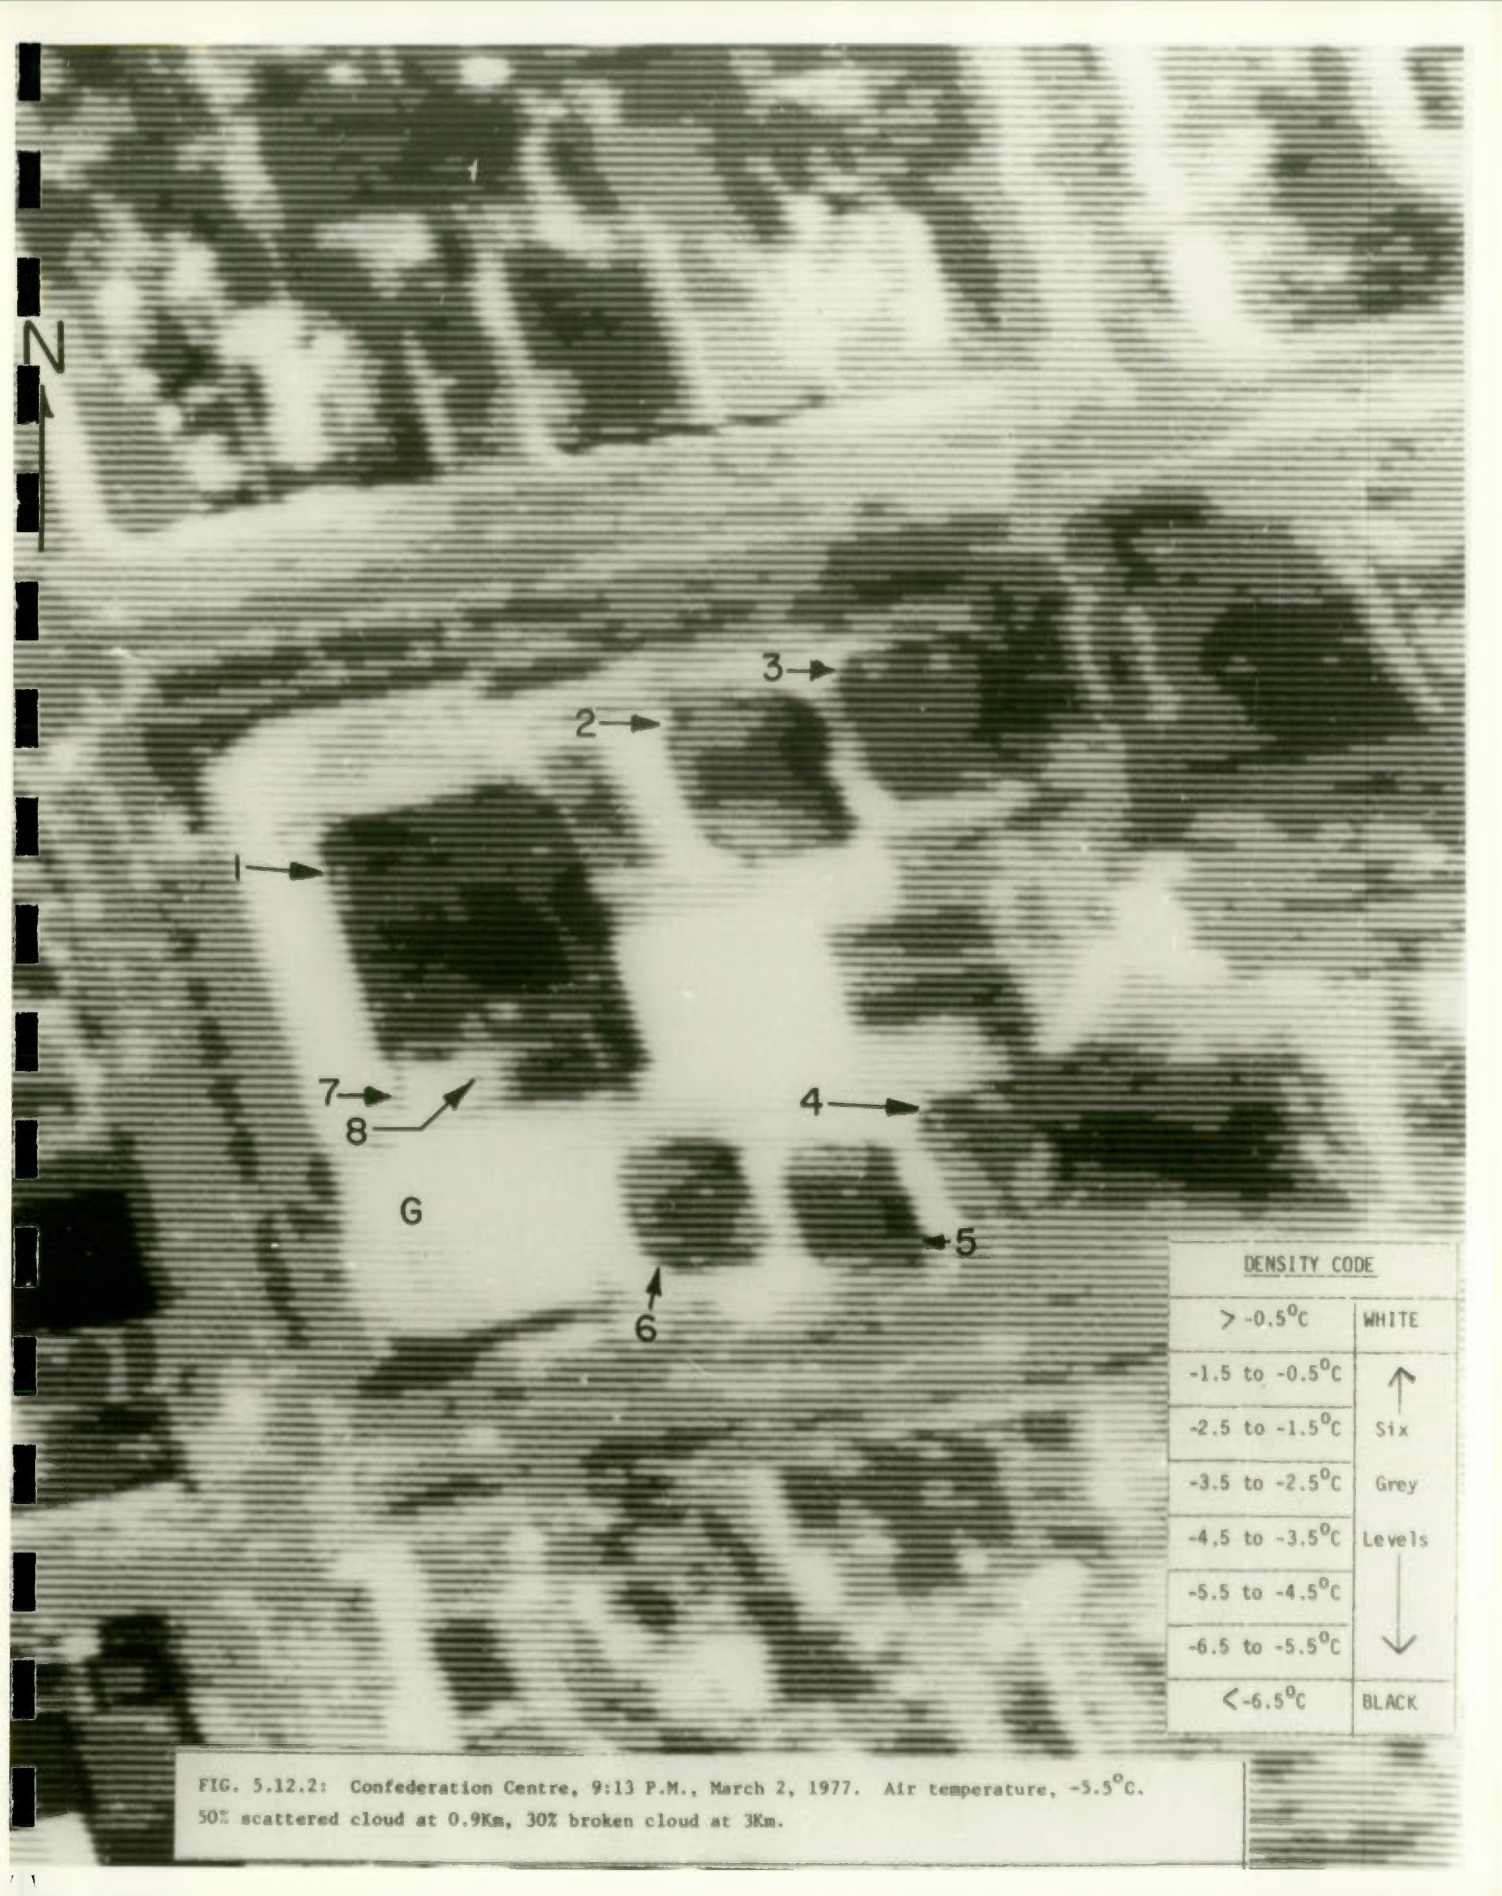
FIG. 5.12.2: Confederation Centre, 9:13 P.M., March 2, 1977. Air temperature, -5.5°C .
 50% scattered cloud at 0.9Km, 30% broken cloud at 3Km.

In summary, comparison of the thermographs of roofs 2 and 6 for the two consecutive years shows both consistency in the thermal performance of a roof from year to year and consistency in the remotely sensed thermal infrared data. In the case of a change in the state of a roof on the other hand, as is the case of the roof of the underground garage, comparison of the year-to-year thermography reveals the change clearly.

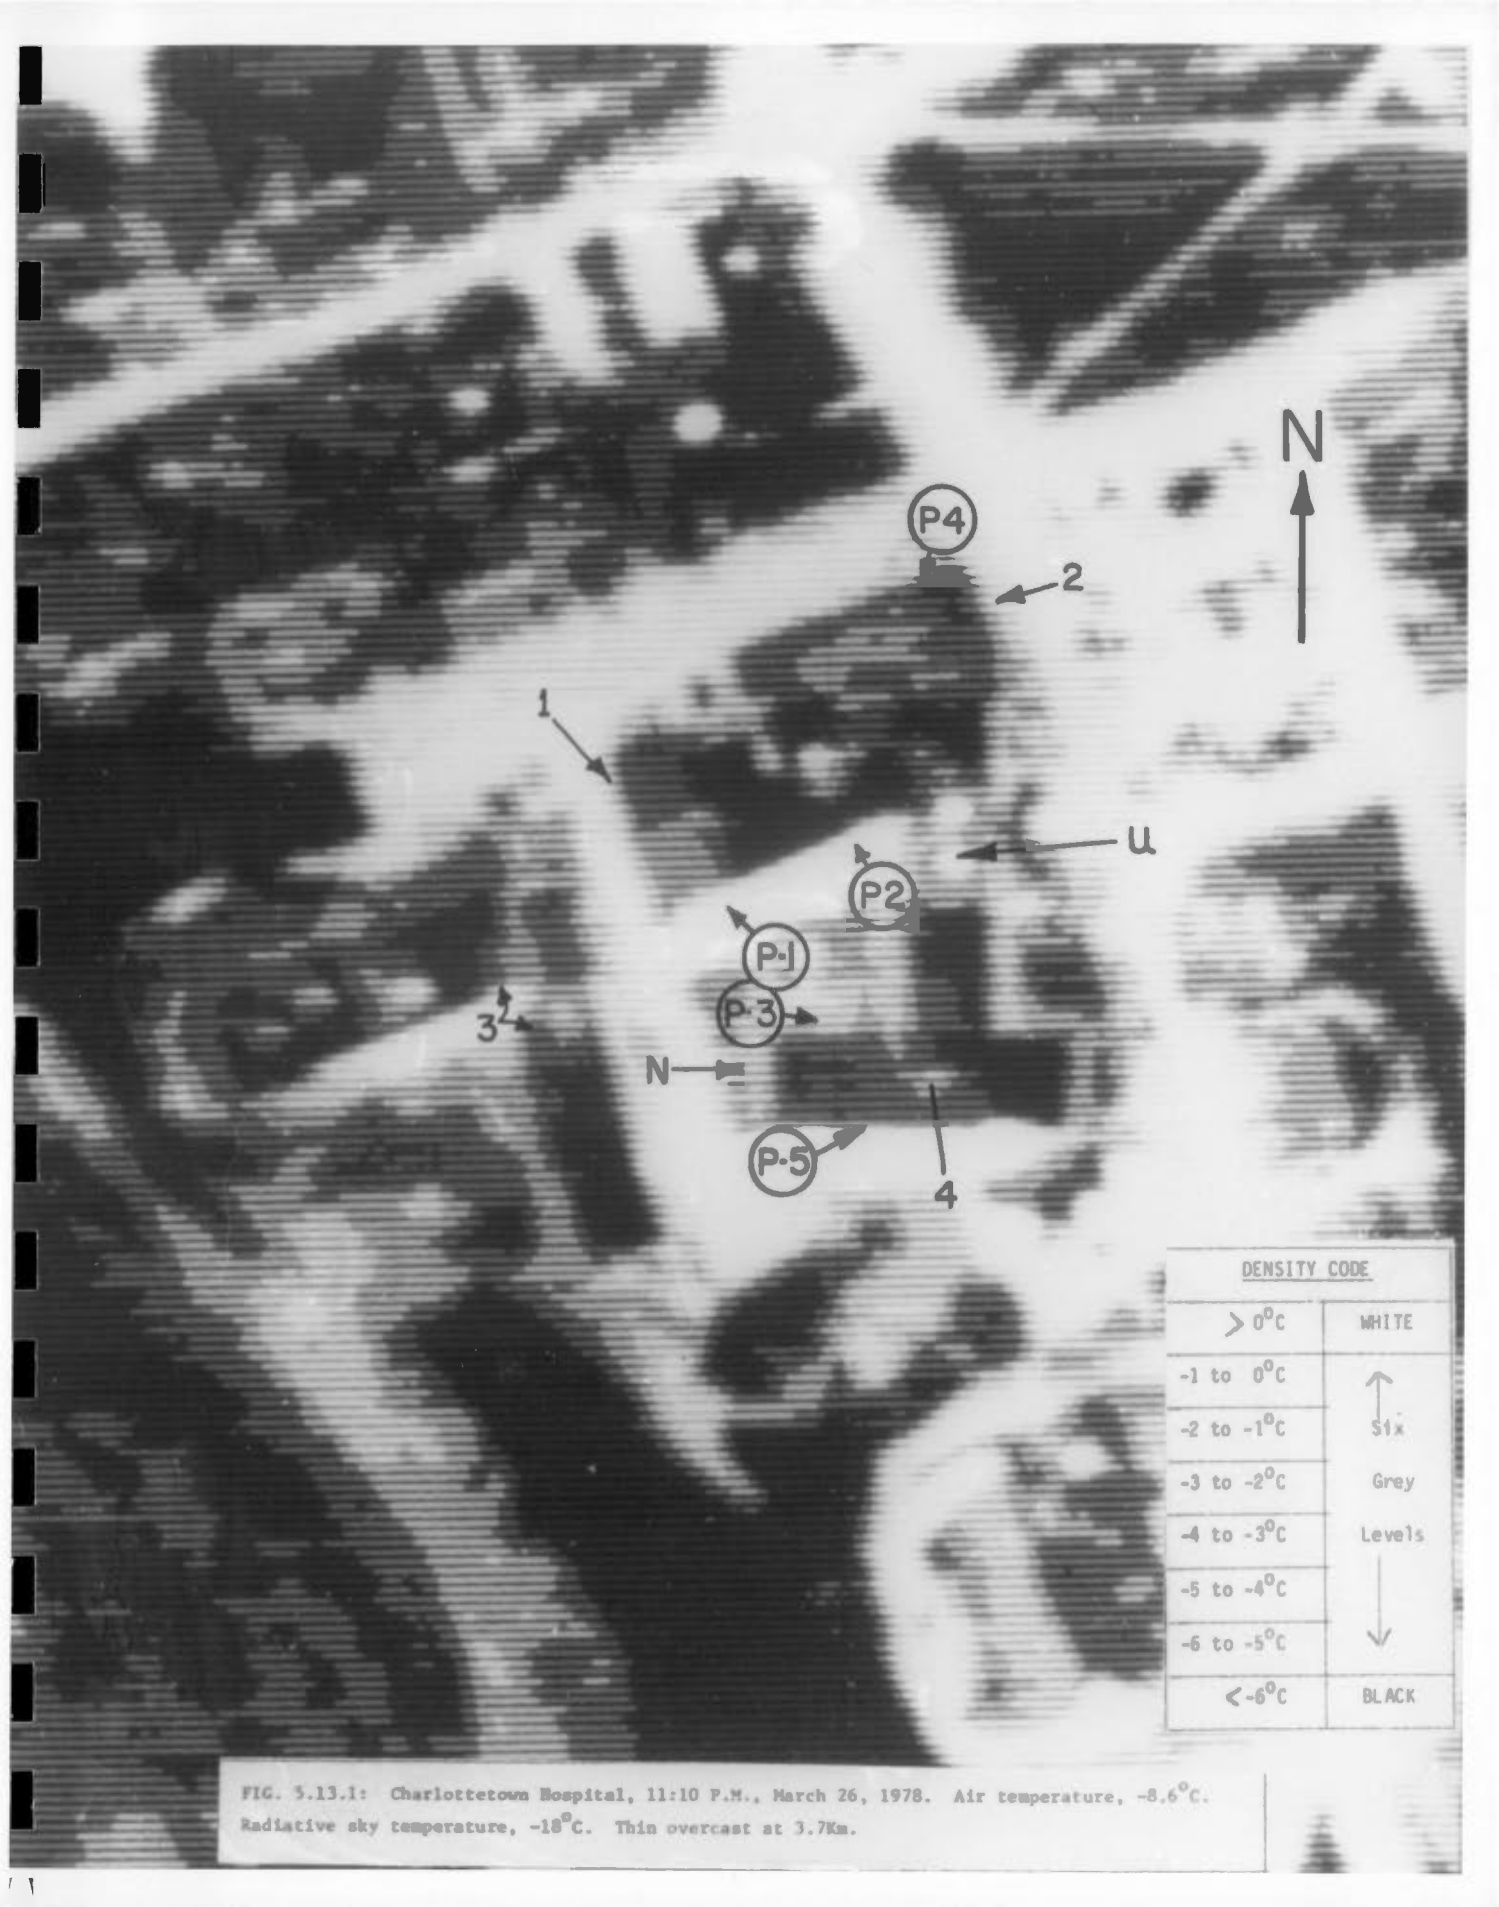
FIG. 5.13.1: Charlottetown Hospital, 11:10 P.M., March 26, 1978. Air temperature, -8.6°C. Radiative sky temperature, -18°C. Thin overcast at 3.7km.

In general, the thermal expression of the roofs of the hospital and the nurses' residence are uniform and consistent between 1977 and 1978 with the exception that roof 1 is more clearly delineated in the 1978 data.

The comparison of the thermograms for this site for both years illustrates how a change in the overall contrast on a roof - in this case the reversal of the temperature trend on roof N - can frequently be attributed to a change in the environment below the roof.
