# Dominion Observatory

## The Saint Lawrence Earthquake

March 1, 1925

ERNEST A. HODGSON

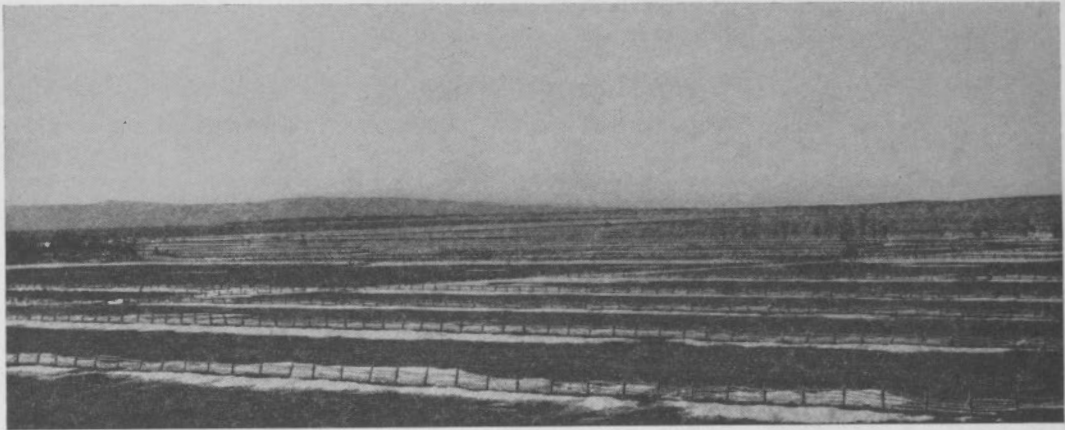
FIG. 2.—Looking north over the valley of Rivière Ouelle from Saint Pacôme

This station is in the valley of Rivière Ouelle (*see* figs 1 and 2.). The soil is deep alluvium. The water table is only a couple of feet below the surface. The station is of frame construction. The stations on either side of it (Sainte Anne de la Pocatière and Rivière Ouelle, respectively) are of brick. The former was badly cracked and has some brick dislodged from its walls, the one at Rivière Ouelle was wrecked as will presently appear.

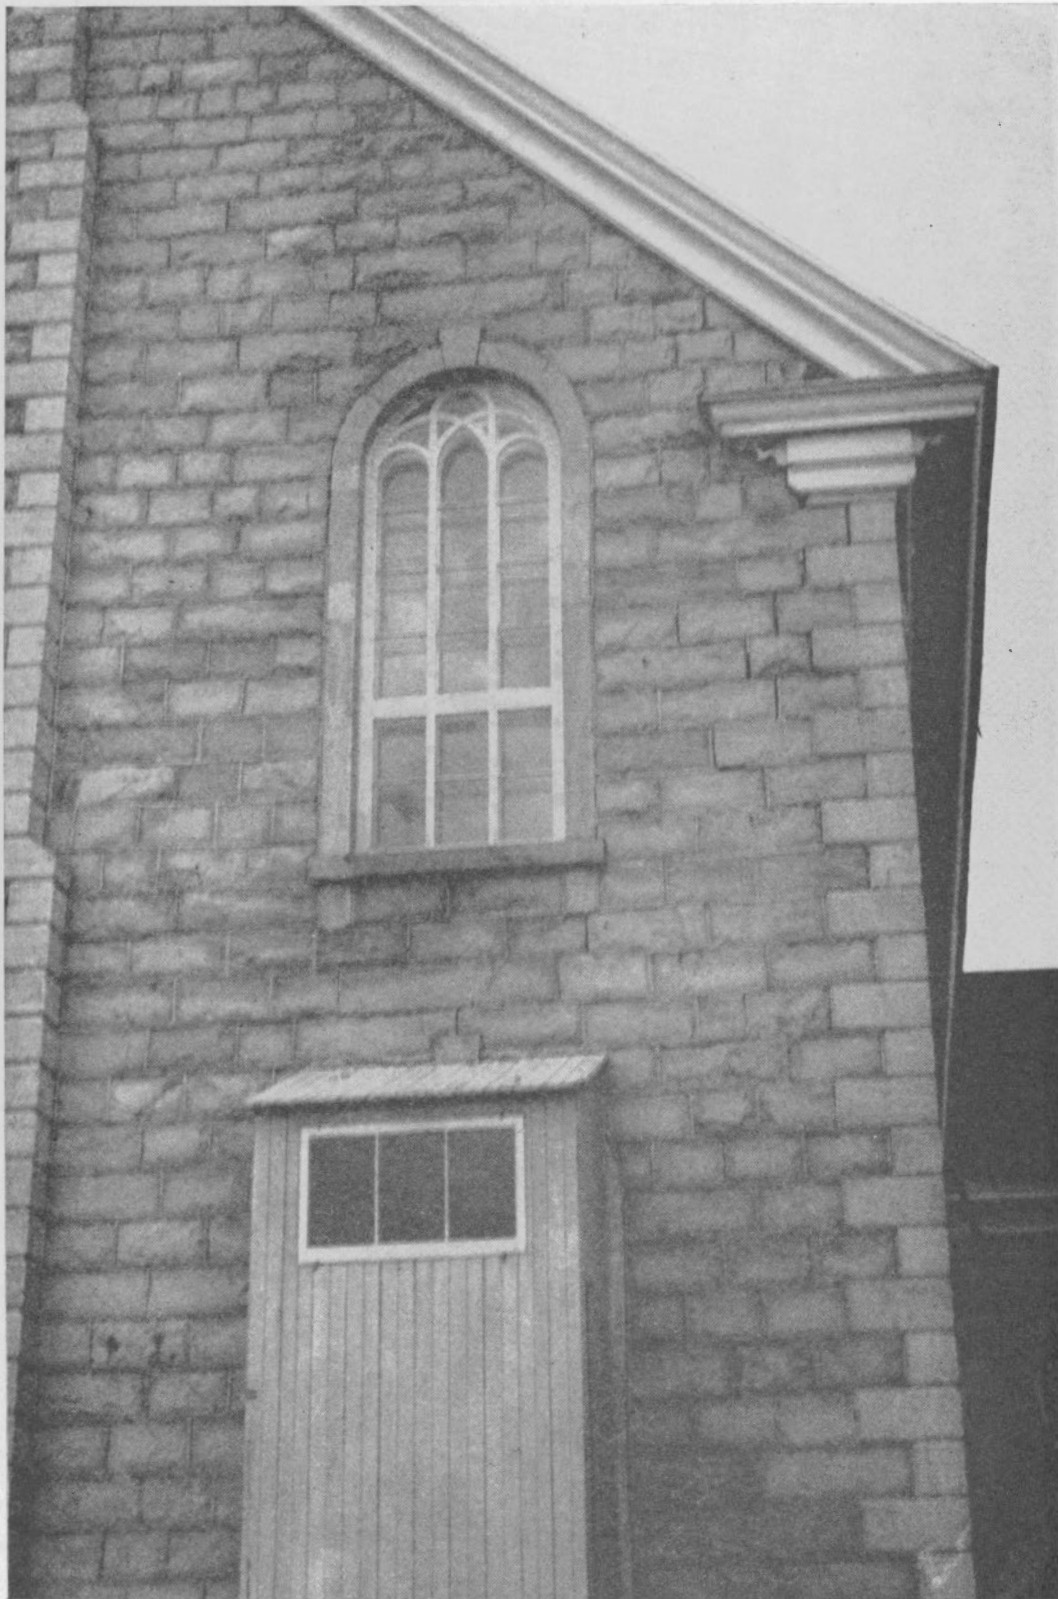
FIG. 3.—East side of front of Rivière Ouelle church

*Rivière Ouelle*—Every chimney for several miles around this point was destroyed. Only three stone buildings were between the station and the Saint Lawrence. All three were destroyed. Two were old stone houses with great walls 2 feet and more in thickness. The owners had to rush out at the time of the quake and could not again make use of the houses. The church was a fine stone structure which had been built in 1872. The organ pipes were projected upward and outward so that they fell in the auditorium clear of the choir loft. The stones of the wall were jarred loose (*see* fig. 3) so that the tops of the walls, especially in the transepts, were thrown down (*see* fig. 4). The great stone chimney was thrown down and crashed through the roof.

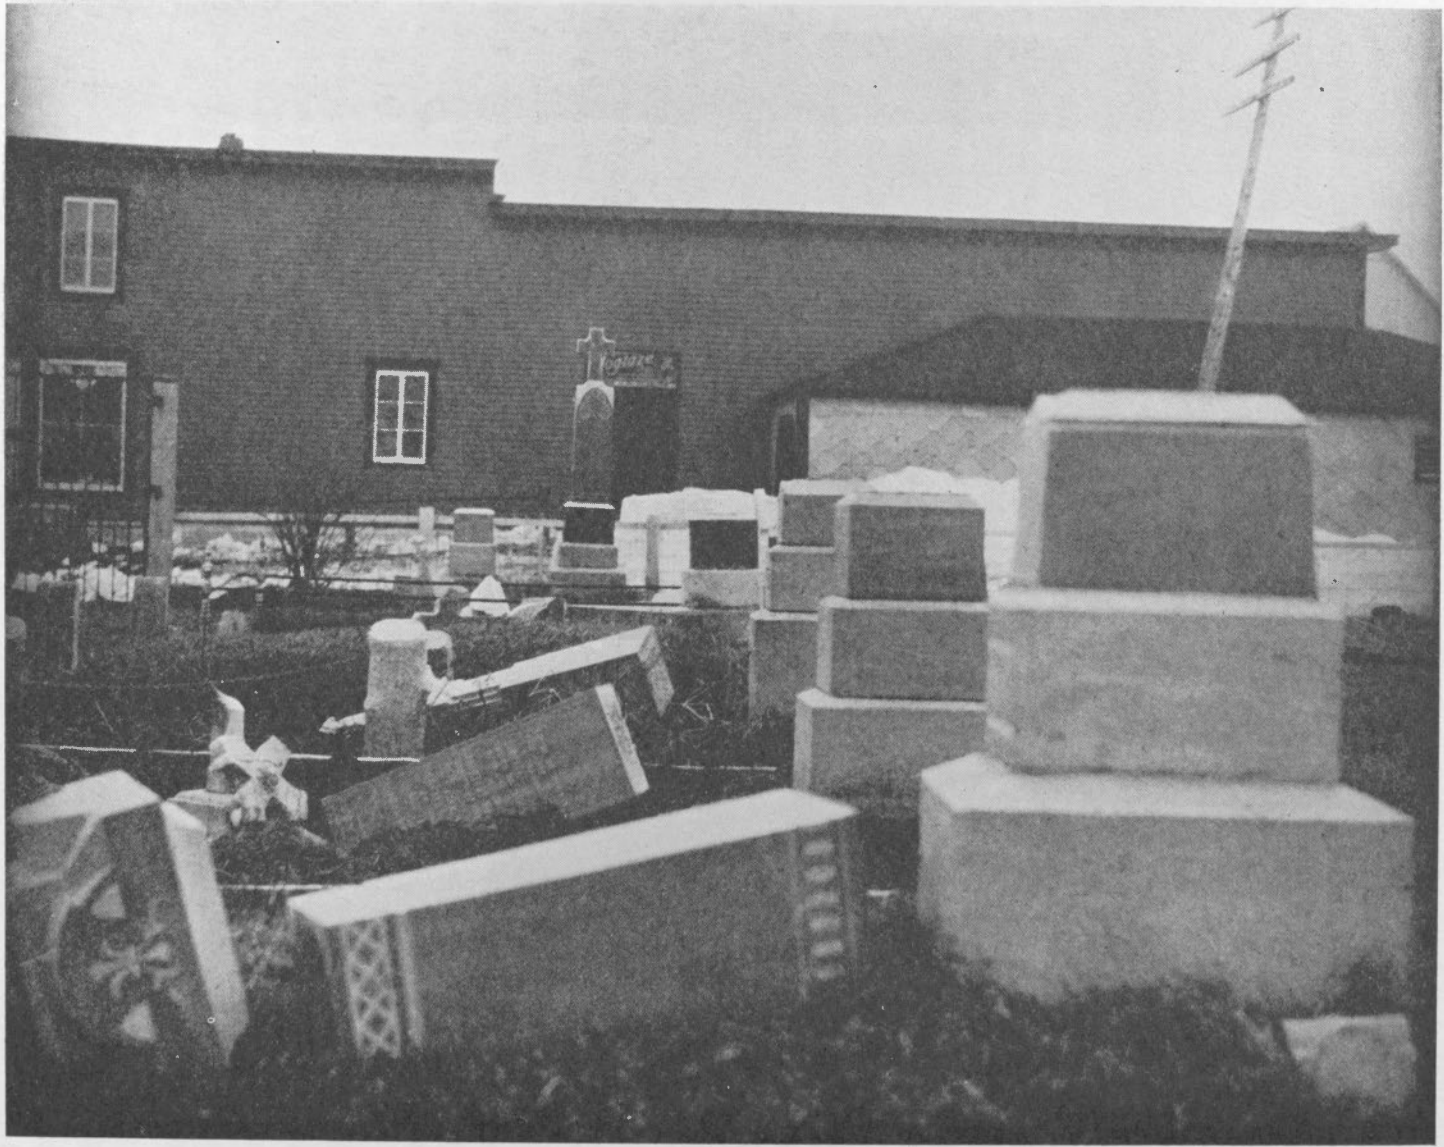
FIG. 5.—Monuments all fallen eastward, Rivière Ouelle cemetery

In the churchyard, the monuments were generally thrown down or rotated (*see* figs. 5, 19, 20, 21). There were three graveyards of different age. In the oldest there were only a few flat headstones. These were probably fallen before the earthquake. Certainly none remained standing afterwards. The second oldest section has stones of various types in it but they were possibly in need of some re-setting previous to the quake. Nearly all were damaged in some way but the fall of the upper sections was in different directions depending on the way the respective monument was tilted out of plumb. The latest section had new stones, well set up and in good order. These were either rotated or thrown down. Every stone in this section which fell lay to the southeast (*see* fig. 5).

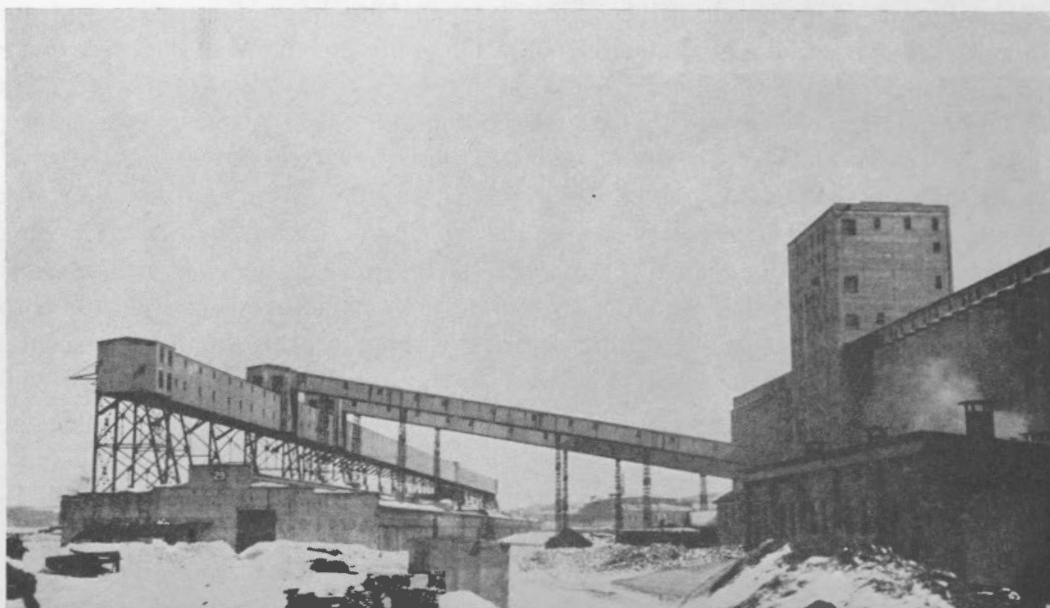
FIG. 7.—Grain elevator and freight sheds at Quebec

The grain elevator and loading sheds are built on made ground on the west bank of the Saint Charles river (*see fig. 7*). To make the ground area required, piles had been driven to a depth of 42 feet along the edge of the river. These piles extended 24 feet above the bottom of the river, being 66 feet over all. The earth required to fill behind the piles was dredged from the river floor. On the land so made a great shed was built, 1,000 feet in length and parallel to the row of piling, but far enough behind it to permit several lines of railway tracks on the water side of the sheds.

200 feet high, 100 feet long and 60 feet wide. The top hundred feet of this section projects beyond the tops of the bins and stands clear, with four stories of floors in it. High in this upper section is a battery of scales for weighing the grain. These are immense affairs, each capable of handling 60 tons of grain. These scales were thrown off their pivots, all falling south. The counterweights, formed of plates of iron about 2 inches thick and 18 inches square, built up into a mass 5 feet high by means of two bolts seven-eighths of an inch in diameter, were swung so violently that the bolts were sheared off and the plates flung to the floor 5 feet below. Four automatic scales, which could not be thrown off pivots, swung to and fro in the steel plate enclosures, banging on the doors until the latter were battered, as if made of lead, by the projecting points of the swaying scales.

The whole upper section of the work room swayed with the heavy machinery so that practically all of the reinforced concrete columns about the outer walls were cracked at the point where the superstructure meets the top of the main building. These were not simple cracks. Some had worked back and forth until great sections of concrete were ground out of the face, several feet long, a foot into the wall, and a foot to eighteen inches wide

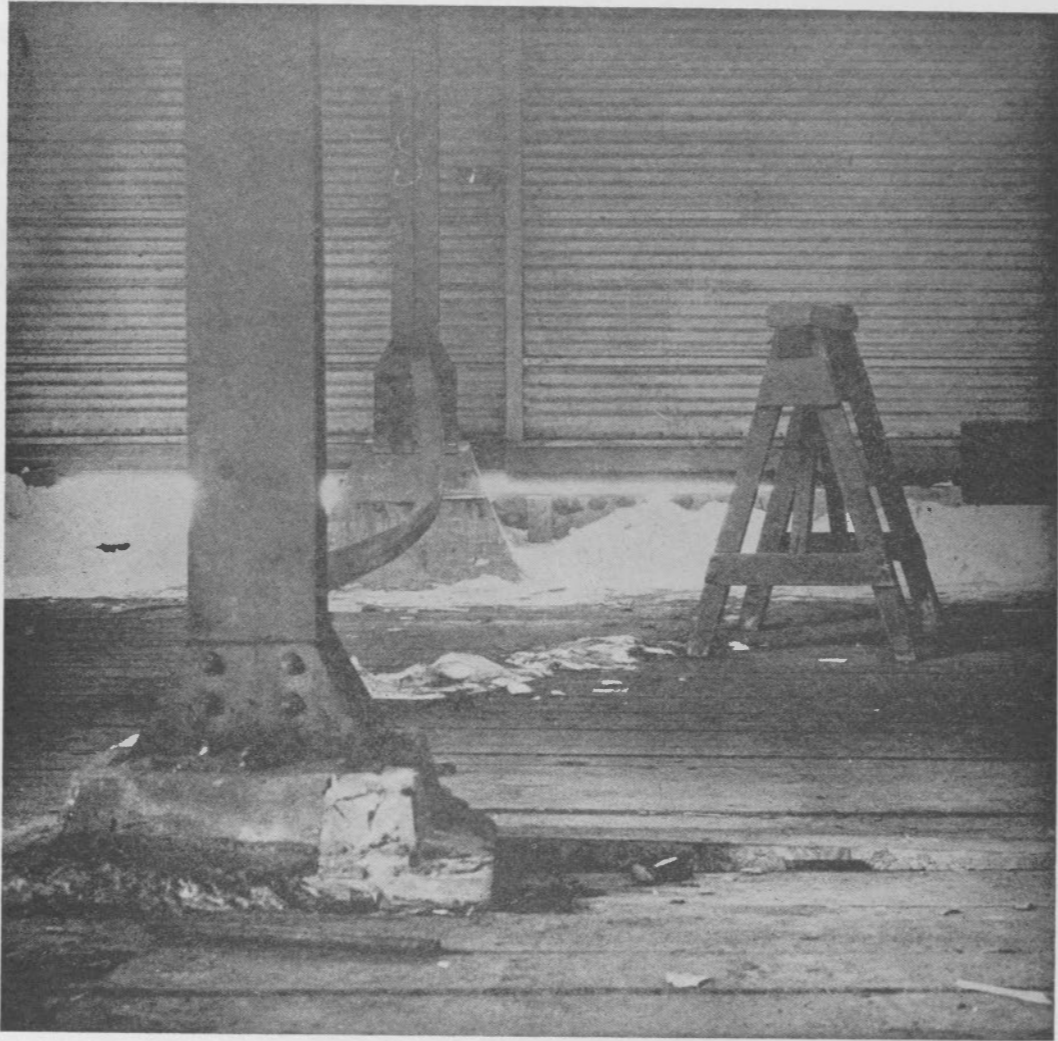
FIG. 9.—Bent back brace at freight sheds at Quebec

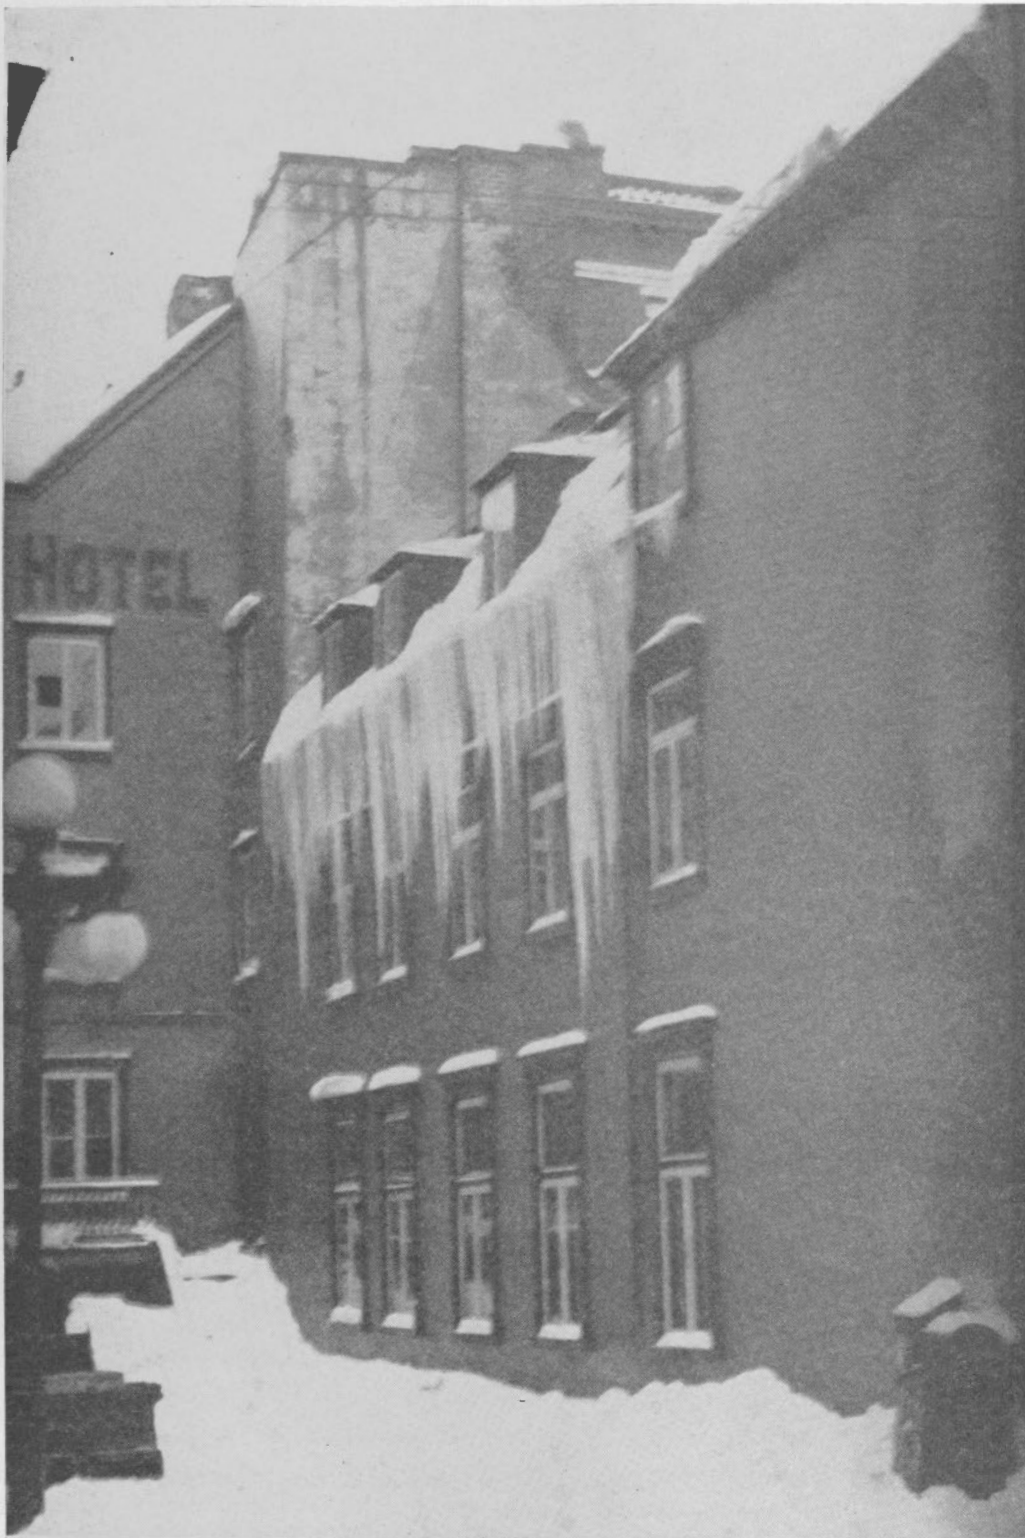
FIG. 10.—Icicles at Neptune Inn, Quebec

At the time of the earthquake great icicles hung on the eaves of many buildings in Quebec (*see* fig. 10). Some of these, on the rocky foundation of centre town, were quite undisturbed by the quake. A number of ice statues and arches (*see* fig. 11) are constructed

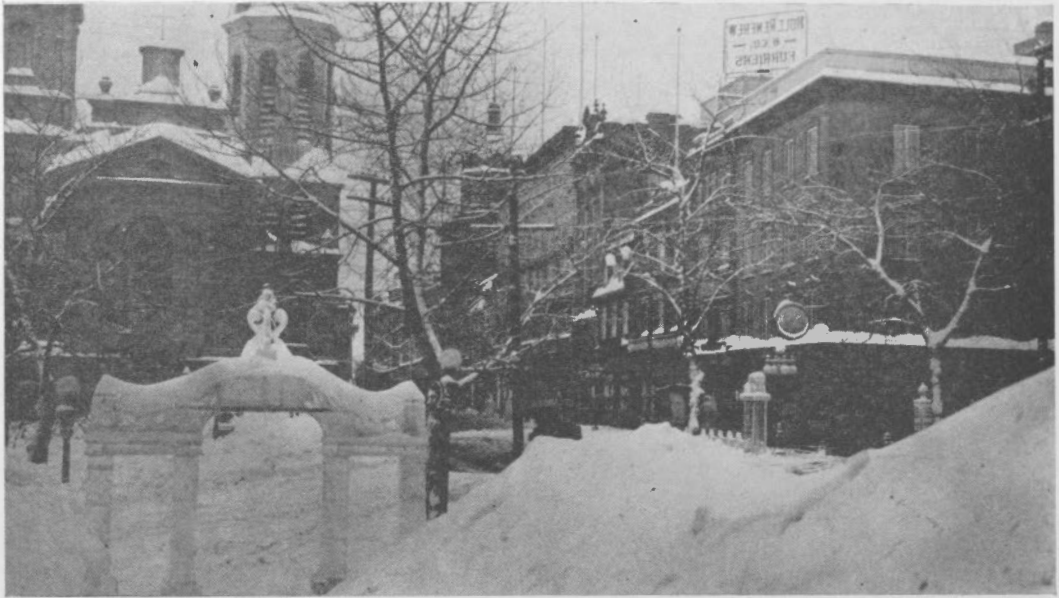
FIG. 11.—Ice arch at Quebec

here and there about this city in the winter. None of these was damaged by the shock. The breaking of chimneys was not at all general, those which yielded being in poor repair, as a rule, and nearly all in the lower sections of the city.

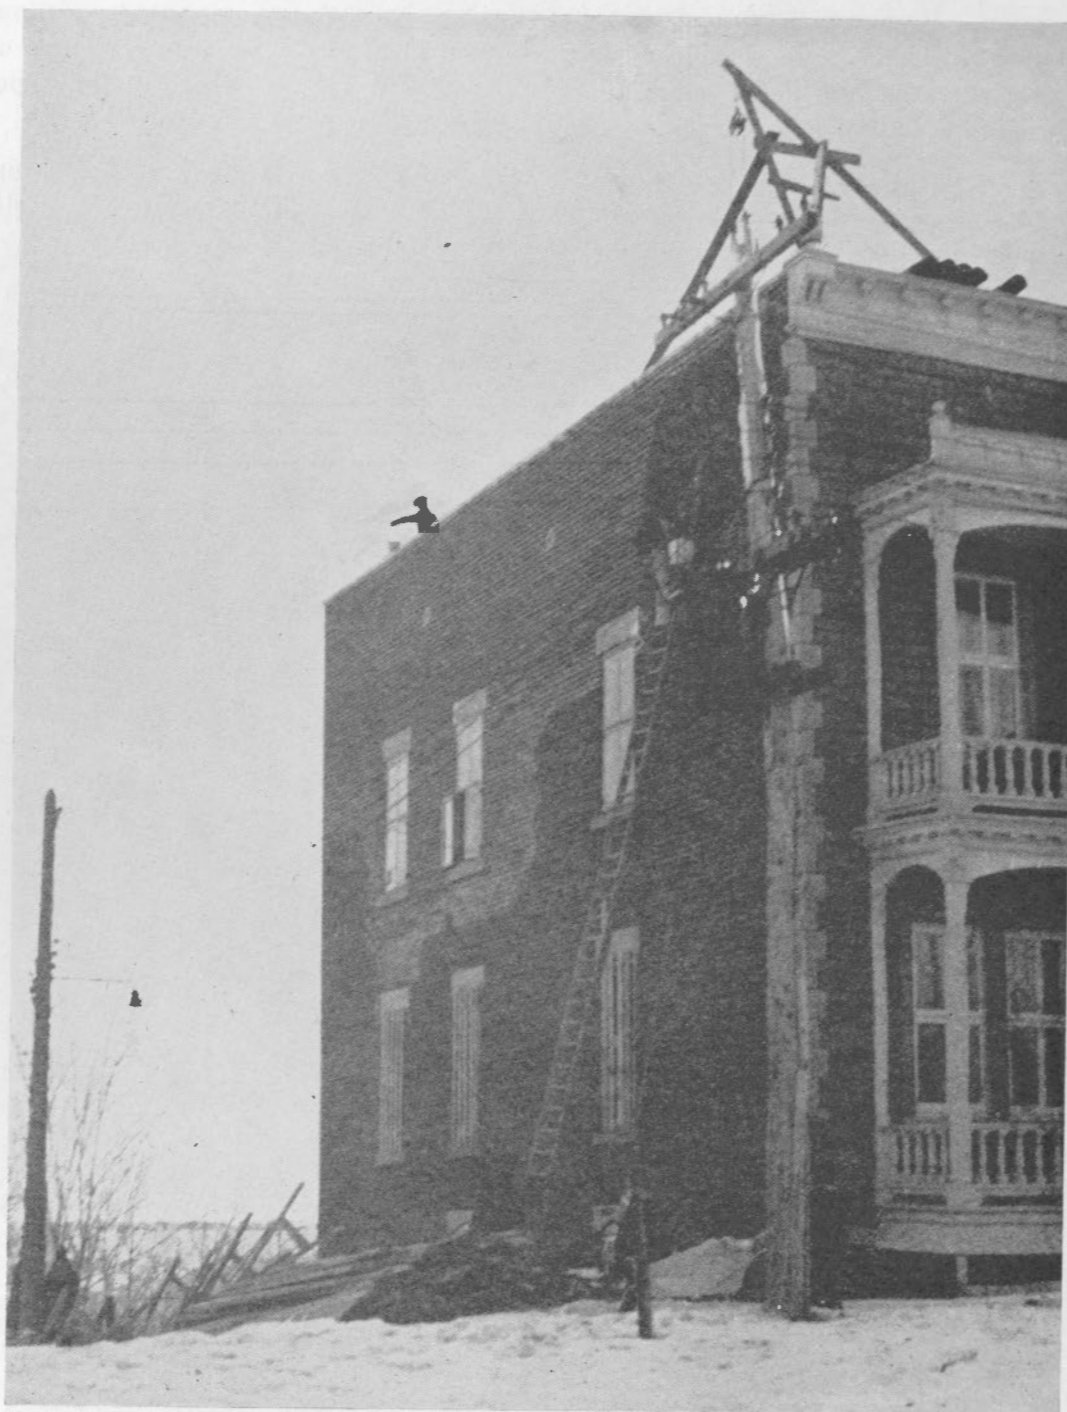
FIG. 13.—Damaged wall at Shawinigan Falls

*Shawinigan Falls*—The damage at Shawinigan Falls was, in each case, due to one or more of four factors: poor workmanship, shoddy material, insecure terrain, or improper design. A number of brick walls were thrown down in part and one altogether (see figs 12 and 13) due in each case to a combination of poor workmanship and insecure terrain. Many stone and brick walls were cracked (though they were well built) due to the buildings being placed on or near the slopes of clay banks. The brick transept wall of Saint Marc church was thrown down (see fig. 14). The steel frame of the factory plant of the Aluminum Company acted as a battering ram, under the influence of the earthquake movements. It battered out the top of the gable ends at each of the units.

"6. Other structures at Shawinigan Falls were damaged because of obvious weaknesses. The brick walls that fell were of inferior construction, unbraced, thin, and laid in poor mortar.

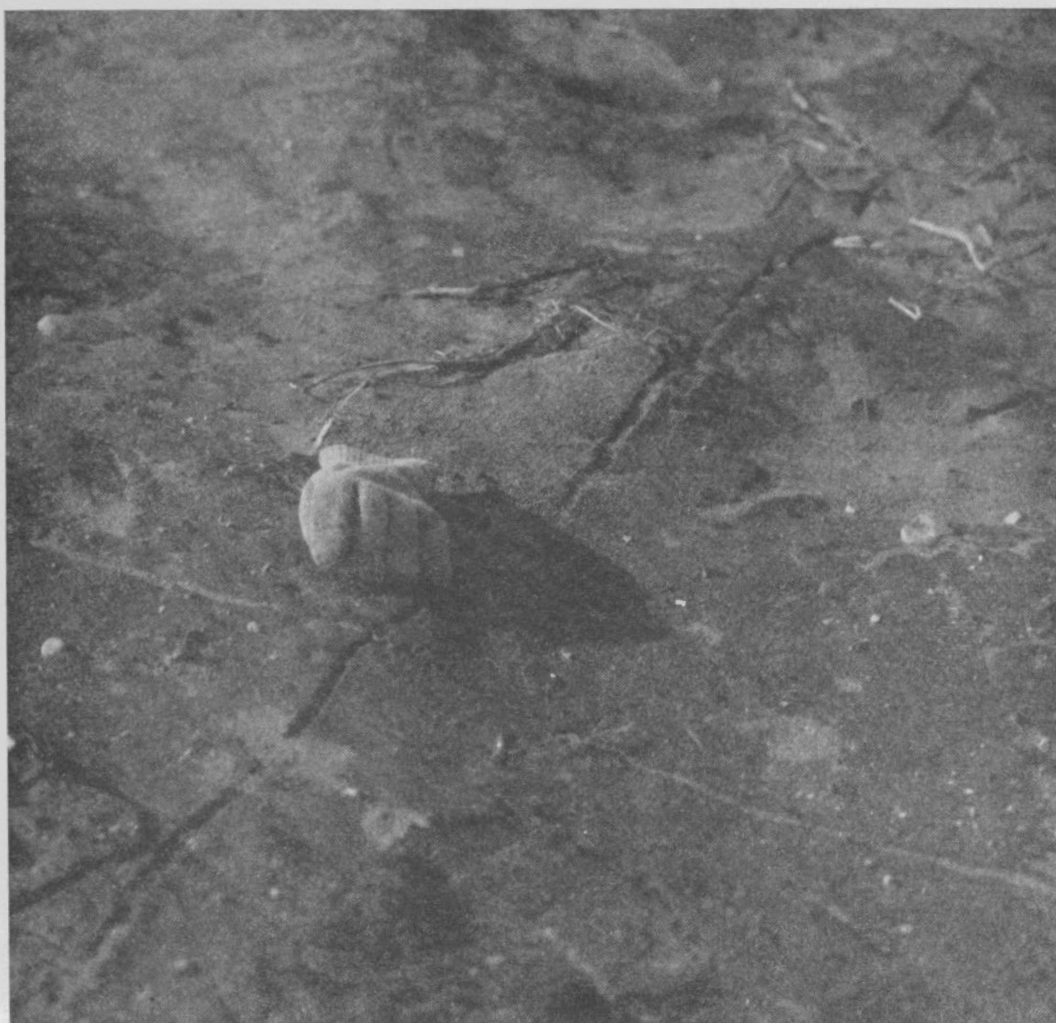
FIG. 15.—Cracks in soil at Sainte Anne de la Pocatière

At Sainte Anne the damage was very marked. Part of the village is on a rocky ledge, part on an alluvial plain. Damage was general throughout the entire village but was greater on the alluvium. Most of the chimneys in the village were thrown down; brick walls were cracked; frame houses were twisted out of shape in a few cases; plumbing was broken; the plaster tops of pillars in the chapel of the college were destroyed; some monuments in the cemetery were thrown down while many others were rotated; crockery was broken throughout the village; the snow which was frozen hard at the time of the quake was cracked generally in this district; the frozen earth beneath the snow was cracked into huge rectangular grids; water conduits buried in the ground were broken.

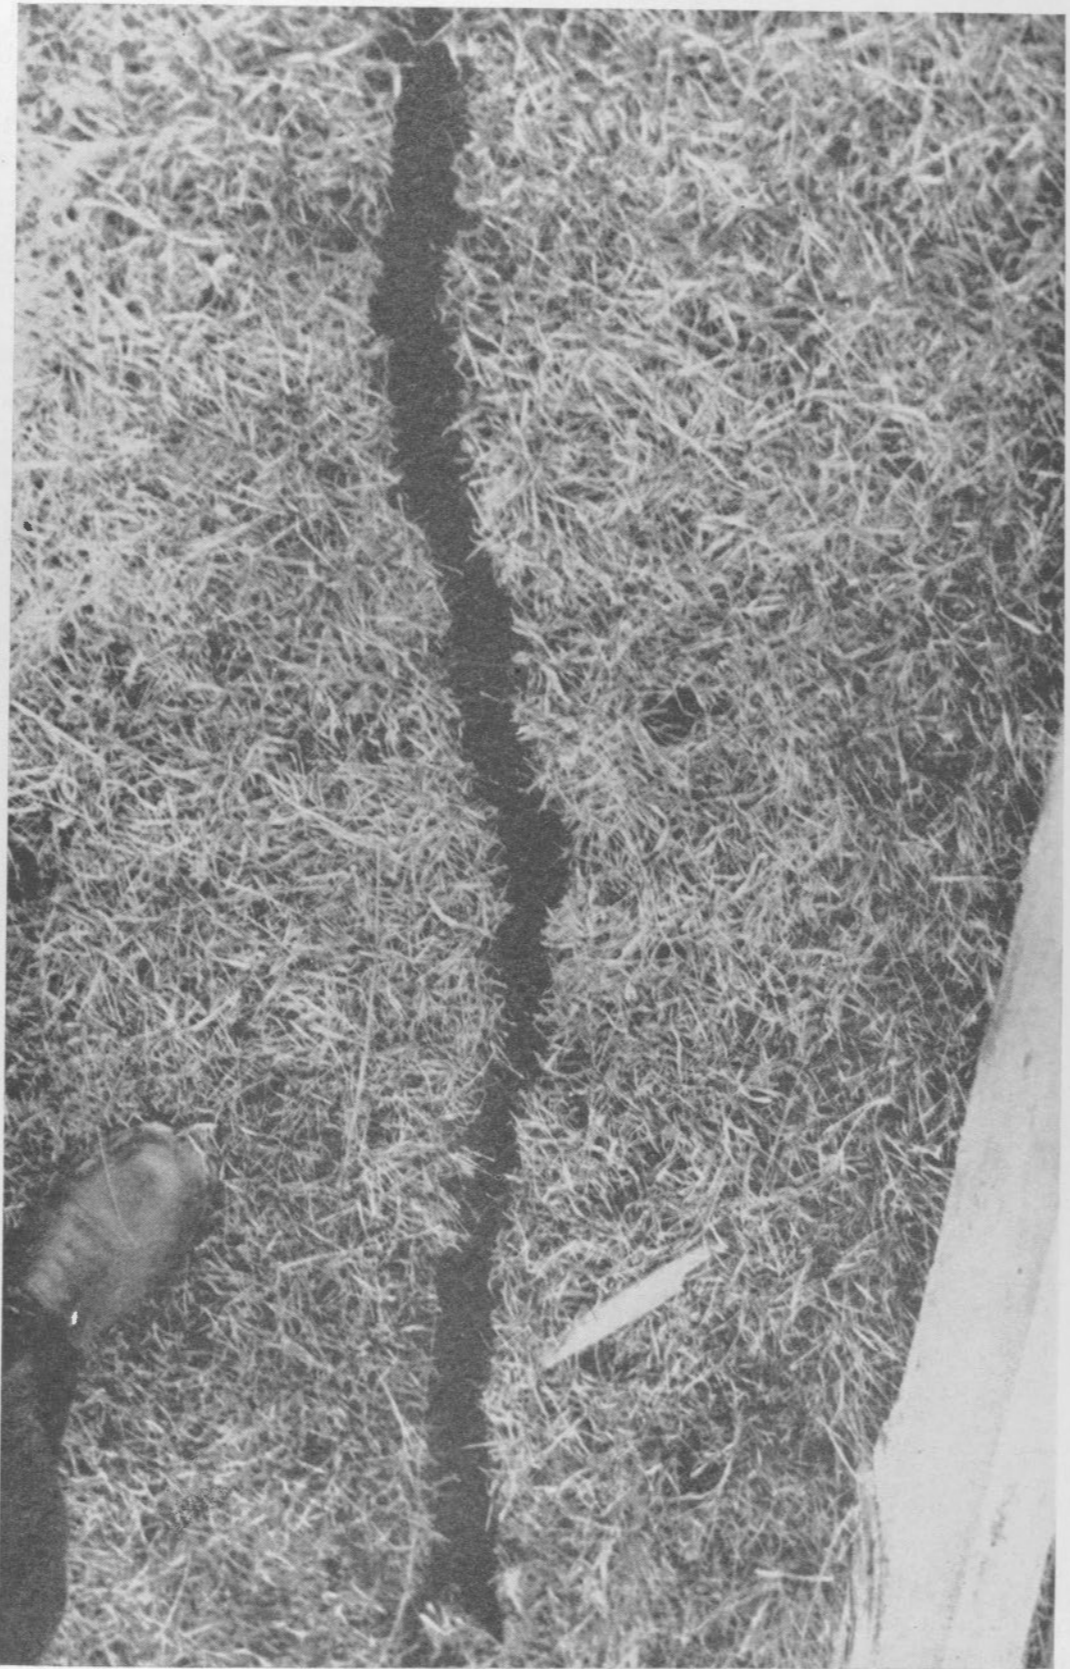
FIG. 17.—Slump crack in ground near Rivière Ouelle church

A great crack formed beside the roadway about a mile from the church (*see* fig. 17). The crack is parallel to the river bank which is about 33 feet distant. Six weeks after the earthquake, the crack was still visible and could be followed for about 100 feet, the edges being from 2 to 3 inches apart. At the time of the earthquake the crack could be followed for 150 feet and a stick could be thrust into it to a depth of 20 feet.

The largest earth cracks reported were inspected. One was between Saint Urbain and Baie Saint Paul and has been referred to on page 371. A second was near the church of Rivière Ouelle parish and has been described on page 377 (*see* fig. 17). The third was at Saint Pacôme. It has been mentioned on page 373, but further details may be given. It

was visited within a couple of weeks after the earthquake. It was along the edge of a hill where the valley of Rivière Ouelle slopes up to a rocky ledge. The crack was well defined for a distance of more than 100 yards. After the snow melted it was still well defined. After the lapse of six weeks or so, a stick could be put in it freely to a depth of about 16 inches. It was, of course, very much deeper when first opened in the deeply frozen soil.

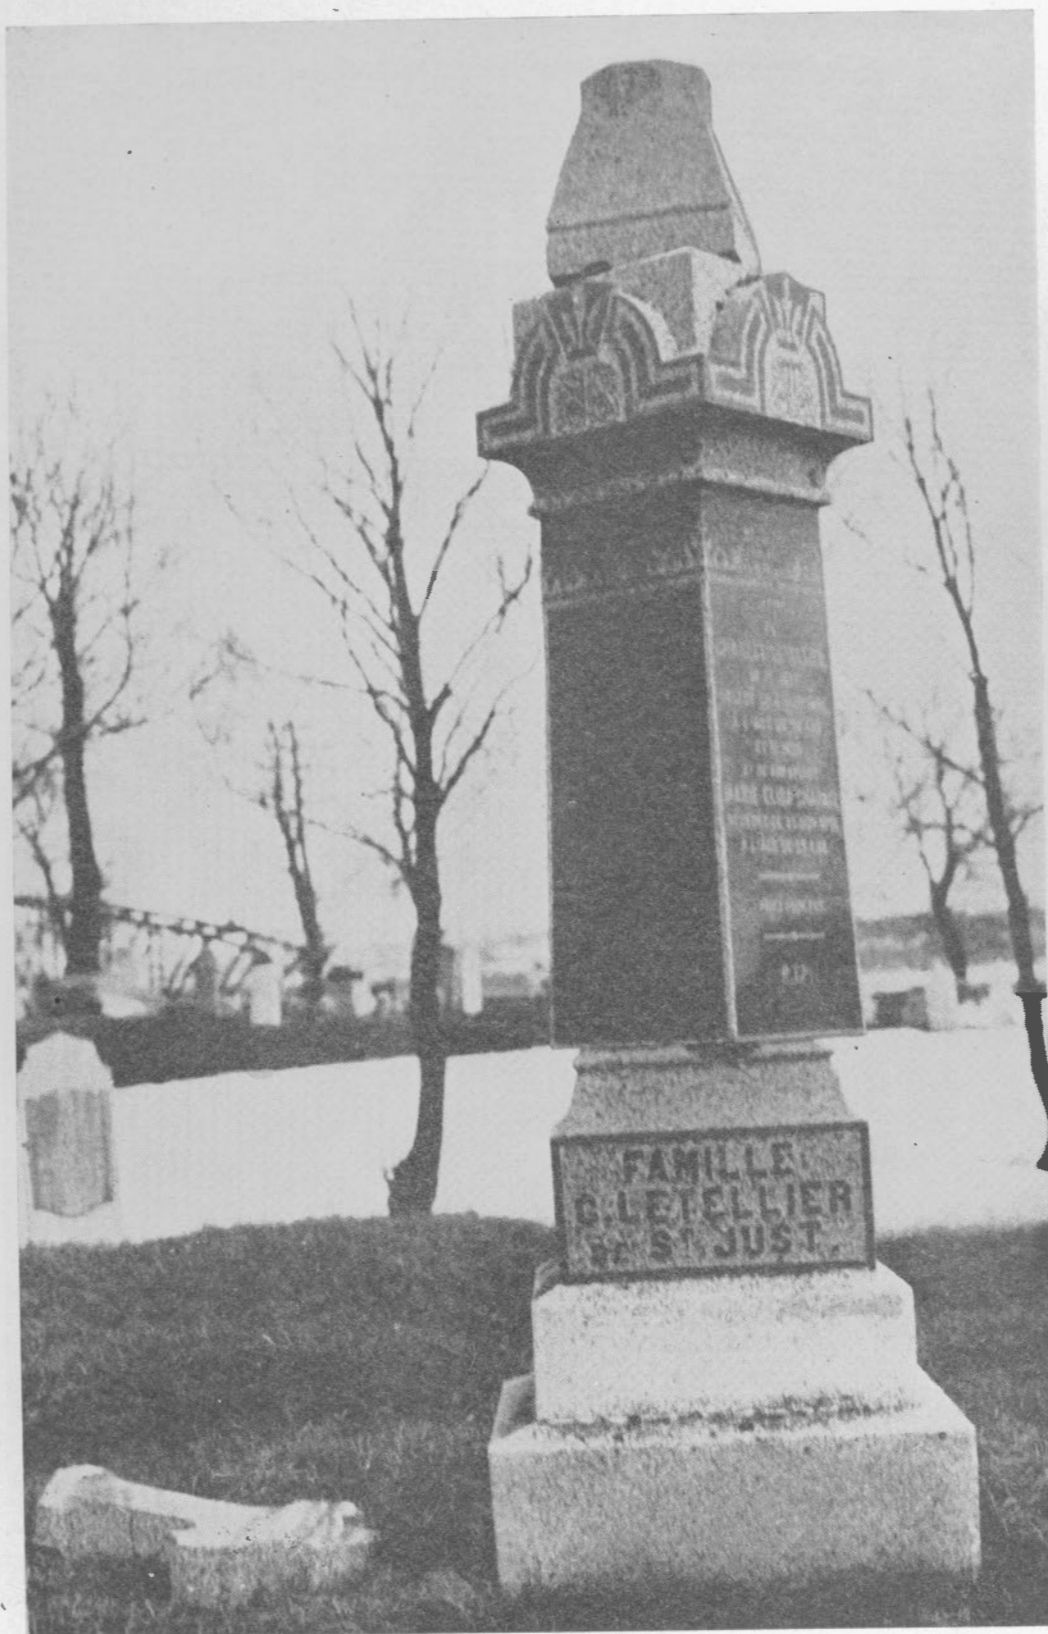
FIG. 20.—Rotated monument at Rivière Ouelle Cemetery

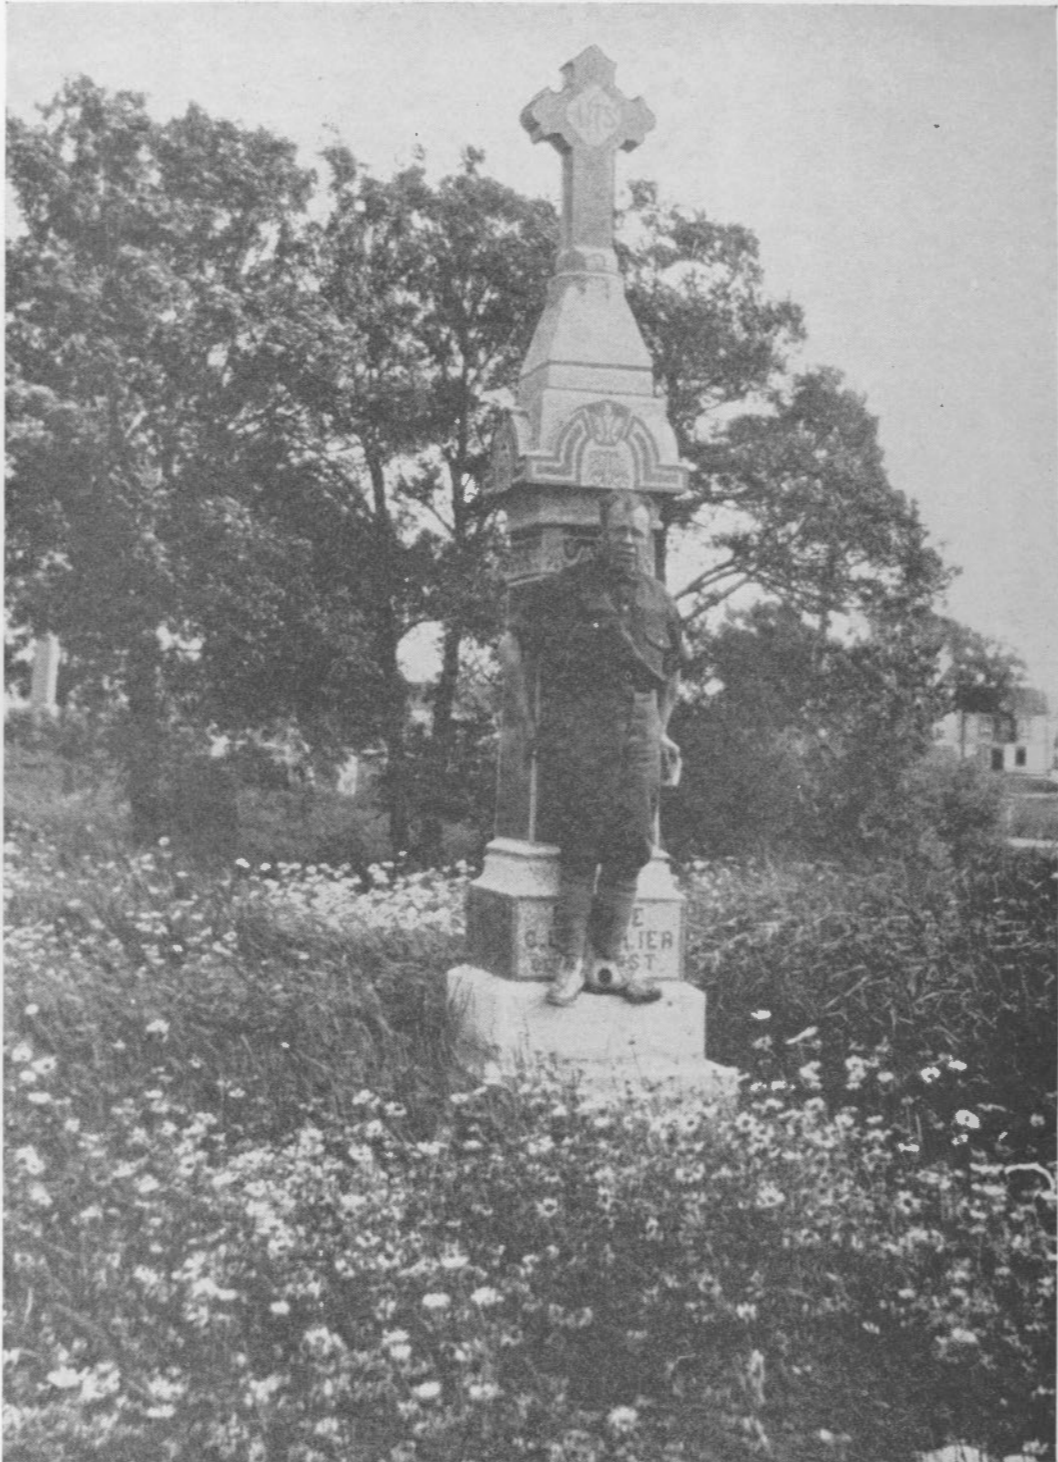
FIG. 21.—Monument shown in Fig. 20 shown here restored  
*Photo by J. W. Goldthwait*
