PRELIMINARY REPORT OF THE
MIRAMICHI, NEW BRUNSWICK, CANADA
EARTHQUAKE SEQUENCE OF 1982.

Anne E. Stevens (editor)
Earth Physics Branch
Energy, Mines and Resources Canada
Ottawa K1A 0Y3

Earth Physics Branch Open File Report 82-24

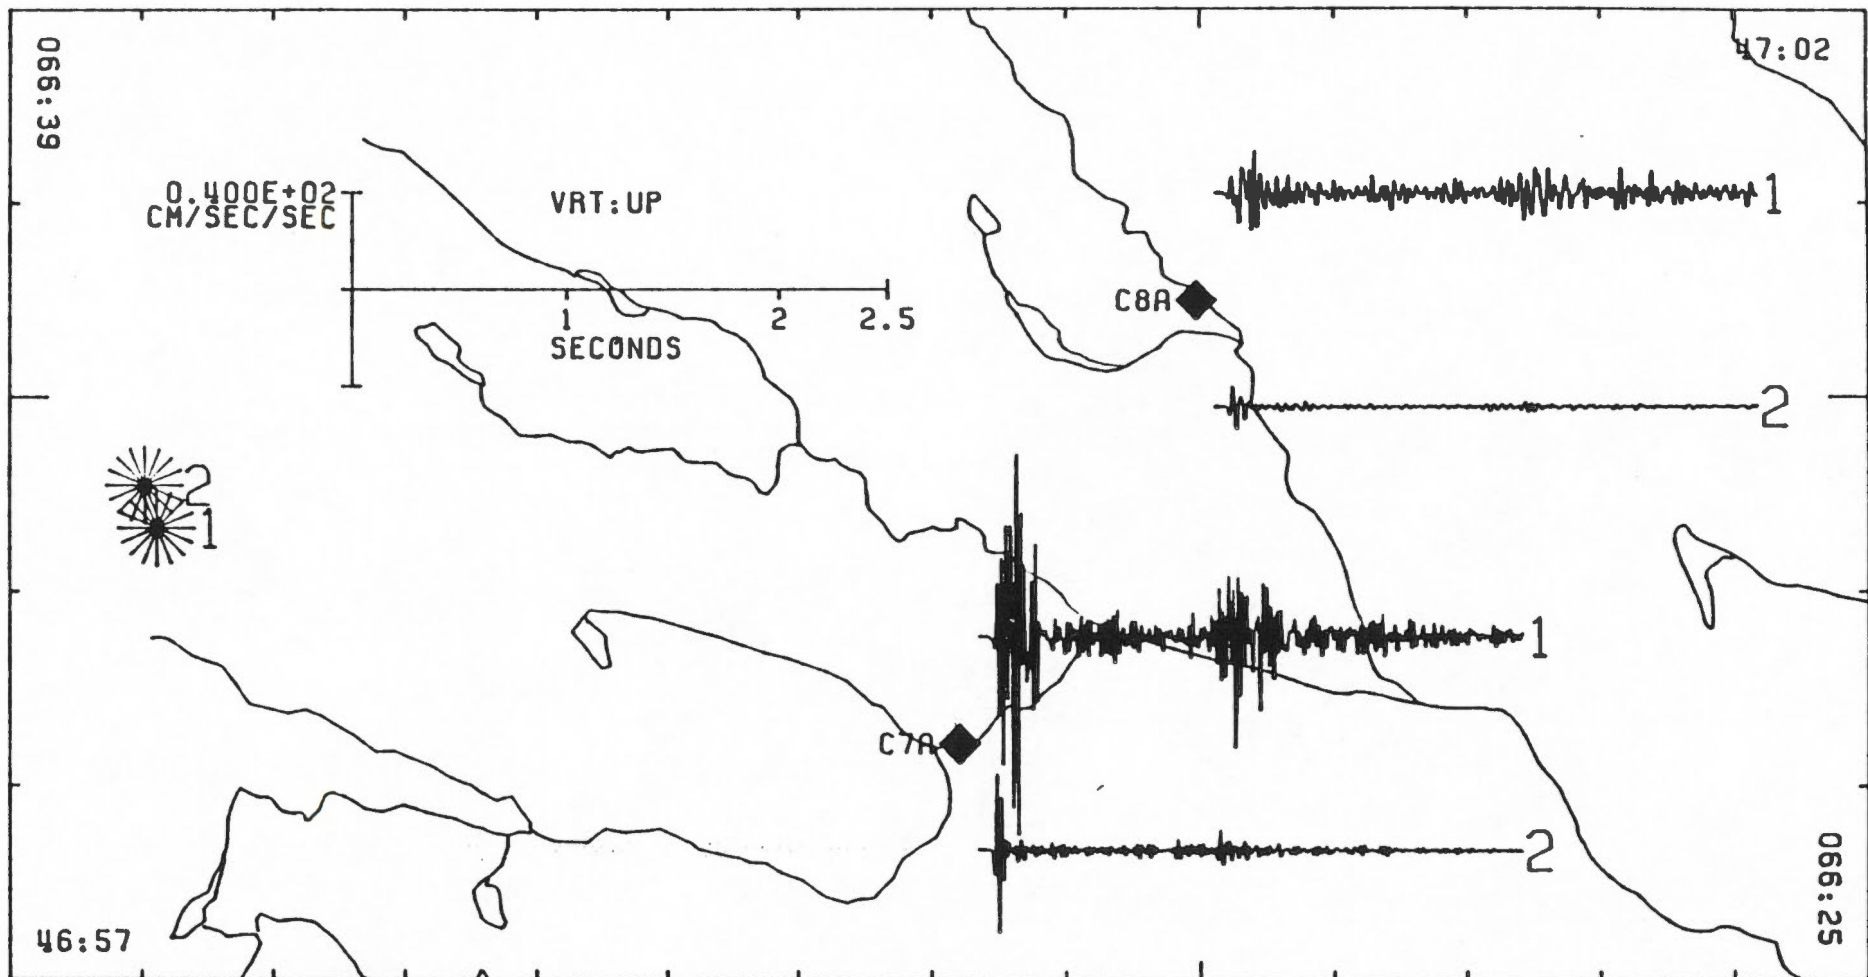
Figure 5.2c

VERTICAL ACCELERATION

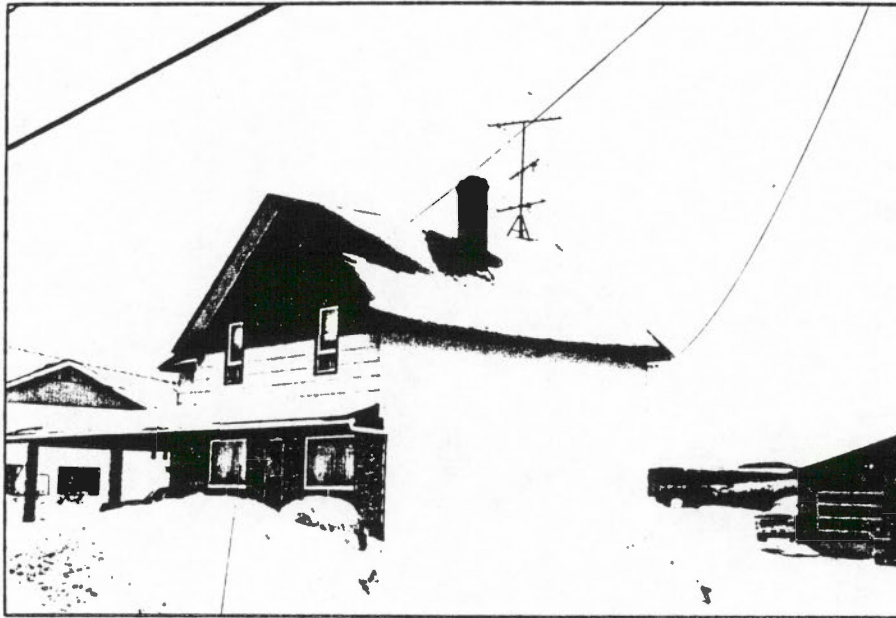
Figure 17.1 Pieces of the chimney have fallen off; chimney in poor condition
