DESTRESSING A ROCKBURST PRONE CROWN PILLAR - MACASSA MINE

FEBRUARY 1987

MINING RESEARCH LABORATORIES
DIVISION REPORT MRL 87-82 (TR)

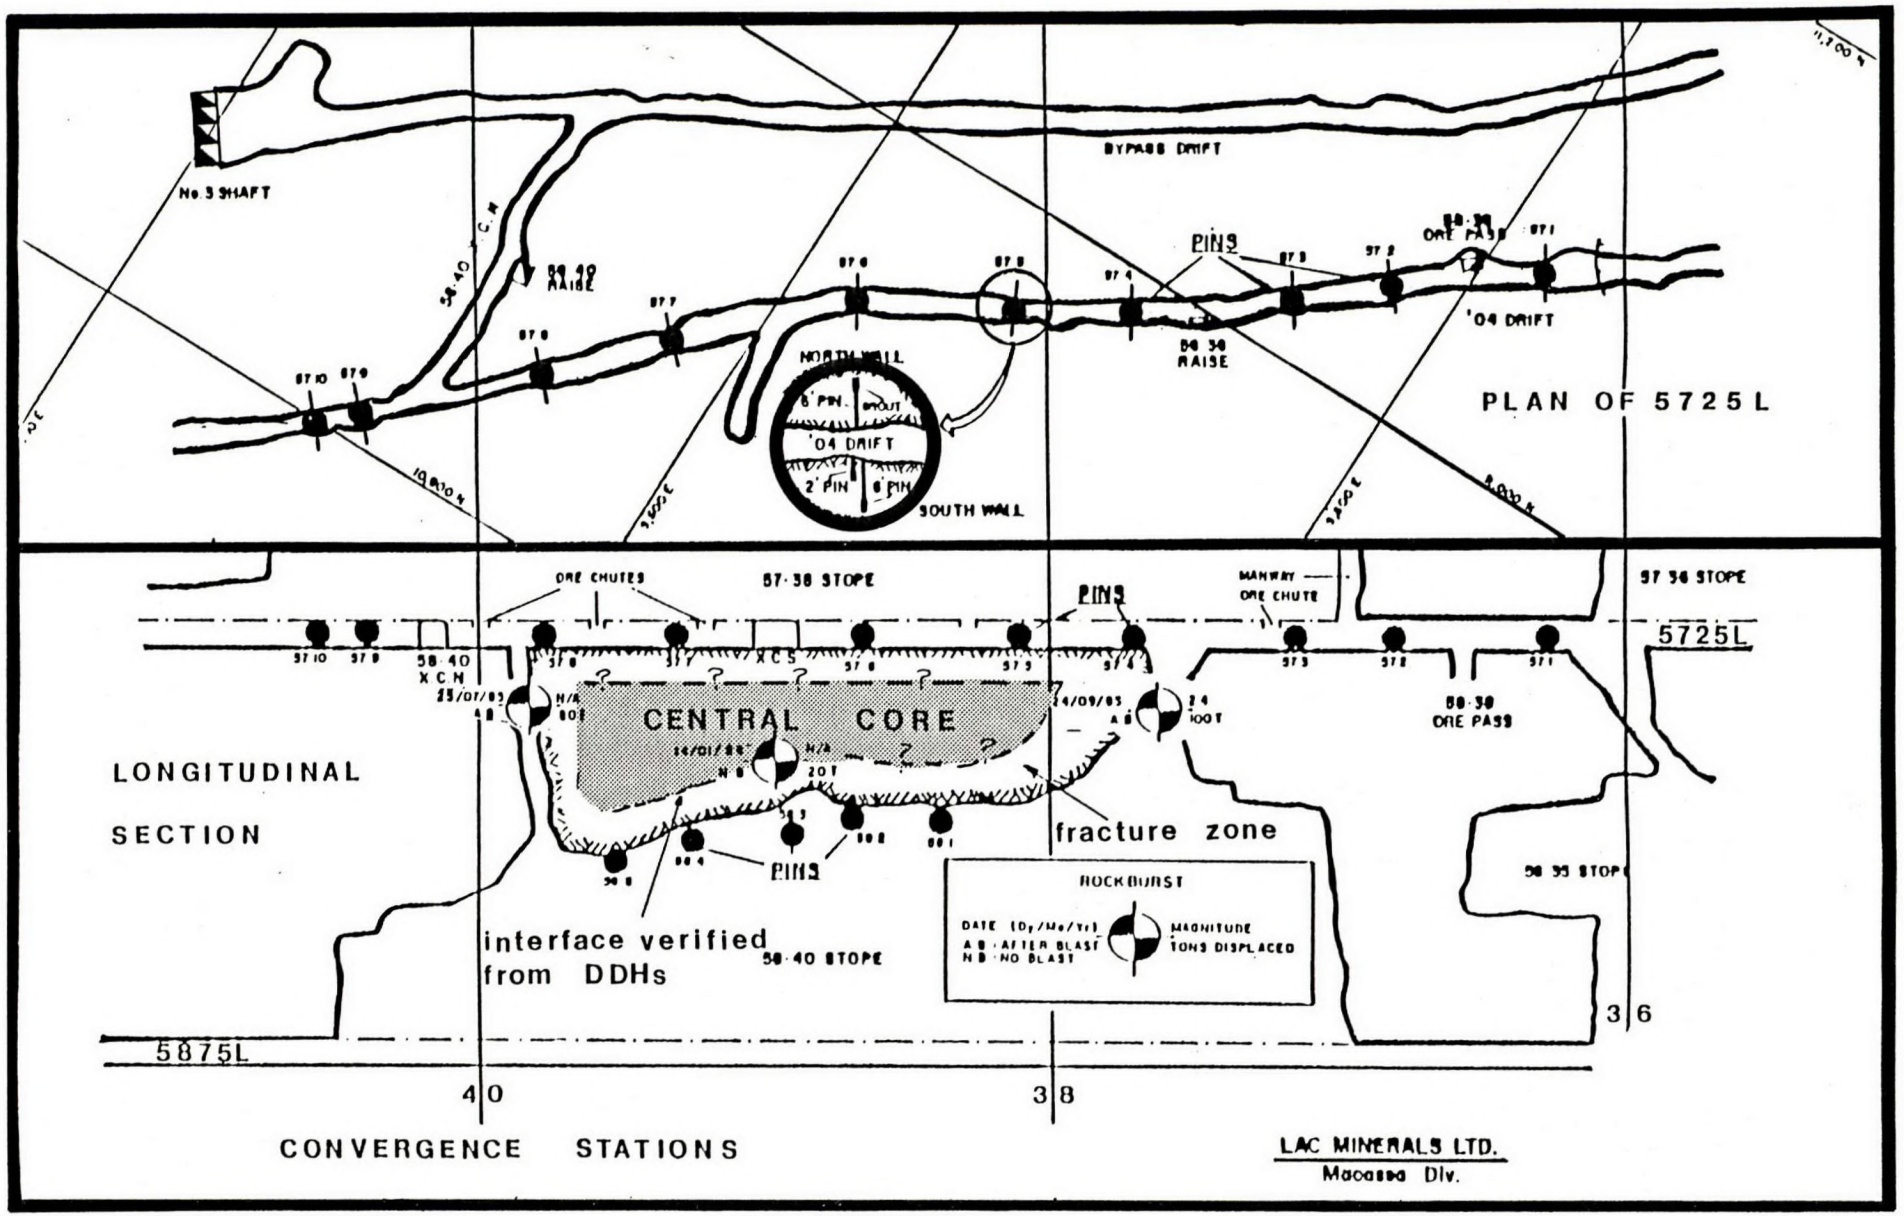
Fig. 5 - Convergence stations, rockburst activity, 58-40 crown pillar conditions.

The diamond drill core did suggest, however, that a 'central core' of the pillar was 9-14 m wide with a peripheral 3 to 3.5 m fracture zone engulfing it (Figure 5).

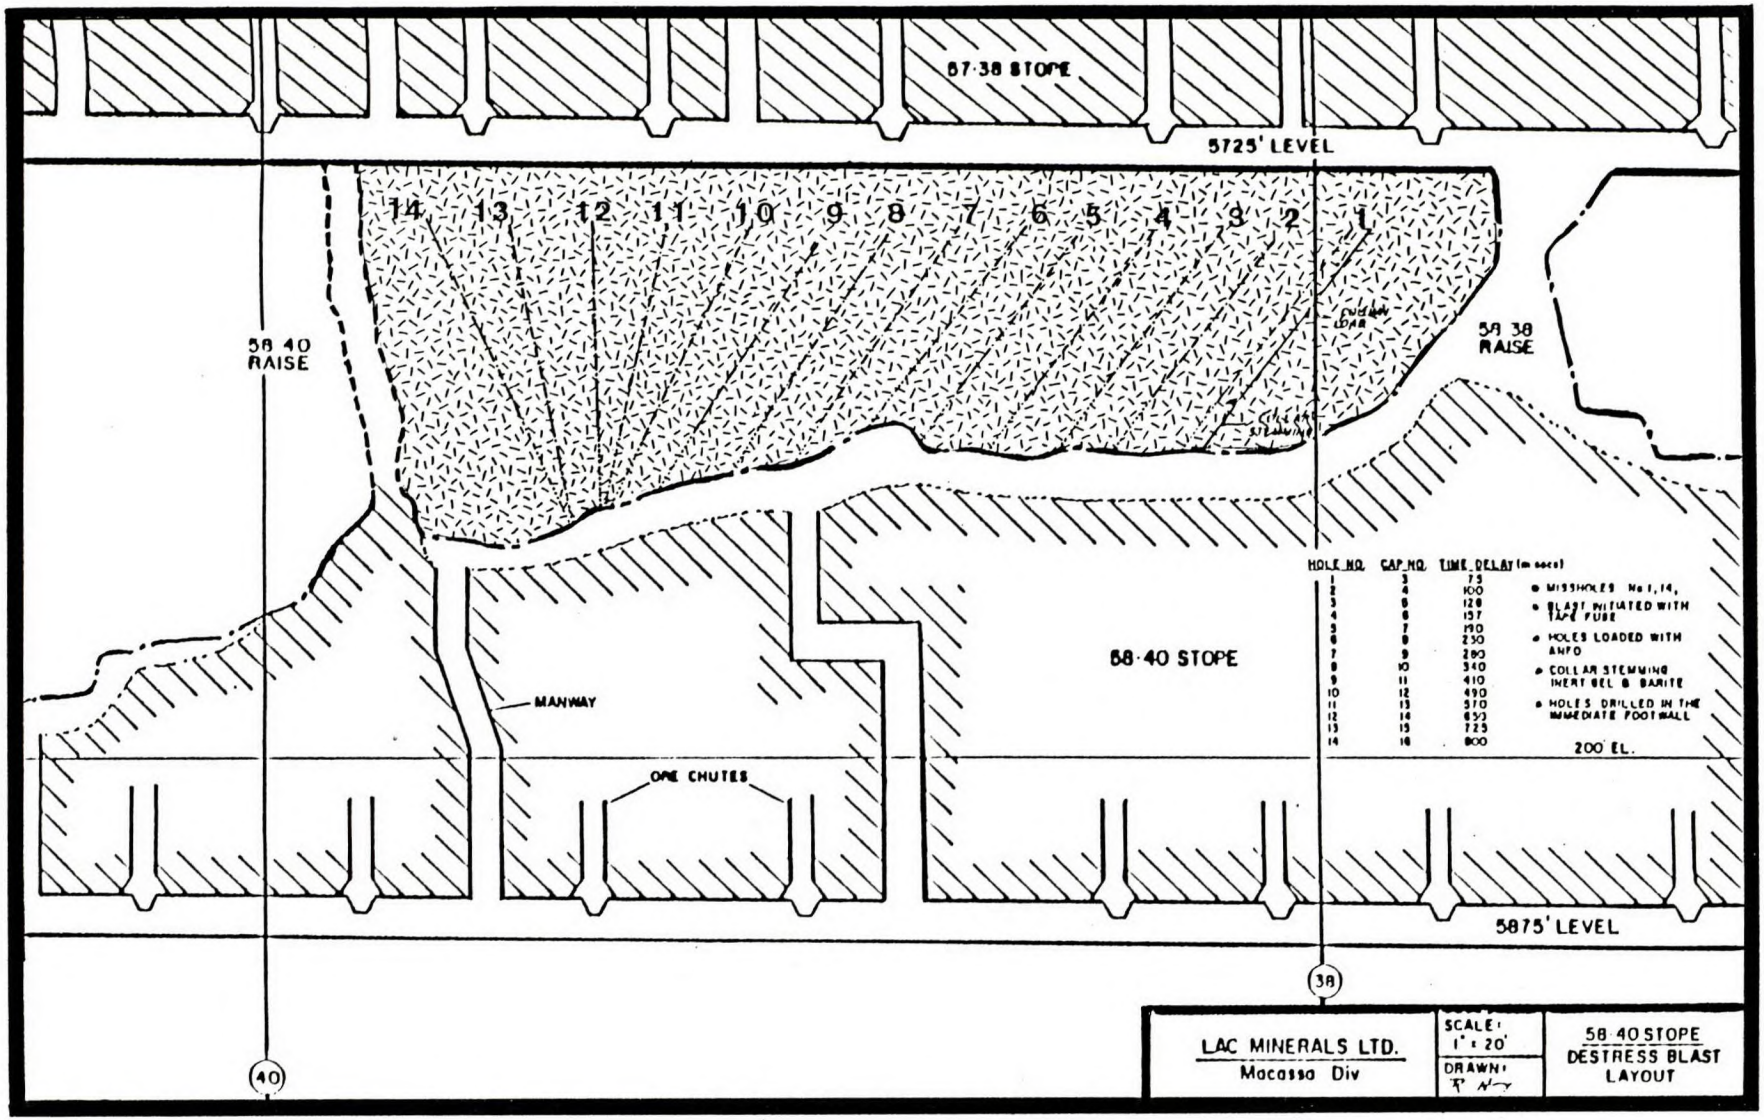
Fig. 8 - Destress blast specifications.

Of the 14 holes that were to be included as part of the destress blast (Figure 8), hole No. 1 could not be loaded properly, and hole No. 14 was not initiated properly and appeared to misfire as was first observed through the Gould waveform analysis equipment, and later through close inspection within the stope back. The designed column loads could not be achieved as hole diameters had squeezed, resulting in a powder factor of 0.03 kg/tonne.

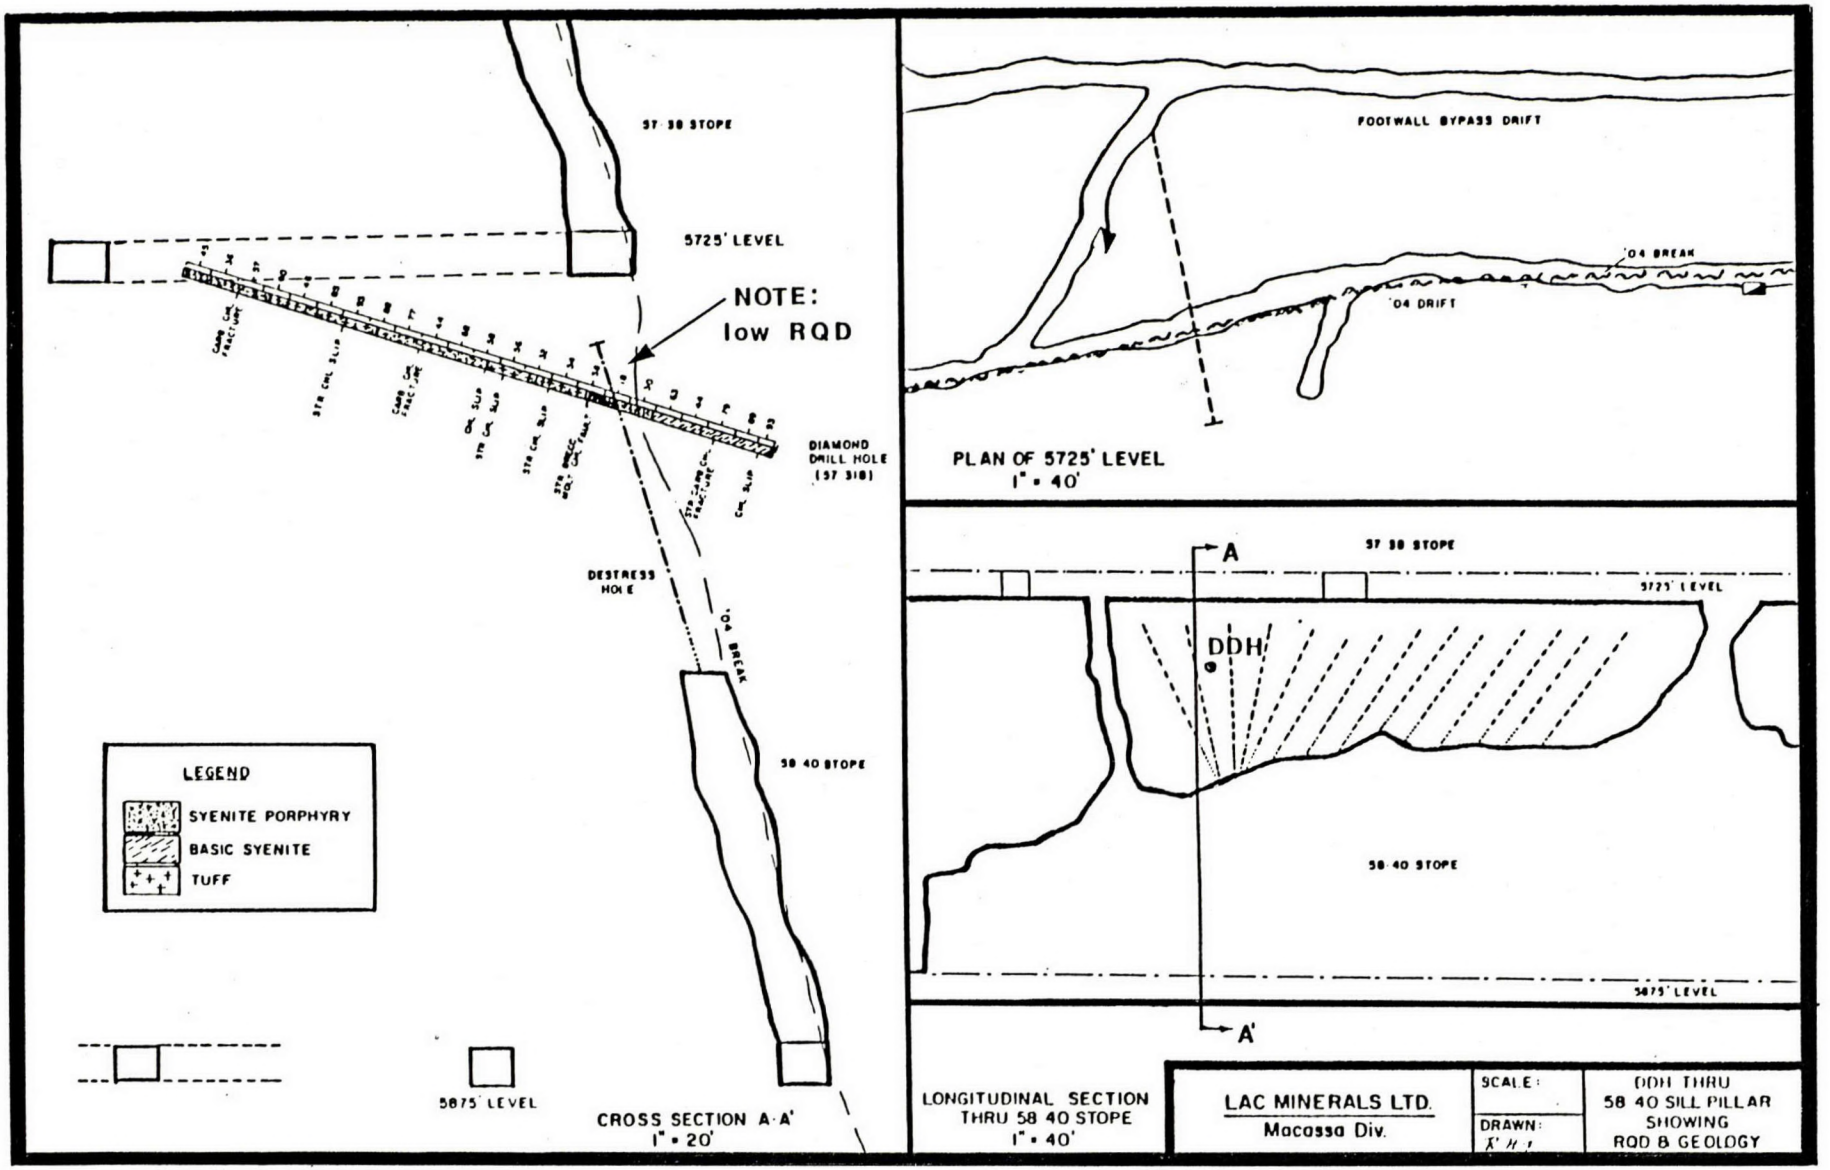
Fig. 9 - Destress blast fracturing assessment through core logging.

The rock mechanics department decided to obtain a better, visual inspection of the blasted pillar's 'central core'. This was achieved by diamond drilling at a location between destress holes 12 and 13, and where the hole intersected the plane of the destress holes the core was extremely fractured (Figure 9). On either side of this intersection no discing of the core was observed and a much higher RQD was obtained.

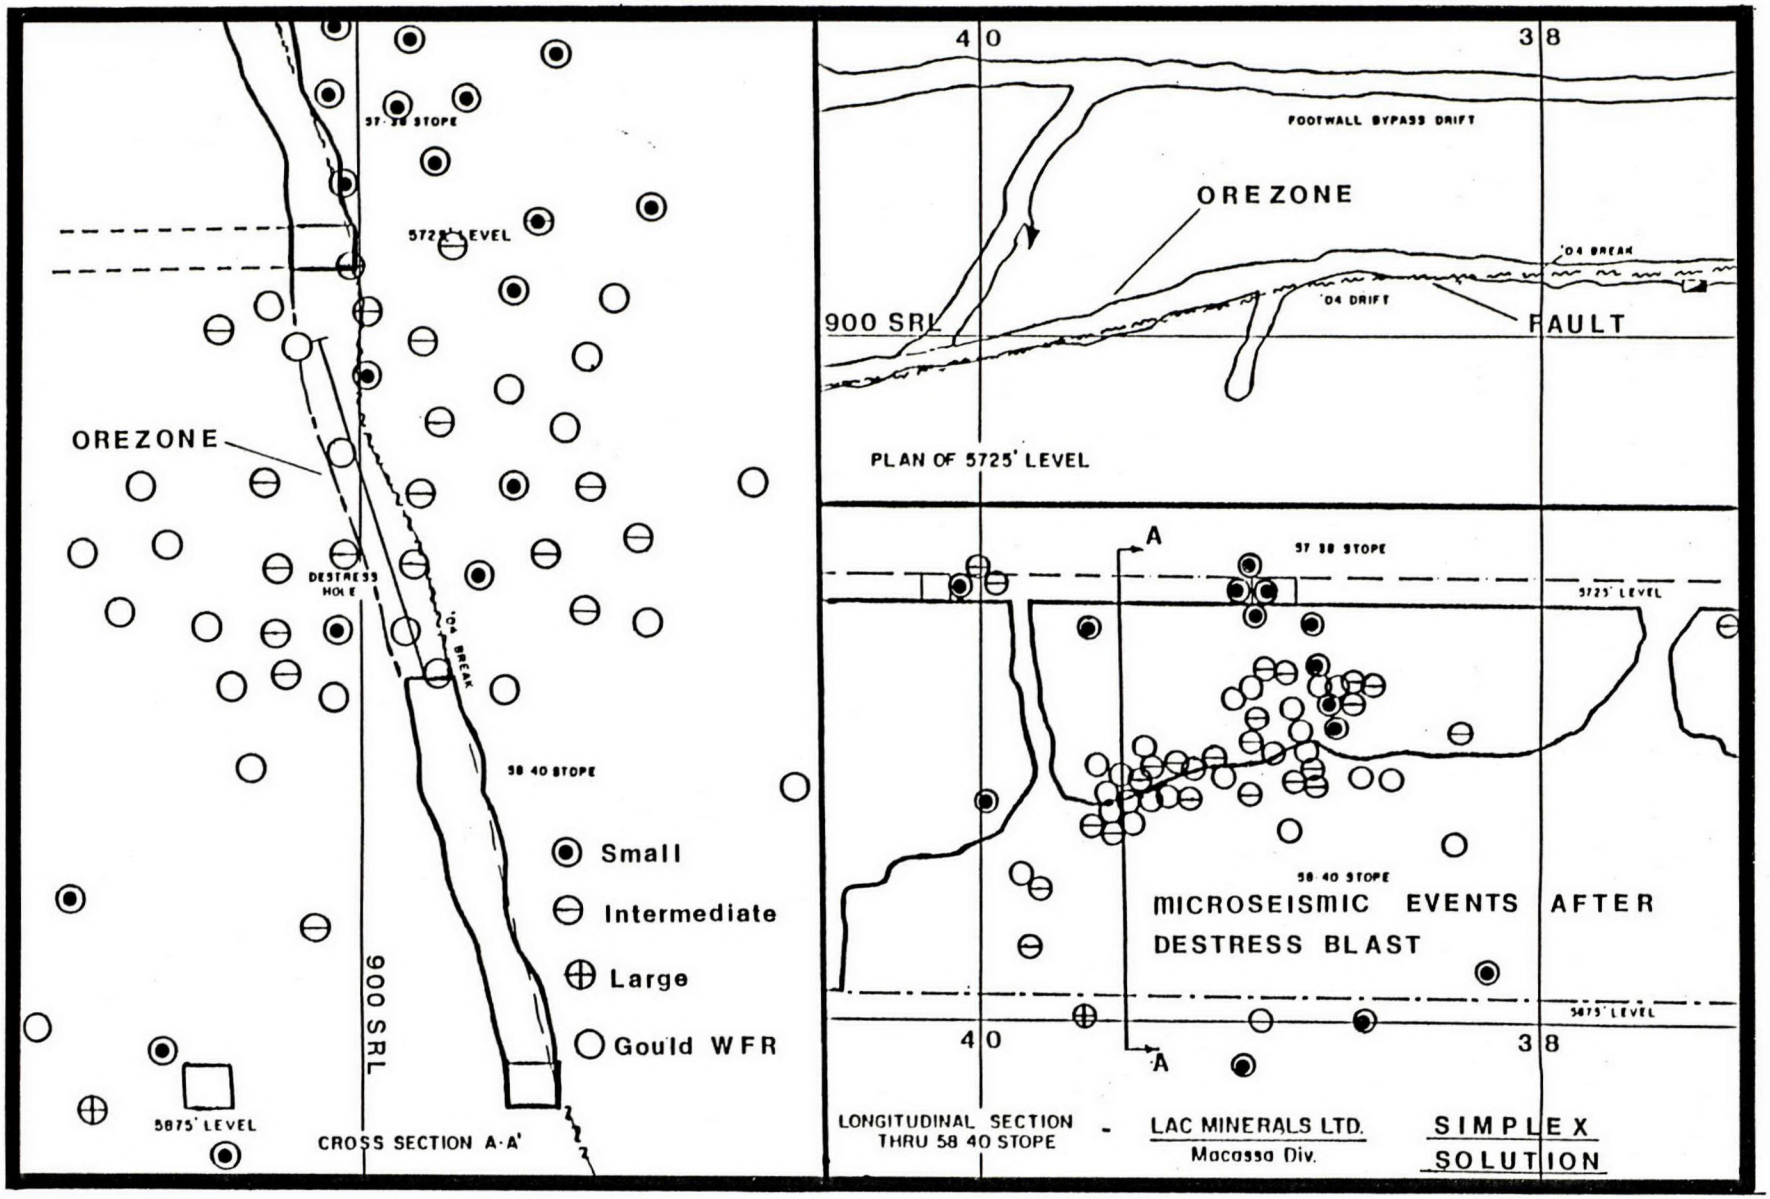
Fig. 10 - Microseismic event source locations generated by the destress blast - Simplex solution.

the 5725 level, with only an isolated spattering of events confined to the large pillar below the 5875 level.

1) The upper portion of the 58-40 crown pillar was already destressed prior to the June 28, 1986 destress blast, or that the destress blast as designed left a narrow intact zone (assumed to be fractured) just below the 5725 sill elevation still intact, but highly stressed.
2) Approximately two-thirds of the 58-40 crown pillar was successfully destressed (western and central portions) except for the eastern section and possibly just below the 5725 level.
3) Seismic events were generated only in the immediate vicinity of the 58-40 crown pillar, and nowhere else in the mine, reflecting adequate buttressing pillars.
4) Most events were clustered within the ore seam.

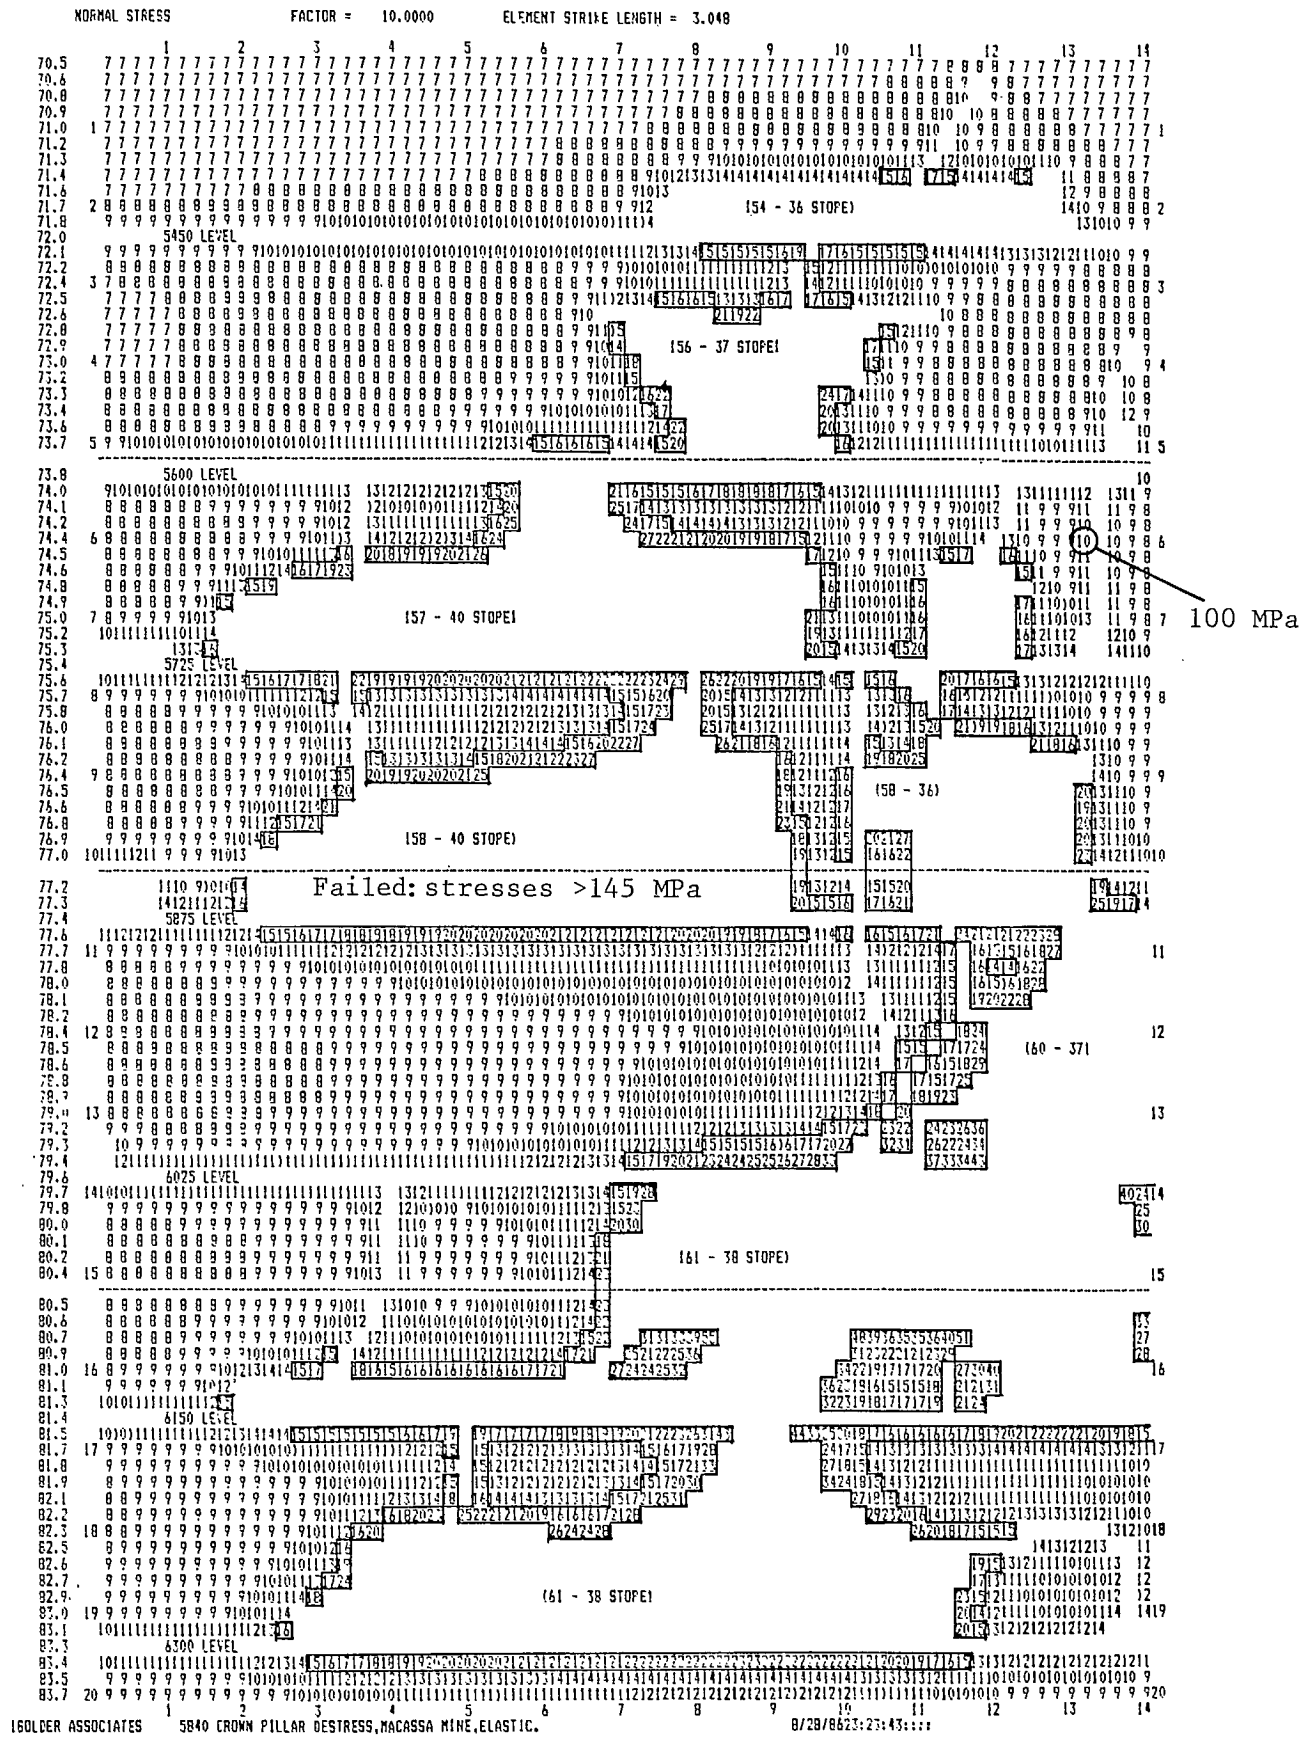
Fig. 12 - Perpendicular stress levels and demarked failure areas, elastic analysis.

Close inspection within the elastic analysis revealed that elements with perpendicular stresses greater than 145 MPa corresponded well with those areas where failure was observed in the mine. Figure 11 shows the mining pattern layout for the elastic case, and Figure 12 shows the perpendicular stresses generated as a result. Figure 12 diagramatically shows those areas flagged as having failed if 145 MPa is used as the criterion. Closer inspection of the 58-40 pillar demonstrates that the 145 MPa failure criterion correlates well with the fractured zone defined through diamond drilling.

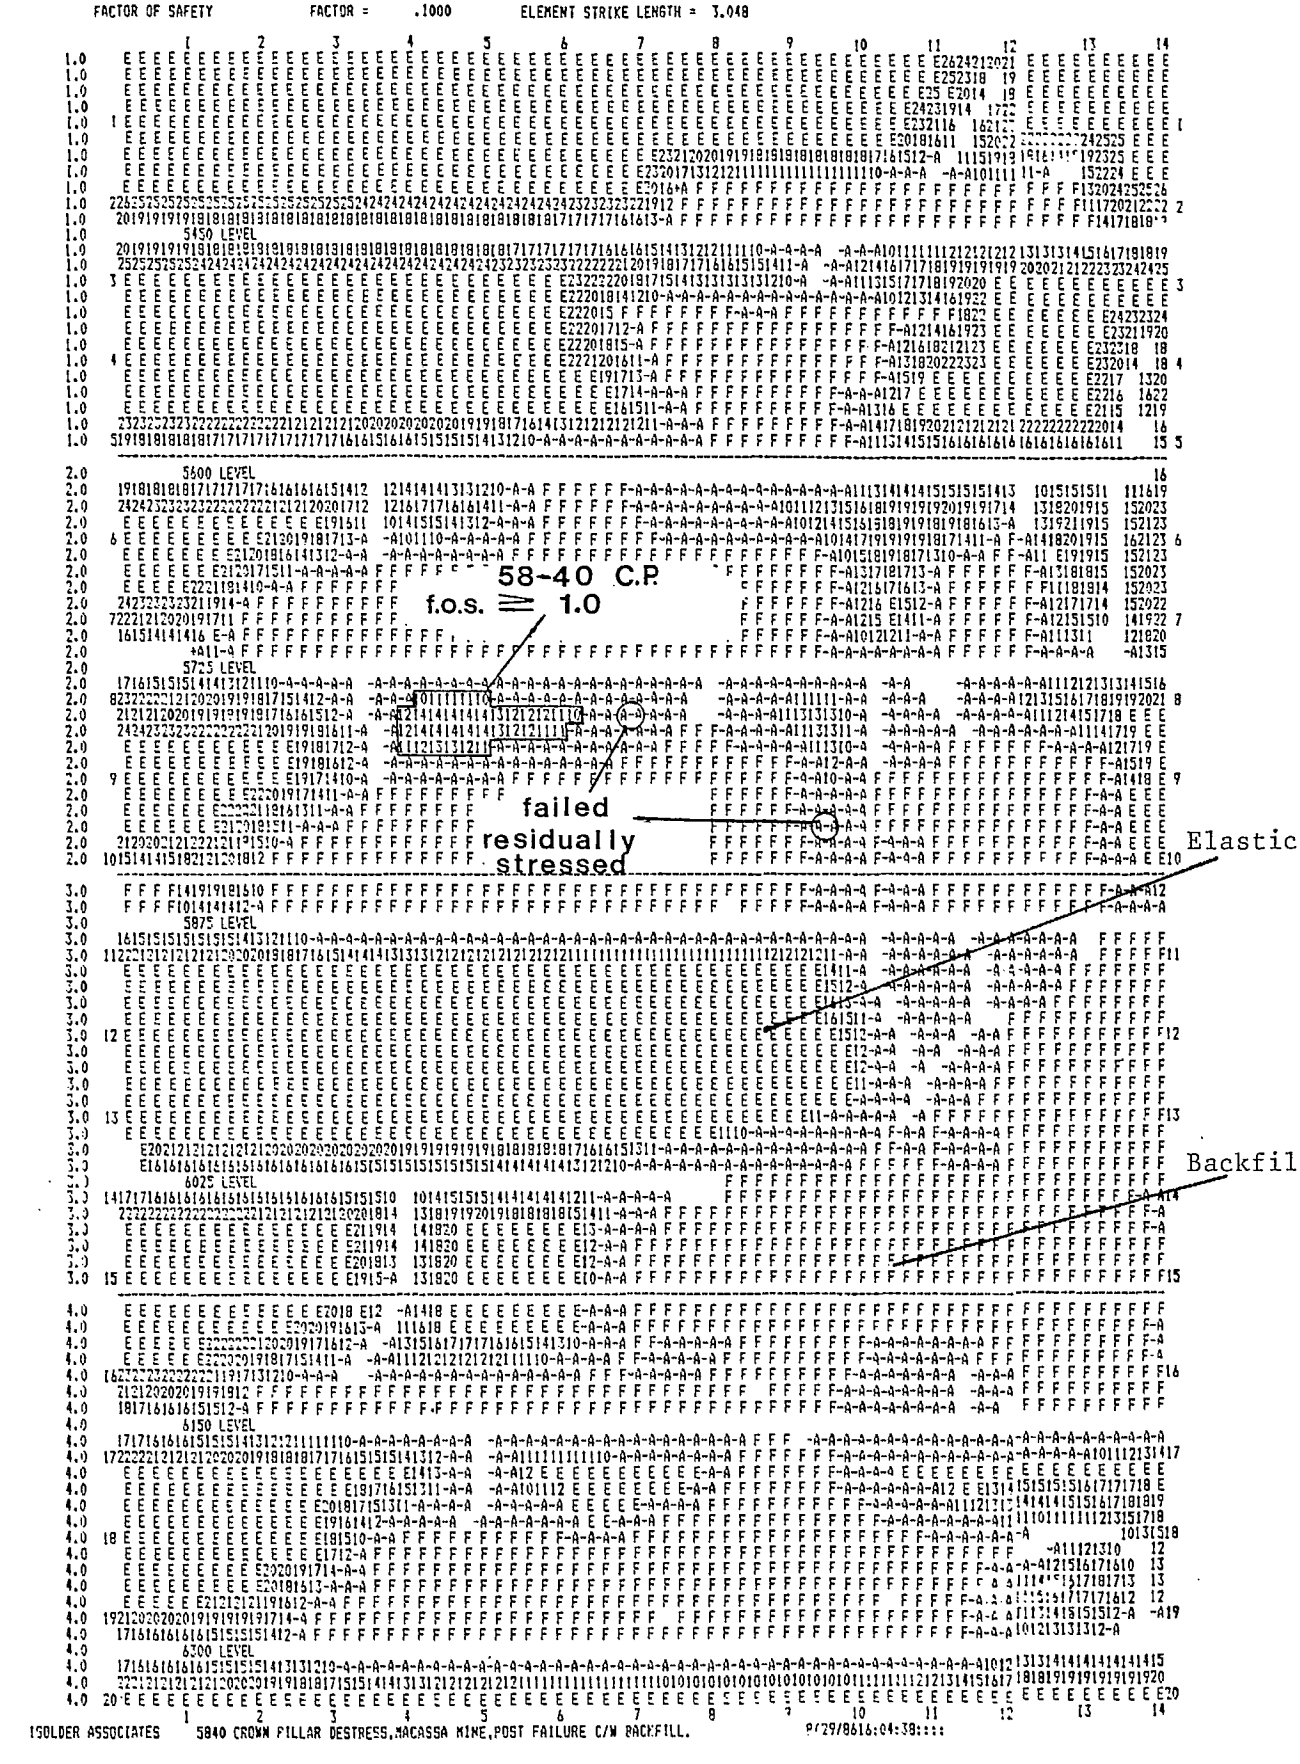
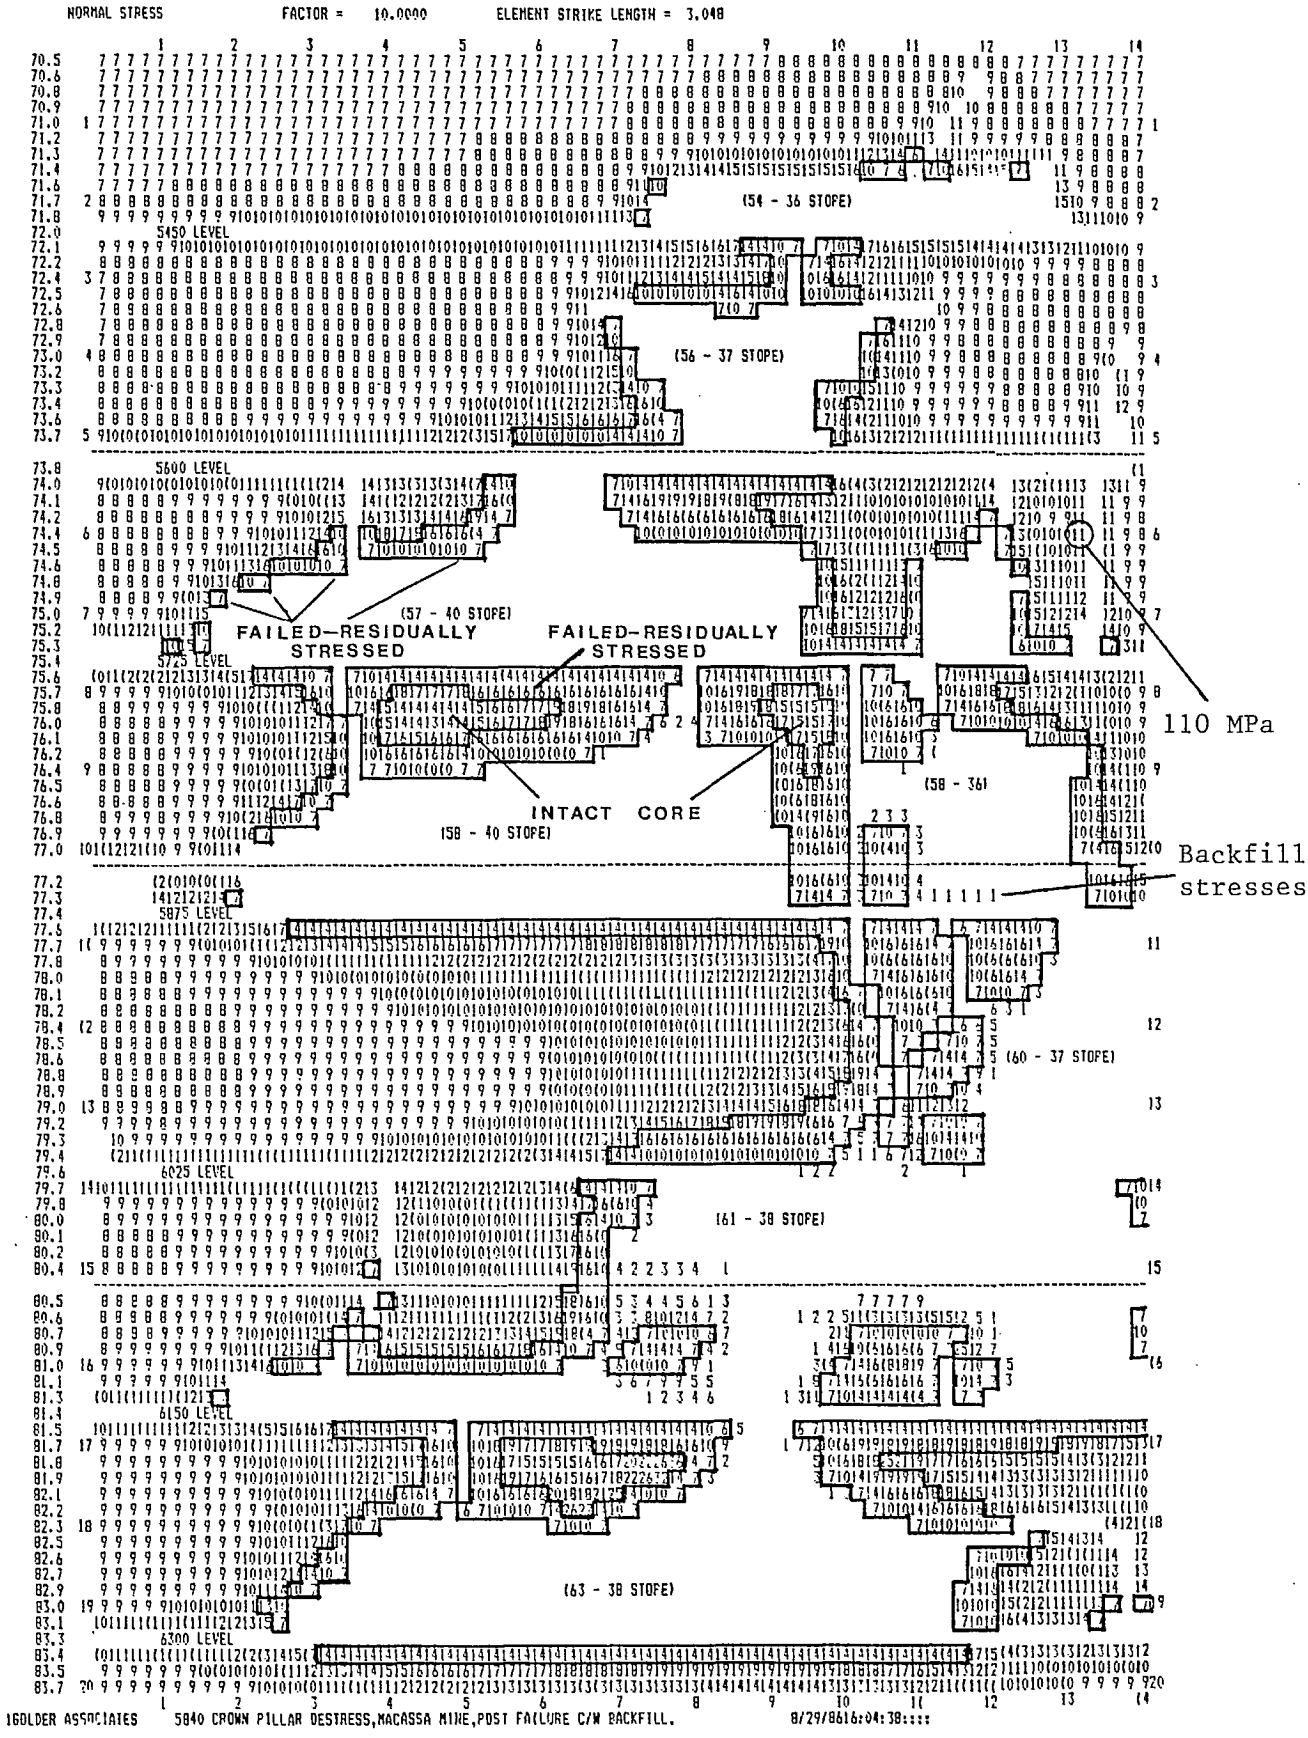
Figures 14 and 15 demonstrate the degree of failure for the calibrated load-deformation properties and show the perpendicular stress levels expected for the various unmined elements. Typically, residual stress conditions are present where the factors of safety are less than unity, and immediate to these areas very highly stressed elements with factors of safety slightly greater than, or equal to, unity are common. Close examination of the 58-40 crown pillar shows this by example. Figure 15 demonstrates the possibility of

failed elements near the inner core having higher stresses than the stronger intact core elements. This suggests triaxial loading conditions near the pillar centre and uniaxial loading conditions at the pillar edges. The central core of elements are highly stressed, but the core is much smaller than for the earlier elastic case. Attempts were made to adjust the peak and residual strengths higher, but significant increases to anomalously high values were necessary to generate a larger intact pillar core.

It should also be noted in examining the perpendicular stress results (Figure 15) that where failure of the unmined elements is fairly extensive (west of the 60-37 stope, bottom 61-38 stope, upper 63-38 stope) significant stress transfer to the backfilled elements has occurred. Although this has not been verified through pressure meters installed in the backfill, the narrow stope width and angular mined waste development would most likely adequately support this stress transfer.

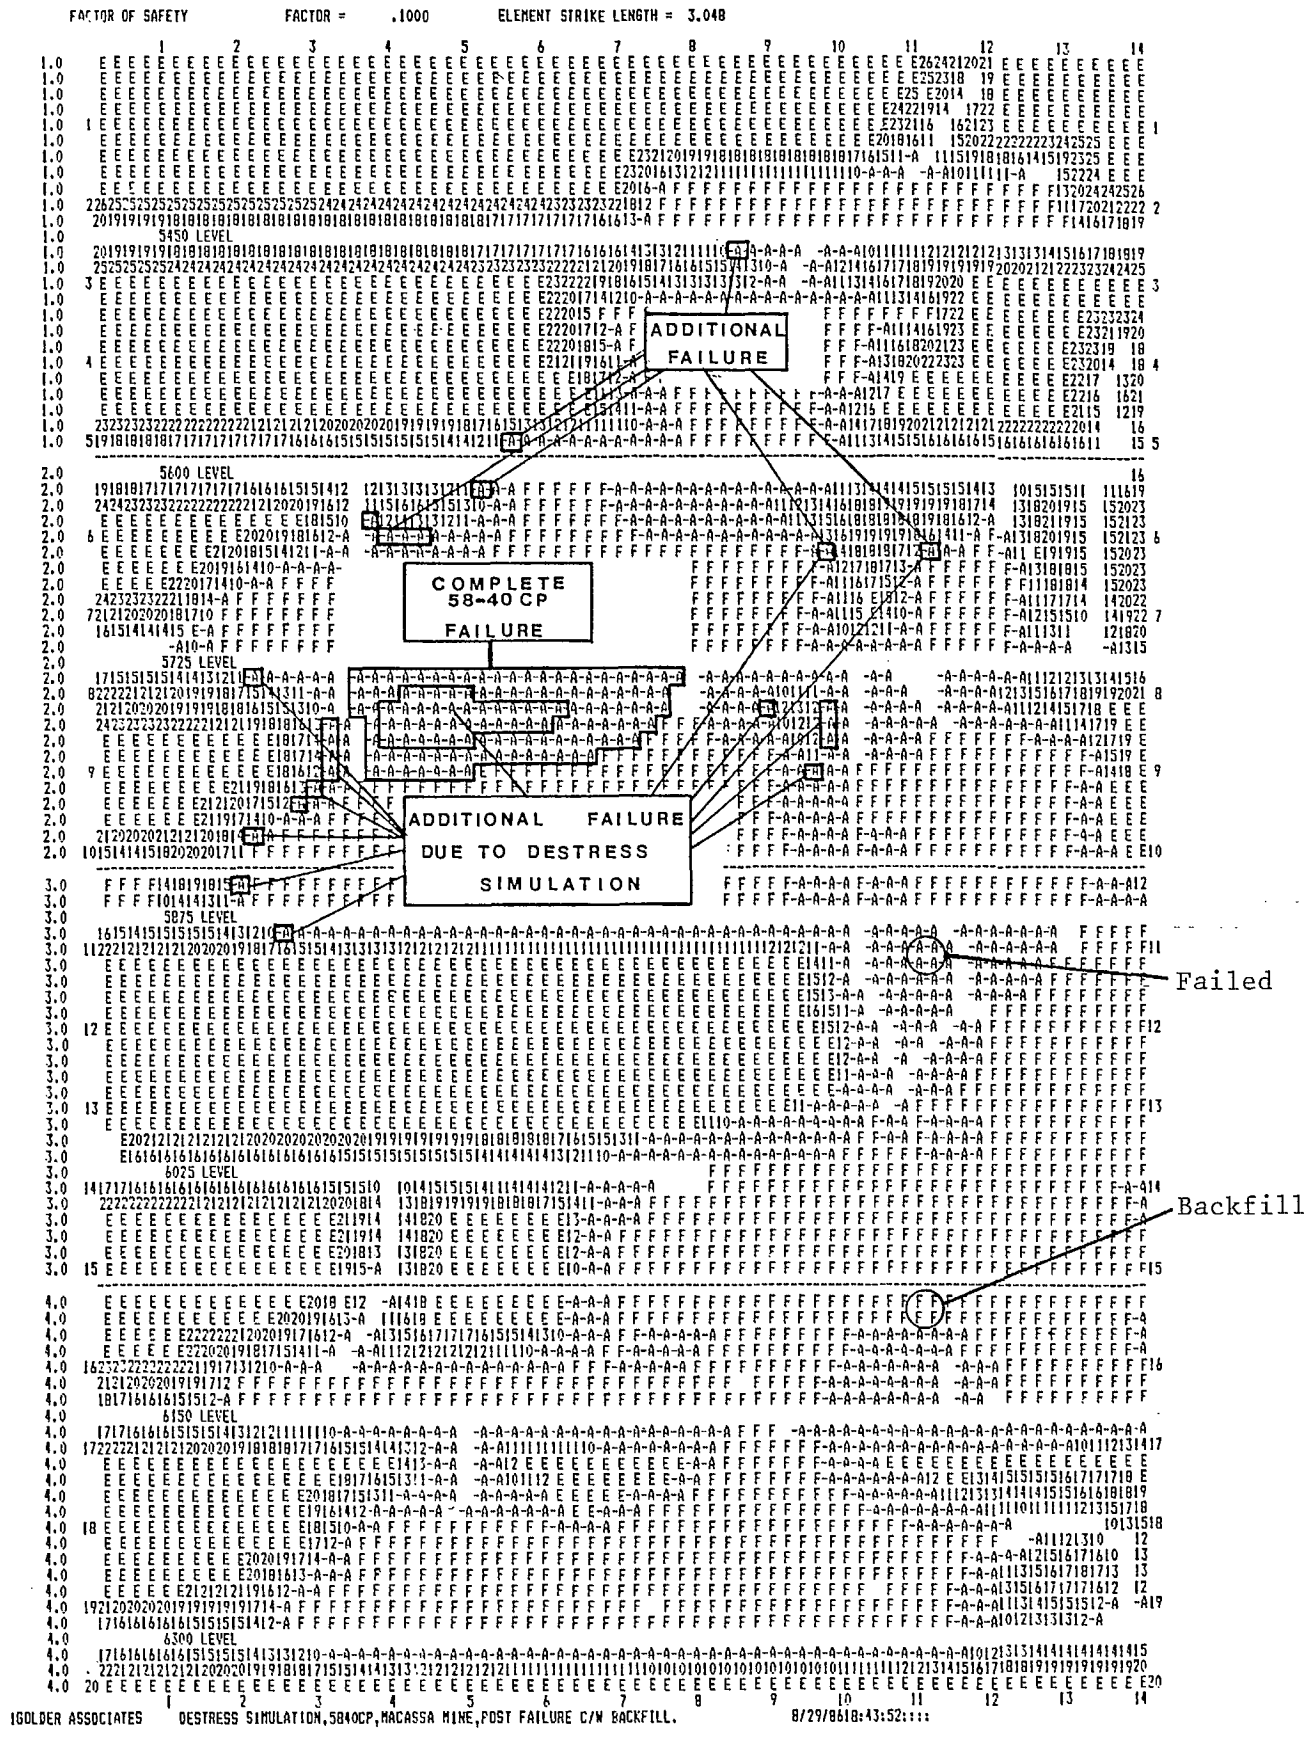
Fig. 17 - Strength/stress ratios displaying limited effect of destress simulation on surrounding pillars - destress simulation.

Figure 17 indicates complete failure of the 58-40 crown pillar which would be the case if the pillar was successfully fractured by the destress blast.

The former NFOLD analyses containing post-failure criteria and an indication of the extent of failure within the 58-40 crown pillar and its surroundings prior to the destress blast were matched against the extent of failure generated from the destress simulation. Very little additional failure was generated in the surroundings (Figure 17) other than the crown pillar.

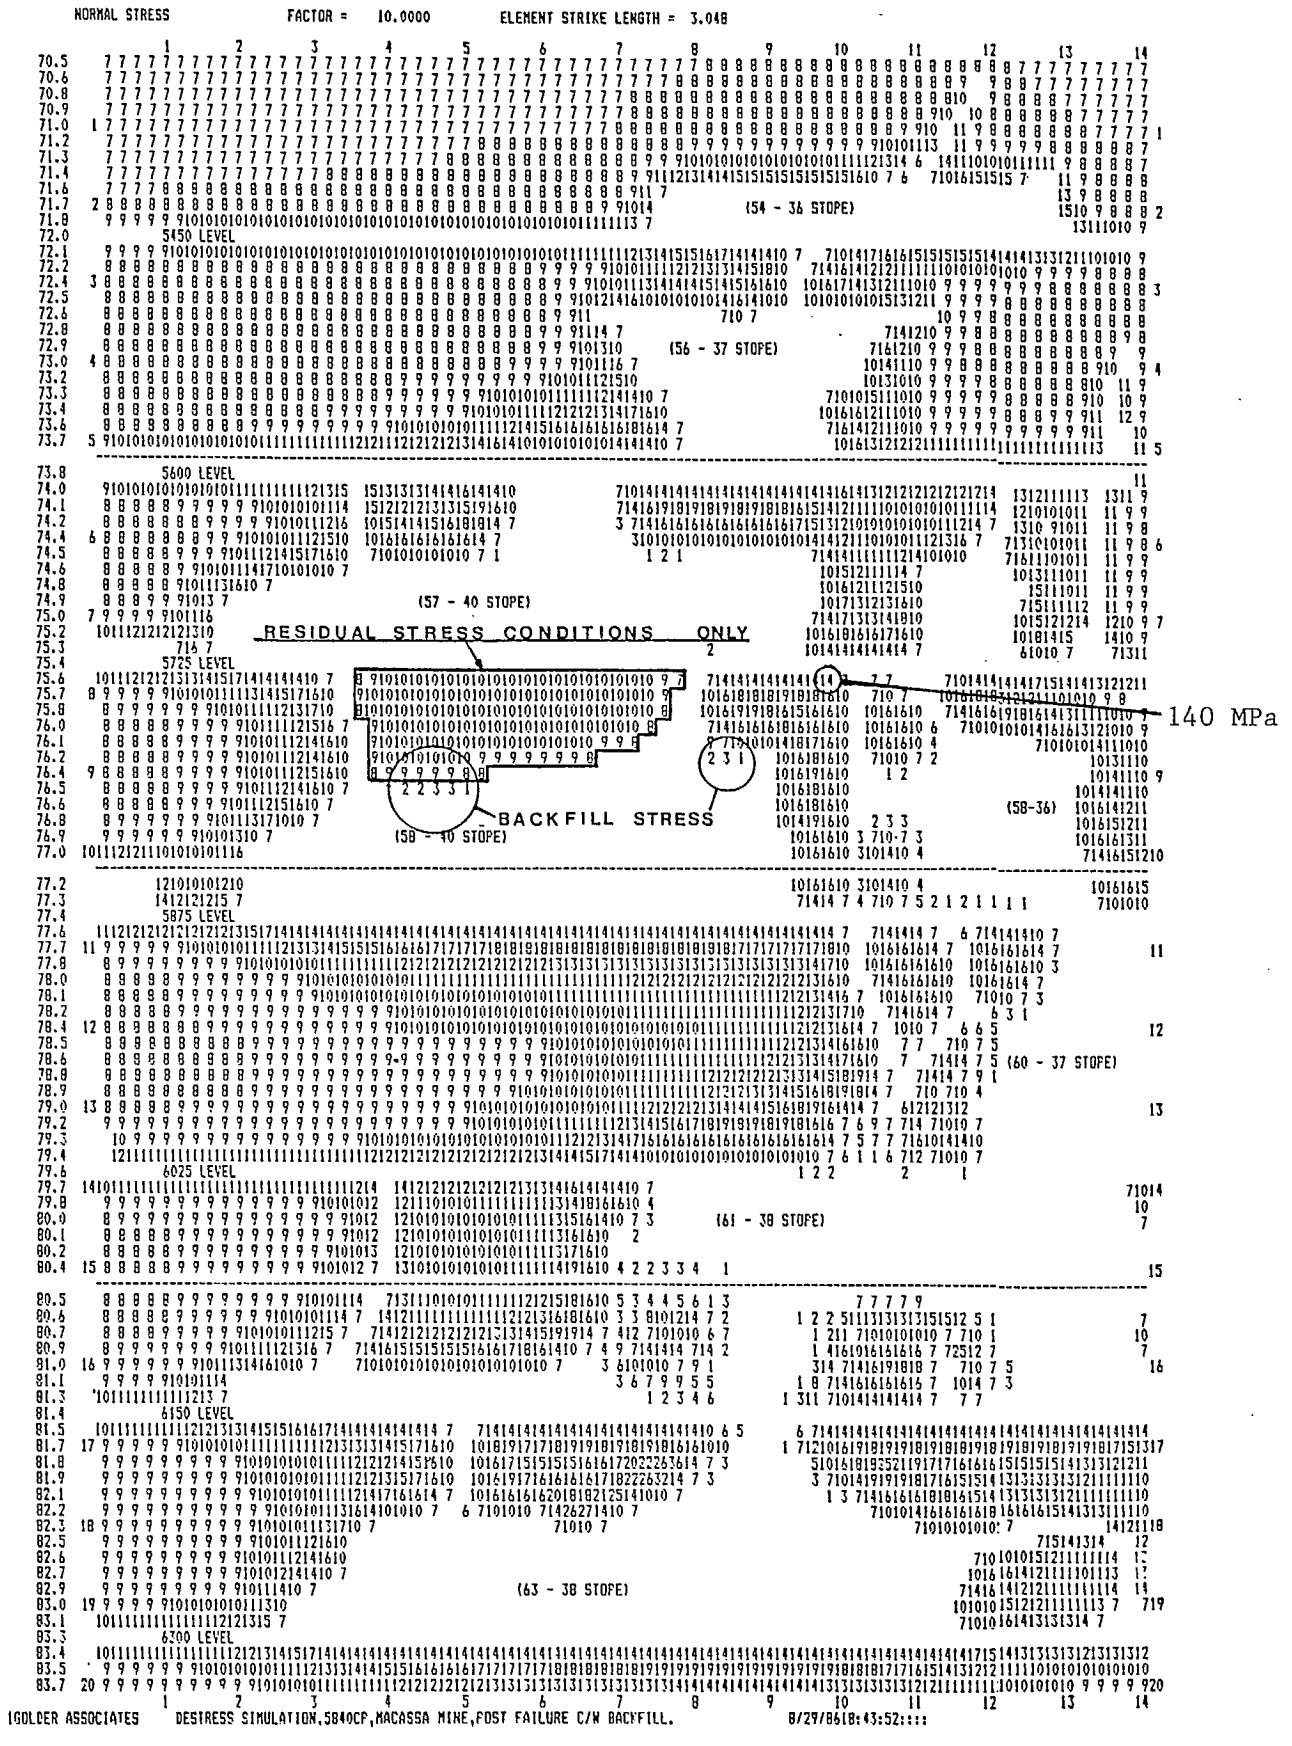
Fig. 18 - Perpendicular stresses with residual stress conditions of the 58-40 crown pillar highlighted - destress simulation.

Only a few additional elements failed within the central core of the 36-waste pillar, the western outline of the 58-40 stope, and the western upper crown pillar buttress of 57-40 stope. None of the other locations in the mine were affected by the destress blast simulation. Limited spans and the degree of extraction were more than likely instrumental in suppressing the effects of the blast. Figure 18 displays the stress conditions as a result of the destress simulation.

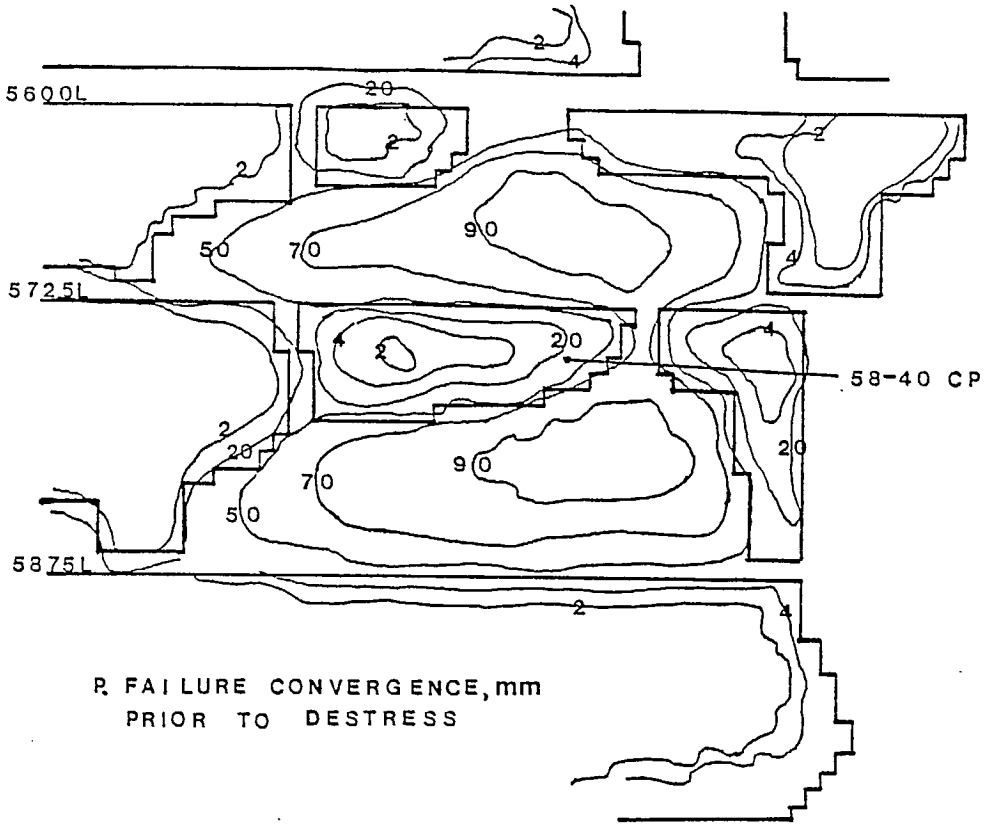
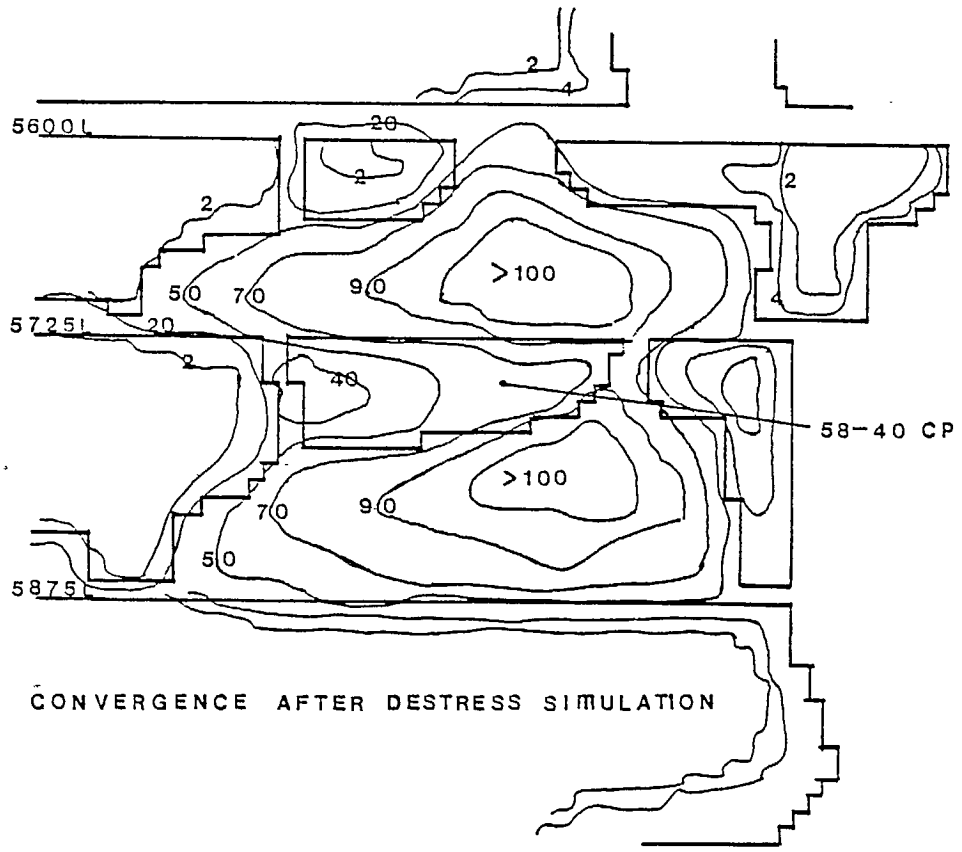
Fig. 19 - Convergence contours before and after the destress simulation.

Just as the numerical analysis was used to compare the differential failure areas before and after the destress simulation, the convergence before and after the destress simulation was compared as well. Figure 19 shows the effect of the destress simulation and the increased convergence as expected.
