DESTRESSING A ROCKBURST PRONE CROWN PILLAR - MACASSA MINE

FEBRUARY 1987

MINING RESEARCH LABORATORIES
DIVISION REPORT MRL 87-82 (TR)

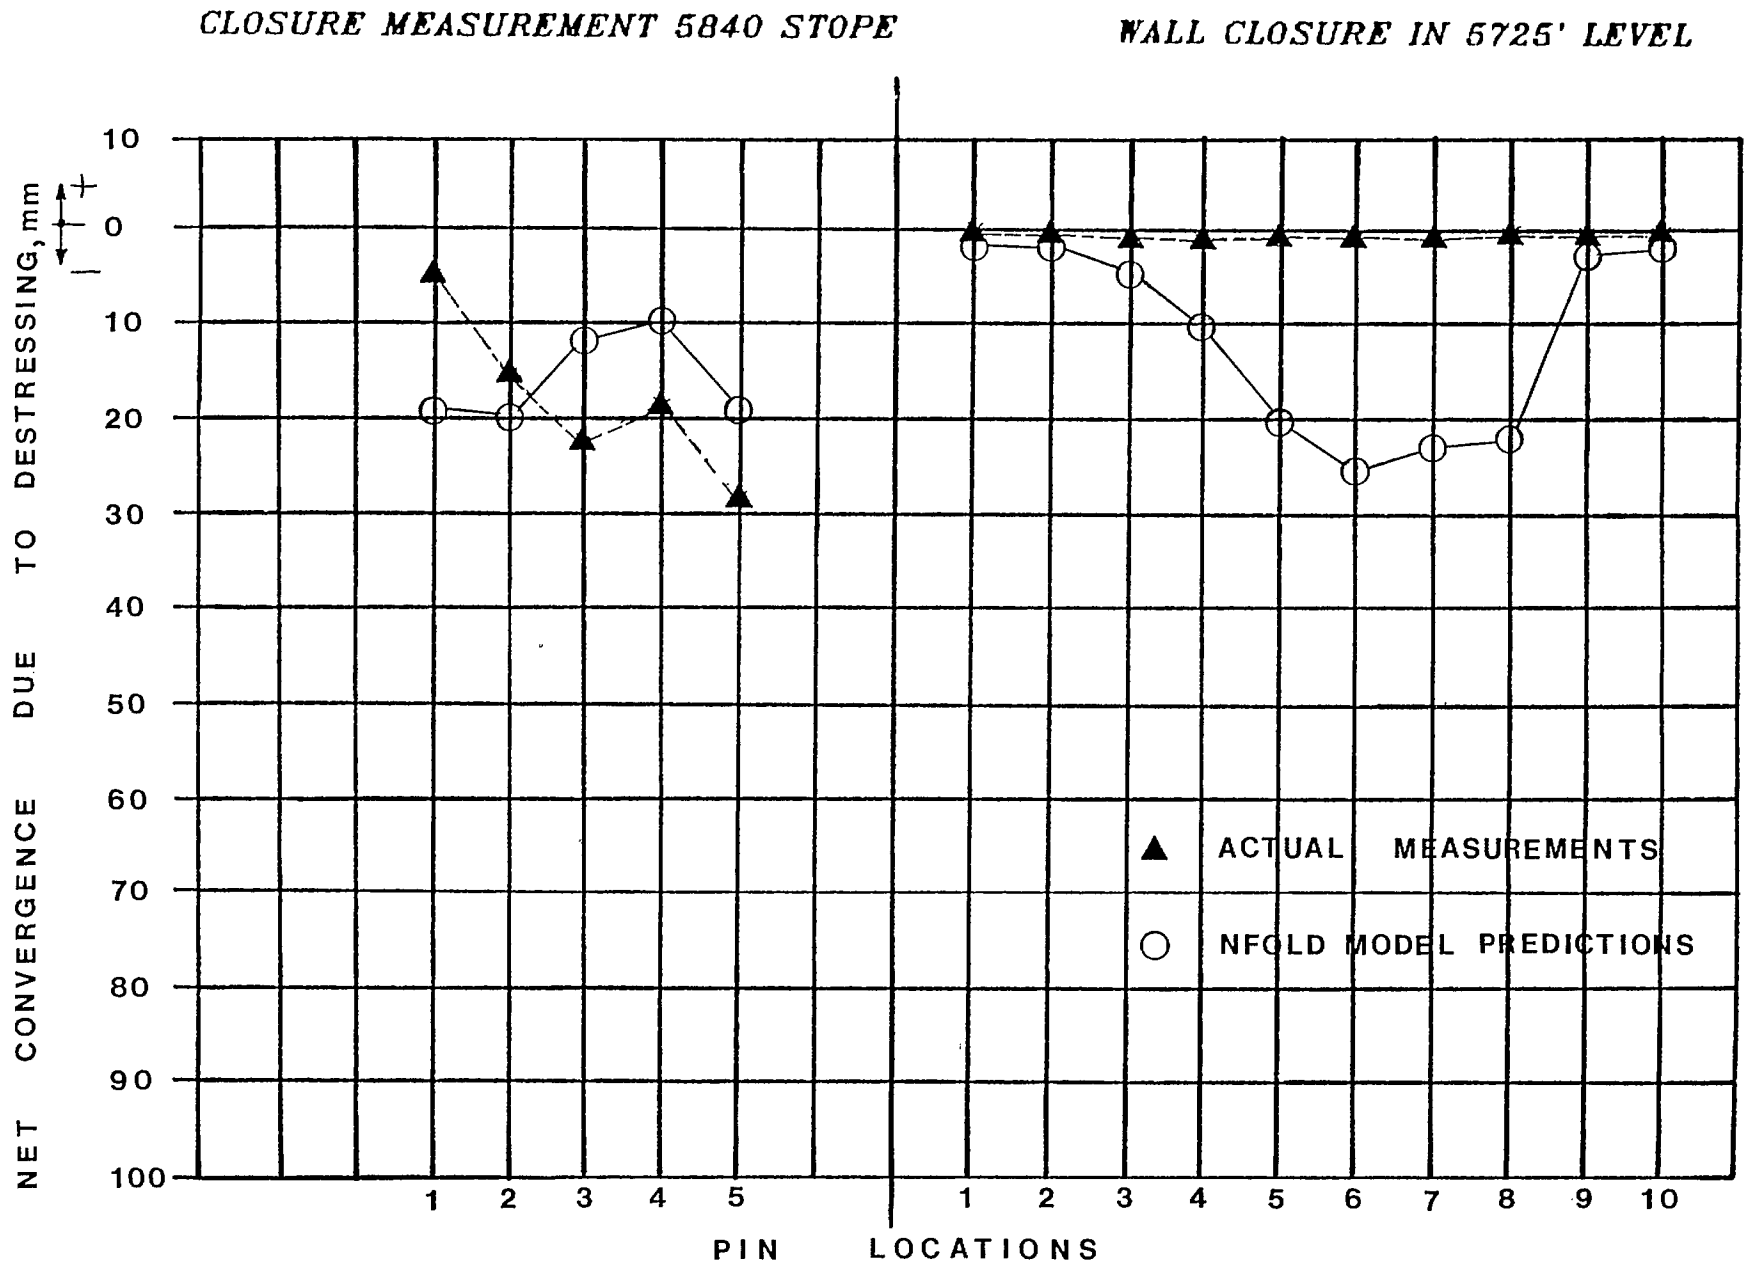
Fig. 22 - Comparisons between the NFOLD predicted convergence versus actual measurements as of July 30/86.

Since this period more recent measurements have indicated additional convergence at the 58-40 stope pin locations and substantially more convergence at those pin locations directly above the 58-40 crown pillar. The recent data suggests that possibly the destress holes might have been located nearer to the 5725 sill horizon and that this same area may still have some burst potential (it was assumed earlier to be highly fractured and therefore not destressed during the blast).

The NFOLD computer mining simulations were considered a success as they had accurately indicated the failure areas prior to the destress blast, determined that destressing the pillar had a limited effect on the surrounding openings, and predicted convergence values that agreed reasonably well with the underground measurements, particularly for the 58-40 stope convergence stations.
