PAPER 79-31

**ENGINEERING GEOLOGY AND GEOTECHNICAL
STUDY OF DRYNOCH LANDSLIDE, BRITISH COLUMBIA**

D.F. VANDINE

1980

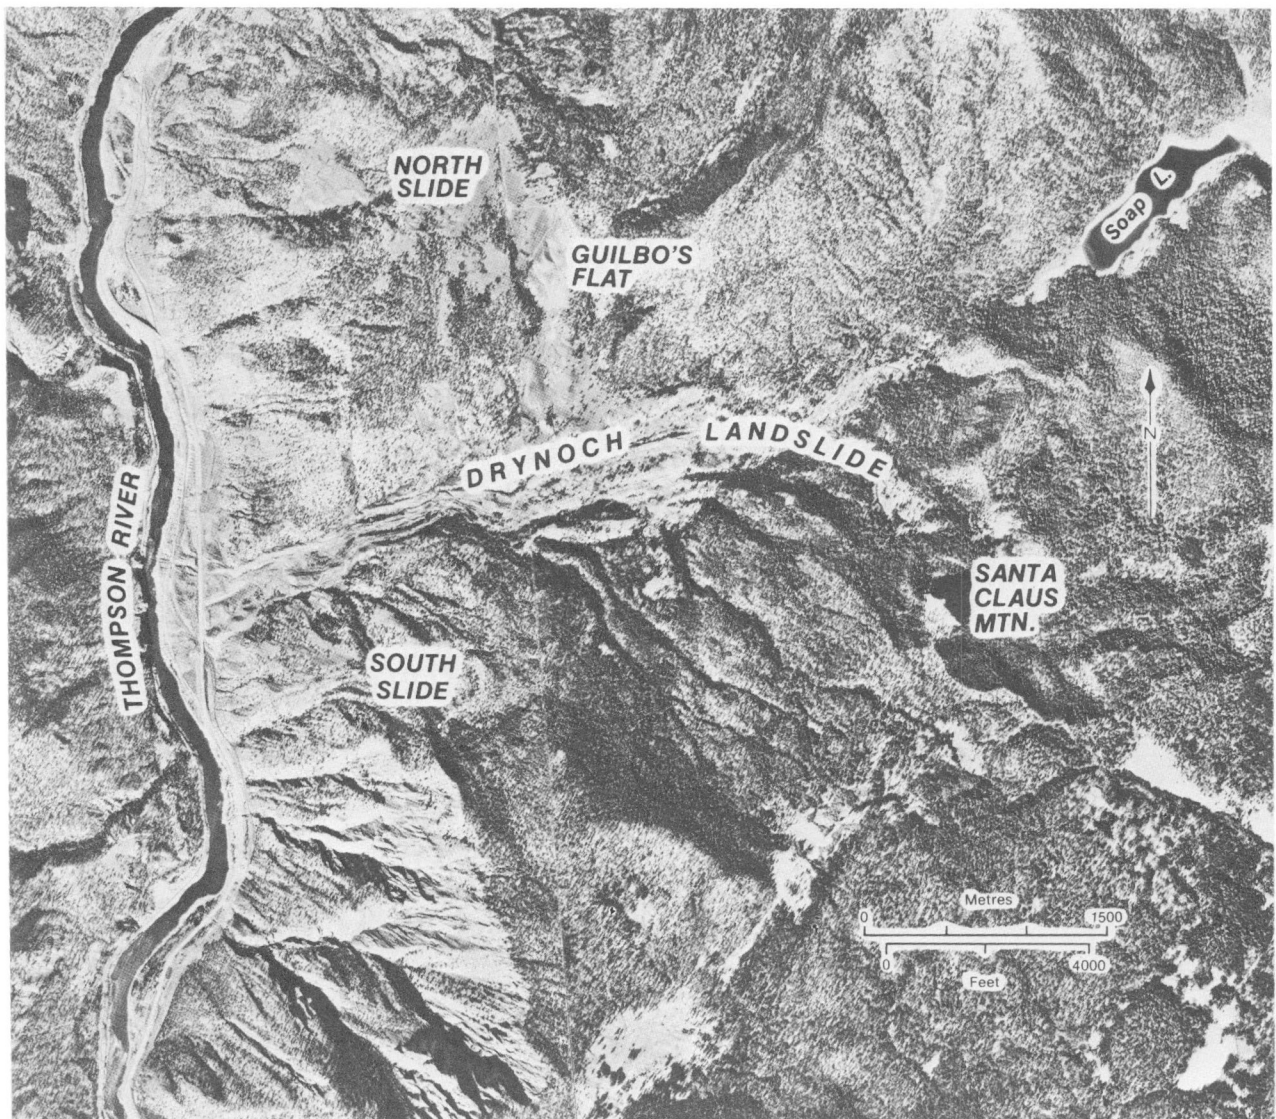
Figure 2. Photomosaic of Drynoch landslide. Some place names are unofficial (British Columbia Lands, Forests and Water Resources airphotos BC 5169-164 and 5170-004). (GSC 175662-5)

The appearance of Drynoch landslide closely resembles that of a valley glacier. Figures 2 and 3 show obvious flow characteristics which are accentuated by two large ridges bordering either side of the lower portion of the slide and by the lines of vegetation which follow surface and subsurface water courses. Longitudinal faults, transverse cracks and ridges, and a cirque-like headscarp complete the valley glacier analogy.

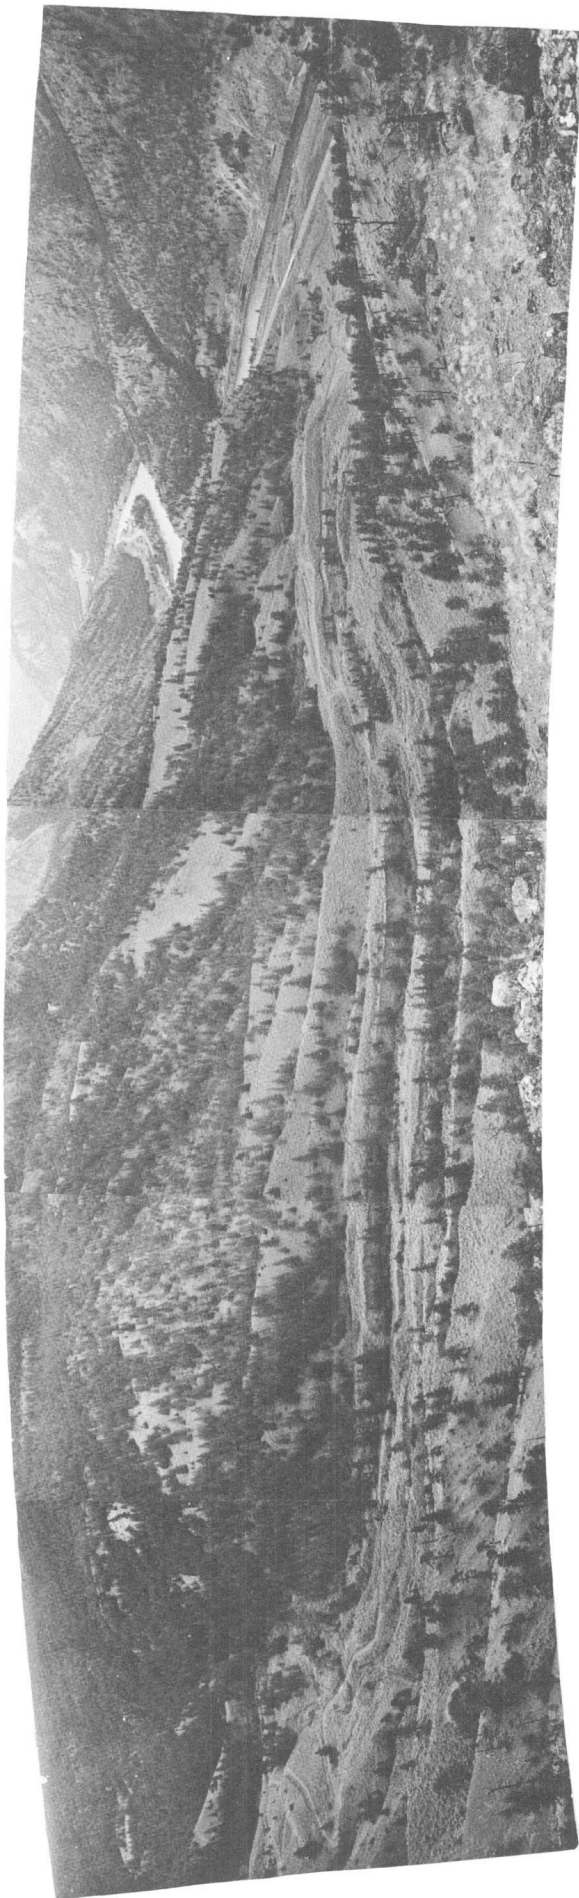
Figure 3. Panoramic view looking southward over lower portion of Drynoch landslide. Note flow features and lines of vegetation. The slide is moving from left to right. (GSC 175662-5)

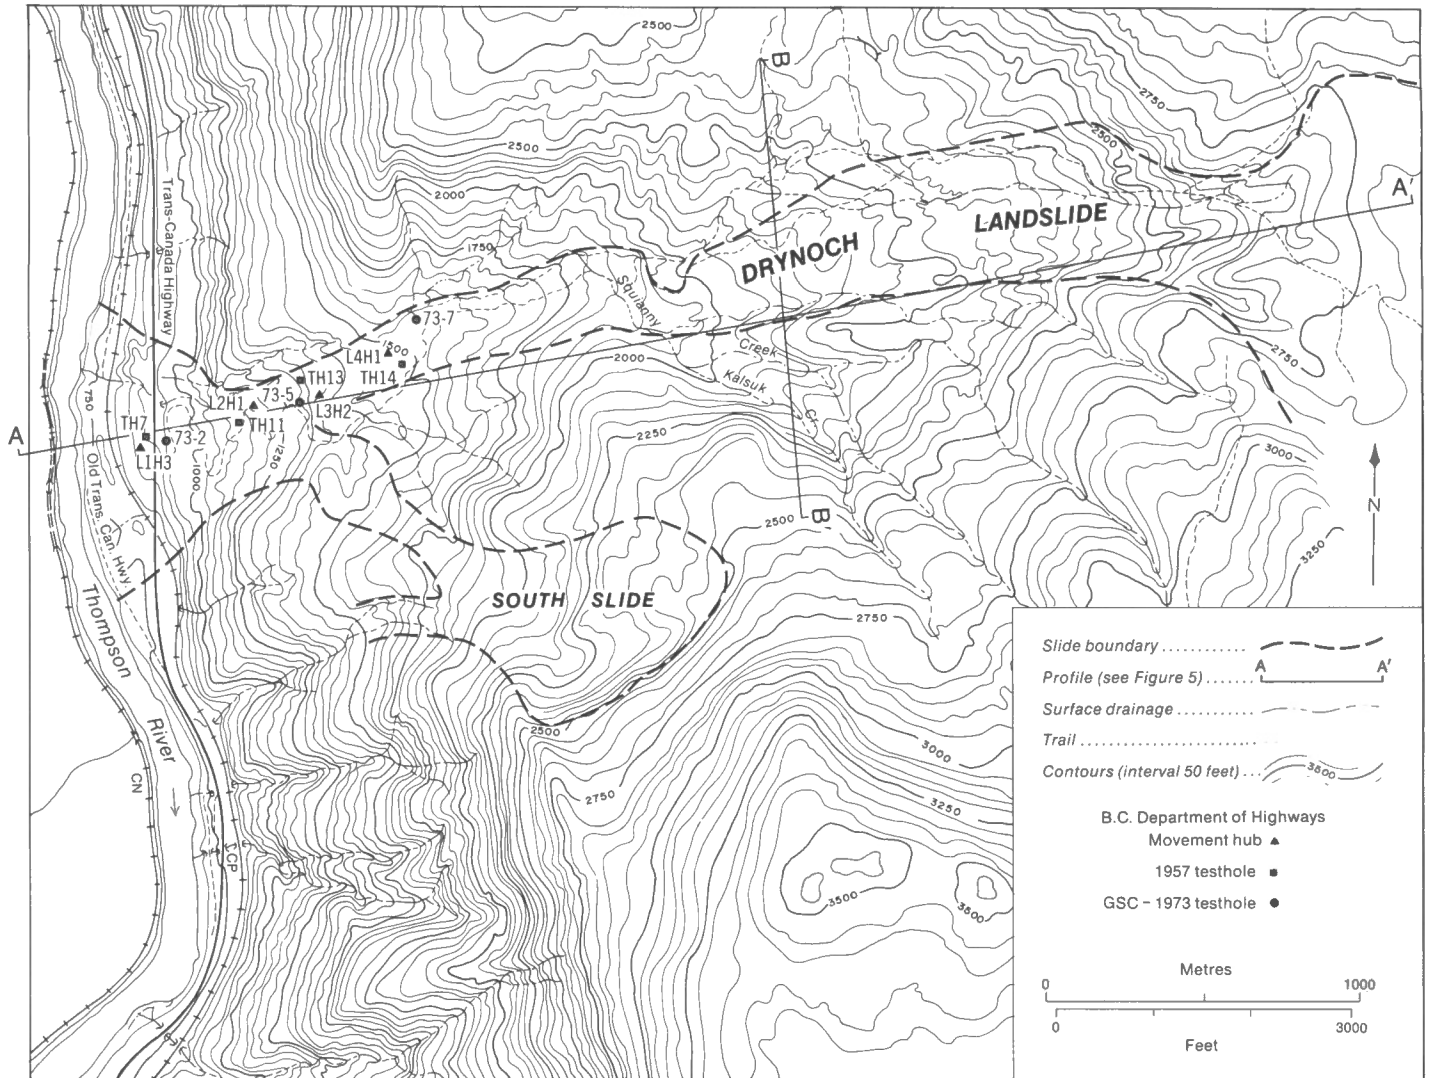
Figure 4. Contour map of a major part of Drynoch landslide.

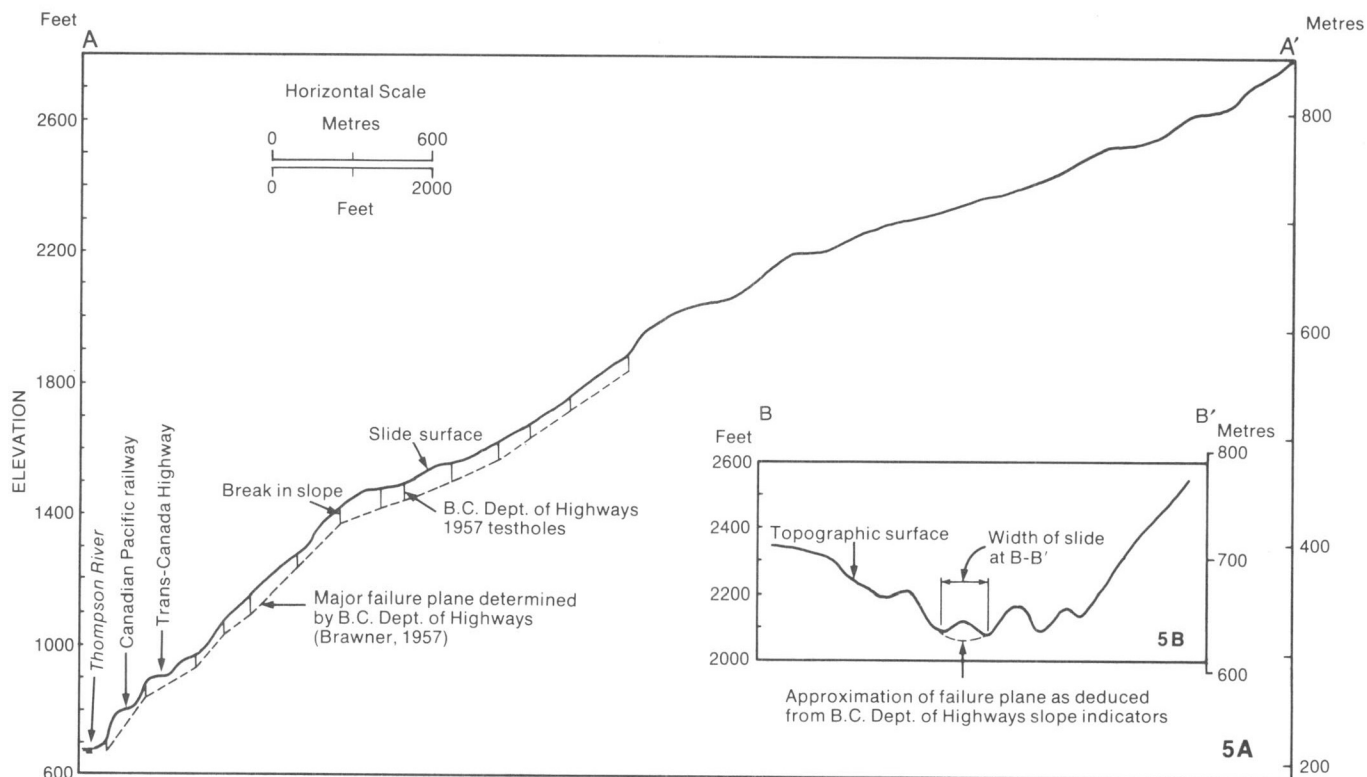
The rate of movement varies with time and with location in the slide. The depressed central portion of the slide (Fig. 5B), flanked by scarps and ridges on either side, is moving the fastest and has been measured by British Columbia Department of Highways to move between 1 and 3 m/year. The department postulates that movement is seated on a failure plane or failure planes which are parallel to the surface at depths ranging between 7.5 and 18 m (Brawner and Readshaw, 1963, p. 8). At the toe, small isolated circular arc failures occur within the slide material.

Figure 5A. Longitudinal profile A-A¹ of Drynoch landslide (see Fig. 4).

Figure 5B. Cross-section B-B¹ across Drynoch landslide (see Fig. 4).

Depth to the failure zone was determined initially by measuring the depth at which standpipes were bent or broken and later by slope indicators. The failure zone was found to be 4.5 to 6.0 m thick, and its cross-sectional profile was determined to be dish-shaped, intersecting the surface of the slide on the north and south sides (Fig. 5B).

Figure 5A indicates that the failure plane is relatively long and generally parallels the slide surface. Therefore, considering an infinite-slope (rather than a circular arc or slide block) analysis to be appropriate, and assuming that because the slide is moving the factor of safety is equal to 1.0, a back calculation was carried out to determine what strength parameters should approximate the soil condition.

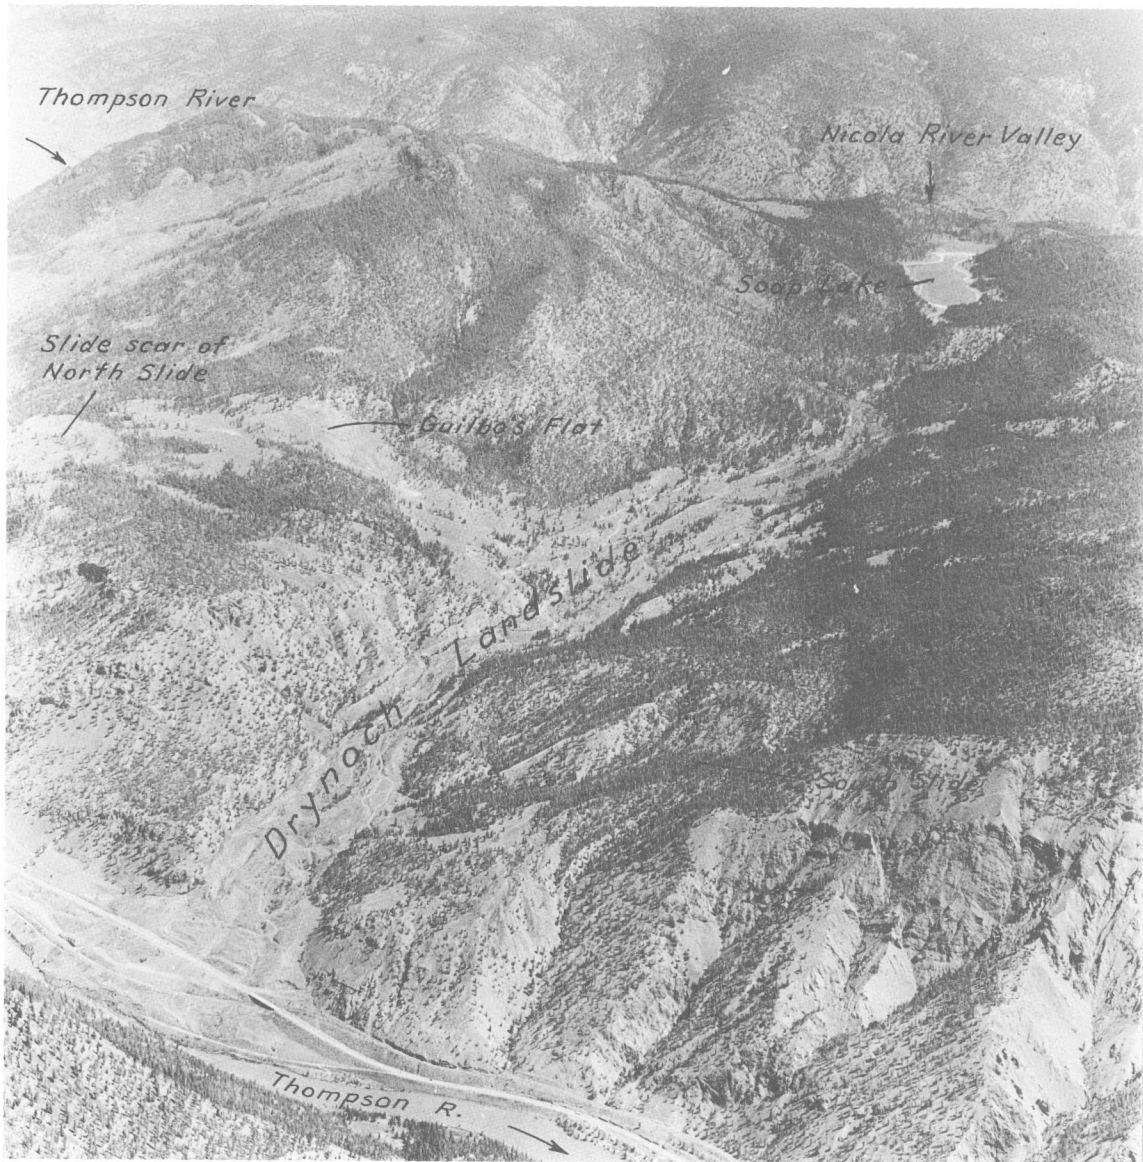
Figure 10

Oblique aerial photograph of Drynoch landslide, looking northeast. Summit in upper left of photo is 1340 m; Soap Lake is 920 m; Thompson River is 208 m a.s.l. Horizontal distance from Thompson River in the foreground to Soap Lake is 5.3 km. Photo by D.A. MacLean.

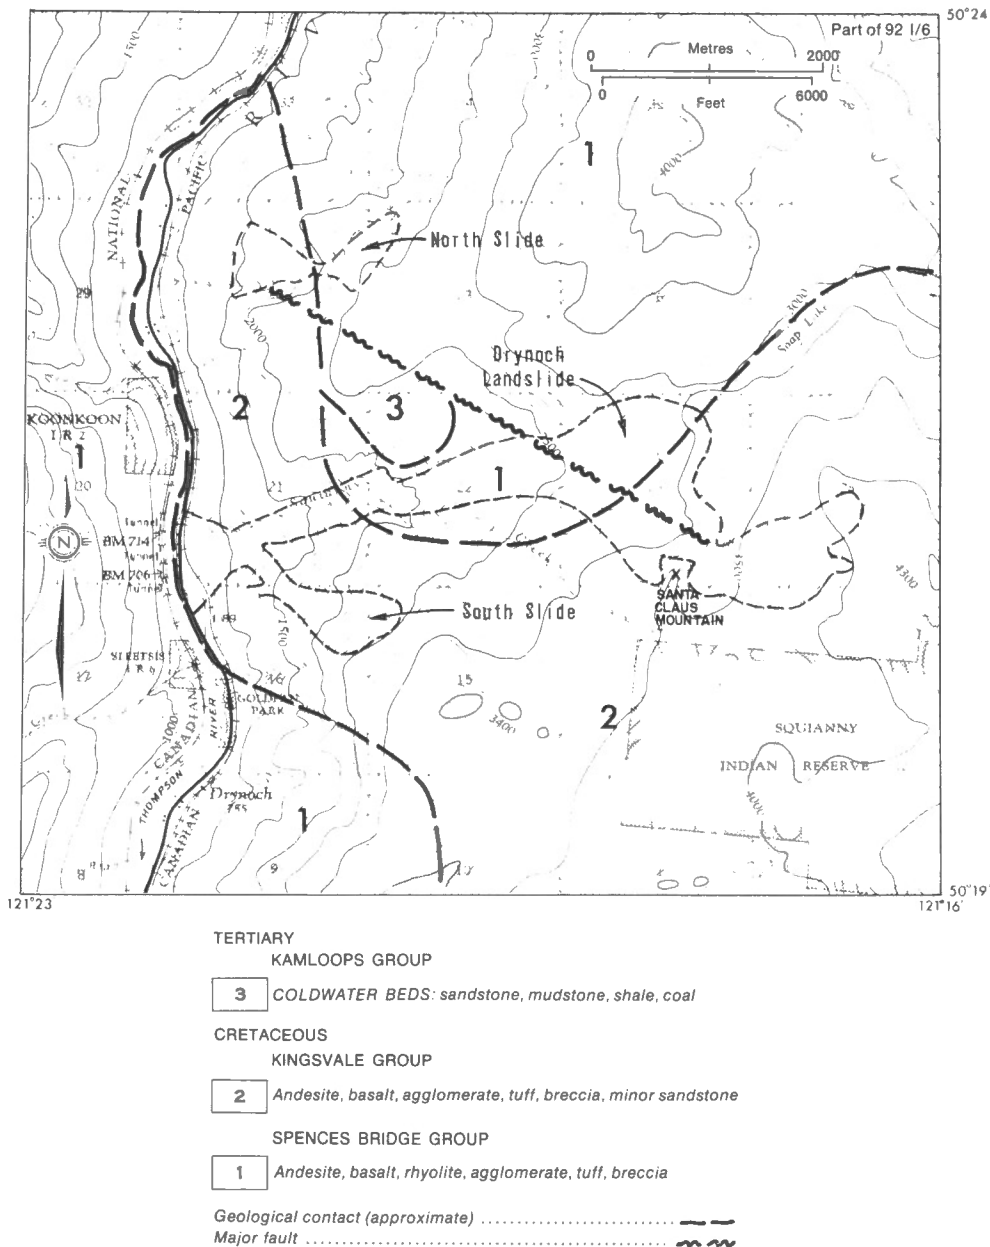
Figure 12 and Table 1 summarize the bedrock geology of the Drynoch landslide area. Relatively massive and competent volcanic flow rocks of the Lower Cretaceous Spences Bridge and Kingsvale groups underlie the present limits of the slide and outcrop in the headscarp and along the flanks. One small outcrop of the Kingsvale sedimentary unit is found west of "Santa Claus Mountain" and consists of competent buff to green sandstone. Fragments of these volcanic and sedimentary rocks, especially the Kingsvale Group, are found throughout the landslide debris.

Figure 12. Bedrock geology of Drynoch landslide area (after Duffell and McTaggart, 1952; Manu, 1974).

A major fault in the area, separating Kamloops and Spences Bridge groups, strikes southeast and dips steeply to the southwest. A series of steeply dipping shear zones up to 0.6 m wide occurs south of and approximately parallel to the slide (Jones, 1959, p. 2). These zones cut the volcanic rock and are filled with "bright red, hematite-rich, clayey fault gouge" (Jones, 1959, p. 2). This same fault gouge was found at approximately 90 m depth by British Columbia Department of Highways during drilling. Other shear zones and faults probably exist but are difficult to find due to poor bedrock exposure and lack of marker horizons.

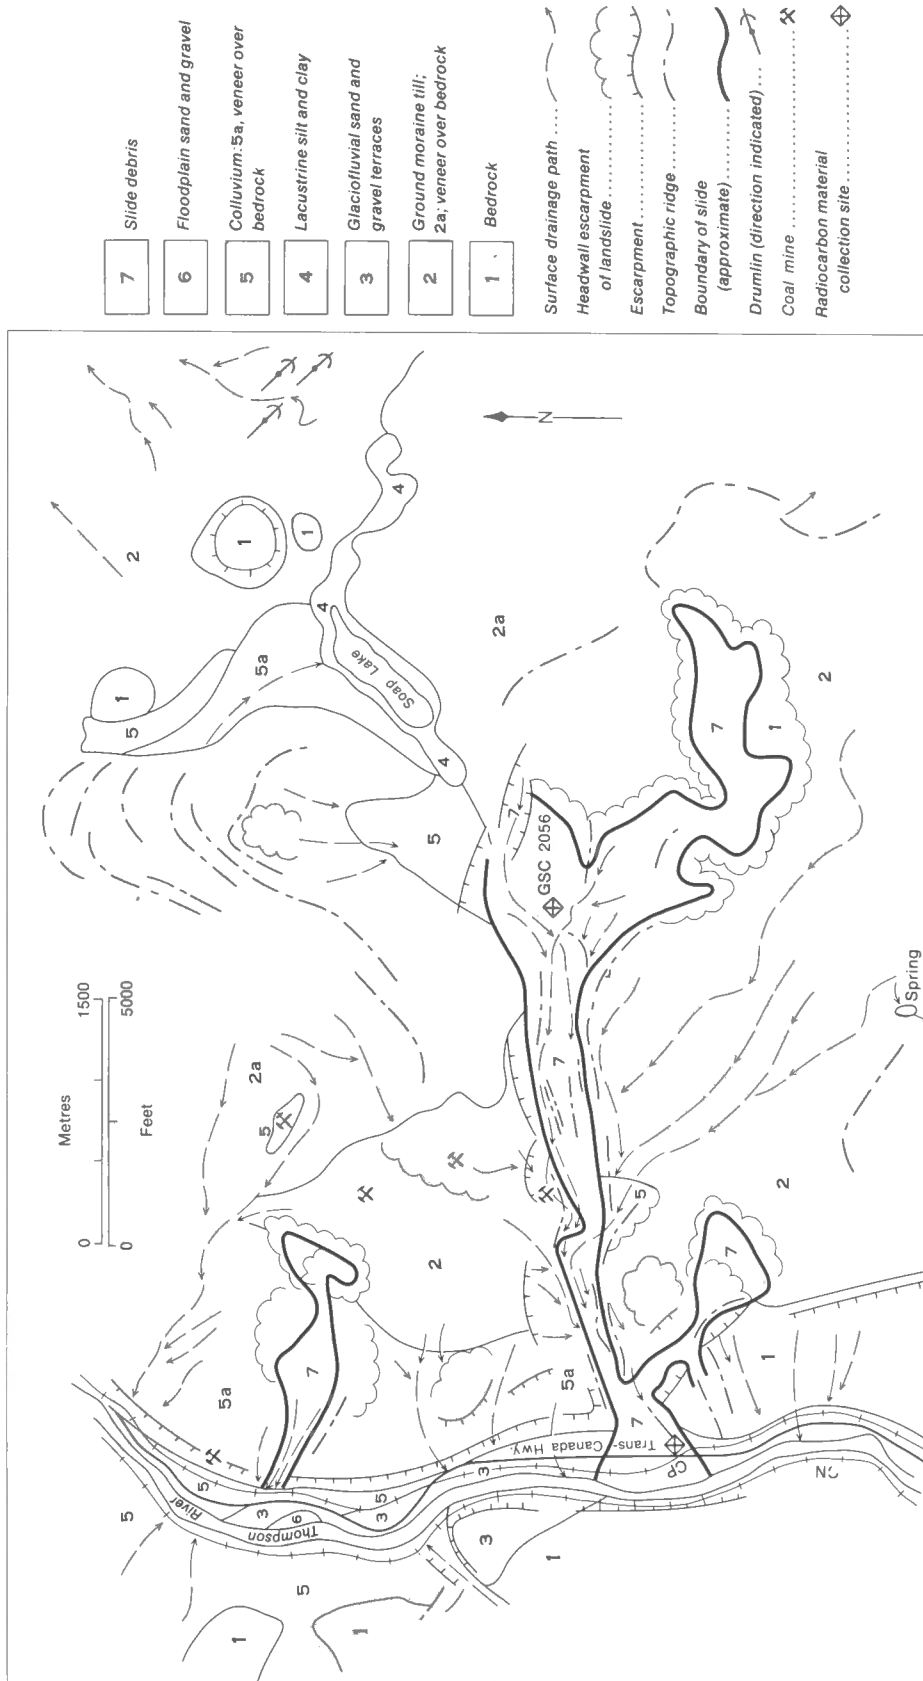
Figure 14. Surficial materials of Drynoch landslide area based on airphoto interpretation.

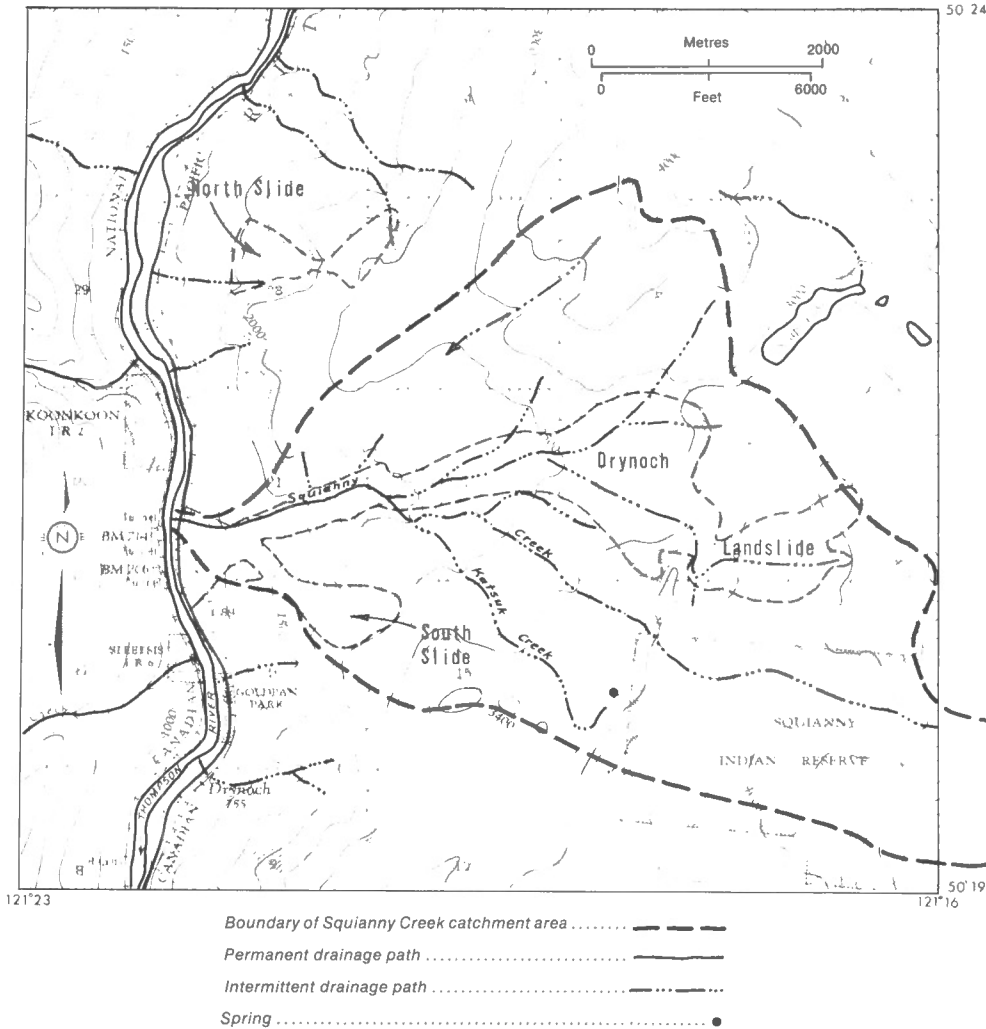
Drynoch landslide is located in the Squianny Creek catchment basin, which is 16.1 km² in area. It is drained by Squianny Creek, Katsuk Creek, and small unnamed tributaries (Fig. 18), which are fed by surface runoff, groundwater, and one small apparently perennial spring southeast of the slide. Although many creeks are intermittent, all the water that they do carry ultimately reaches Drynoch landslide. Surface

water follows gullies and crevasses formed by the slide; some becomes groundwater by flowing into tension and shear cracks within the slide and eventually enters Thompson River by following permeable substrata within or beneath the slide material. Both surface and some subsurface drainage paths can easily be traced by the resulting vegetation distribution and type.

Figure 18. Surface drainage and catchment basin of Drynoch landslide area.

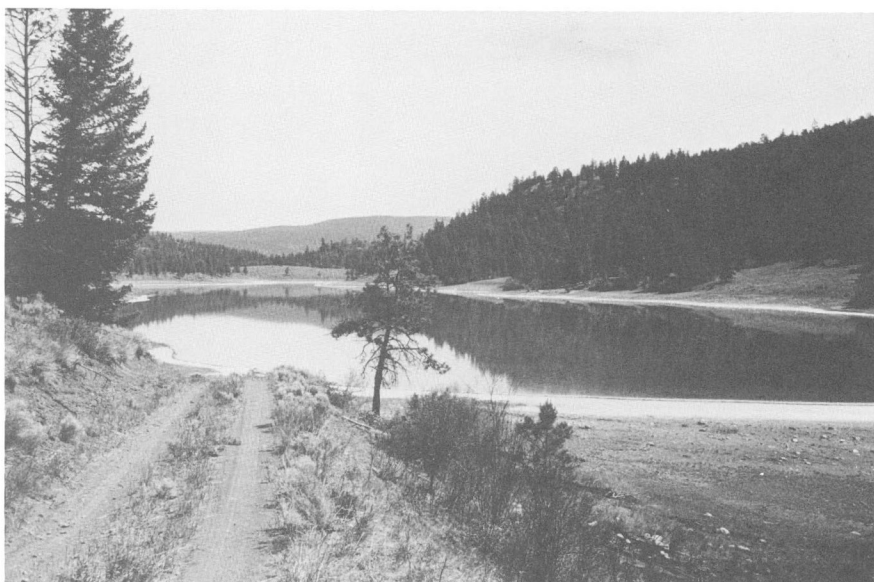
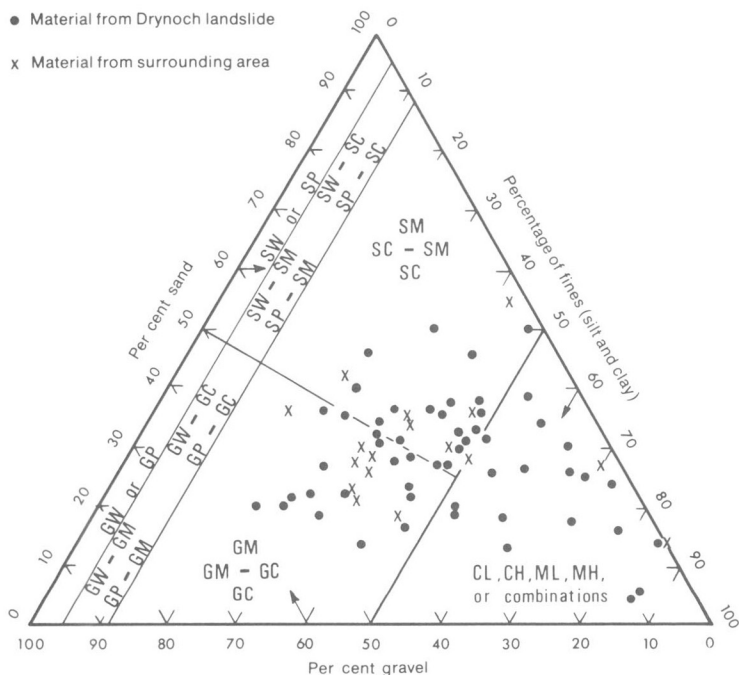
Figure 20 shows the grain size distribution of 73 samples from the landslide area. The slide material appears to have an even distribution of gravel, sand, and fine grained material and grades finer than material from the surrounding area. In the fine fraction (Fig. 21), the slide material is almost equally divided between silt and clay, whereas the surrounding area contains more silt than clay.

Figure 20. Distribution of grain size for 73 samples from Drynoch landslide area, superimposed on Unified Soil Classification Identification triangle.

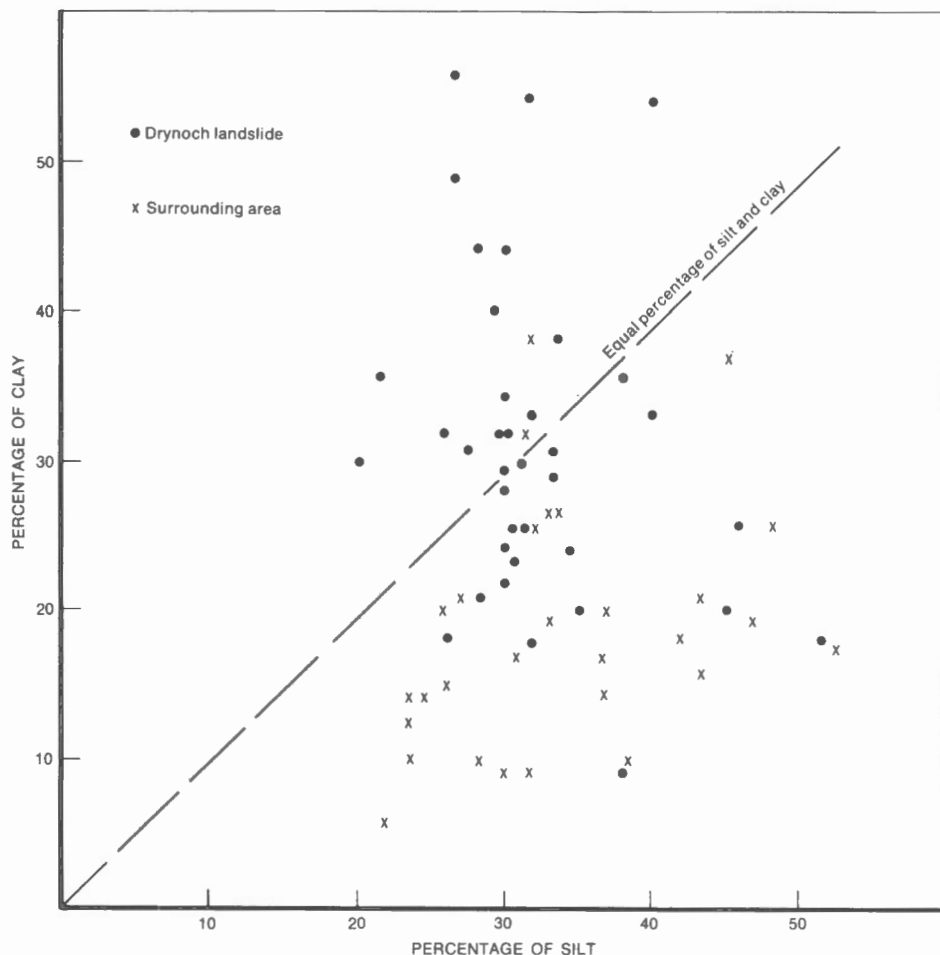
Figure 21. Distribution of fine fraction between silt and clay particle size for 66 samples from Drynoch landslide area.

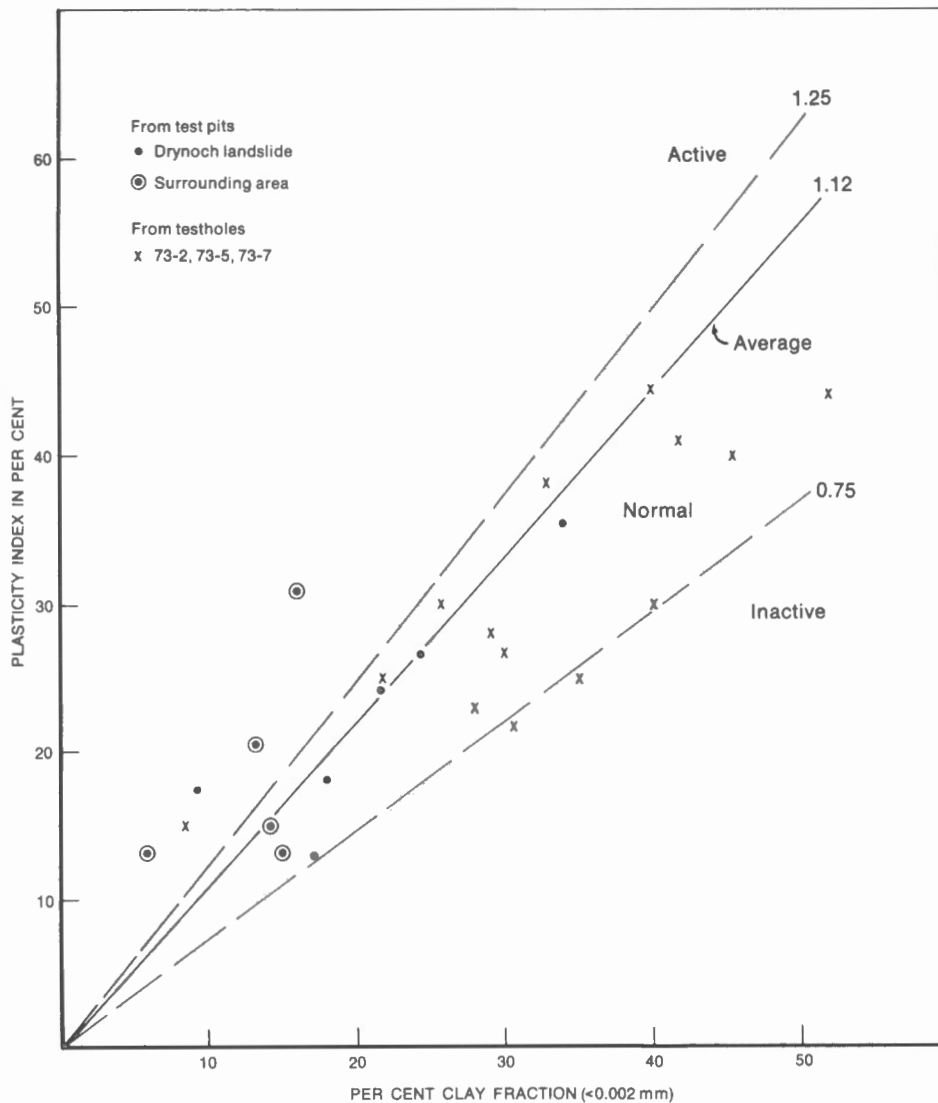
Figure 22 indicates that there is little difference between the "activity" (plasticity index vs. % clay >0.002 mm) of material surrounding the slide and that of the slide itself and that neither are abnormally active.

Figure 22. Activity (plasticity index vs. % clay) of 25 samples from Drynoch landslide area.

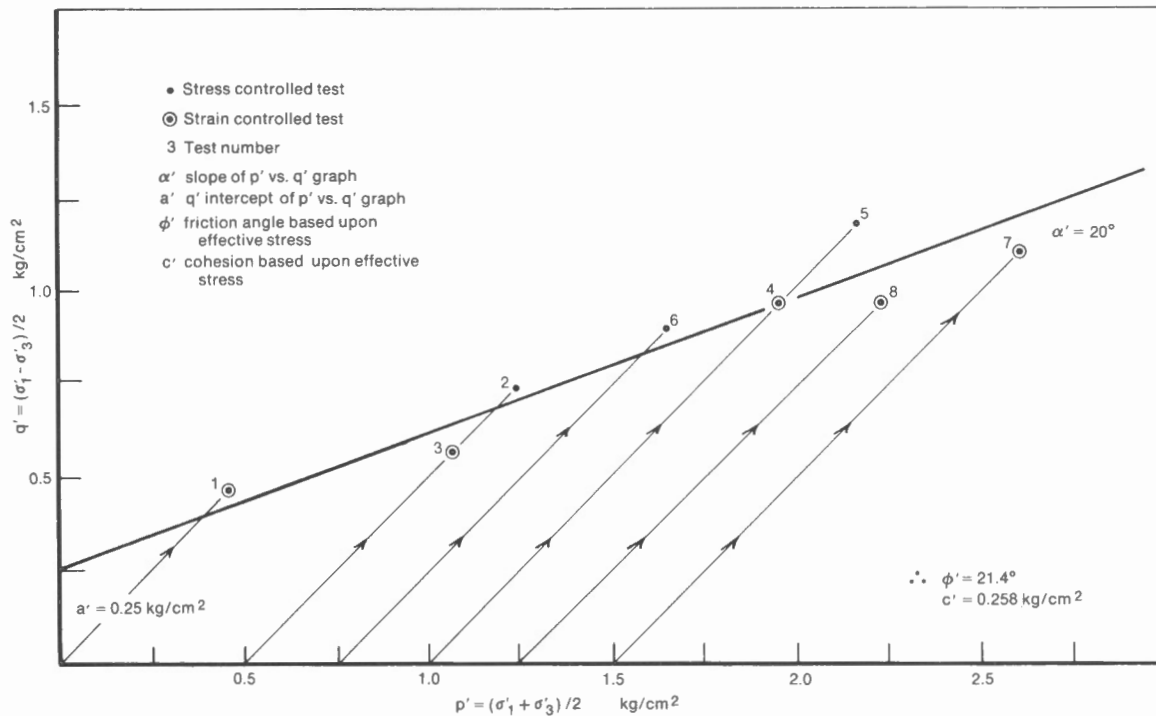
Three drained, stress controlled triaxial tests also were carried out under standard procedures. An estimate of the failure load was determined beforehand, and as that load was reached, successively smaller load increments were applied to the sample after pore water pressure from the previous increment had reached equilibrium. Results of the triaxial tests are plotted in Figure 23 and summarized in Table 2. From the failure envelope the following estimates of shear strength parameters were made: $\alpha'^* = 20^\circ$, $a' = 0.25 \text{ kg/cm}^2$, corresponding to $\phi' = 21.4^\circ$, $c' = 0.26 \text{ kg/cm}^2$.

Figure 23. Triaxial test results of samples from Drynoch landslide, plotted on a p' (hydrostatic stress) vs. q' (deviator stress) diagram.

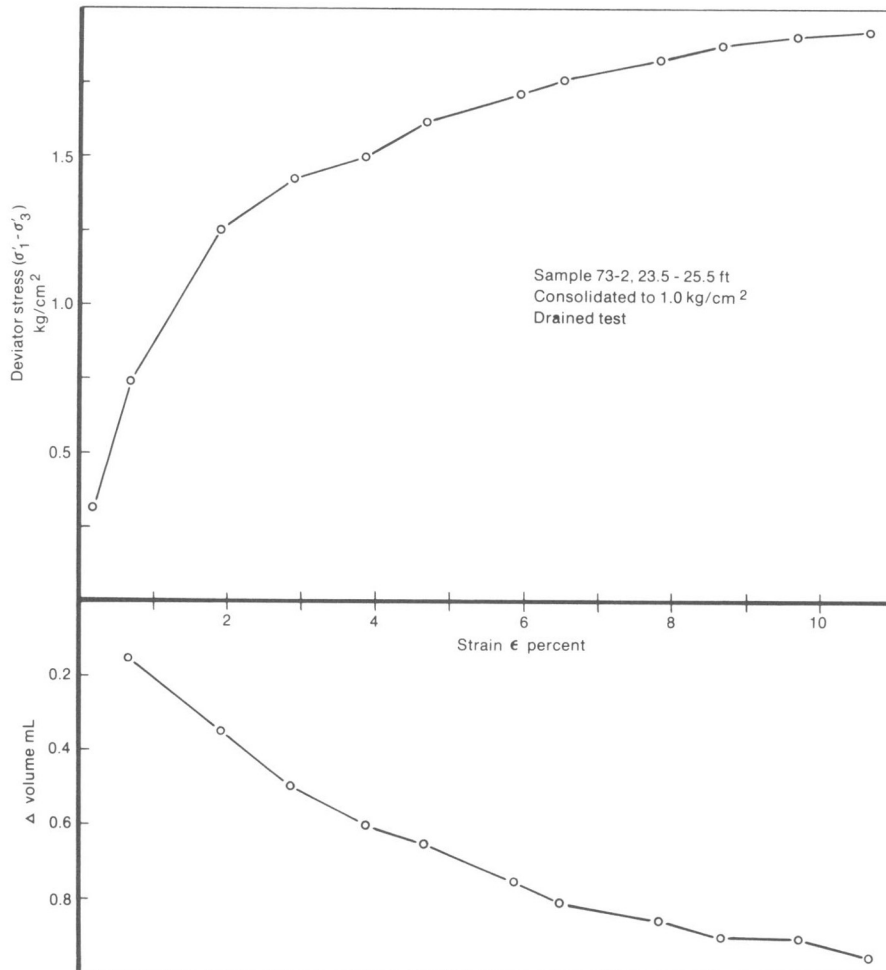
Figure 24 shows slickenside features developed on the failure plane of a sample from 23.5 feet depth in testhole 2. Slickensides generally indicate alignment of clay particles and subsequent residual shear strength characteristics. Even though the strain controlled tests were taken to an axial strain of 10.8%, no significant strain softening occurred (Fig. 25).

Figure 25. Typical deviator stress vs. strain curve and change in volume vs. strain curve in strain controlled triaxial test for sample from Drynoch landslide.

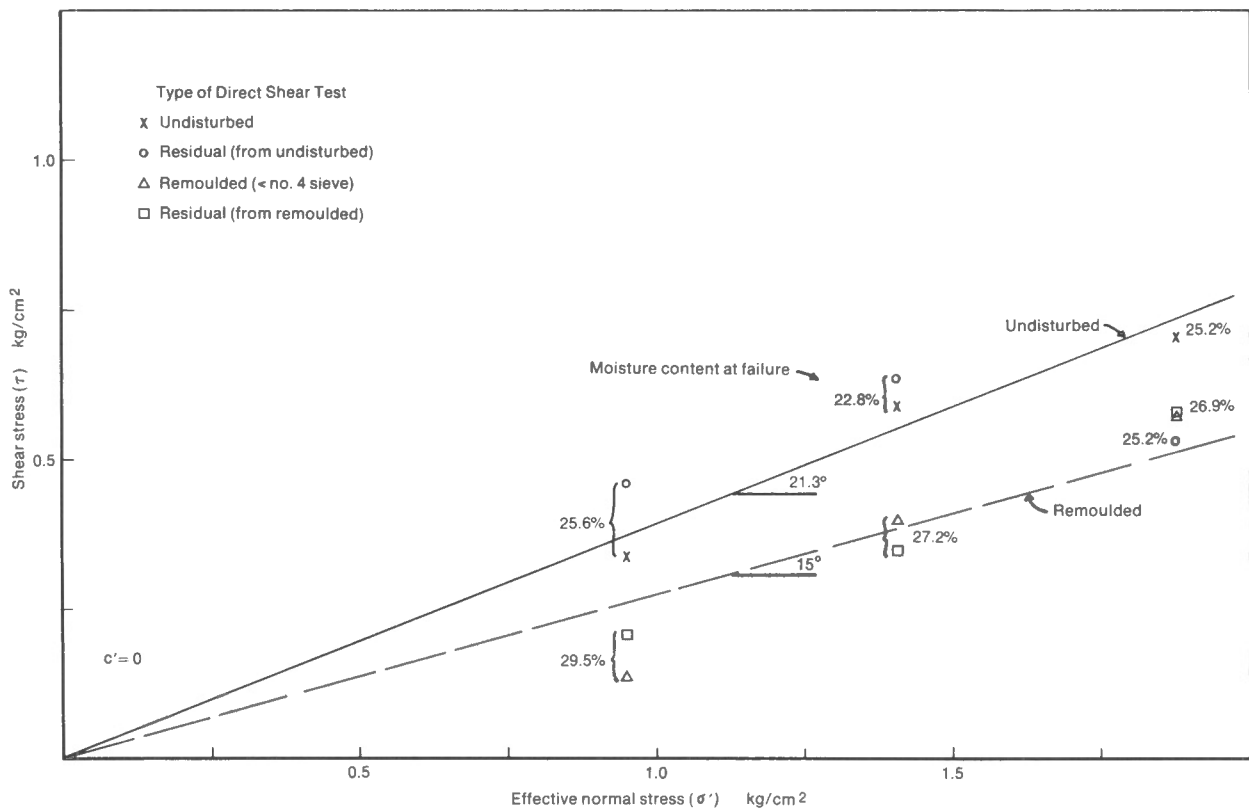
The results of the direct shear tests are shown in Figure 26. Soil strength parameters for the undisturbed samples are $c' = 0$, $\phi' = 21.3^\circ$, for the remoulded samples, $c' = 0$, $\phi' = 15^\circ$. In both series of tests, the corresponding residual tests show a scatter of shear strengths, and in several cases samples actually appear stronger than the corresponding undisturbed or remoulded peak strength. No estimate of residual shear strength has been made for these data.

Figure 26. Direct shear test results, sample 73-3 30 ft (10 m) from Drynoch landslide.

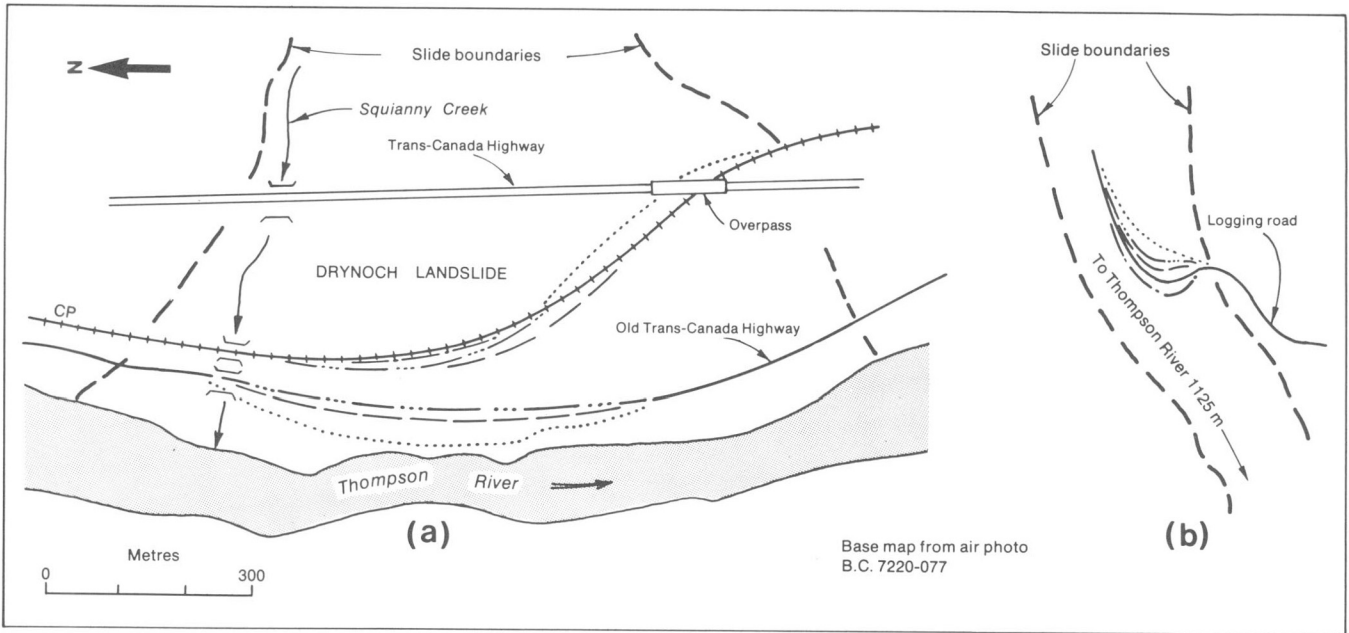
<u>Year</u>	<u>Symbol</u>	<u>Remarks</u>
Old Trans-Canada Highway		
1951	Movement of slide prior to 1951 caused considerable disruption of designed curve, bringing it close to edge of Thompson River.
1960	-----	Between 1951 and 1957 highway was realigned uphill. Further disruption is evident on left side of sketch.
1965	-----	Movement continued downhill as maintenance of old highway was discontinued on completion of new highway.
1969 & 1972	=====	Old highway has been washed out by toe erosion and subsequent toe failure.
New Trans-Canada Highway		
1969	=====	Built in 1961, this road has undergone little movement because most of the failure plane was removed during construction.
Canadian Pacific railway		
1951	Movement prior to 1951 created a sharp curve.
1960	-----	CP Rail realigned tracks and removed some of the curve prior to construction of overpass by B.C. Department of Highways.
1965	-----	Movement increased sharpness of curve.

1969	+++++	Realignment in 1967 decreased curve once more.
1972	-----	Downhill movement continued between 1969 and 1972.
Logging Road		
1951	} Continual downhill movement increased sharpness of curve of logging road.
1960	-----	
1965	-----	
1969	=====	
1972	-----
