**GEOLOGICAL SURVEY OF CANADA
OPEN FILE 1999**

**THE 1988 SAGUENAY EARTHQUAKE –
A SITE VISIT REPORT**

Denis Mitchell¹, René Tinawi² and Tim Law³

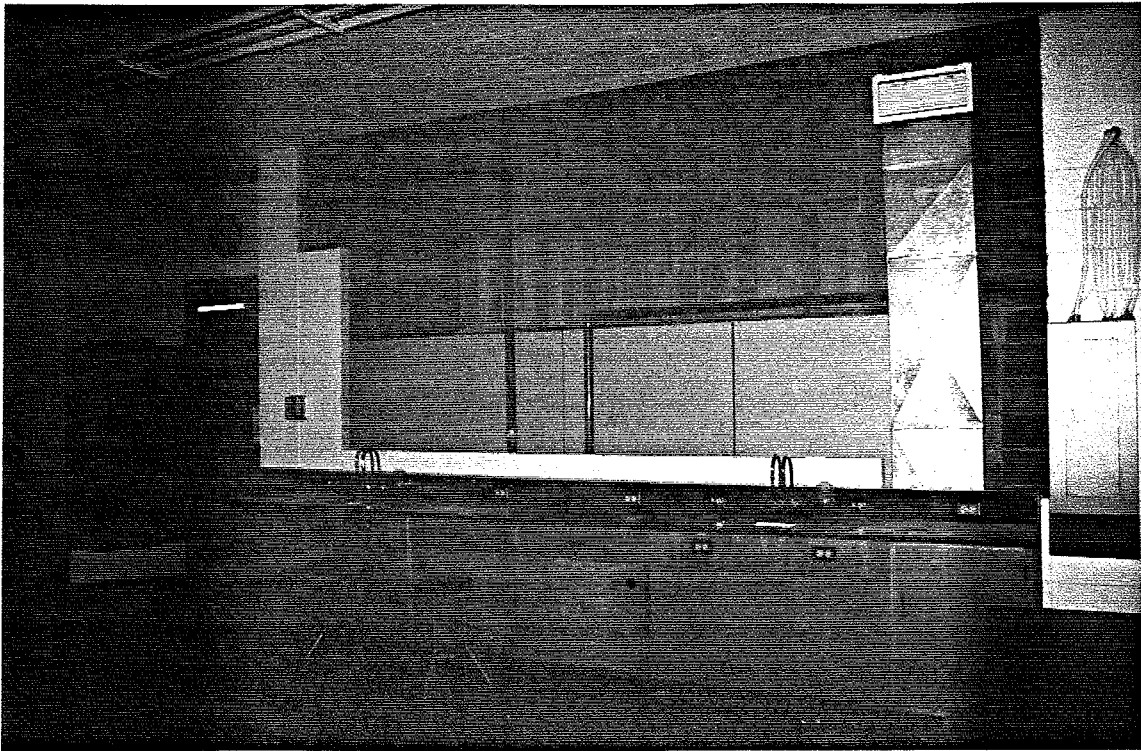
Figure 2.12 Collapse of masonry block wall in Physics laboratory of Dominique Racine school.

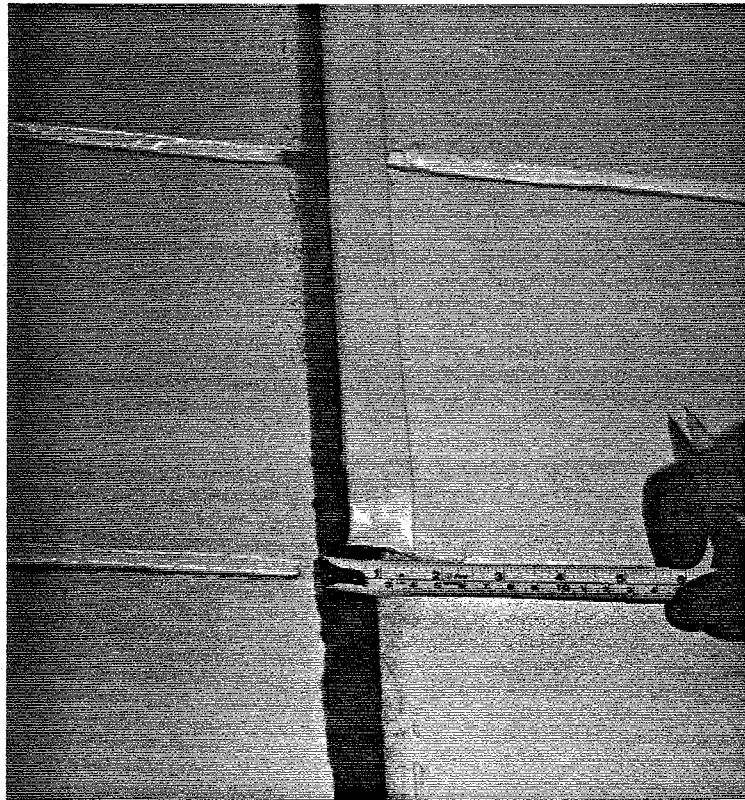
Figure 2.13 Expansion joint movement in Dominique Racine school.

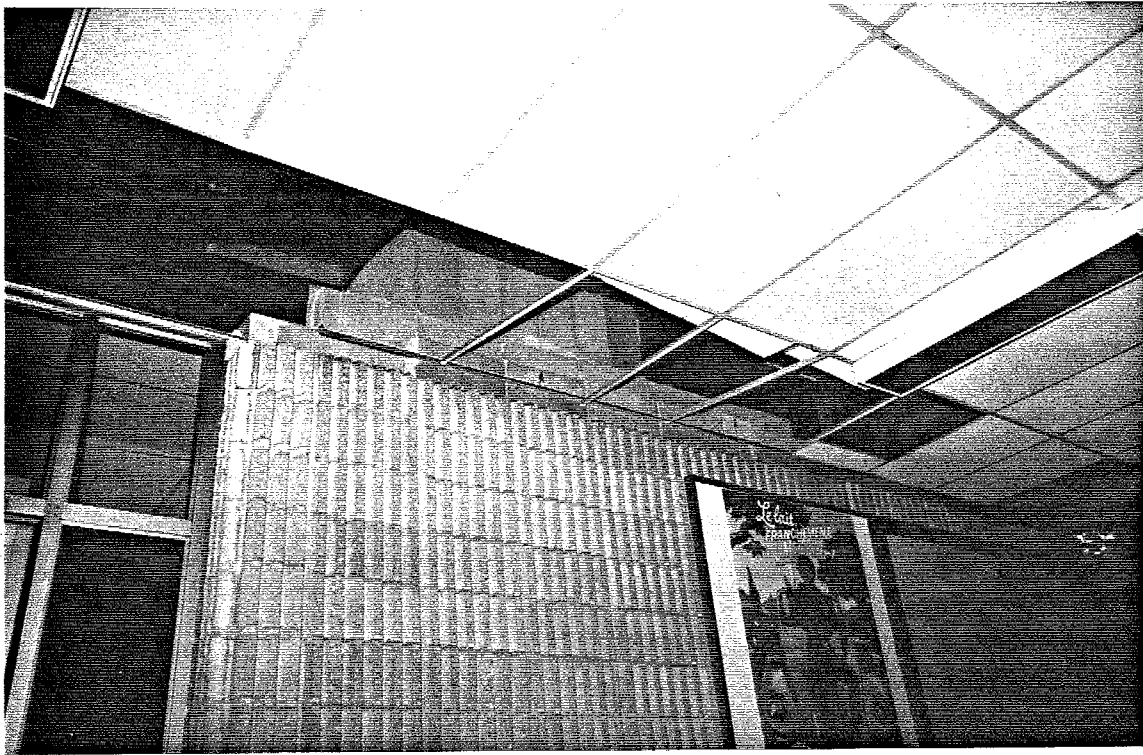
Figure 2.14 Masonry blocks standing on end in Dominique Racine school.

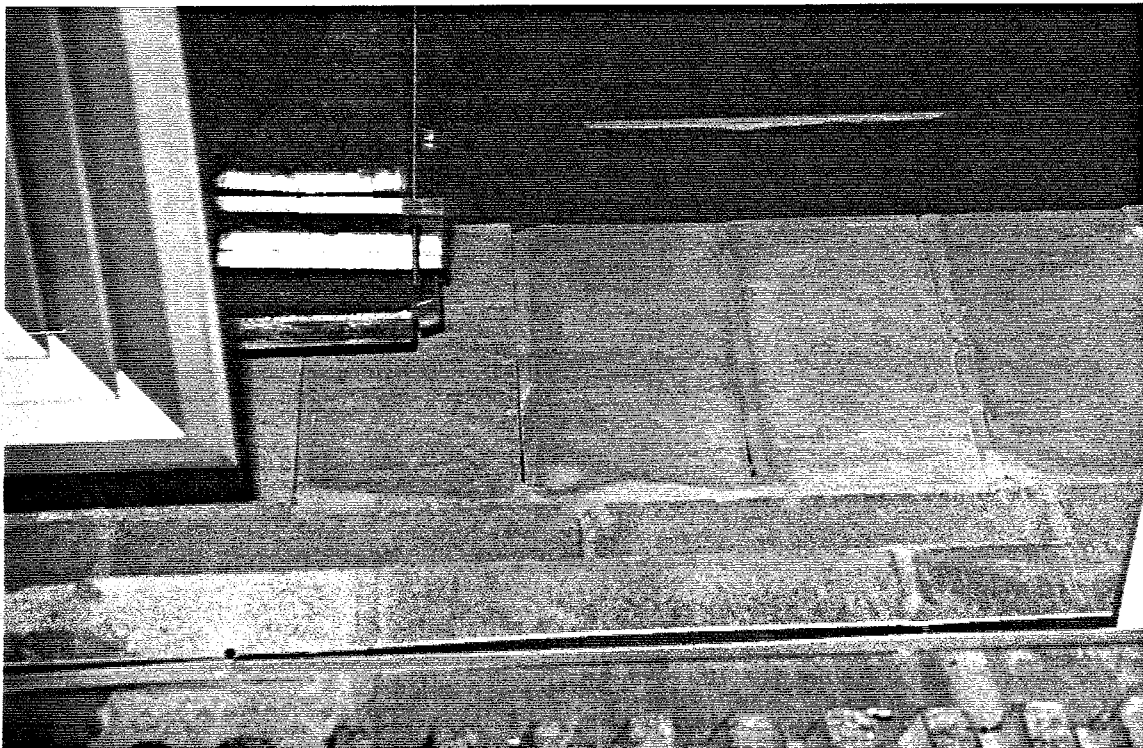
Figure 2.15 Close-up of masonry blocks standing on end in Dominique Racine school.

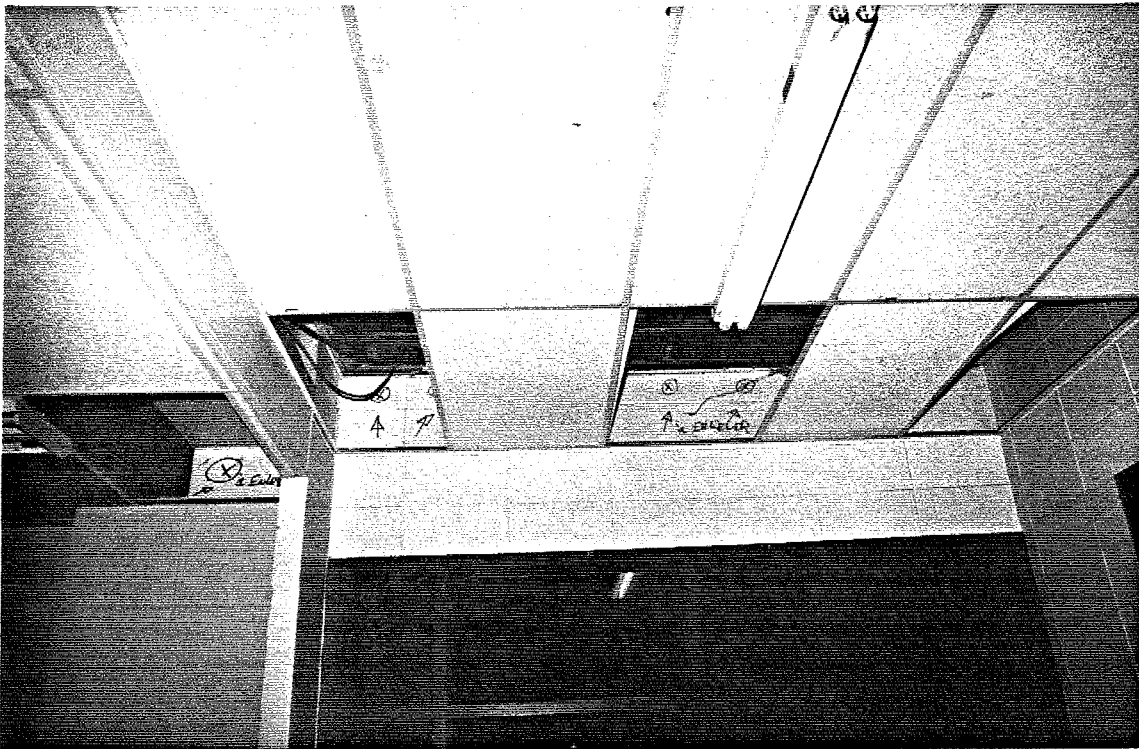
Figure 2.16 Identification of blocks to be removed for safety.

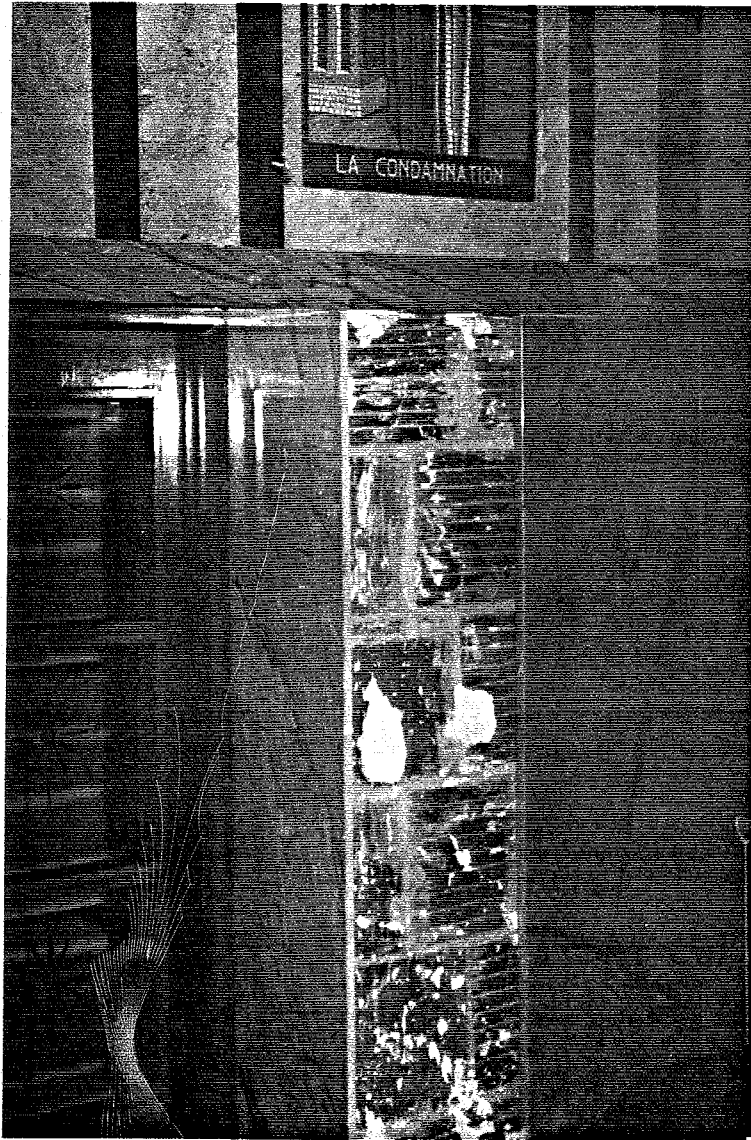
Figure 2.30 Detachment of marble panel located in the nave.

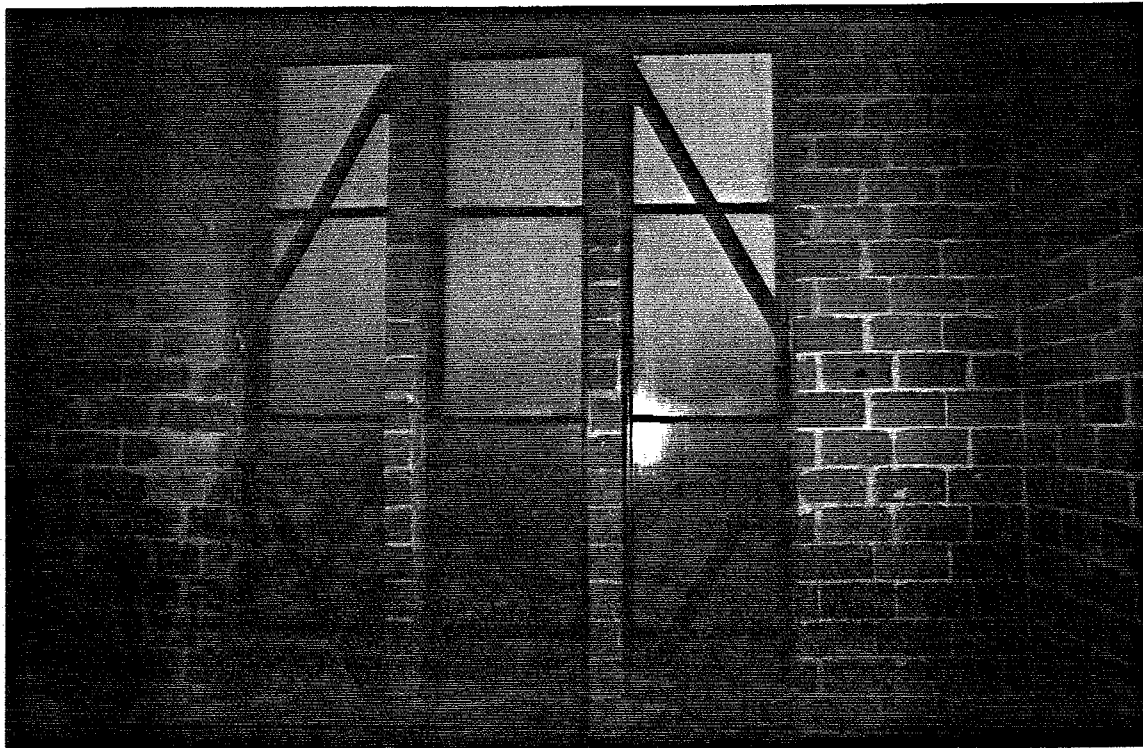
Figure 2.33 Inside view of cross-bracing and masonry walls of bell tower.

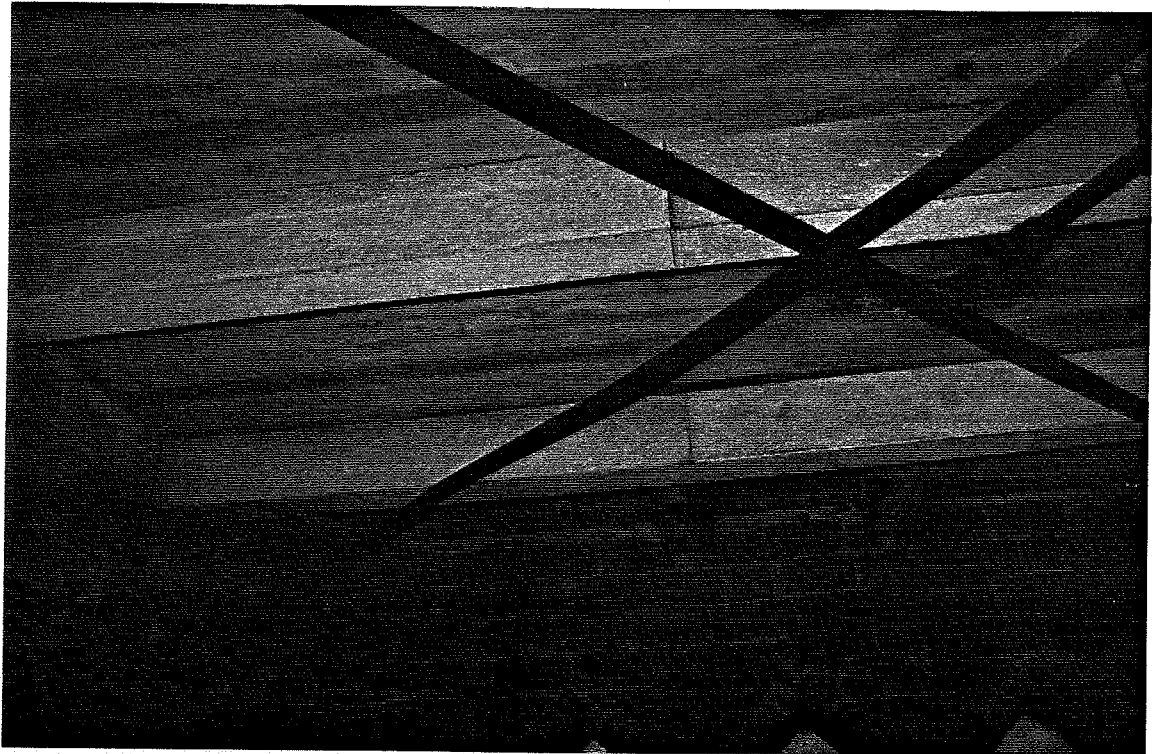
Figure 2.36 Steel tension braces in plane of floor.

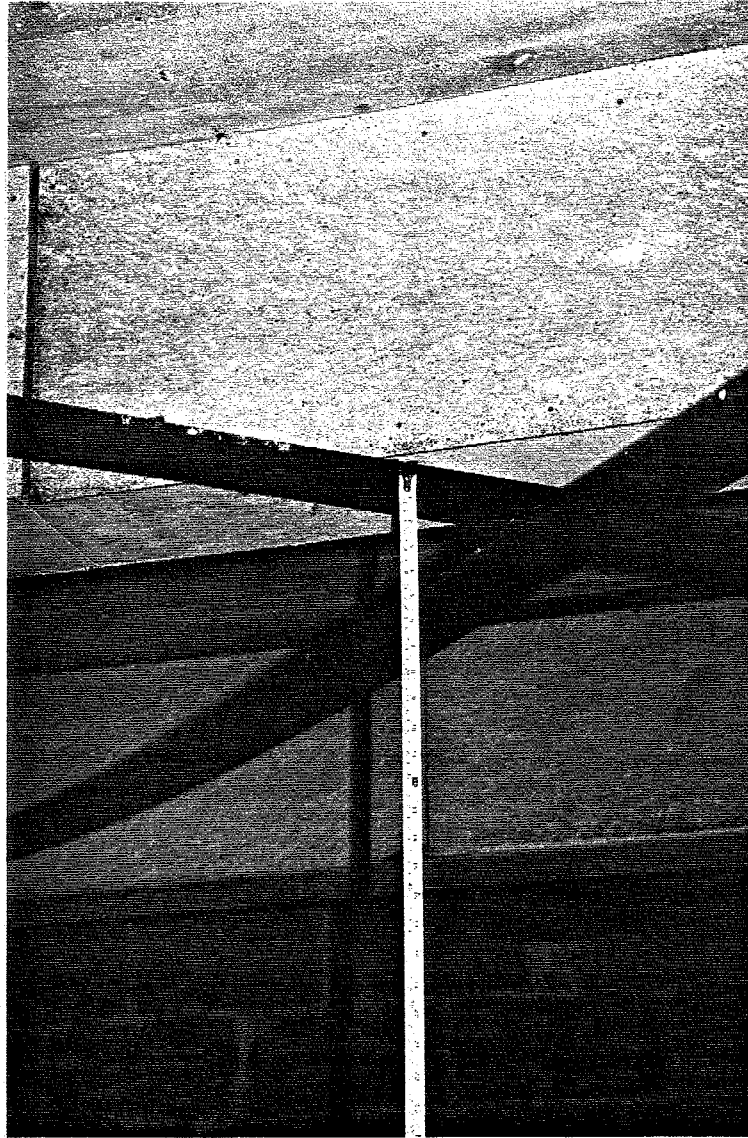
Figure 2.37 Buckling of steel braces in floor diaphragm.

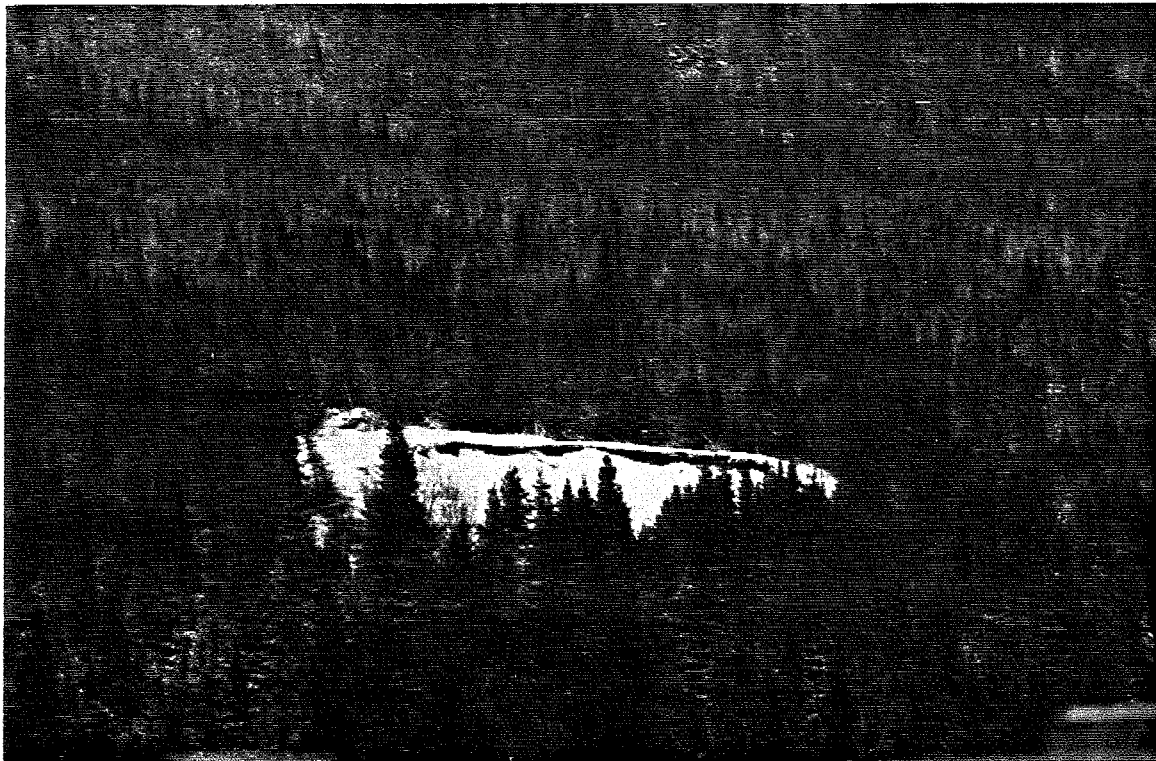
Figure 2.40 shows a natural slope landslide in Parc des Laurentides just east of Route 175 close to the epicentral region.

Figure 2.40 Natural slope landslide close to the epicentral region.

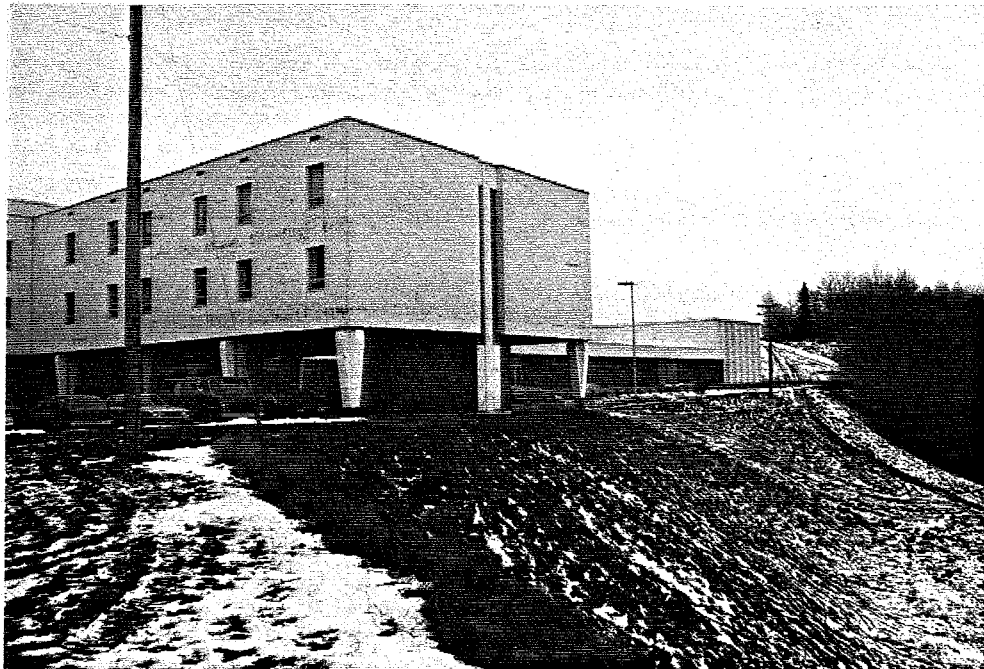
This new addition was on pile foundations due to the soft clay underlying soil and due to the presence of a steep slope on one side of the school (see Fig. 3.10). Although this slope had to be stabilized in the past, there was no evidence of any ground movement due to the earthquake.

Figure 3.10 Front view of additional wing.

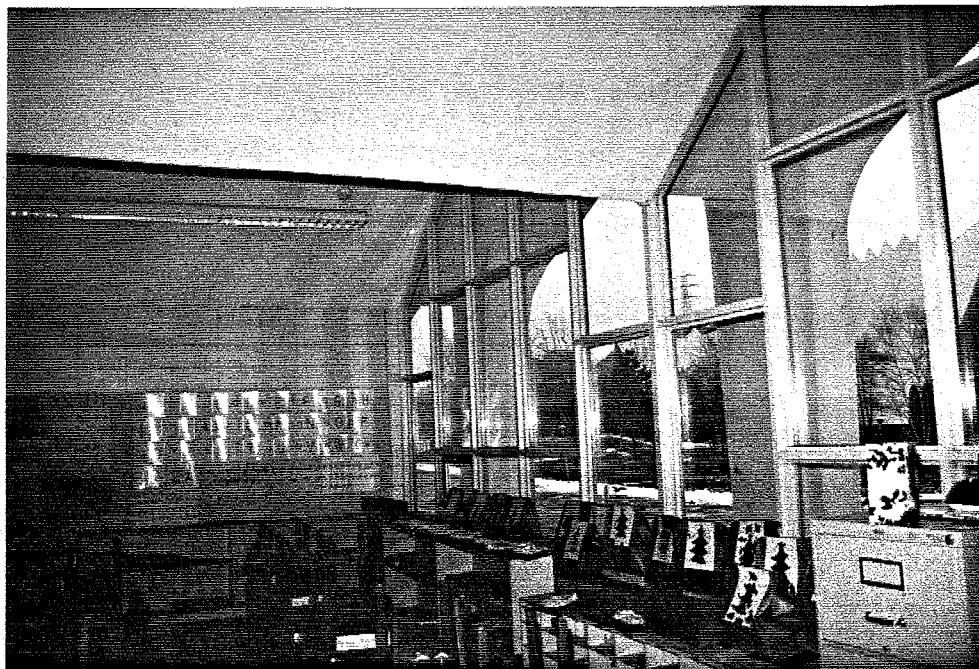
columns. Due to the ground motion, there was considerable differential movement between the roof and the floor slab causing extremely severe damage to the masonry partition walls between the slab and the roof (see Fig. 3.18 and 3.19).

Figure 3.18 Inside view of classroom.

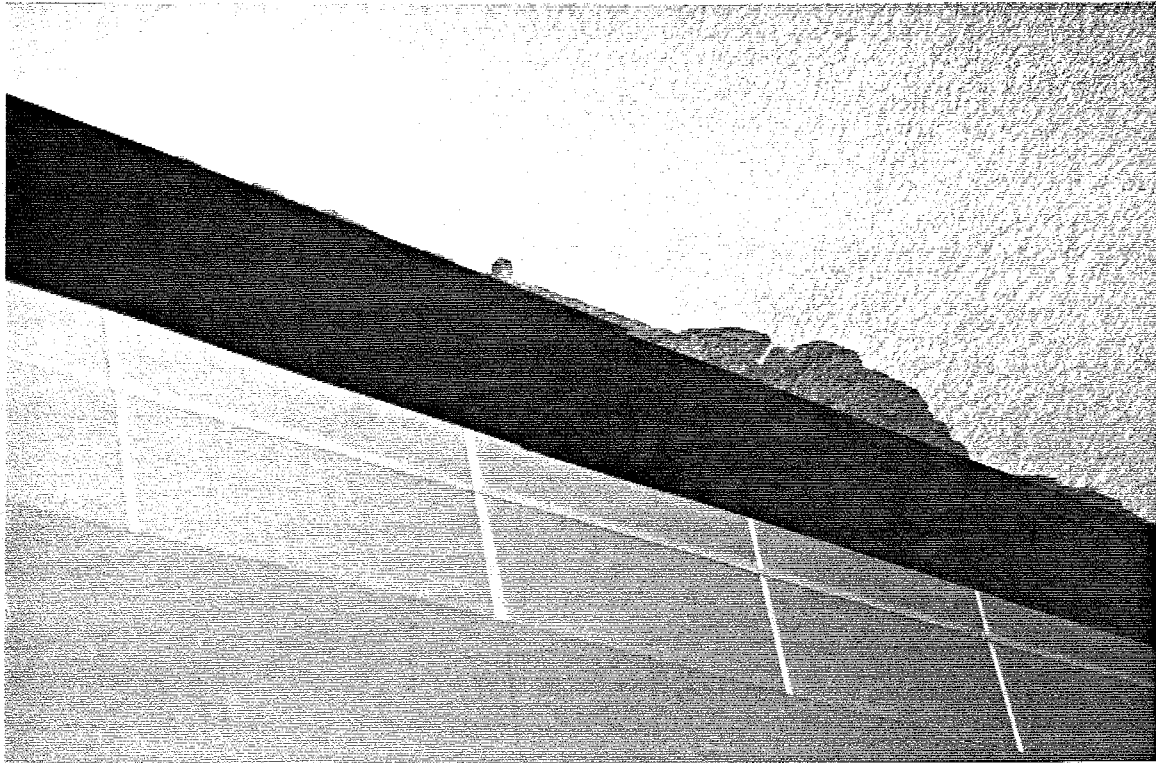
Figure 3.24 Light-gauge metal preformed angles bolted through partition walls.

Figure 3.23 shows the temporary repair which consists of lateral support for the masonry partition walls. This consisted of light gauge metal preformed angles that were moulded to fit the angle of the roof and were bolted through the partition walls.

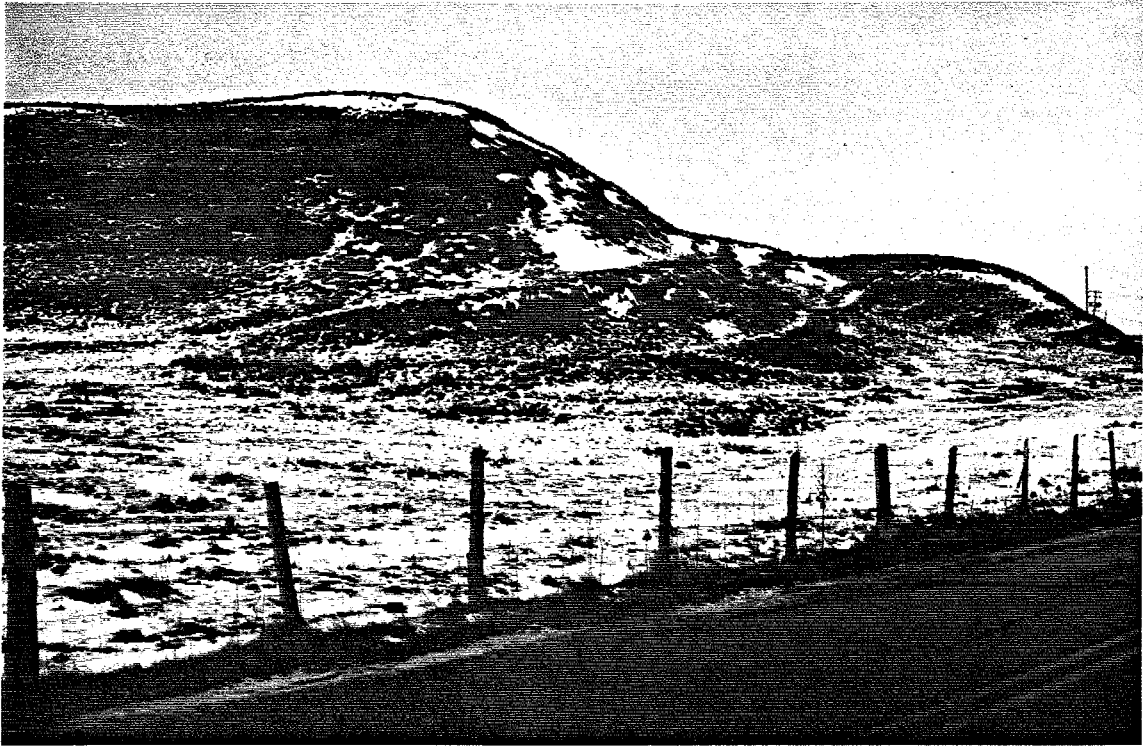
Soil settlement resulting in a small surface slump was observed on Route 170 between Chicoutimi and Ville de la Baie as shown in Fig. 3.25. A small surface slump was observed just outside Ville de la Baie as shown in Fig. 3.26. A more obvious, but small slope failure (see Fig. 3.27) was observed on Route 381 between Ville de la Baie and the villages of Ferland and Boileau.

Figure 3.26 Small surface slump outside of Ville de la Baie.

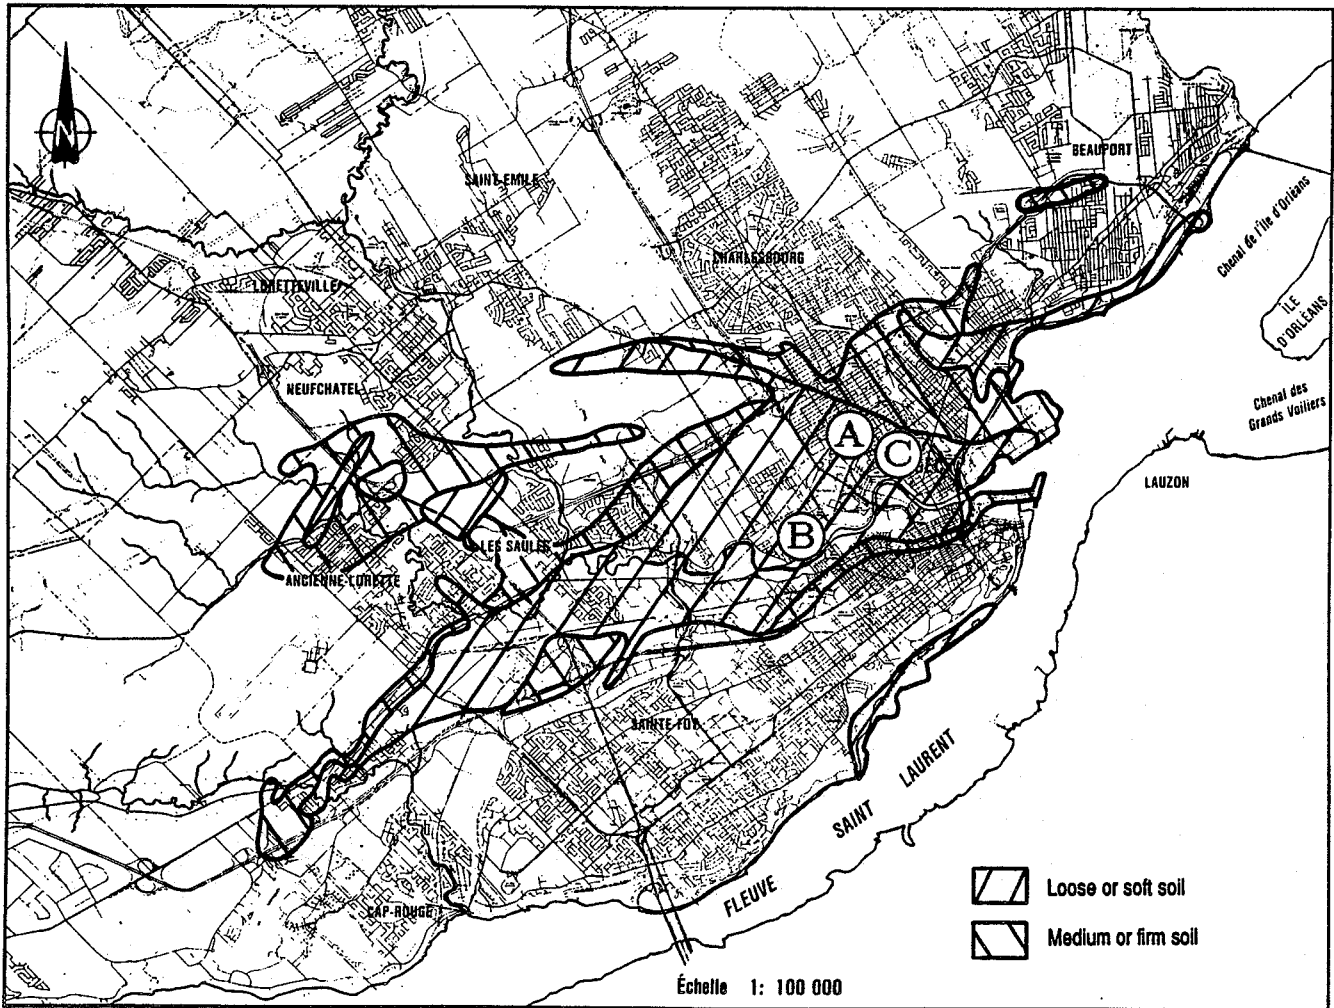
Quebec City can be divided into lower town ("basse ville") and upper town ("haute ville") based on the regional topology. The subsoils of lower town are largely composed of thick alluvial deposits from Rivière St. Charles. The approximate extent of these deposits is shown in Fig. 4.1. A cross-section of the subsoil profile along an axis coinciding with Dufferin-Montmorency (Route 138) near the mouth of Rivière St. Charles is shown in Fig. 4.2. As can be seen from Fig. 4.2 the soft soil deposits exceed 50 m in depth. In upper town the surface soil deposits are generally thin with bedrock out-cropping to the ground surface at some locations.

Figure 4.1 Approximate distribution of soft soil deposits in Quebec City (adapted from Chagnon and Doré 1987).

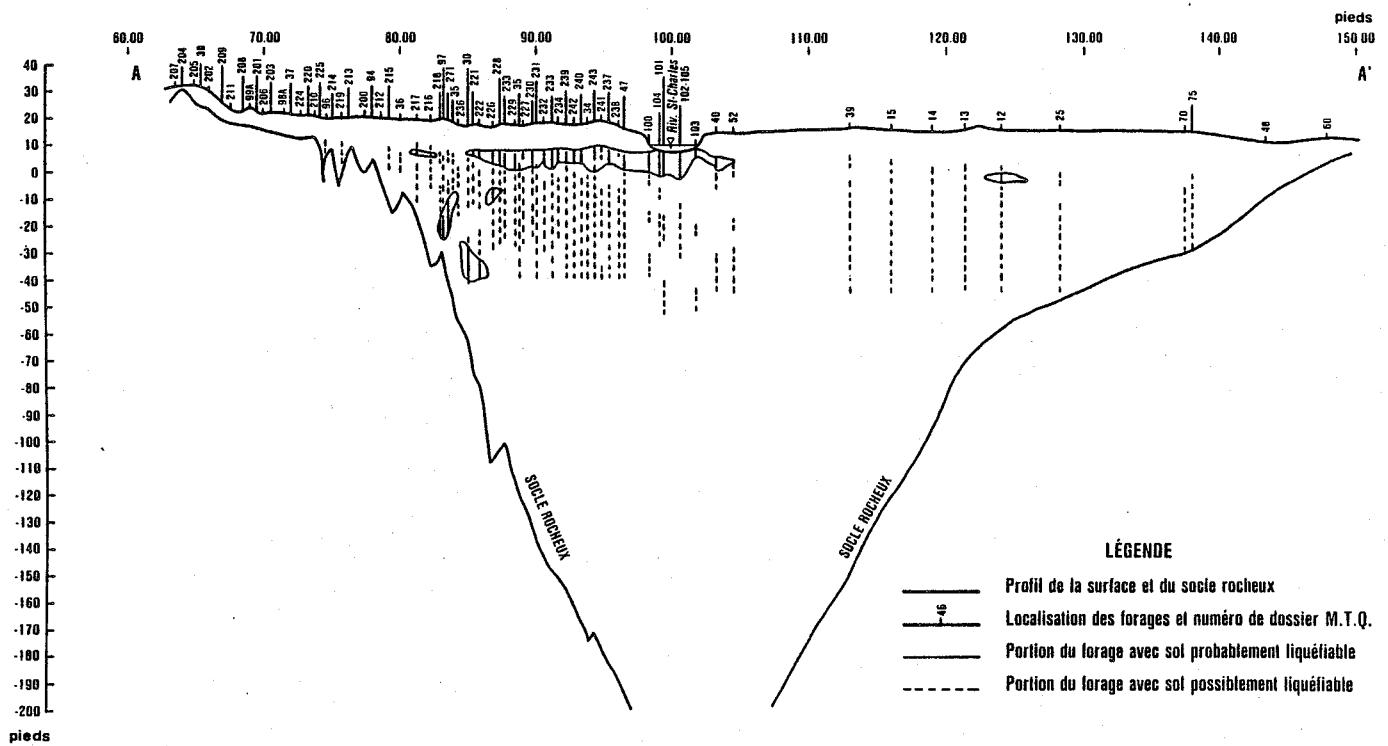
Figure 4.2 Cross-sectional profile along Dufferin-Montmorency (Route 138) in Quebec City, (adapted from Chagnon and Doré 1987).

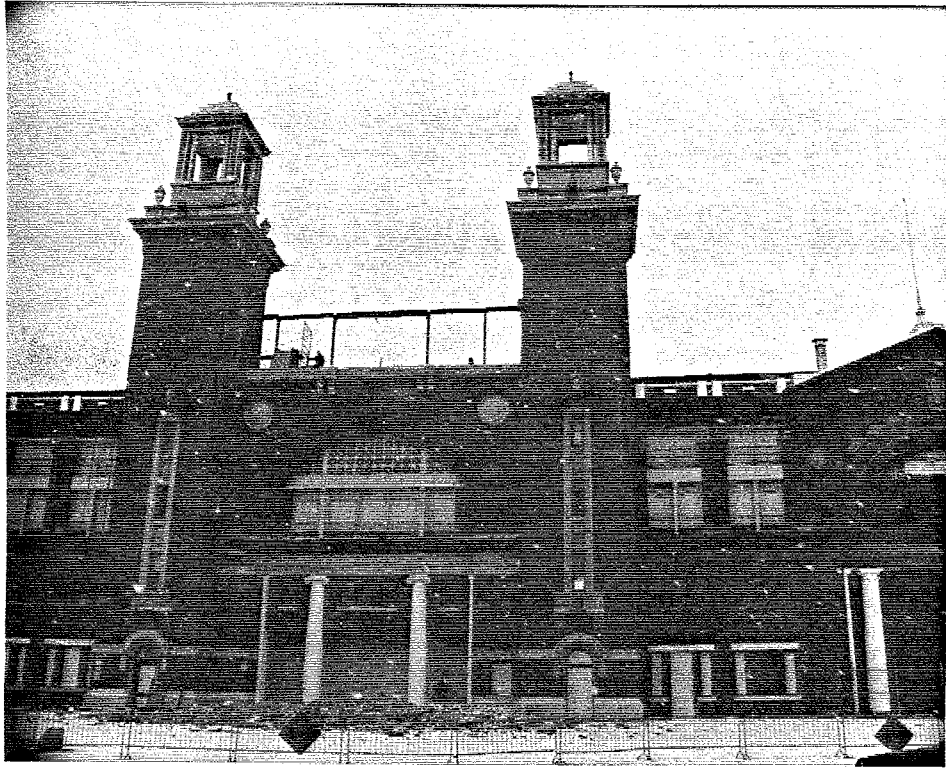
The Hippodrome in Quebec City is part of Parc de l'Exposition located on Boulevard du Colisée. This structure is an older unreinforced masonry building which suffered partial collapse of a masonry wall. Figure 4.3 shows the debris on the ground from the masonry wall that had existed between the two towers. The photograph in Fig. 4.3 was taken 7 days after the earthquake and after the remainder of the masonry wall had been demolished. Figure 4.4 shows the very flexible light steel frame that was used to provide lateral support for the wall.

Figure 4.3 Overall view of Hippodrome.

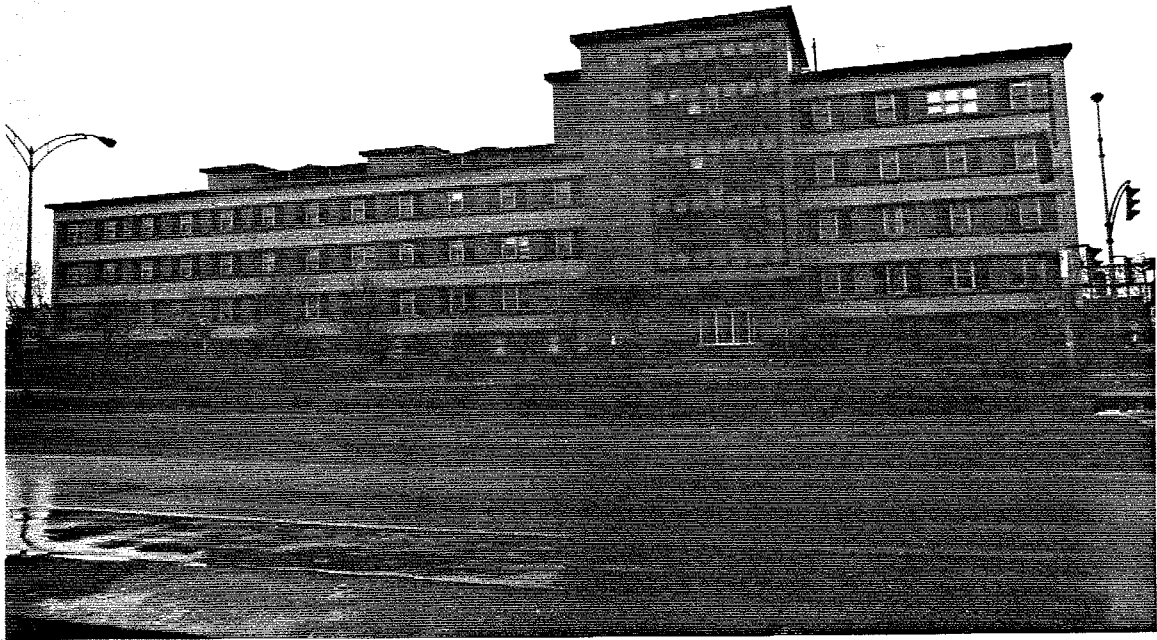
The structure is composed of three separate wings, two four-storey wings connected together by a five-storey wing to form a building that is U-shaped in plan (see Fig. 4.5).

Damage was very light throughout the hospital and consisted mainly of cracks in the plaster walls which were evident in the corridor connecting the two four-storey wings of the structure.

Figure 4.5 Christ-Roi Hospital.

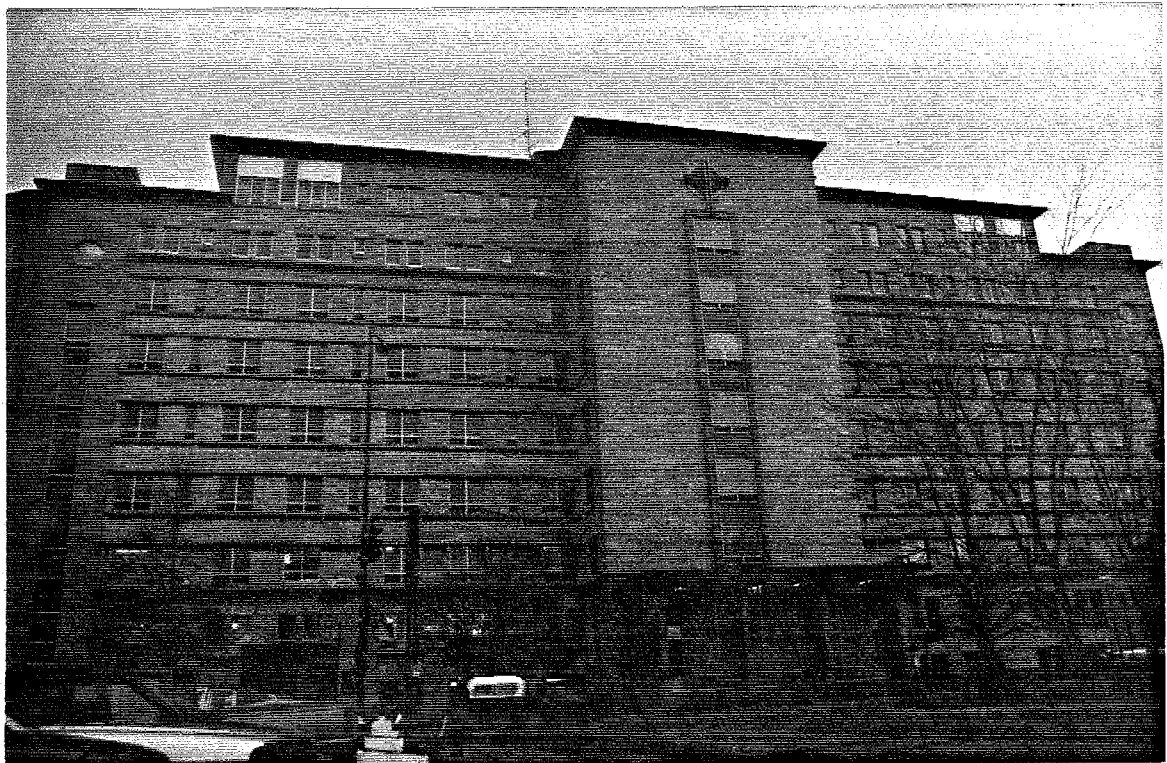
Saint-François d'Assise Hospital is located at 10 rue de l'Espinay, very close to the St. Charles River. The main part of the hospital consists of three interconnecting wings some of which were built on an old river bed. The oldest wing (wing C) was built in 1914 with an extension added in 1929. Wing C is primarily a timber frame structure that suffered little damage in the 1988 earthquake. Wing B, built in 1947 is a nine-storey masonry structure (see Fig. 4.6). There was significant damage to the plaster walls of this wing, particularly in the corridors and the stair wells (see Fig. 4.7).

Figure 4.6 Wing B of Saint-François d'Assise Hospital.

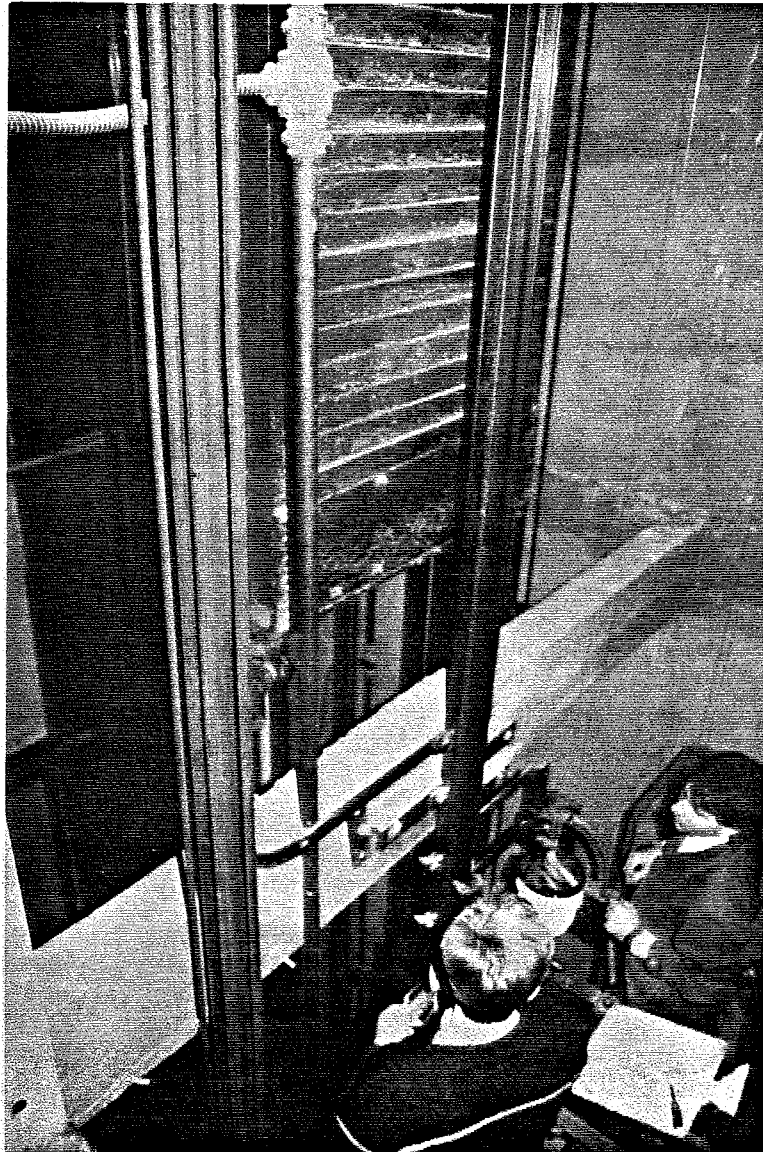
During the site-visit the position of the counterweight was adjusted (see Fig. 4.8) in order to recreate the sequence of events that had led to the failure of the reinforced concrete

Figure 4.8 Elevator counterweight positioned above reinforced concrete beam.

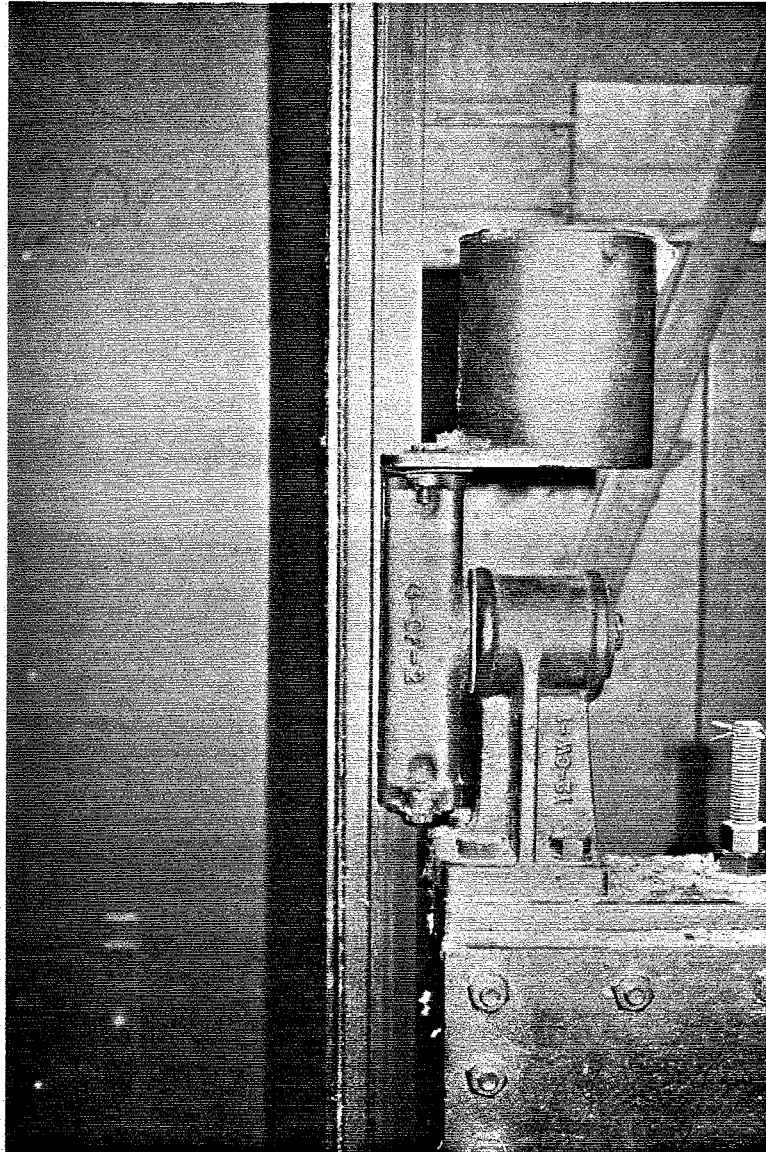
beam. Figure 4.9 shows the shear failure in the concrete beam, the guide-rail support and the temporary repair measures for the concrete beam. The concrete beam contained three #5 top bars and three #5 bottom bars but had no shear reinforcement. Figure 4.10 shows a close-up view of one of the four counterweight guides and the guide-rail.

Figure 4.10 View of counterweight guide and guide-rail.

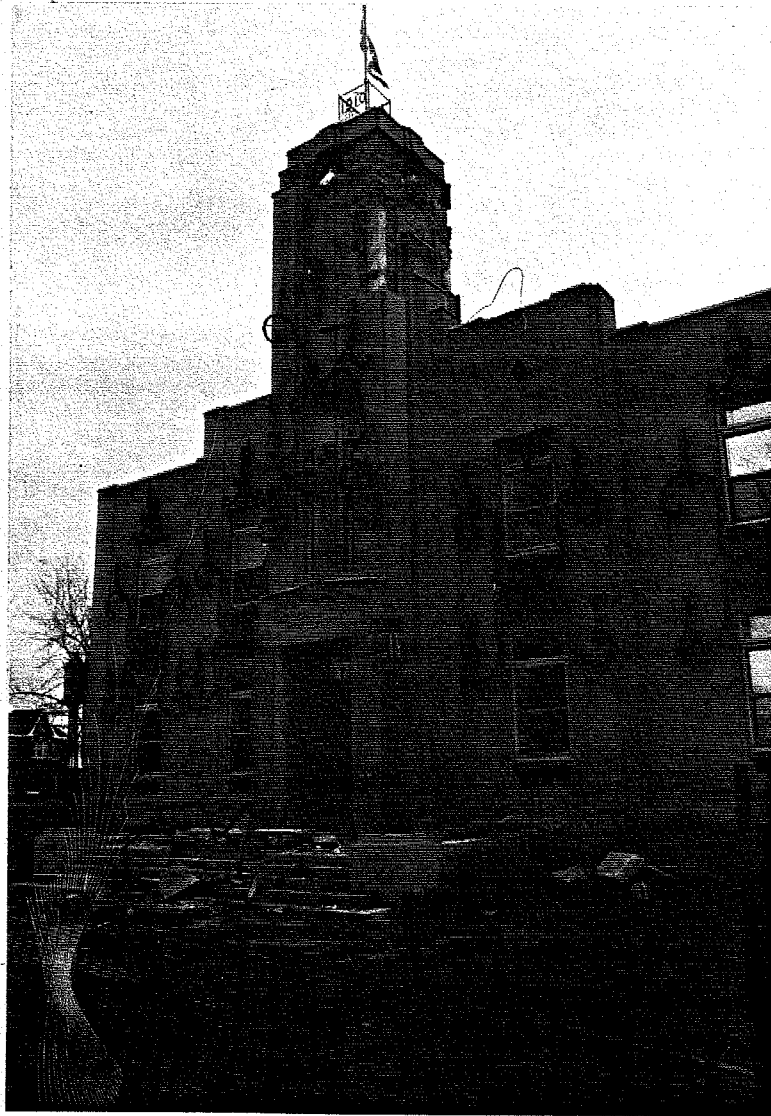
The Montreal East City Hall (Hotel de Ville) located at 11370 Notre Dame Est was constructed in 1937. It is a two storey reinforced concrete frame structure with masonry cladding. This structure suffered severe damage to the masonry cladding as shown in Fig. 5.3, 5.4 and 5.5. It is important to realize that this structure is founded on 17 m of clay. The foundation consists of a one foot thick mat located 8 ft. below grade. The structure had a problem with excessive settlements and this problem had been under investigation since 1983. A differential settlement between the front and the back of the structure of over 90 mm had caused excessive cracking in both the masonry cladding and the interior walls before the earthquake occurred. The clay is stiffer near the surface with an average shear strength of 60 to 70 kPa. It is believed that the numerous large trees at the back of the structure resulted in significant moisture loss in the clay and therefore caused a larger settlement at the rear of the structure.

Figure 5.3 Overall view of Montreal East City Hall.

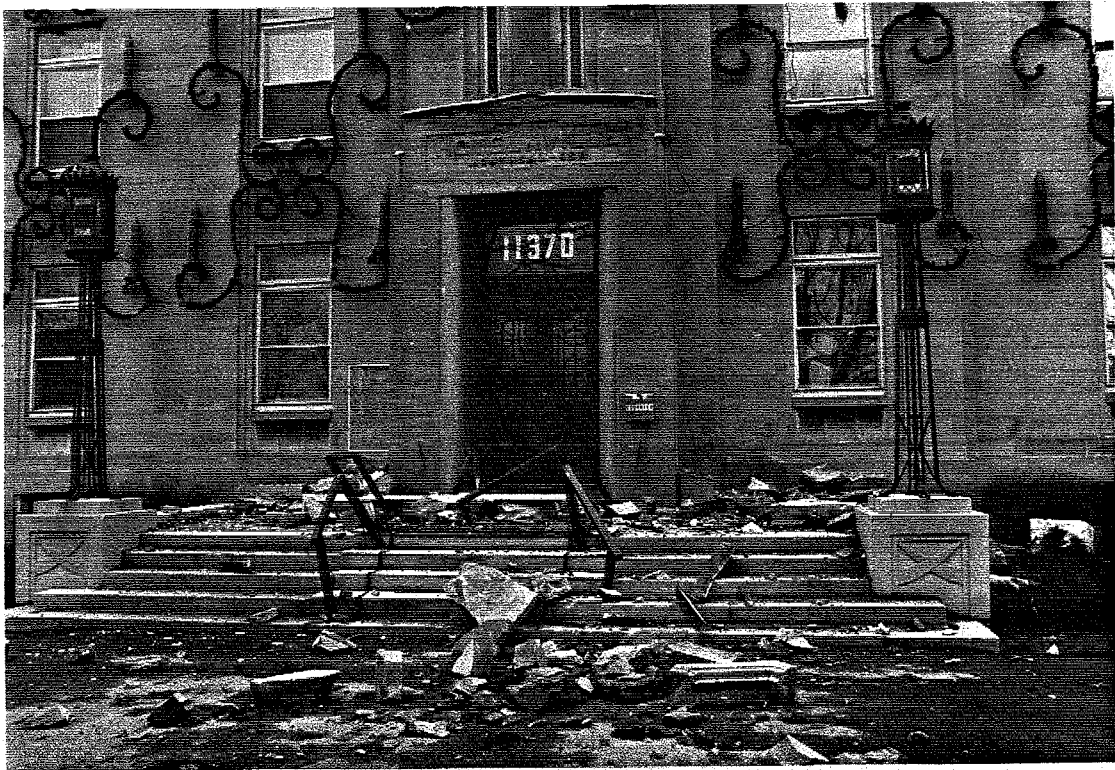
Figure 5.4 Debris from fallen masonry cladding.

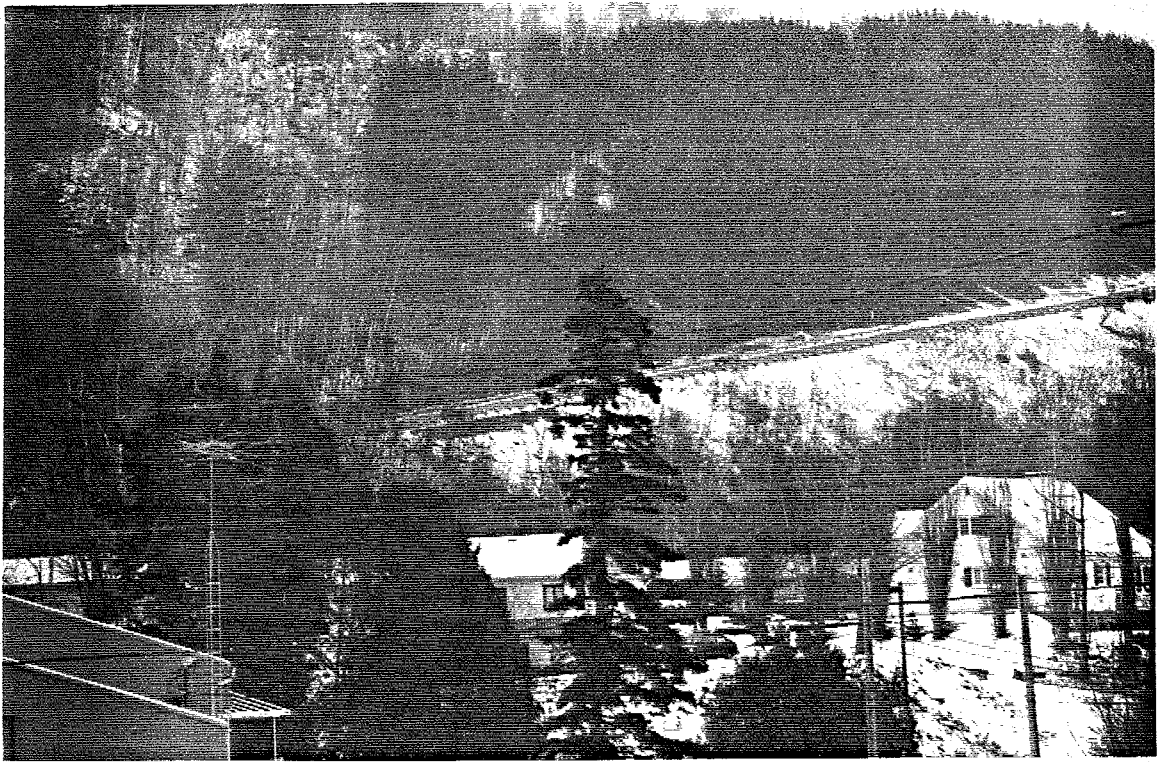
At least 6 highway embankment failures and several large natural slope landslides due to the earthquake were reported. Two highway embankment failures were visited. One of the embankment failures was on Route 175 near Stoneham just north of Quebec City which had been repaired just before the team's visit. This embankment consisted of a granular fill of about 4 m in height with a 1:1 slope. The second embankment failure was located on the shoulder of Route 138 just east of Ste. Anne de Beaupré on a steeply inclined (11% slope) stretch of the highway as shown in Fig. 6.1. The embankment material consisted of medium to fine sand fill and the slope failure took place over a stretch of about 60 m. At the location of the failure the fill was about 24 m high with a slope of 1.5 horizontal to 1.0 vertical. As can be seen from Fig. 6.2 and Fig. 6.3 the failure consists of a relatively shallow slip that did not appear to involve much of the subsoil. As a result of the slide the inside lane of the highway was closed as shown in Fig. 6.4. Liquefaction appeared to be the mechanism for this failure. It was reported that the sand at the toe of the fill flowed out as if it were liquefied. Soil investigations at the site, by the Ministère des Transports du Québec shows that there are some very loose granular layers that are susceptible to liquefaction in an earthquake.

Figure 6.1 Location of embankment failure on Highway 138 near Ste. Anne de Beupré.
