Hot spots on wood chip insulated slopes,
Norman Wells Pipeline,
Northwest Territories

**HOT SPOTS ON WOOD CHIP INSULATED SLOPES,
NORMAN WELLS PIPELINE, N.W.T. :**

**Chronology of 1984 to 1993 observations and summary
of 1993 instrumentation program**

Burgess, M.M., Lawrence, D.E., MacDonald J., and Desrochers, D.T.

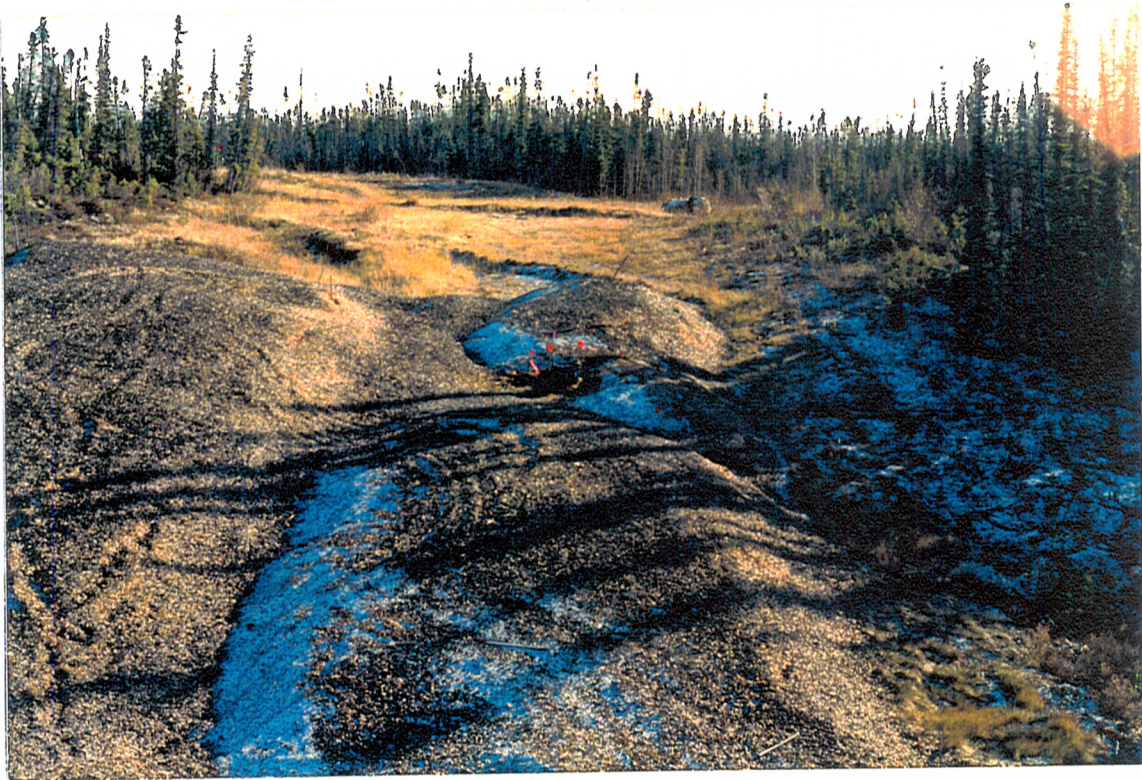
Plate 8. Slope 31A, Unnamed Creek South, KmP 84.5, Oct. 7, 1993. Northward view of slope with hot spot instrumentation. Note subsided hot area and ditchline, and tension cracks in the wood chips.

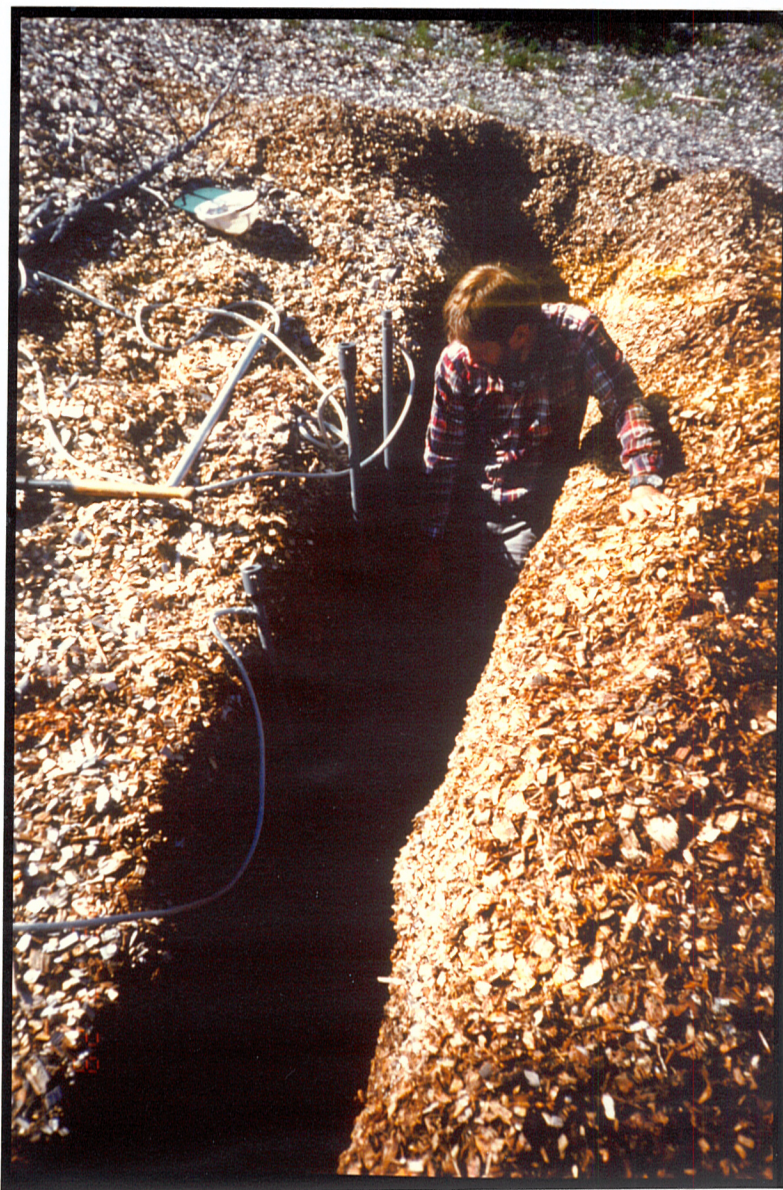
Plate 16.

Slope 45, Unnamed Creek South, Kmp 133.7, July 1993. Trench dug across one edge of hot spot to investigate hot spot and install instrumentation.

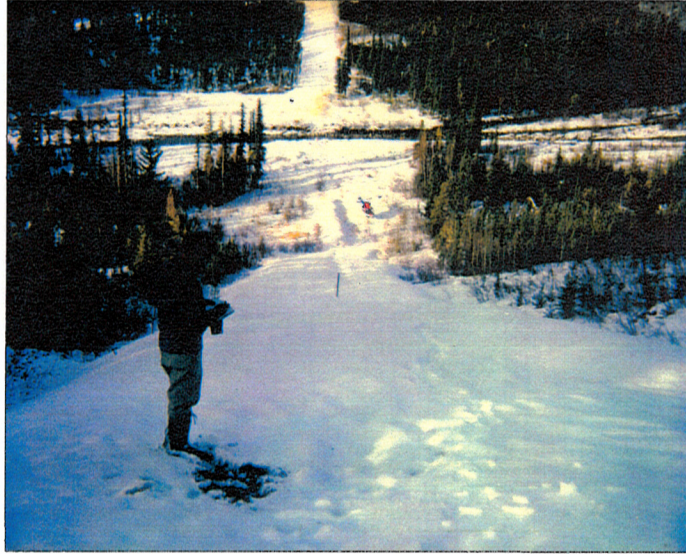
Plate 19. Slope 63, Steep Creek South, KmP 194.9, Oct. 6, 1992. Extensive hot spots were recognized from ground inspection of the slope.

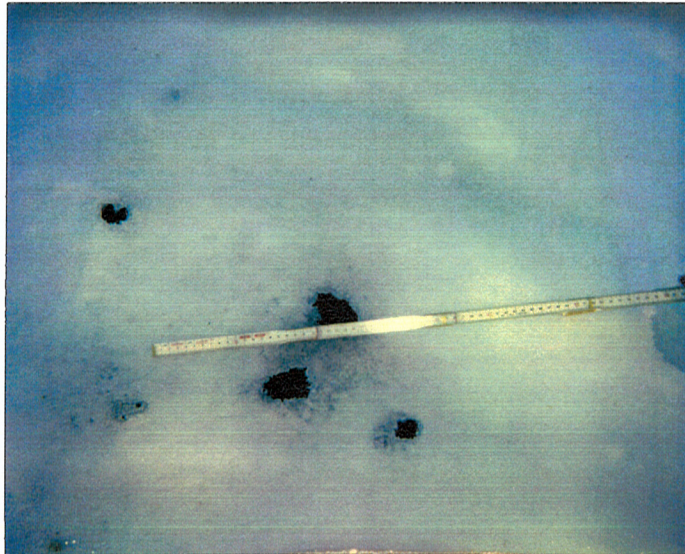
Plate 20. Slope 63, Steep Creek South, Kmp 194.9, Oct. 6, 1992. Hot spot melted through the overlying blanket of snow. Snow depth away from hot areas is 22 to 30 cm.

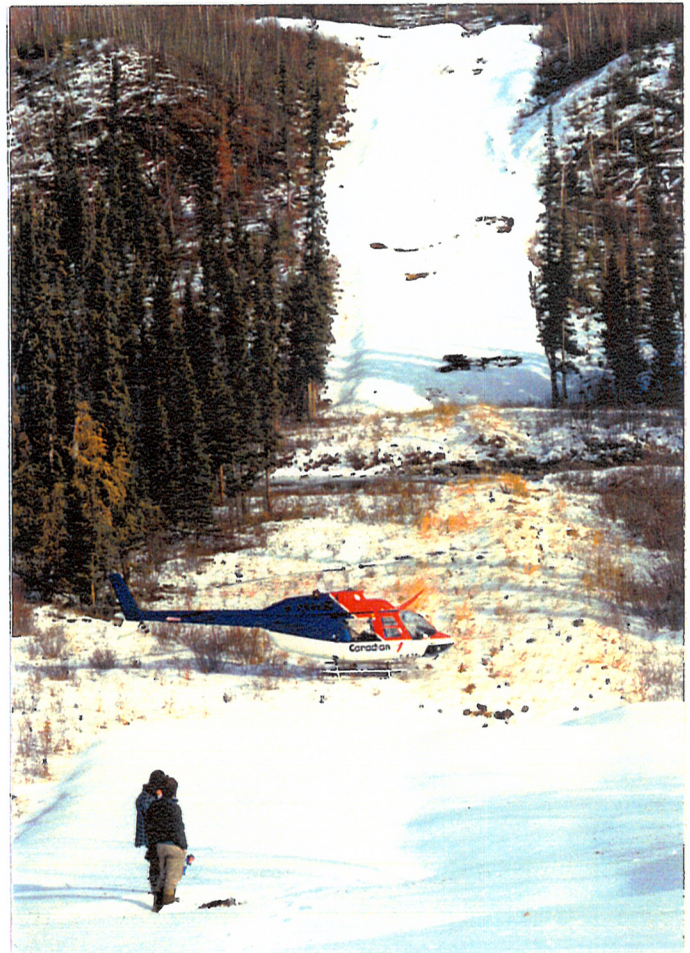
Plate 26.

Slope 79 and 80, Whitesand North and South (in the foreground), KmP 279.0 - 279.3, Oct. 1992. Standing on Slope 80 facing north to Slope 79. Snow melt indicating areas of hot spots on both slopes.

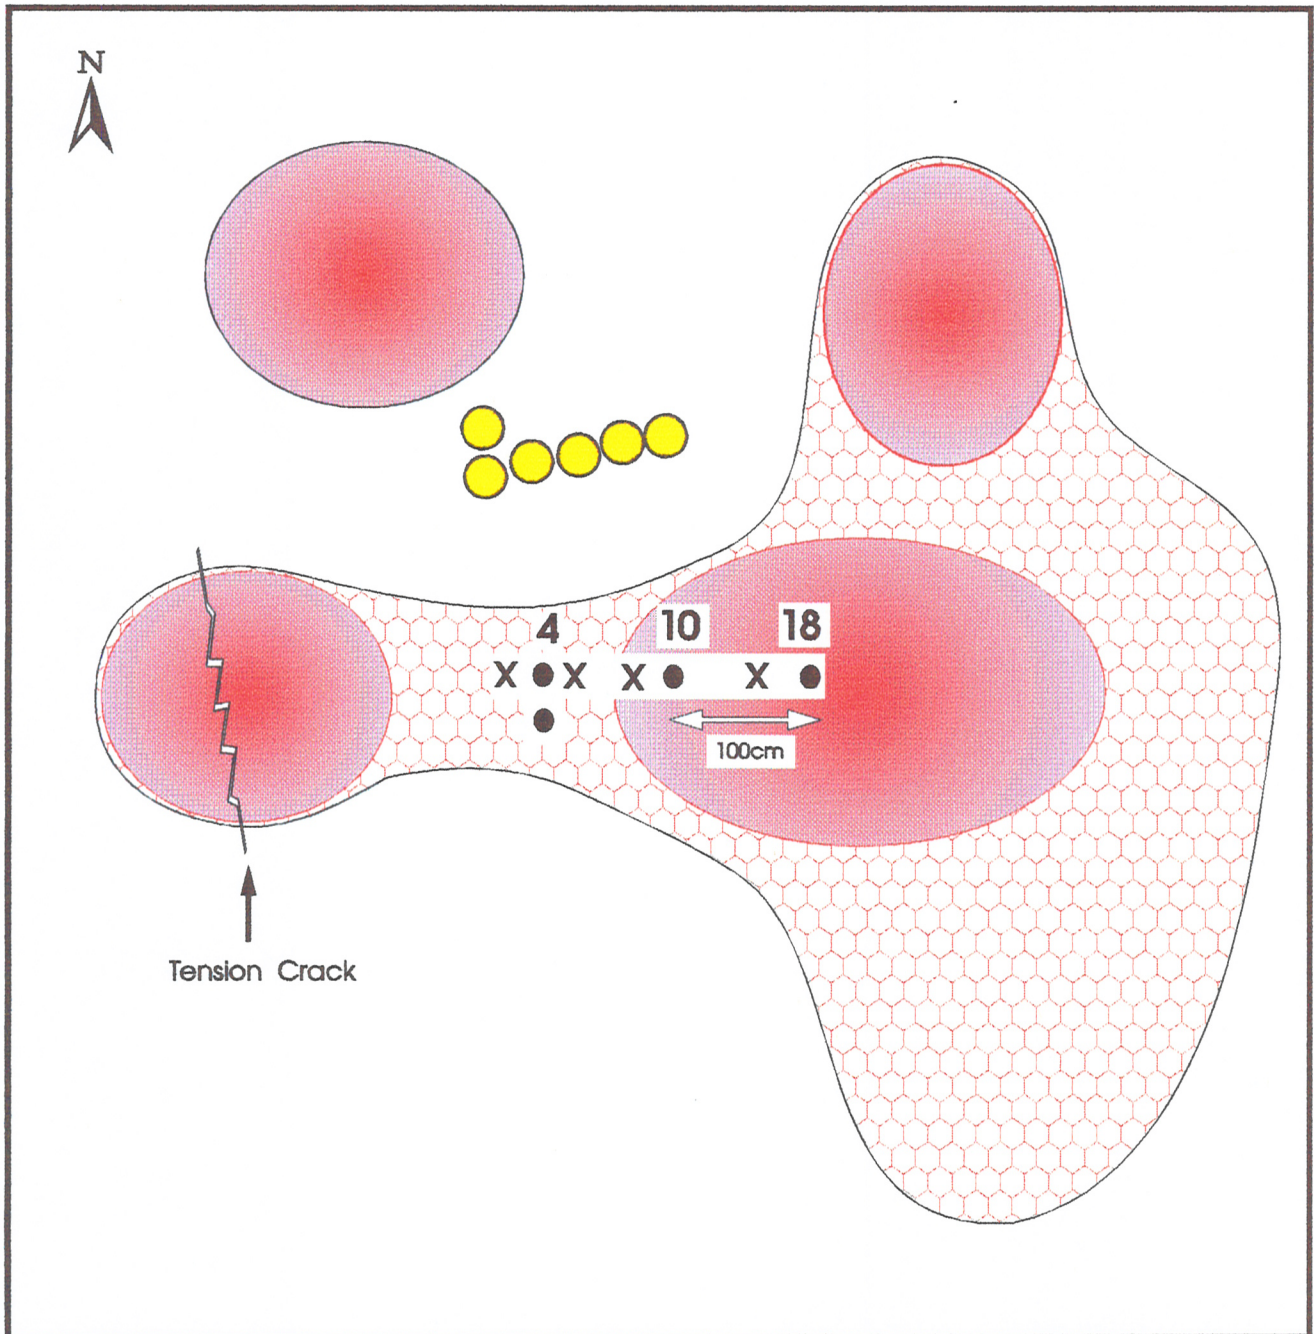
Slope 31A, Kmp 84.5

Map View of Hot Spot Transect

#s = Temperatures at 30cm depth, measured in degrees celsius, recorded at 10:10, October 7, 1993.

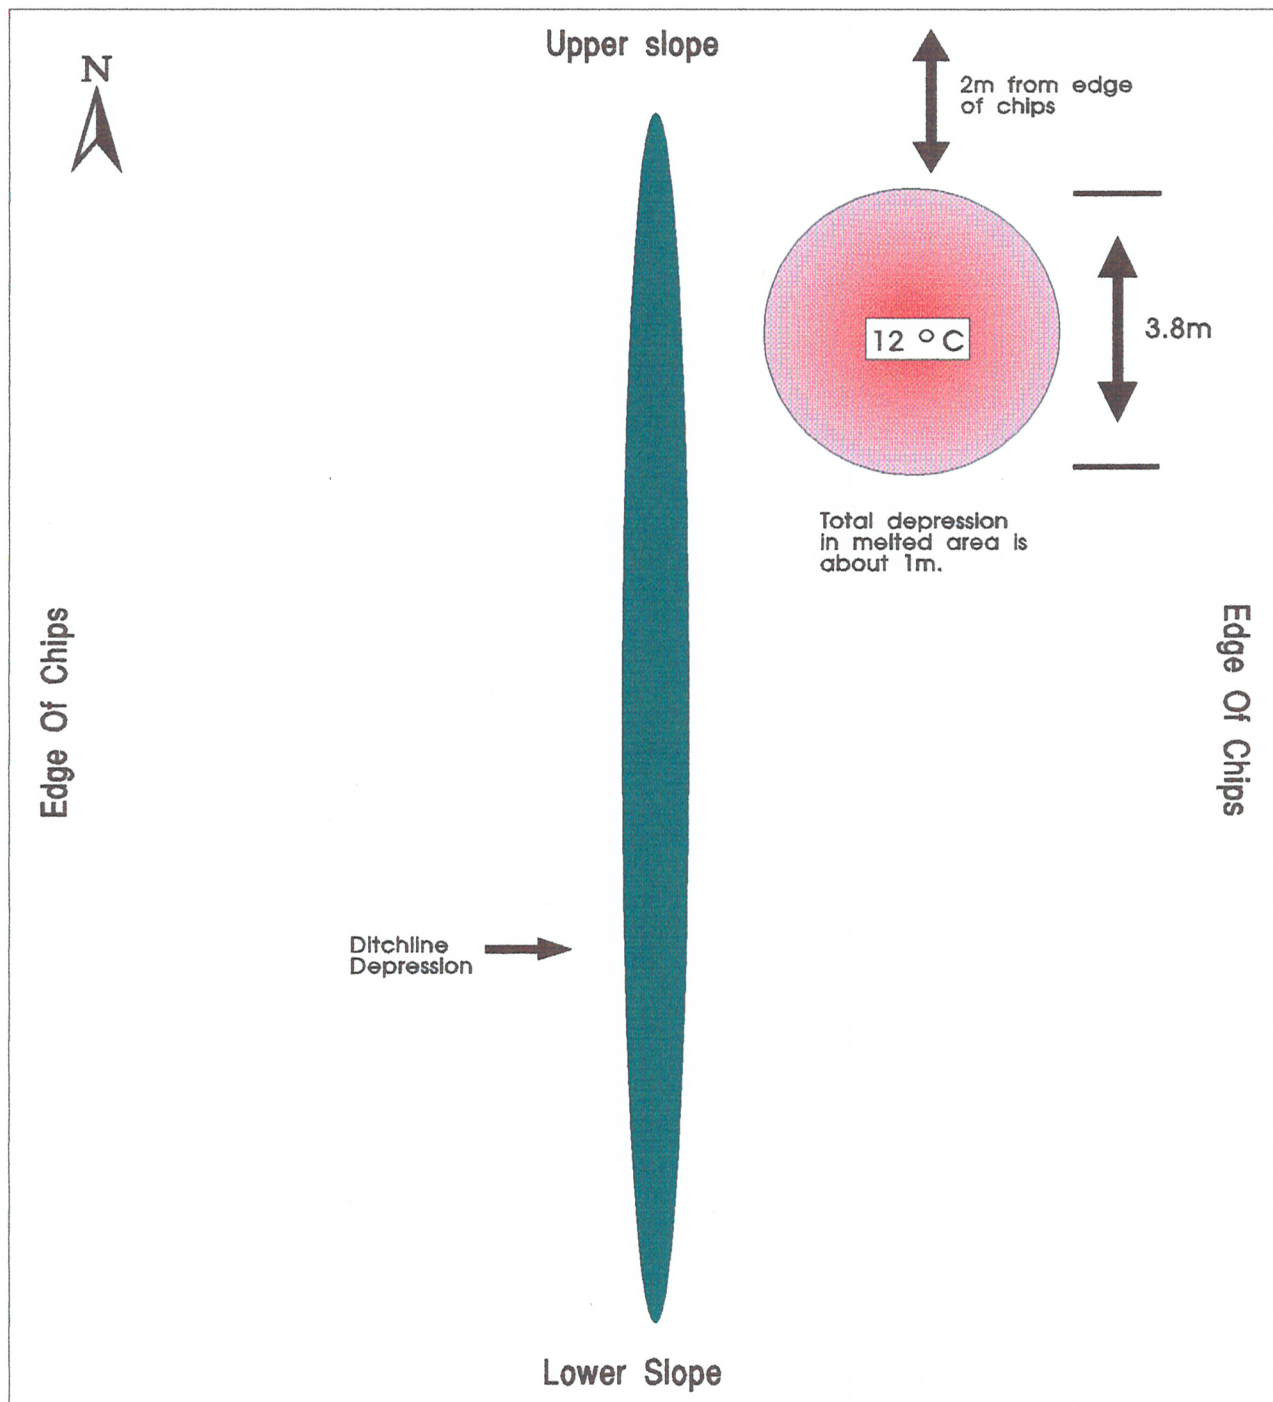
Slope 32A, Kmp 93.2 Location of hot spots, October 1992

Temperature = Max. temp. in hot spot recorded in ° C at approx. 20cm depth.

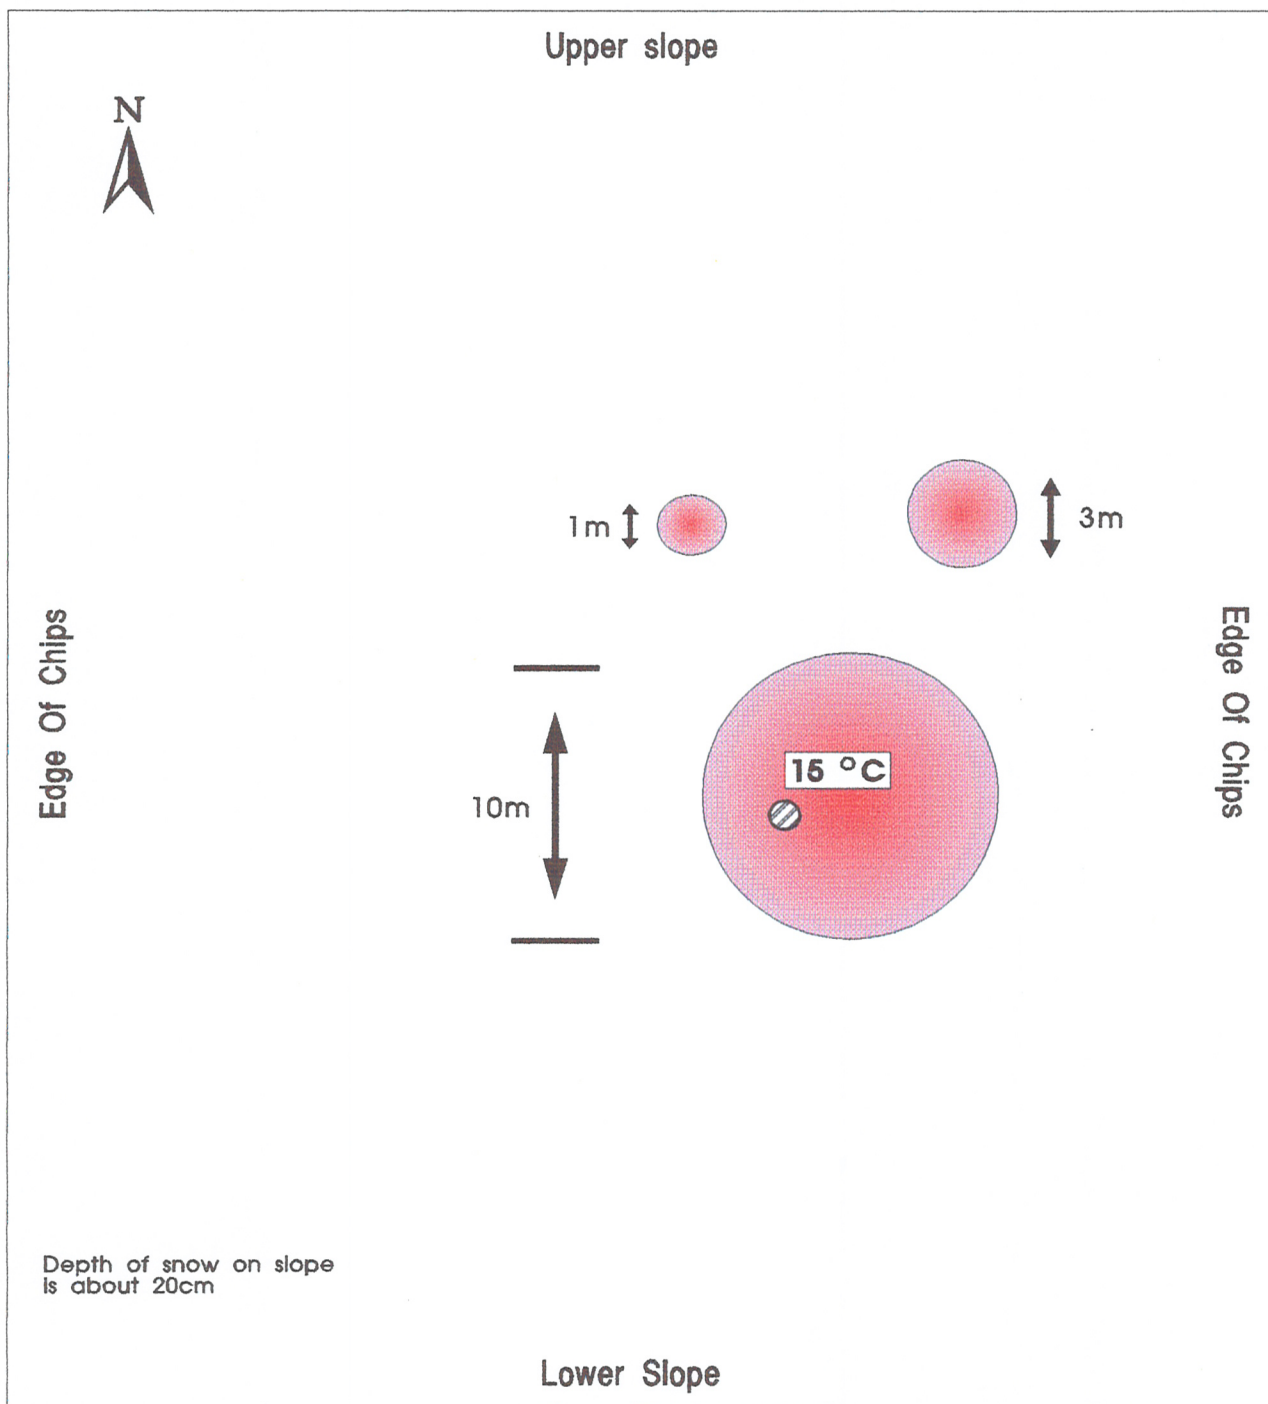
Slope 36, Kmp 103.2 Location of hot spots, October 1992

Temperature = Max. temp. in hot spot recorded in ° C at approx. 20cm depth.

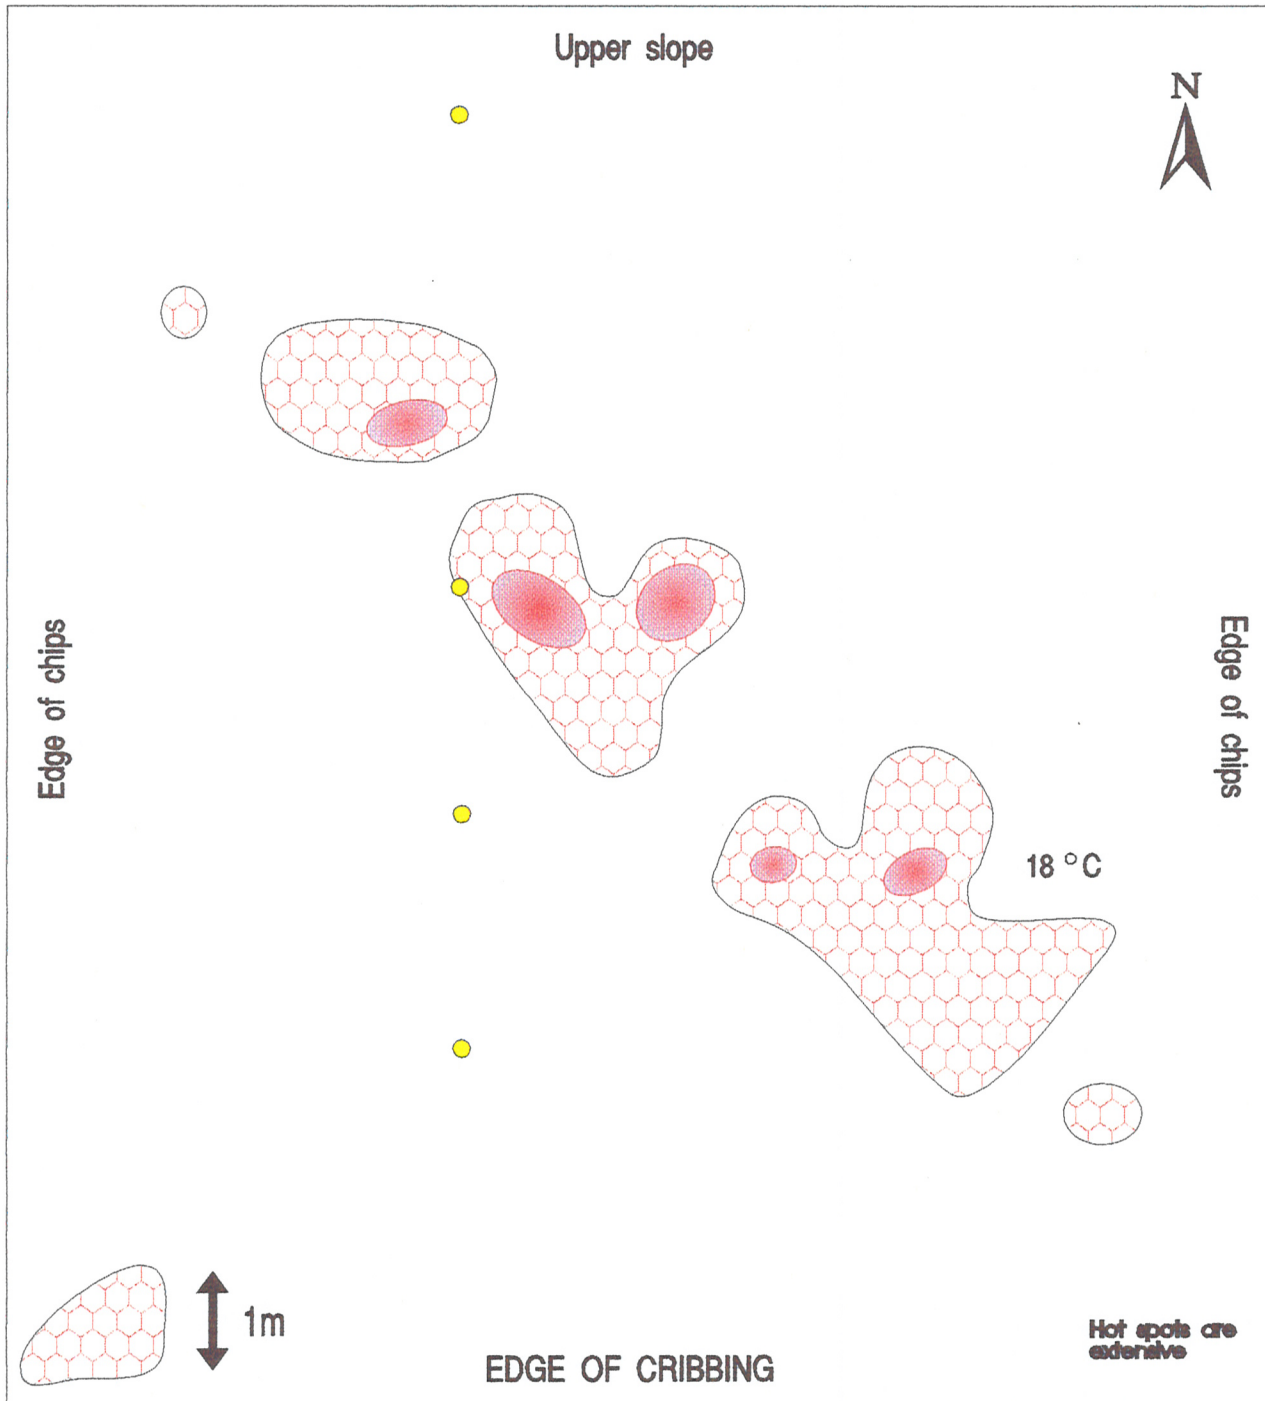
Slope 44, Kmp 133.6 Location of hot spots, October 3, 1992

Temperature = Max. temp. in hot spot recorded in ° C at approx. 20cm depth.

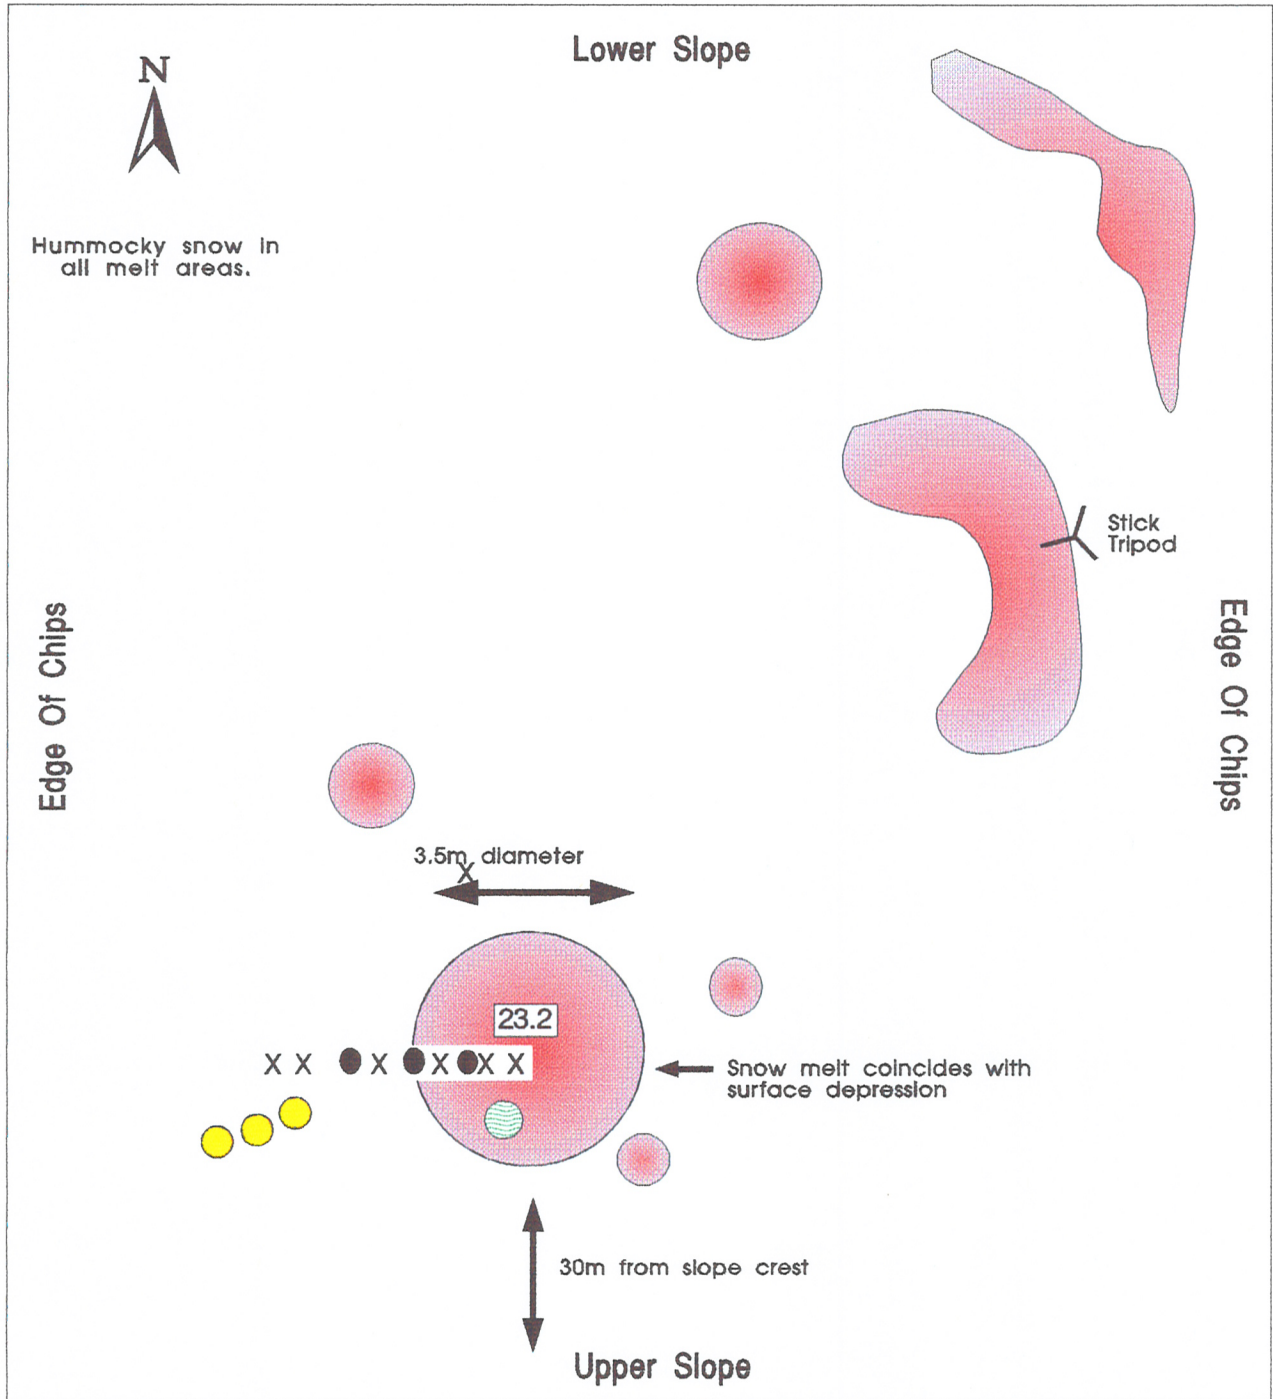
Slope 45, Kmp 133.7 Location of hot spots, October 1992

Temperature = Temp. in hot spot recorded in ° C at approx. 20cm depth.
(July 6, 1993)

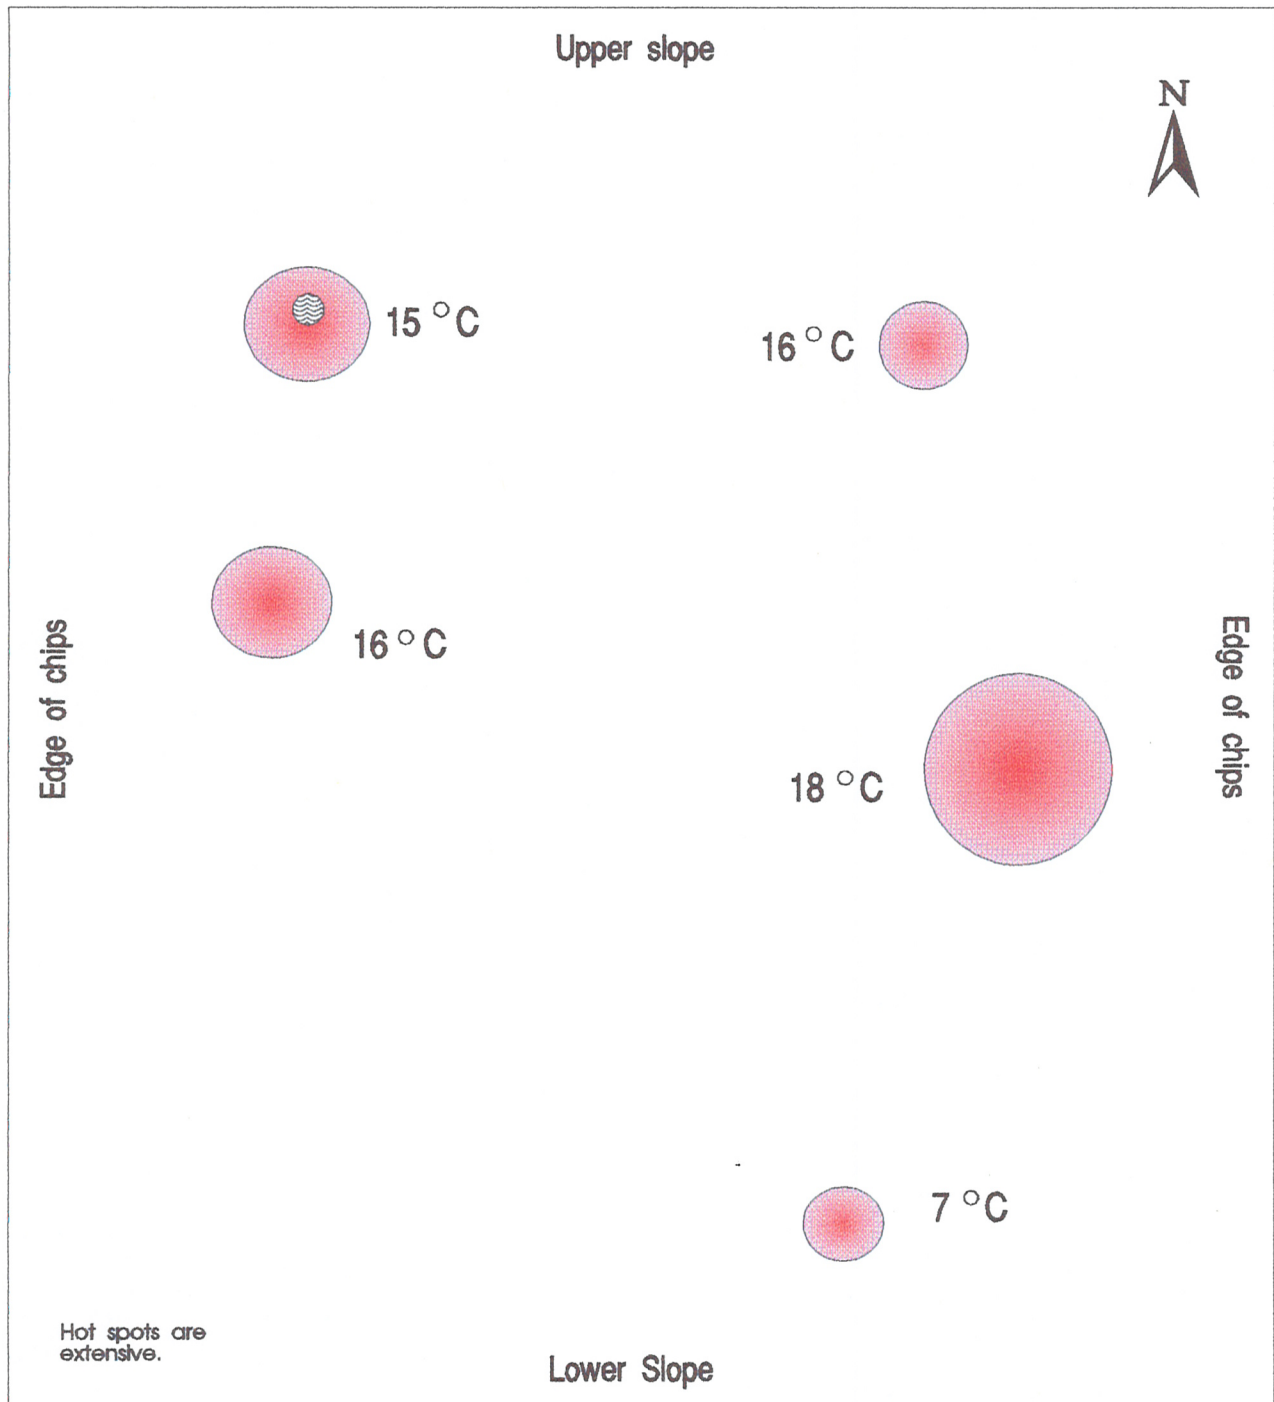
Slope 47, Kmp 160.1 Location of hot spots, October, 1992

Temperature = Max. Temp. in the hot spot recorded in °C at approx. 20cm depth.

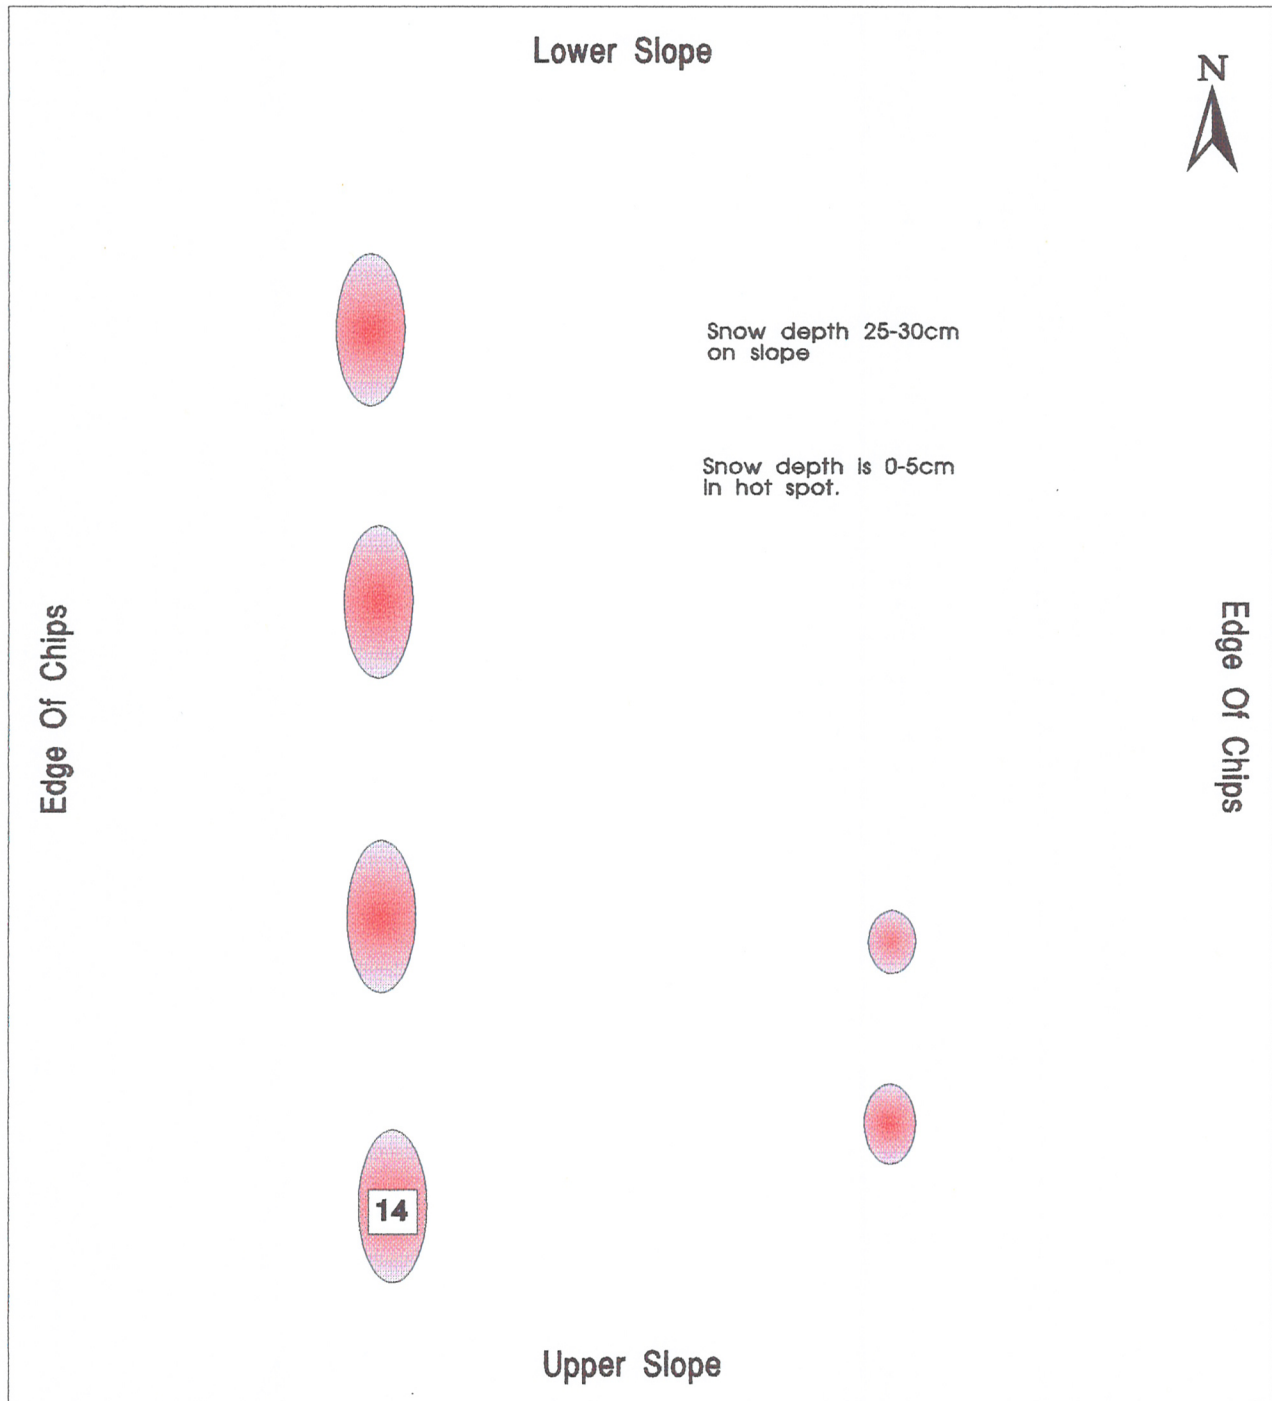
Slope 63, Kmp 194.9 Location of hot spots, October 1992

Temperature = Max. temp. in hot spot recorded in ° C at approx. 20cm depth.
Hot spots are small (1-3m) and medium (3-6m) in diameter.

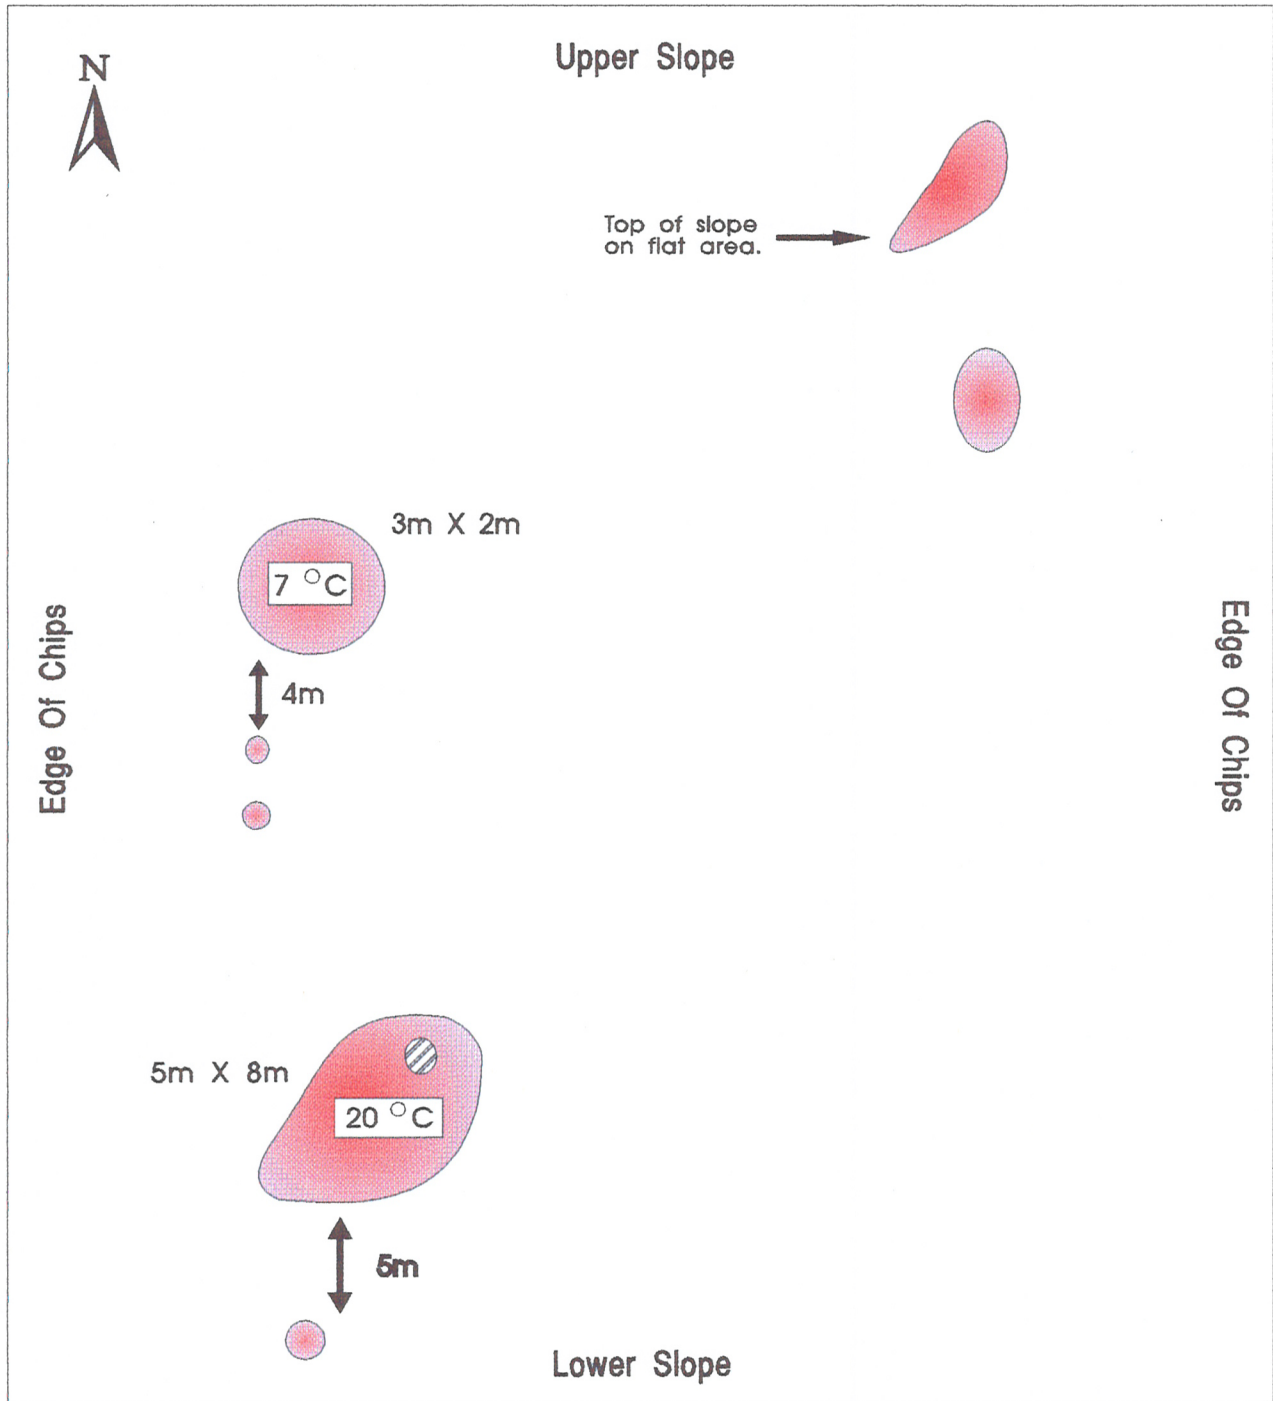
Slope 75, Kmp 273.5 Location of hot spots, October 1992

Temperature = Temp. in woodchips recorded in ° C at approx. 20cm depth.

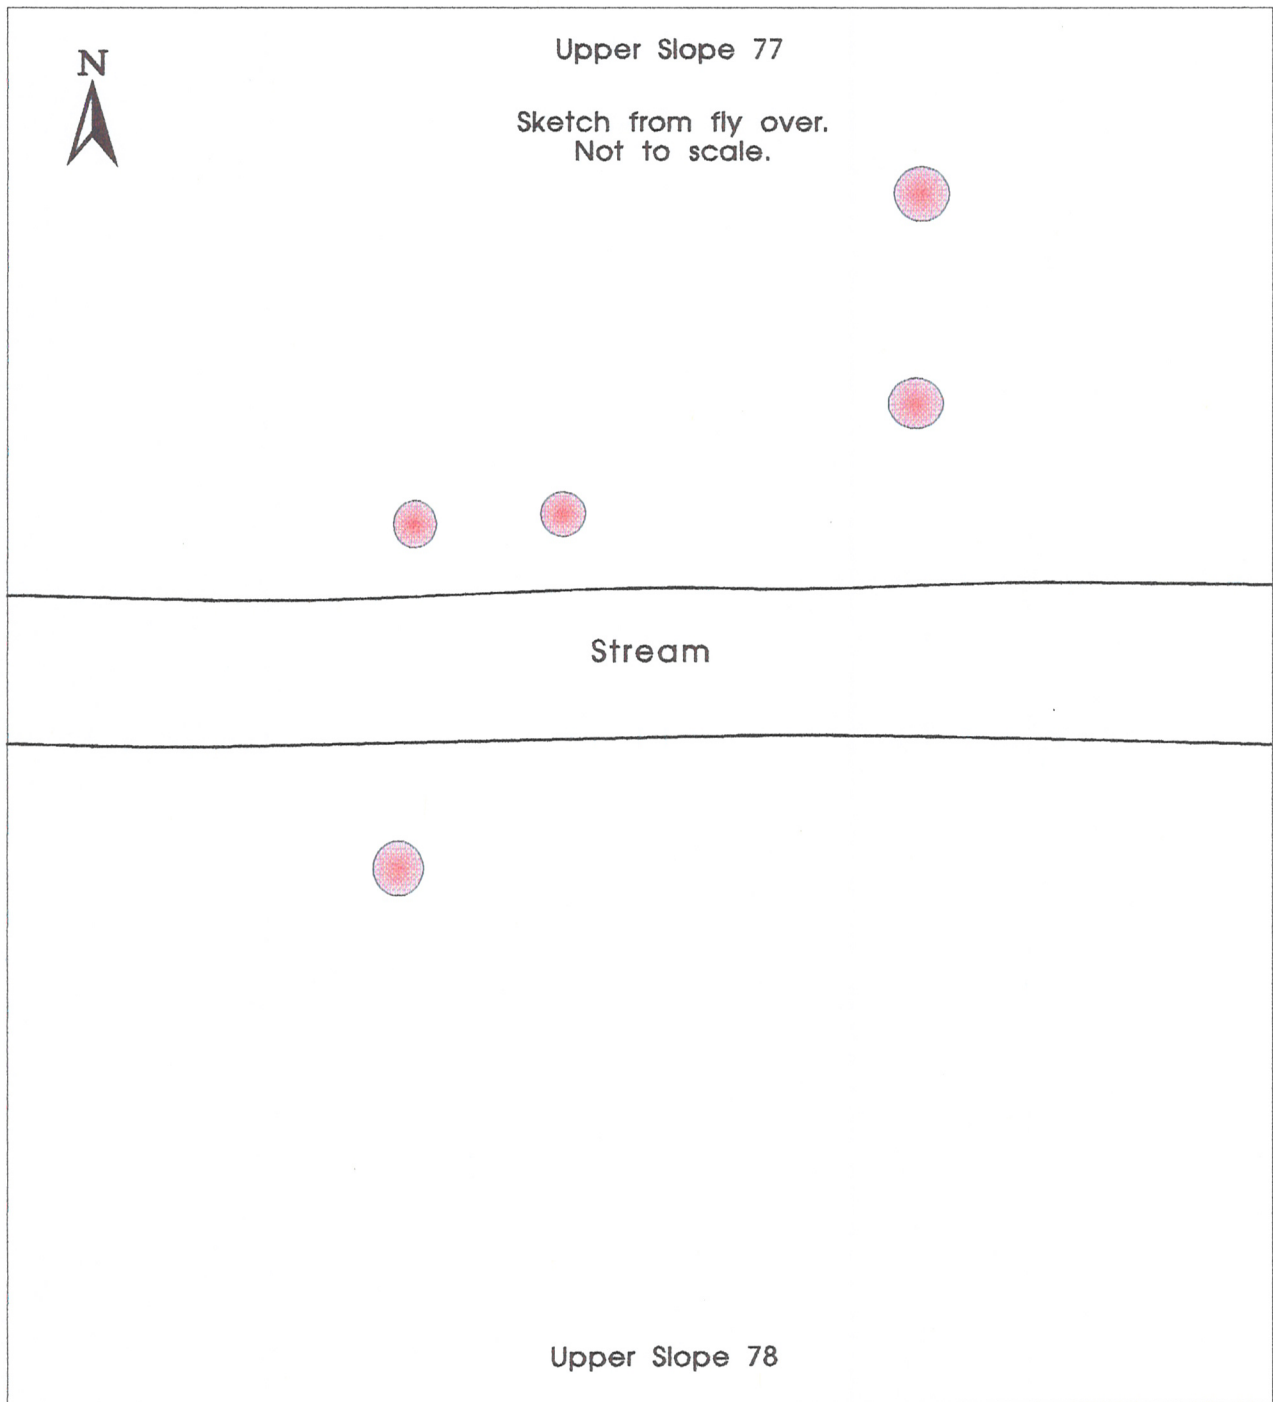
Slopes 77 and 78, Kmp 275.5-275.6 Location of hot spots, October 1992

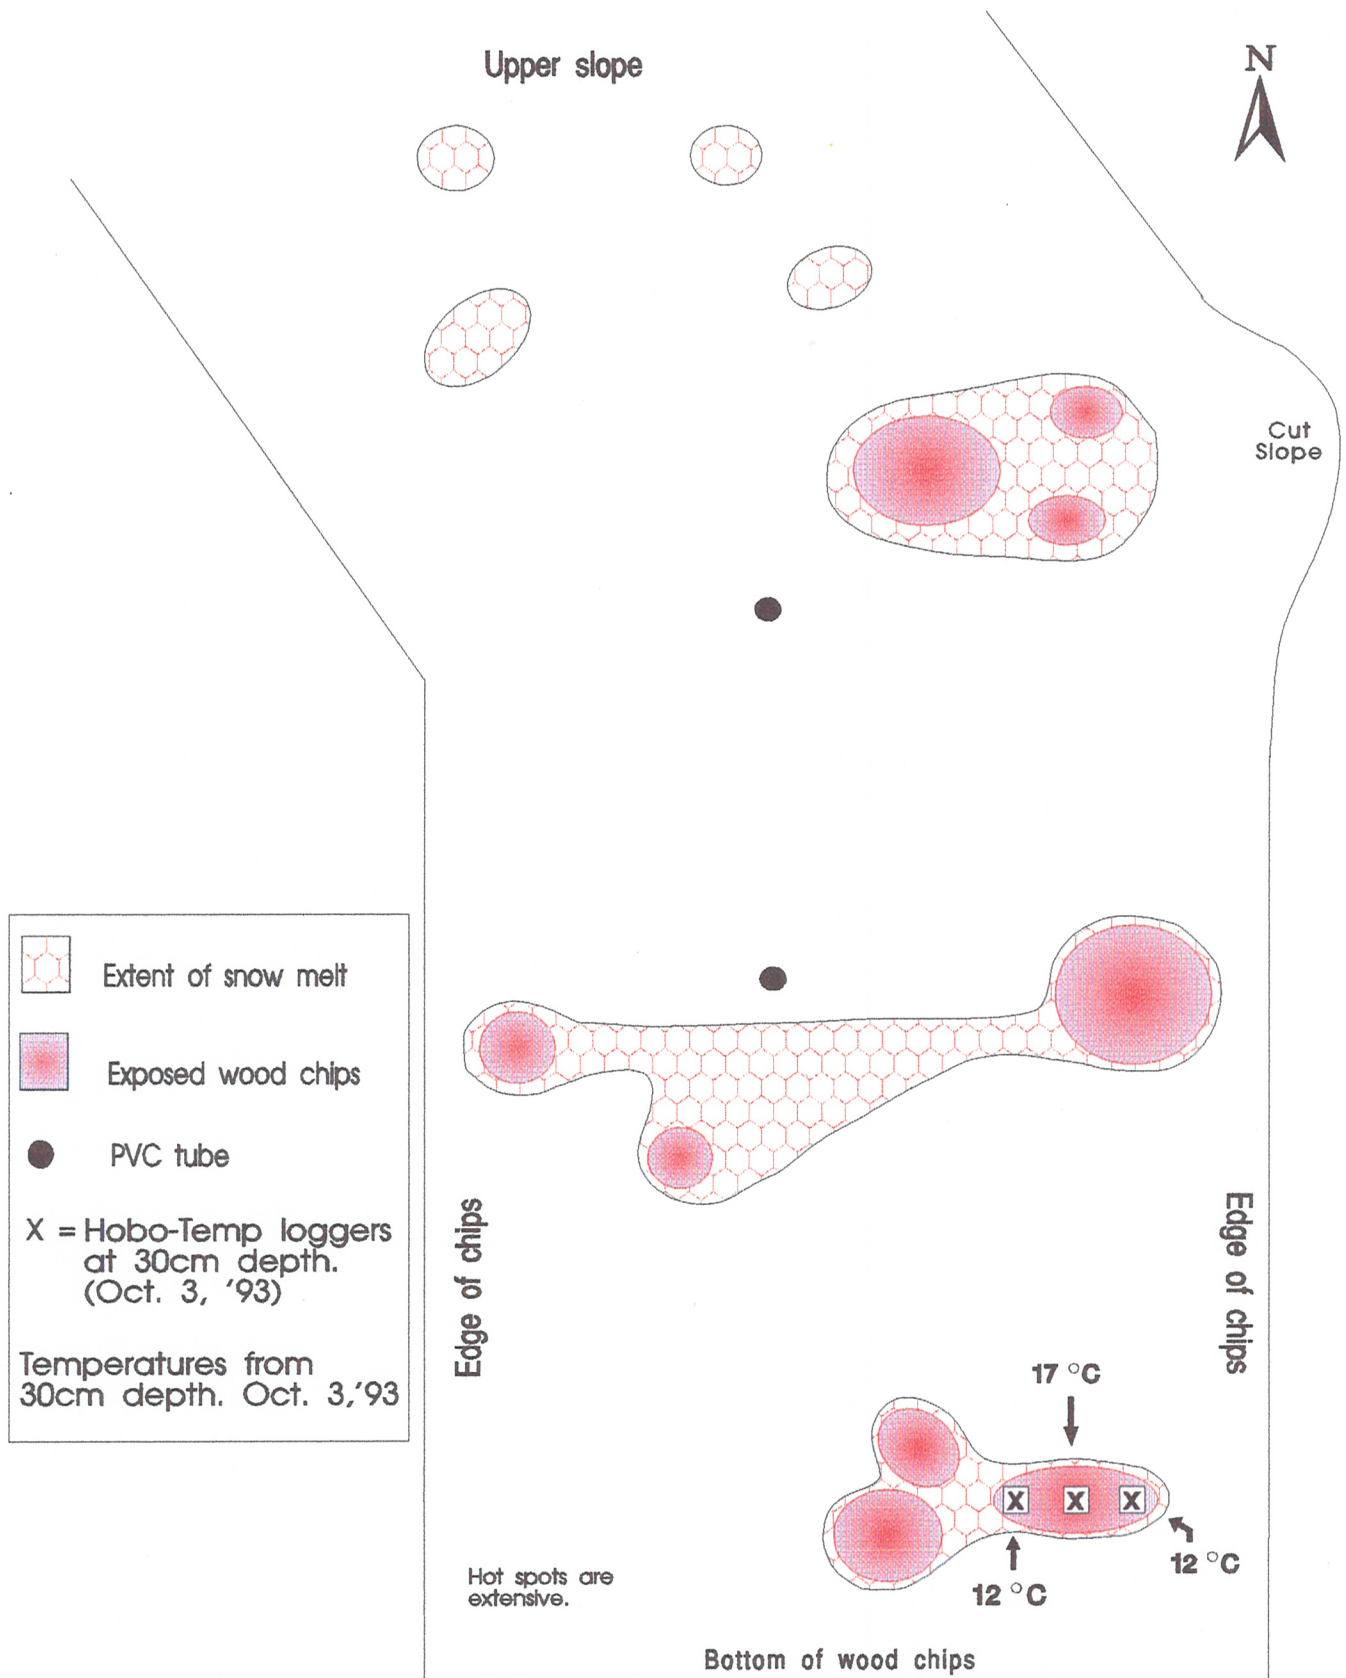
Slope 79, Kmp 279.0

Location of hot spots, October, 1992
