Hot spots on wood chip insulated slopes,
Norman Wells Pipeline,
Northwest Territories

**HOT SPOTS ON WOOD CHIP INSULATED SLOPES,
NORMAN WELLS PIPELINE, N.W.T. :**

**Chronology of 1984 to 1993 observations and summary
of 1993 instrumentation program**

Burgess, M.M., Lawrence, D.E., MacDonald J., and Desrochers, D.T.

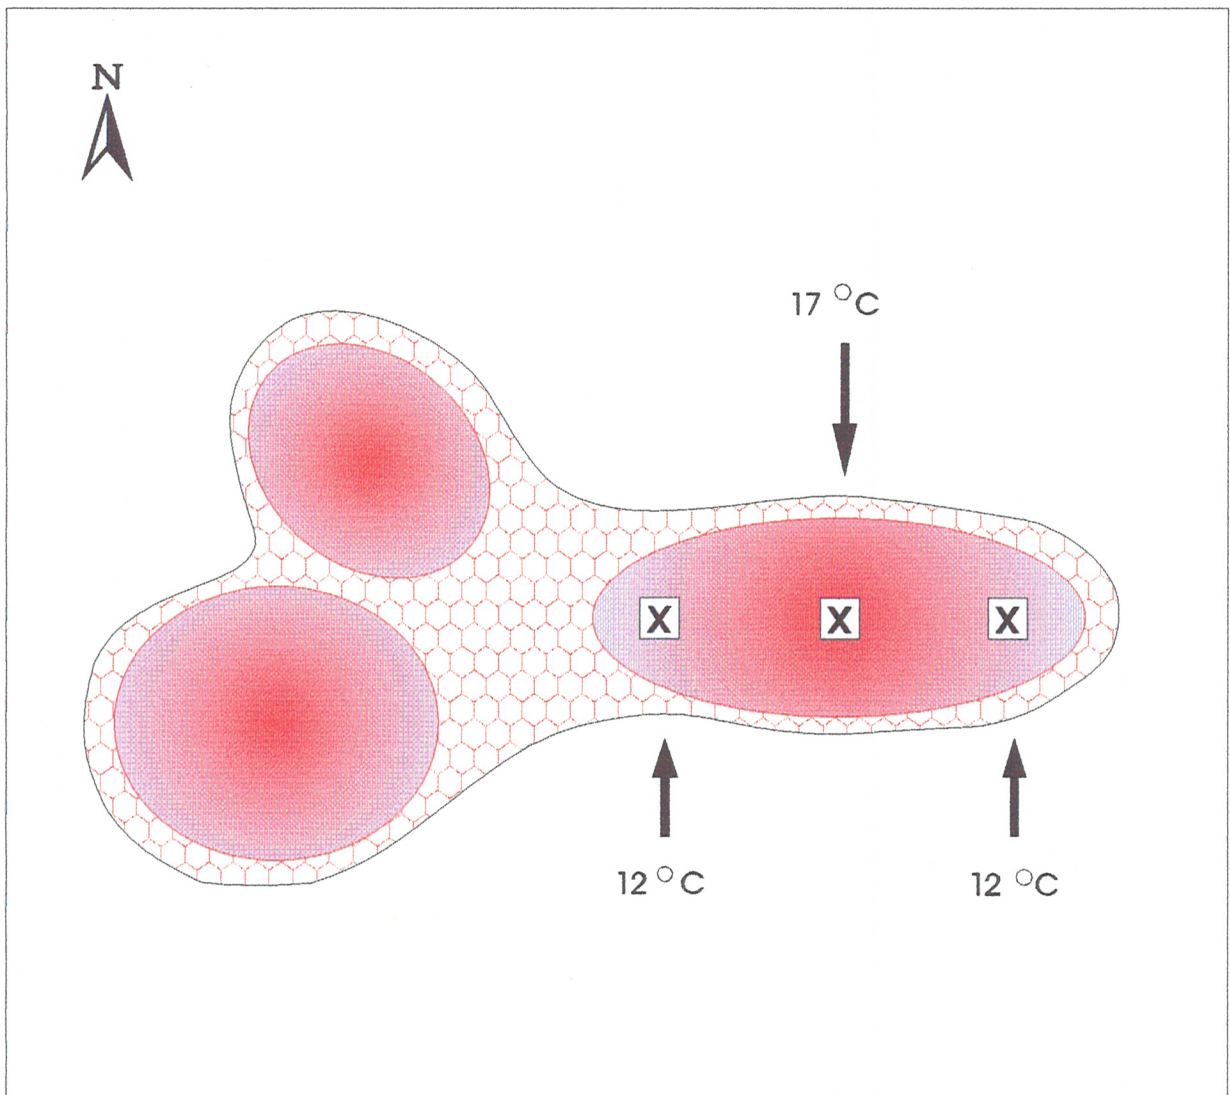
Slope 79, Kmp 279.0 Map View of Hot Spot Transect

Temperatures recorded at 30cm depth, October 3, 1993, when loggers were installed.

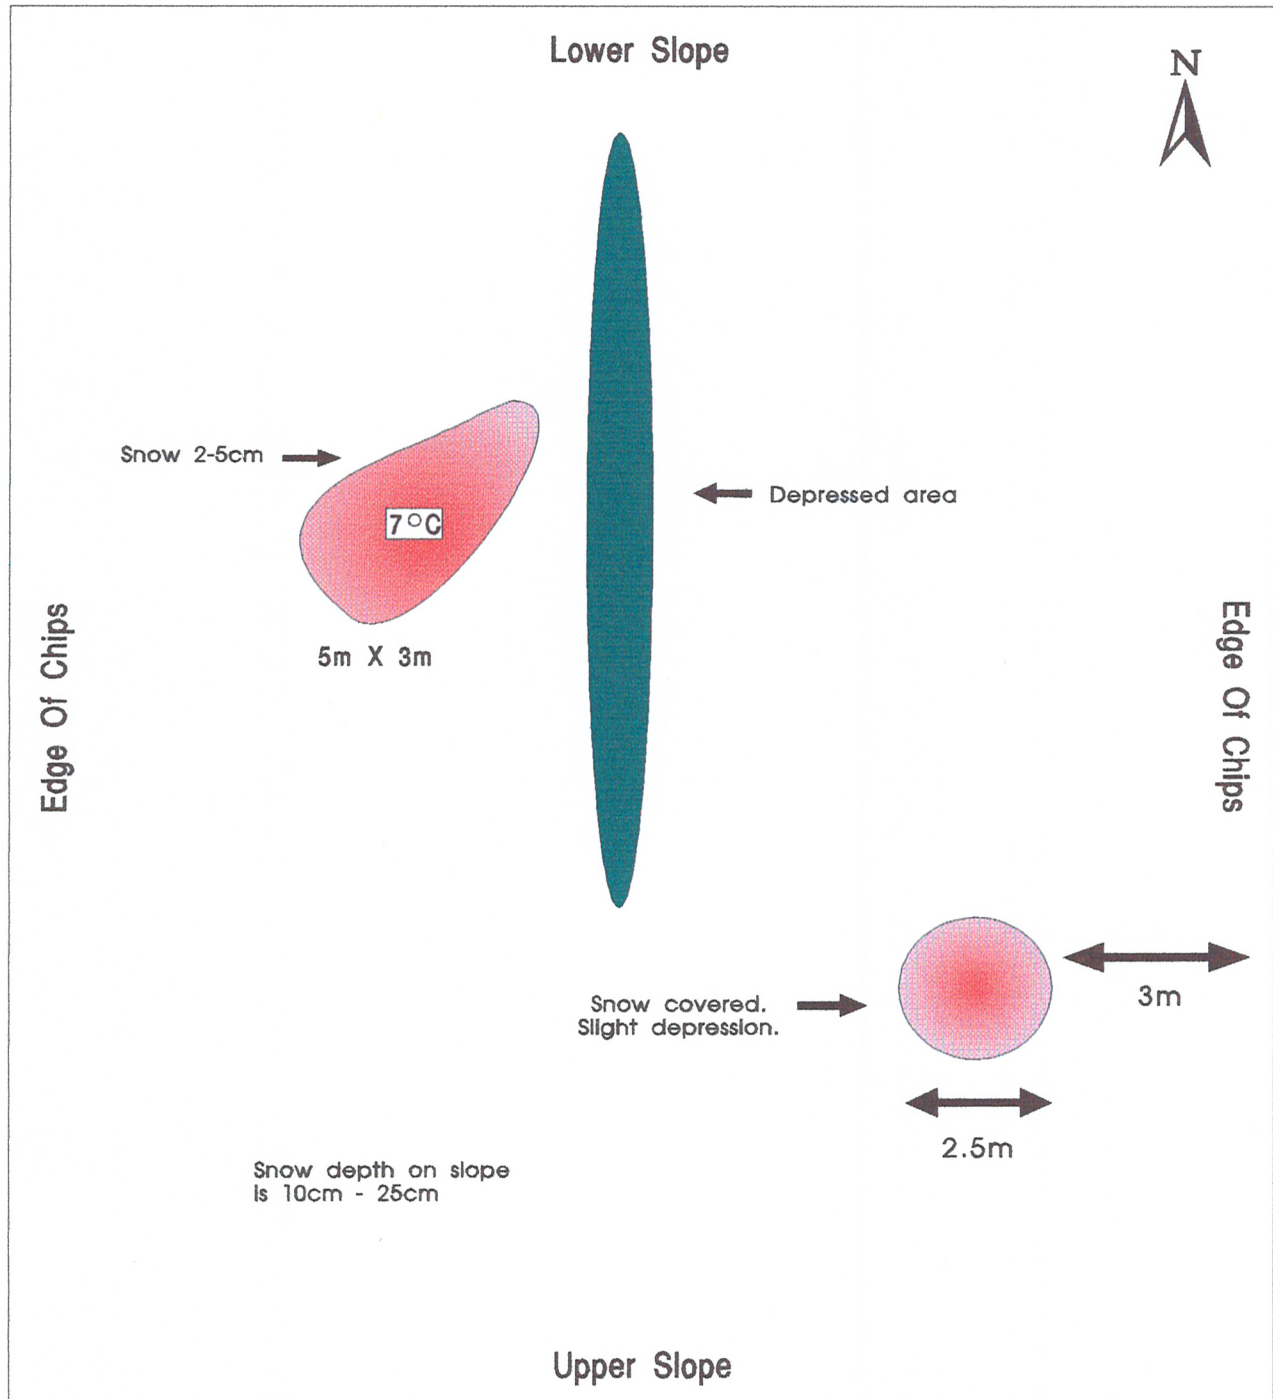
Slope 80, Kmp 279.3 Location of hot spots, October 1992

Temperature = Max. temp. in hot spot recorded in °C at approx. 20cm depth.

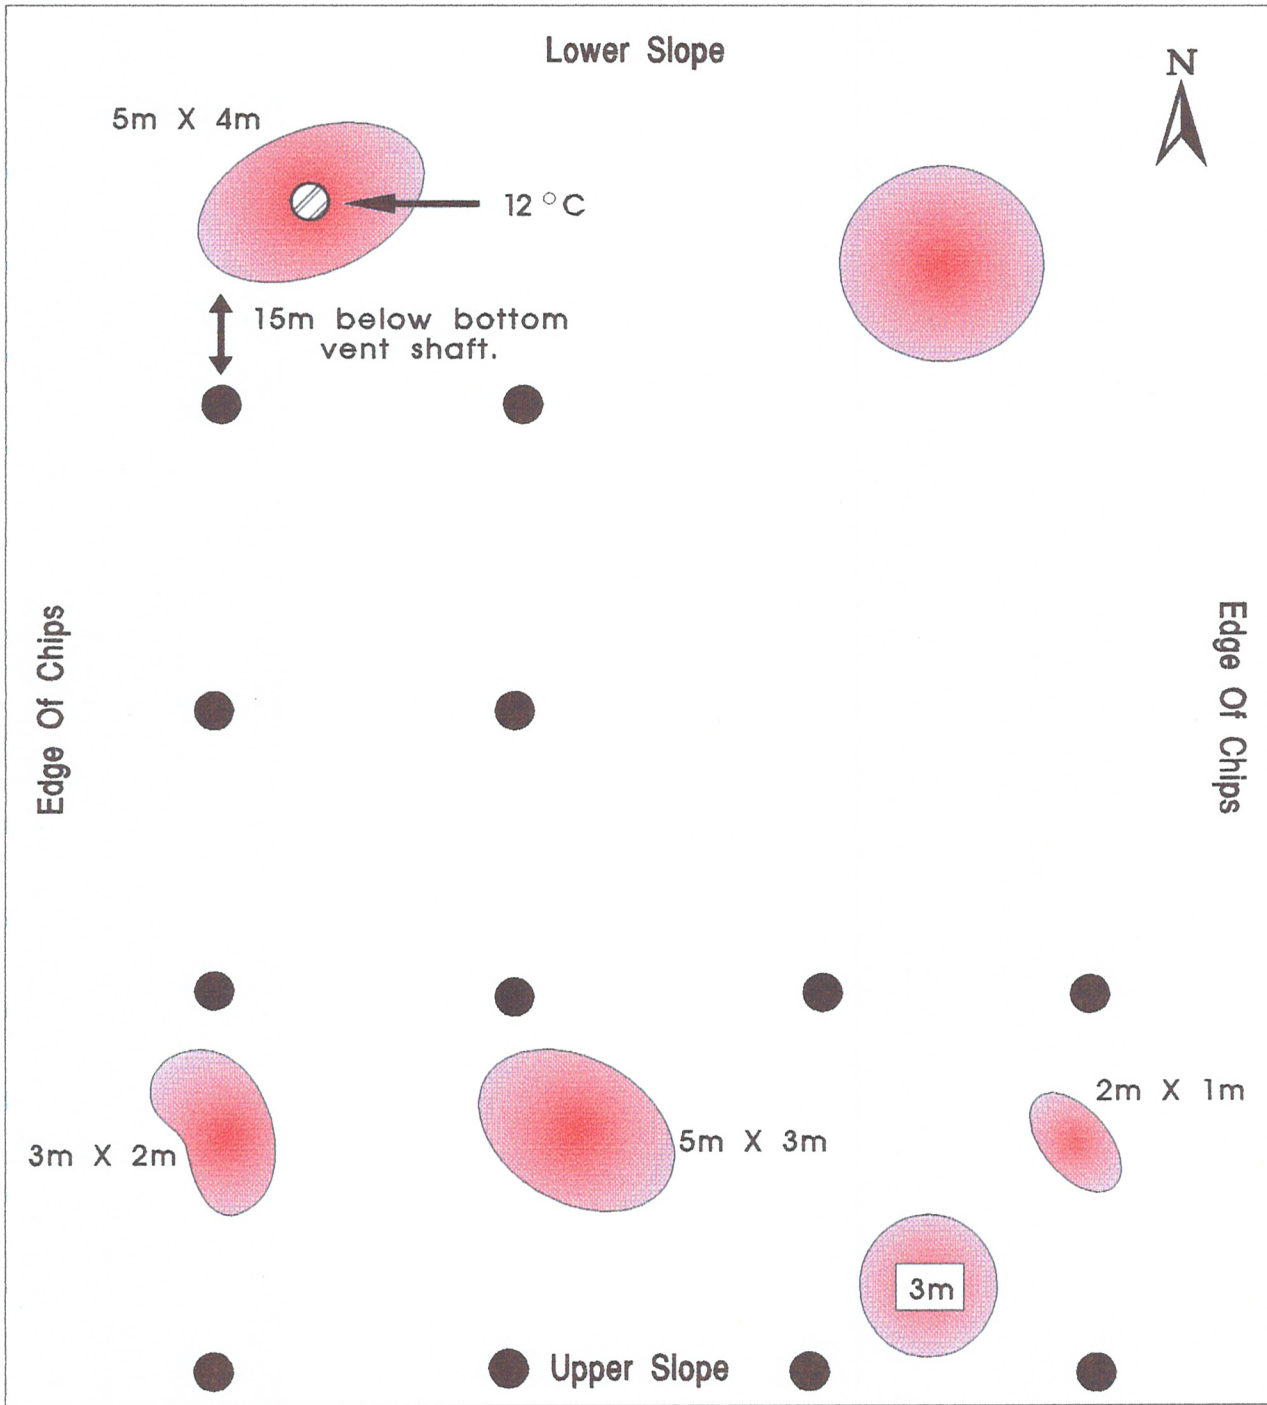
Slope 82, Kmp 286.6 Location of hot spots, October 1992

Temperature = Max. temp. in hot spot recorded in °C at approx. 20cm depth.

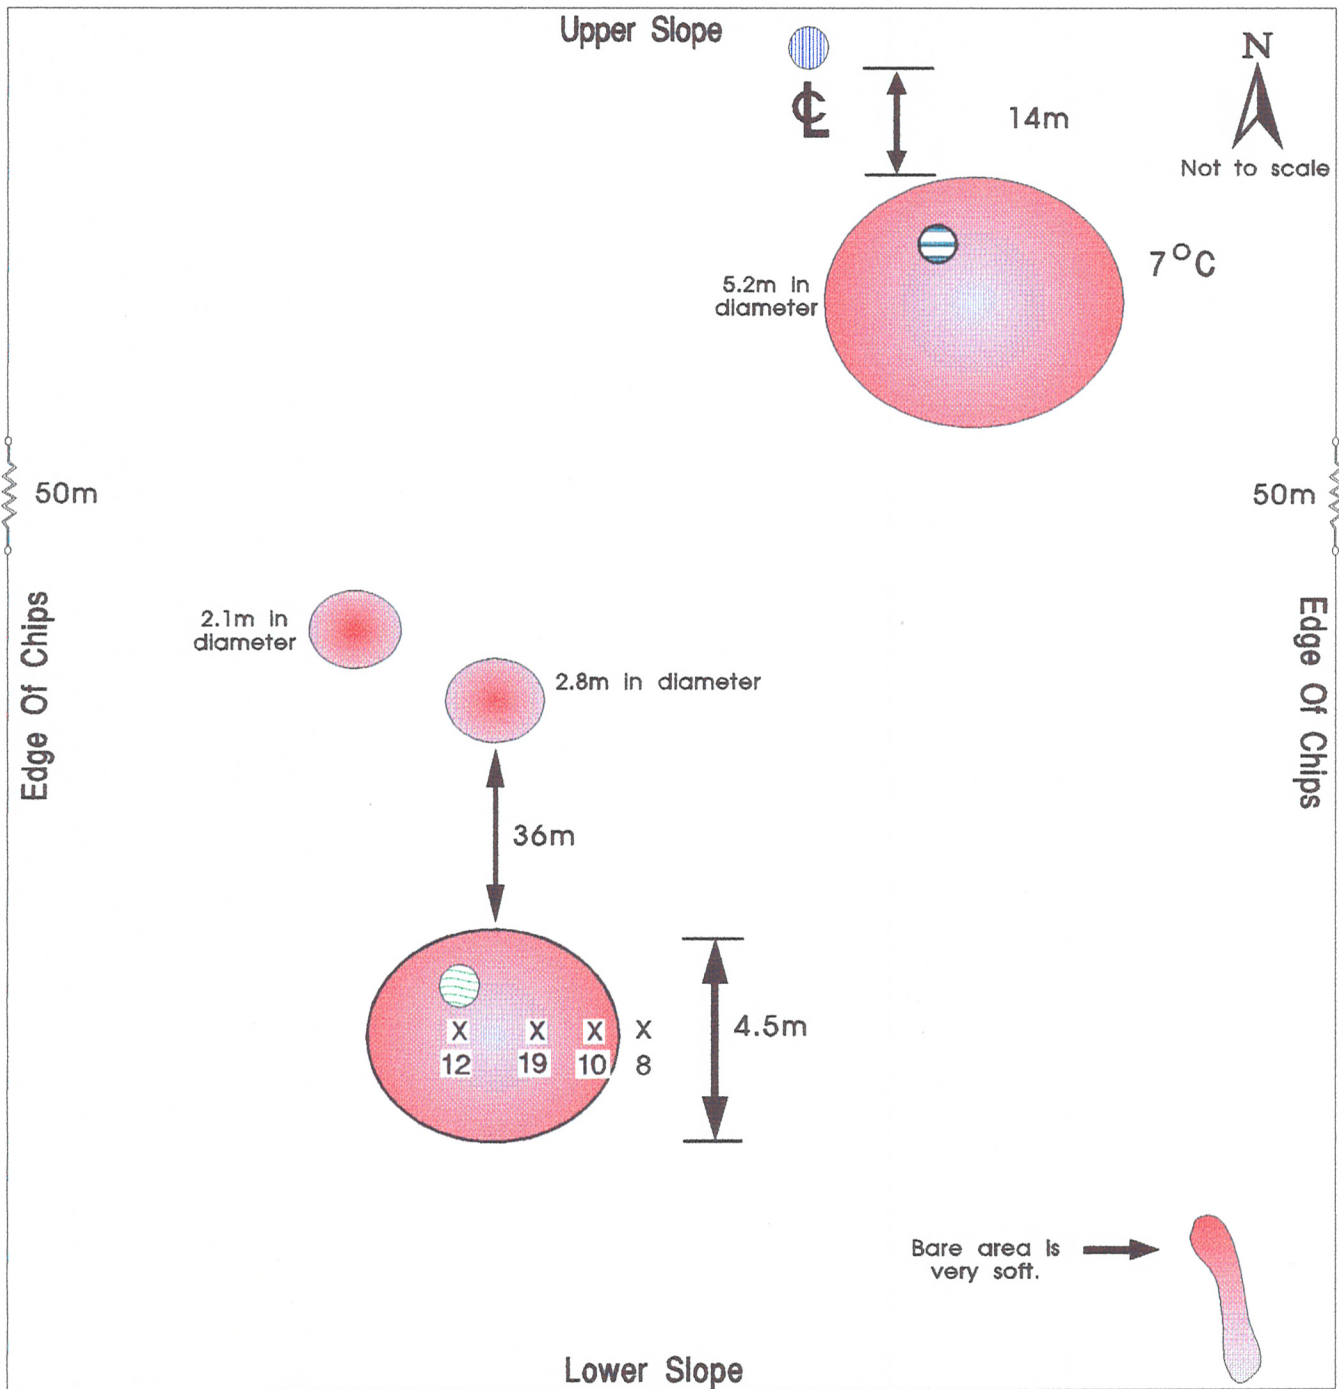
Slope 112, Kmp 352.3 Location of hot spots, October 1992

Temperature = Max. temp. in hot spot recorded in °C at approx. 20cm depth.

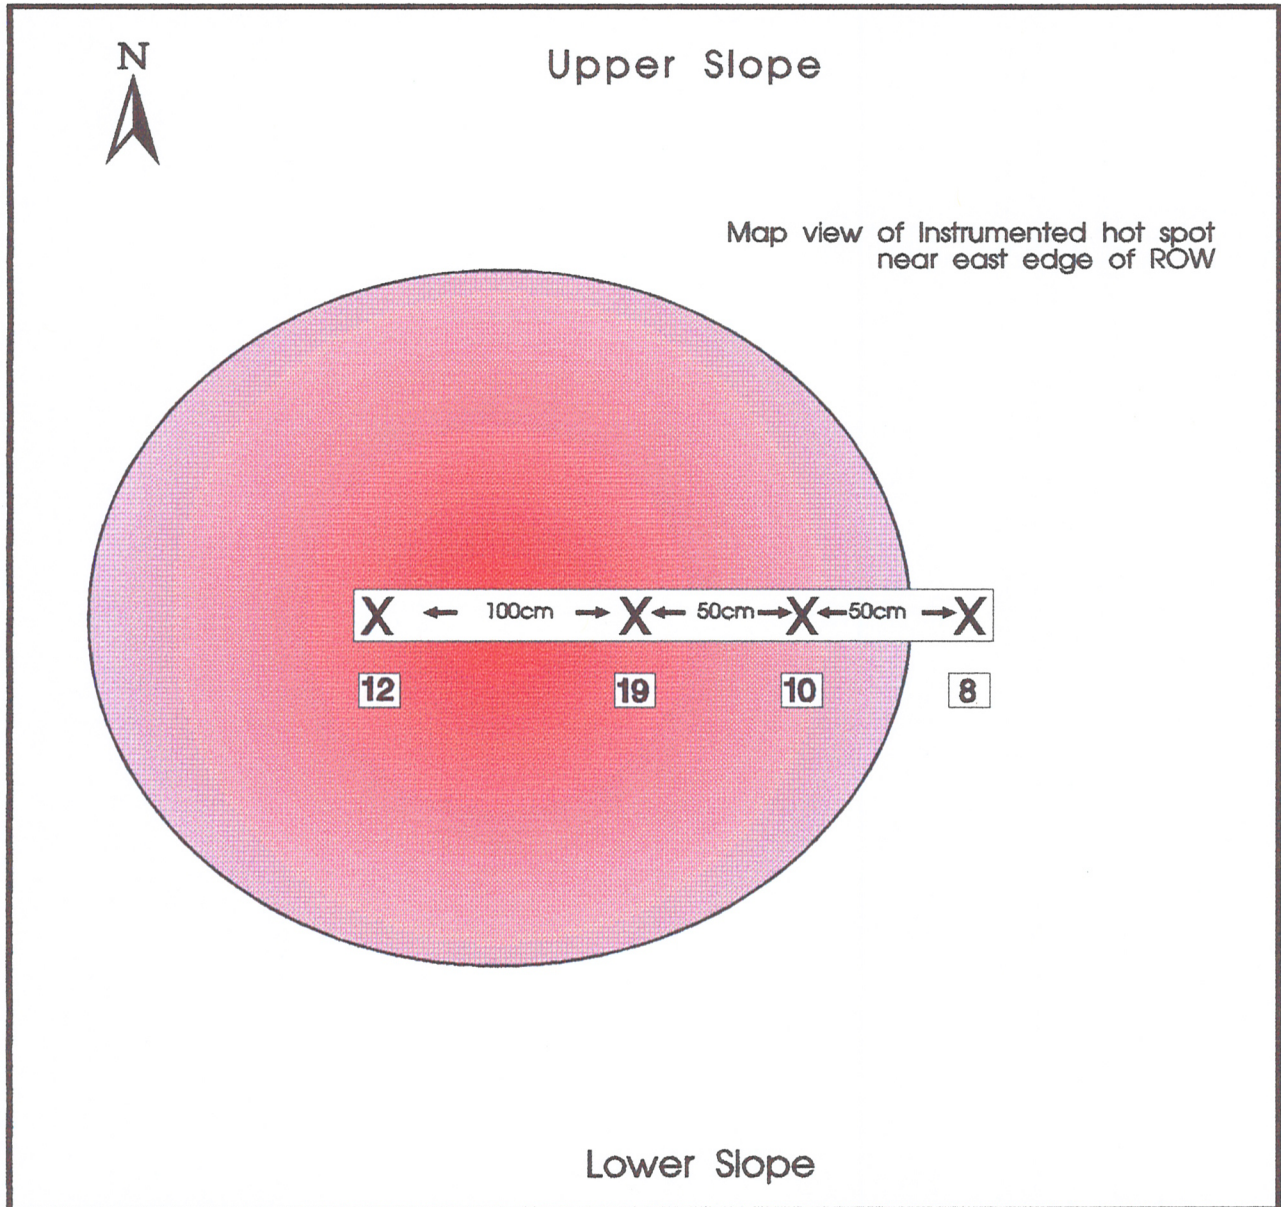
Slope 112, Kmp 352.3
Map View of Hot Spot Transect
October 6, 1993

#S = Temperatures at 30cm into wood chips, measured in degrees celsius. Recorded at 10:05, October 6, 1993.

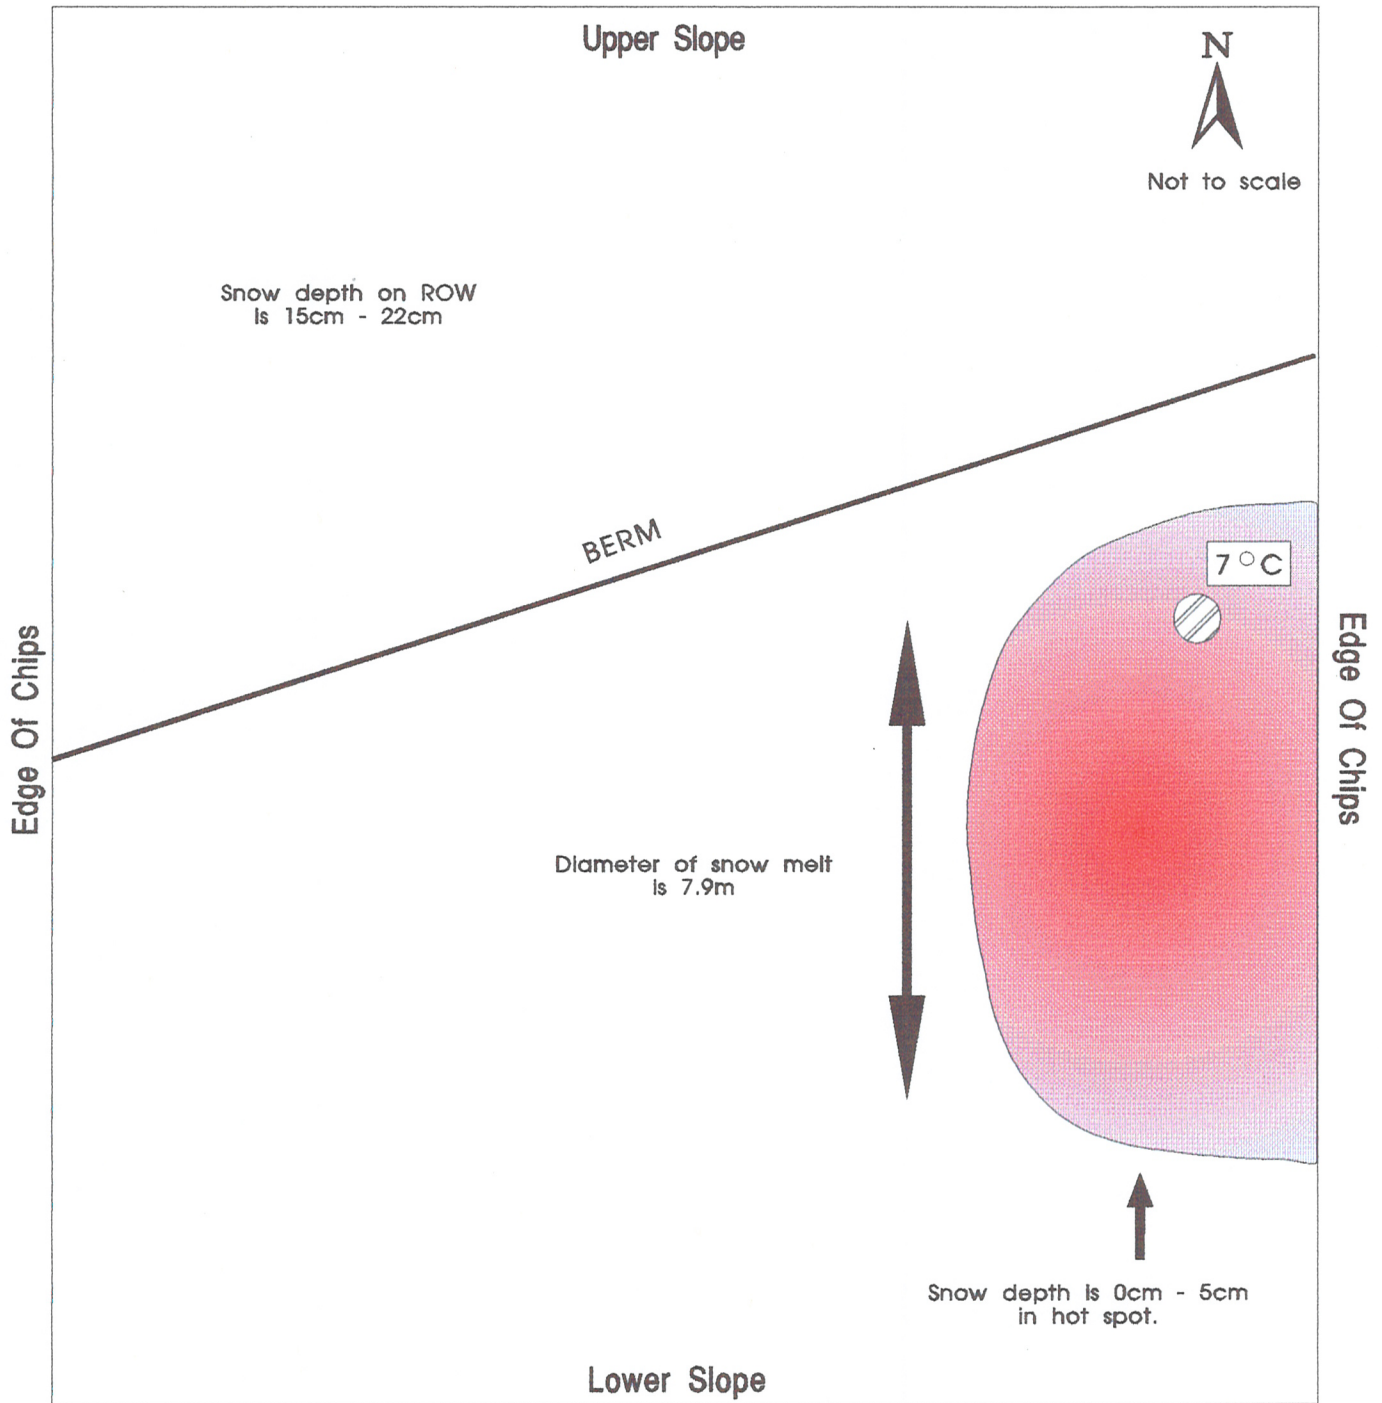
Slope 123, Kmp 403.7 Location of hot spots, October 1992

Temperature = Temp. in hot spot recorded in ° C at approx. 20cm depth.
