GEOLOGICAL SURVEY OF CANADA MISCELLANEOUS REPORT 62

GEOMORPHIC EFFECTS AND IMPACTS OF SEVERE FLOODING: PHOTOGRAPHIC EXAMPLES FROM THE SAGUENAY AREA, QUEBEC

> **G.R. Brooks** and **D.E.** Lawrence

1998

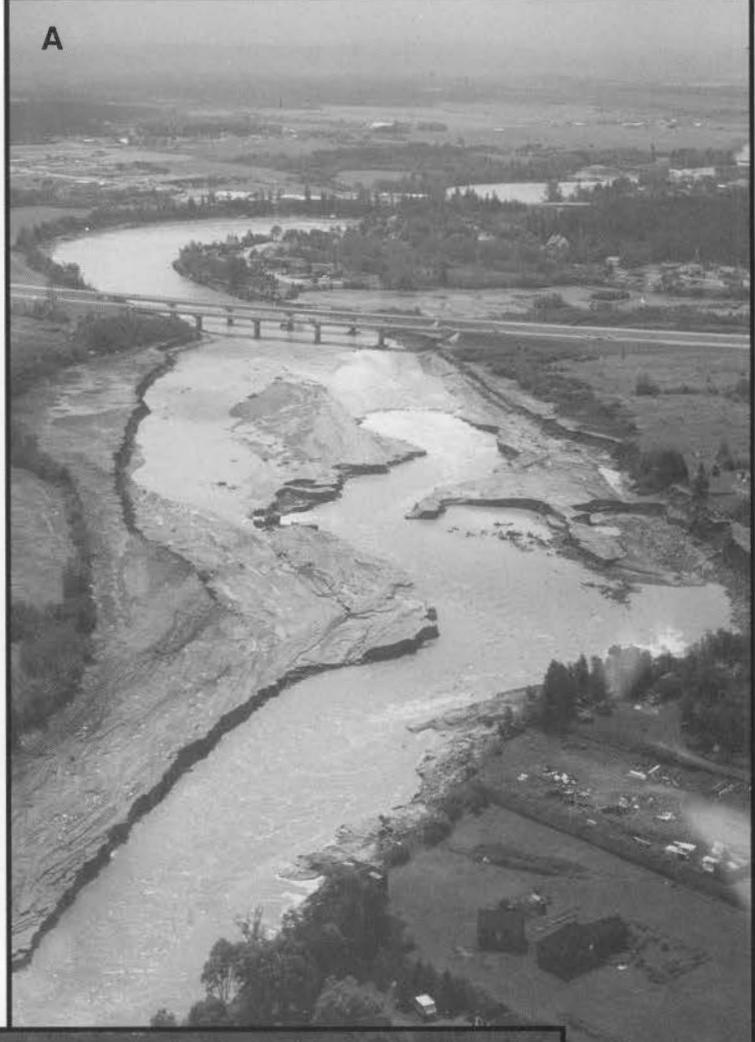
Figure 18. The erosion of a new channel adjacent to and lower than a dam creates a drop in the local base level, which can initiate channel incision upstream into the reservoir bed. A spectacular example of this occurred along the Chicoutimi River within the area of the drained Port-Arnaud dam reservoir. (A) A shallow steepsided channel 1.2 km long has been cut into marine deposits (silt and clay) of the reservoir floor (GSC 1997-42Q). (B) This incision is the product of 'knickpoint' retreat that occurred during the flood, whereby a 'step' forming a low waterfall 2 to 4 m high developed on the river bed (GSC 1998-015E). Turbulence and cavitation to the lee of the step scour and undermine the nearly vertical face of the marine deposits below the crest of the waterfall. This erosion causes the knickpoint to migrate upstream, extending the erosional 'gorge', while maintaining the stepped profile of the knickpoint. A waterfall still existed at the upstream end of the gorge when these photographs were taken on July 26, 1996. Most of the knickpoint retreat occurred between the time the reservoir was breached during the morning of July 21 and the morning of July 24 (INRS-Eau, 1997).
