# Seabed Characterization and Soil Response at the Terra Nova O-90 Glory Hole: Observed Changes, 1990-1995

GSC OPEN FILE # 3681

April, 1996

**G.V. Sonnichsen<sup>(1)</sup> and John Zevenhuizen<sup>(2)</sup>**

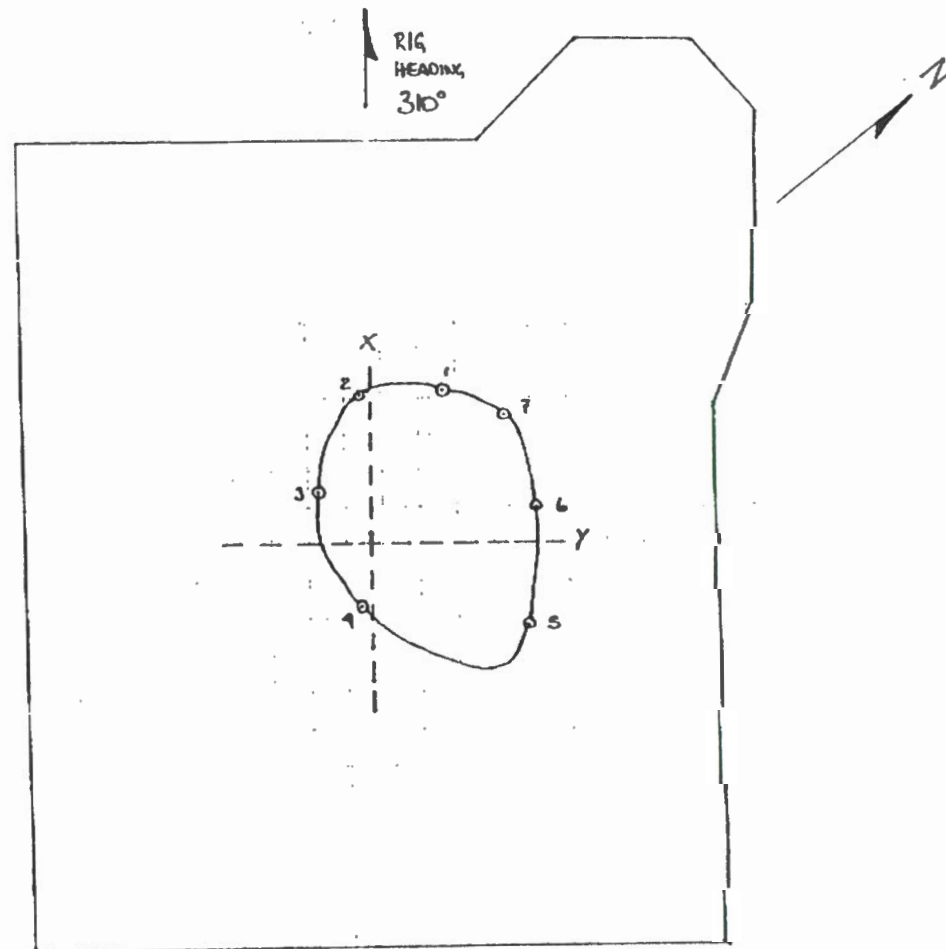
Figure 13

- Figure 12:** Suspension System for easing assembly of nose ring sections in limited space.
- Figure 13:** Glory hole survey by ROV, video inspection/Honeywell tracking (from letter from Peter Hampton to Russell Parrot, 90-10-15). Note the resulting hole is off

ROV DEPTH IN CENTER  
6.0m - 7.5m.

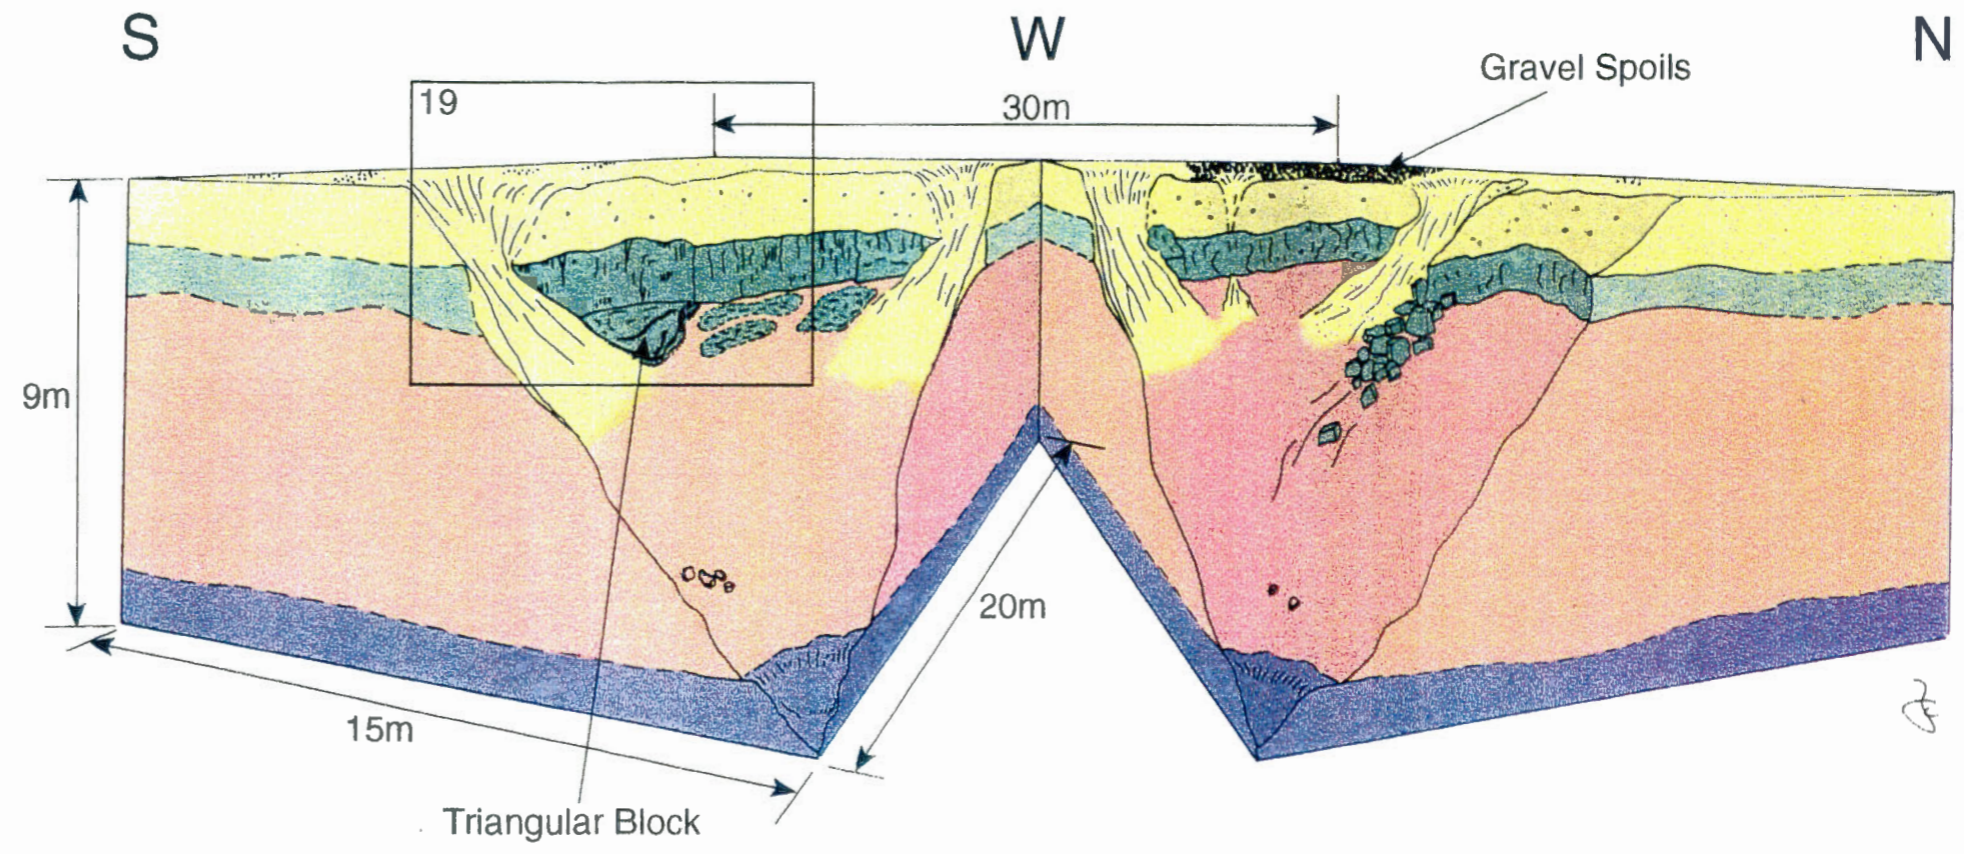
**Figure 18:** Generalized representation of the initial O-90 Glory Hole excavation into the upper geological units. Features were drawn from vertical SIT camera data collected by Petro-Canada after the completion of the glory hole with description derived from comments by Poorooshab (1990).

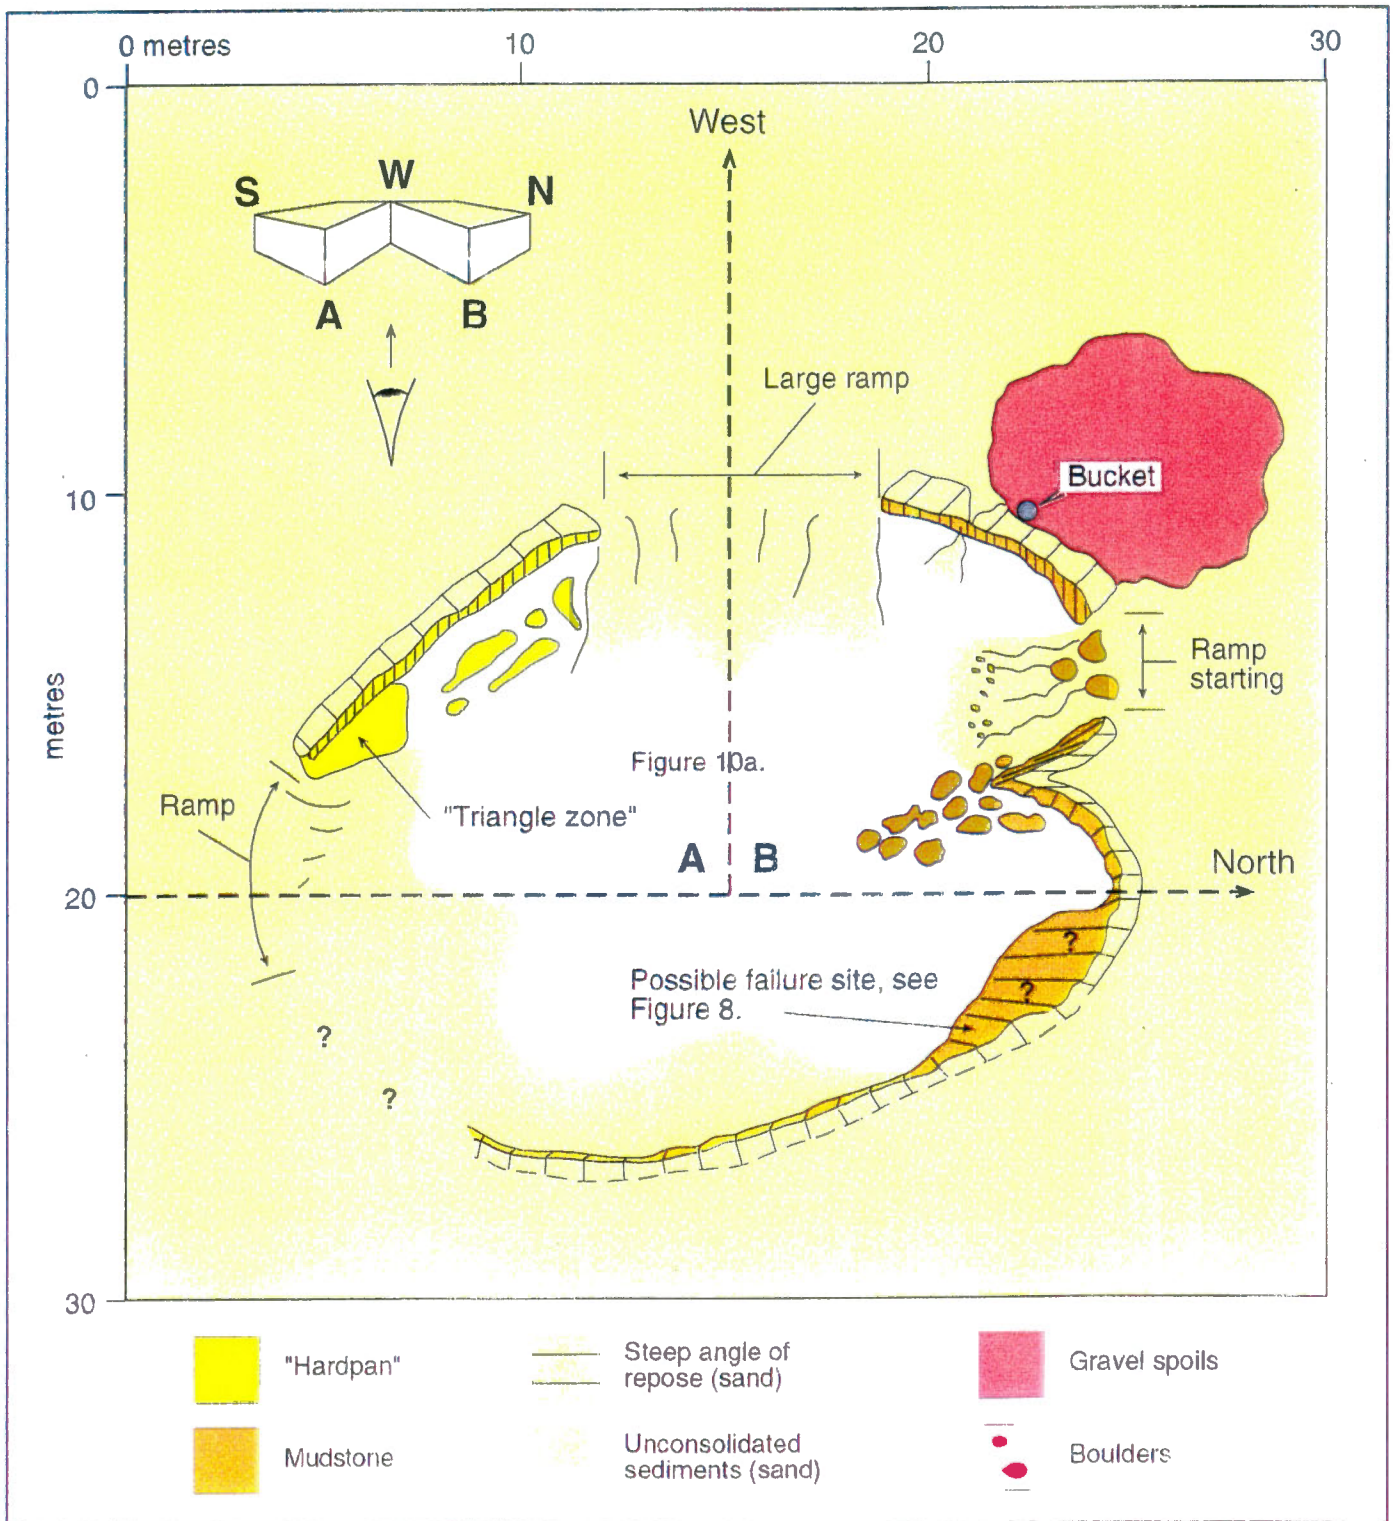
Figure 21

**Figure 21:** Plan view of the excavation three months after completion. Note the location of the ROV for point from which Figure 20 image was obtained.

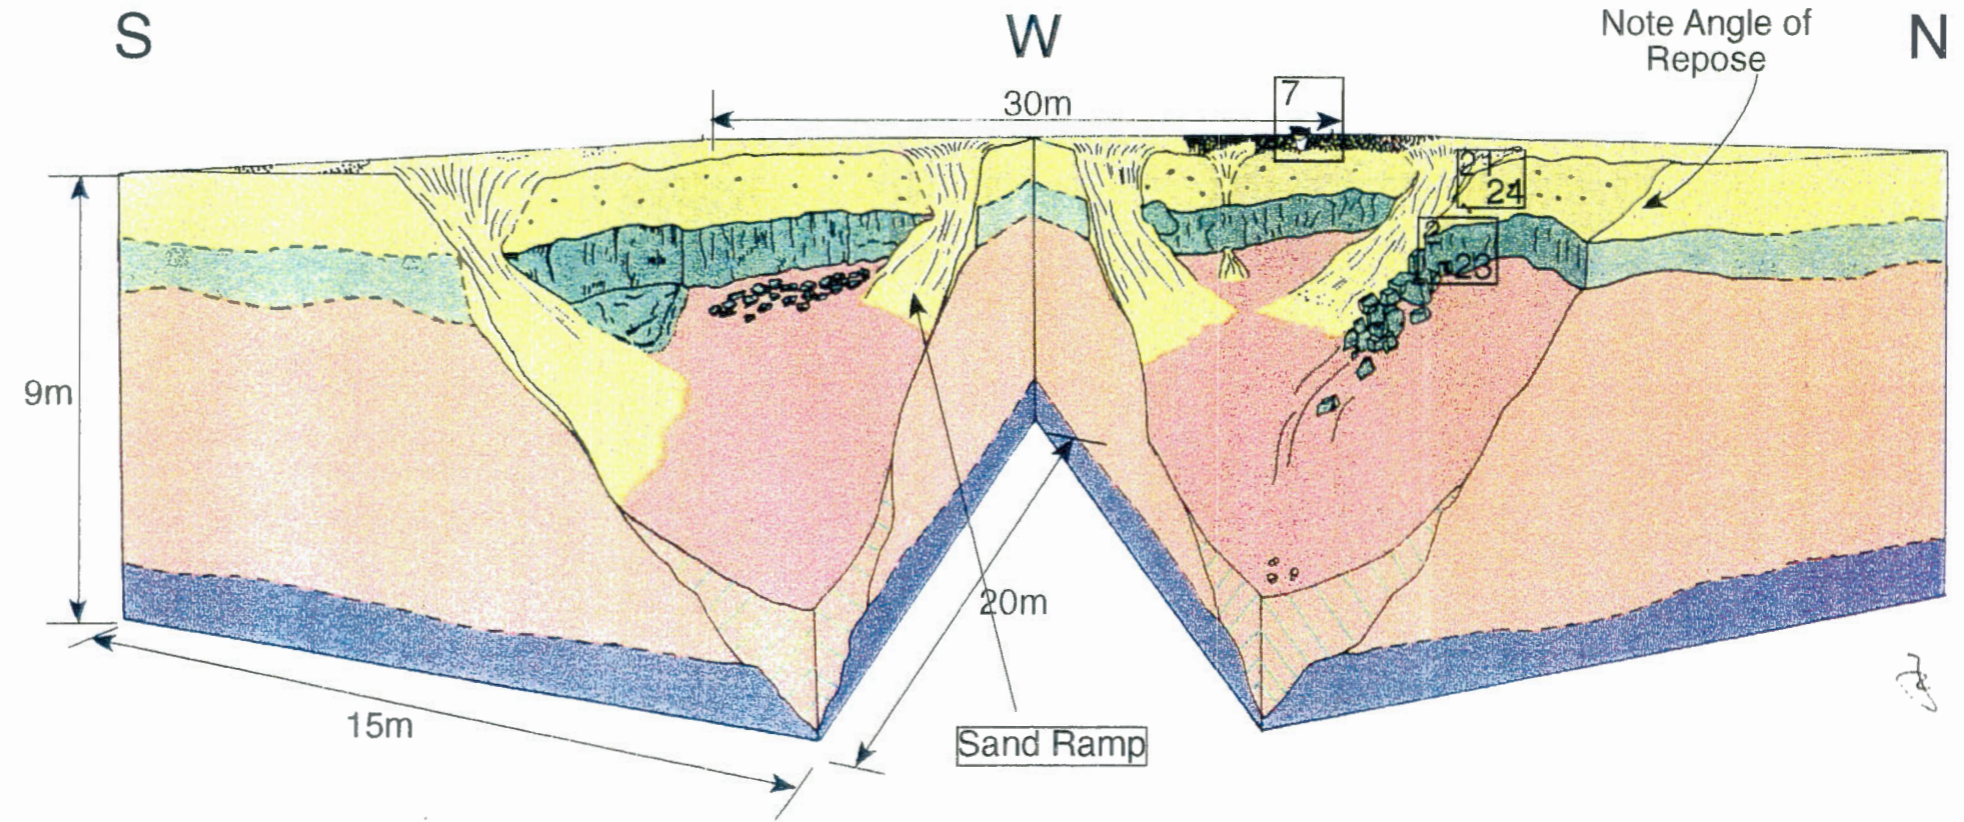
**Figure 22:** Generalized representation of the excavation three months after completion. SIT black and white, VHS colour and colour scanning sonar data collected from the Hysub 5000 ROV provided increased resolution when compared to Figure 18.

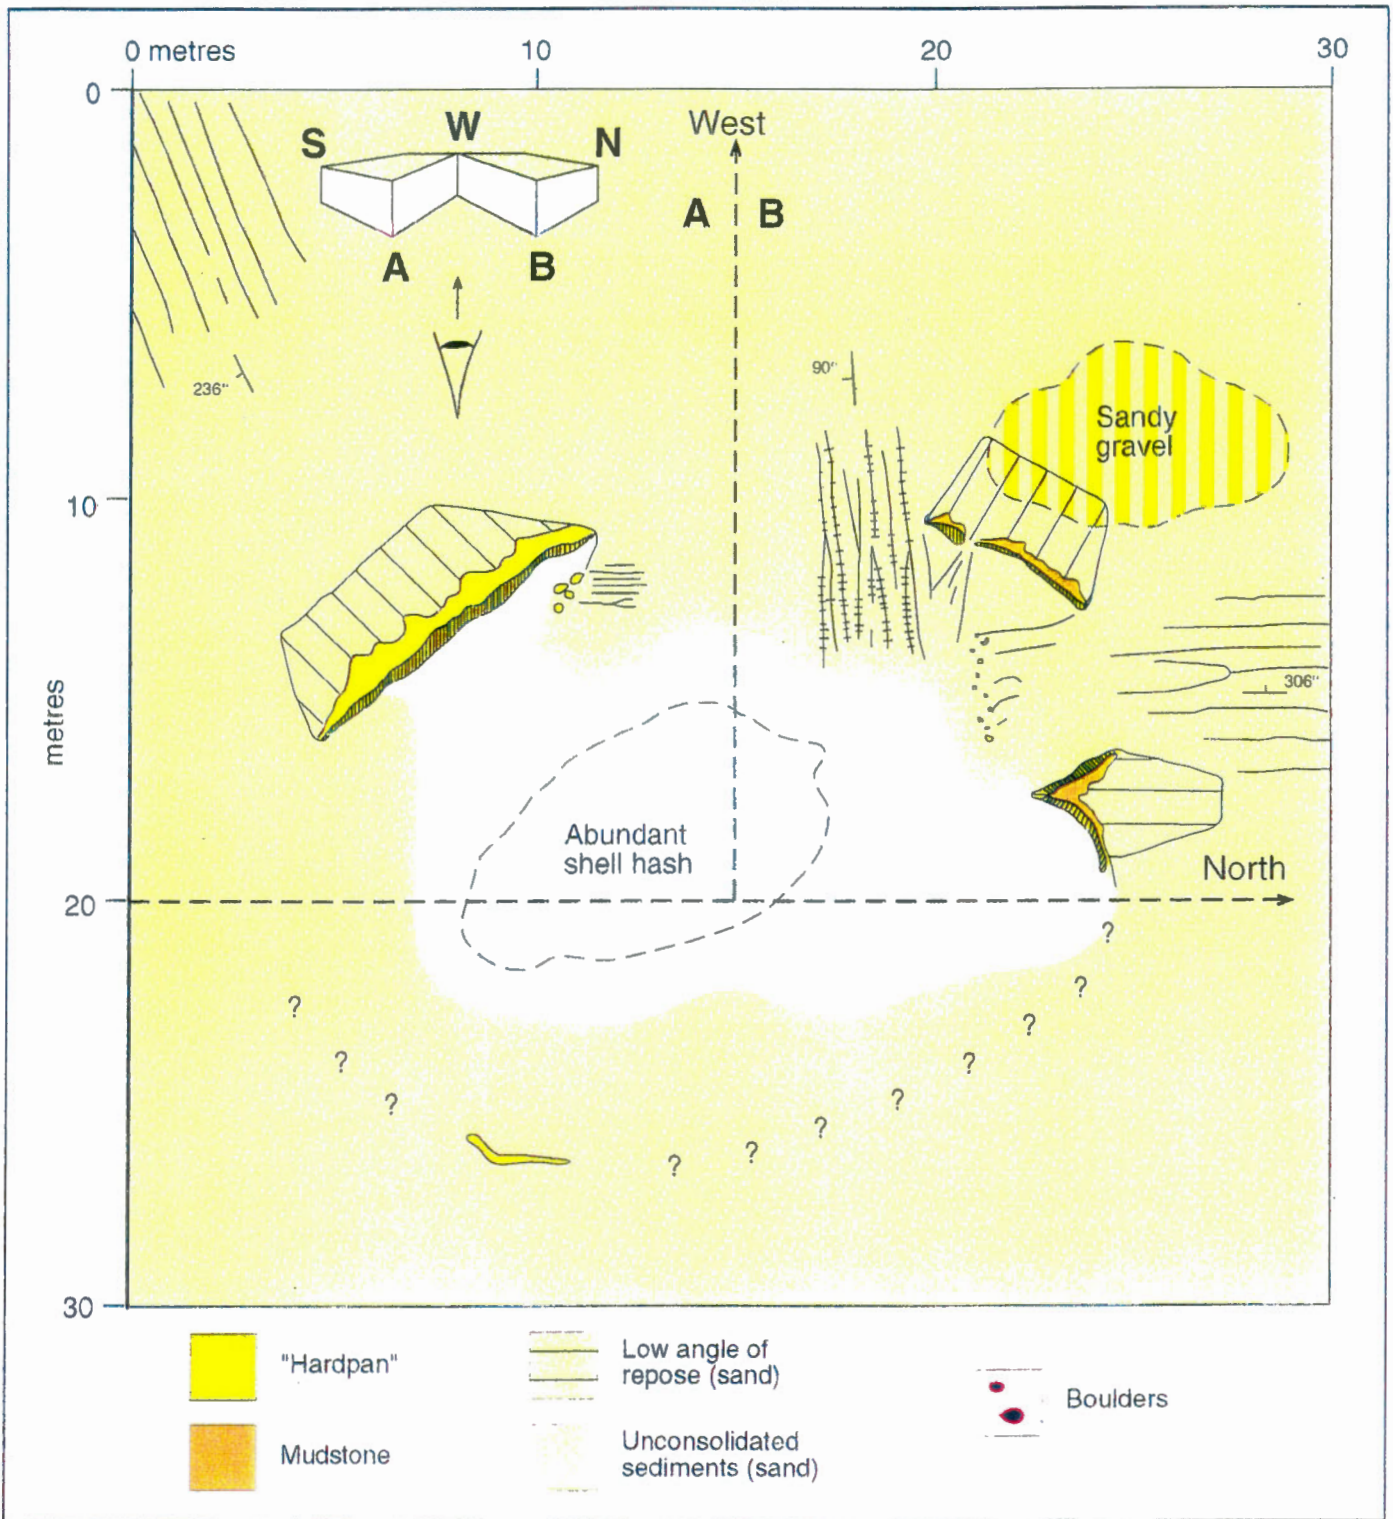
Figure 26

- By 1995 the edge of Unit 1 has retreated away from the hole, exposing a 1-2 m wide rim of the upper surface of Unit 2 (Figures 28 and 29). The 1995 data also show a more gradual angle of repose for Unit 1.

**Figure 26:** Plan view of the Glory Hole five years after excavation (March, 1995).

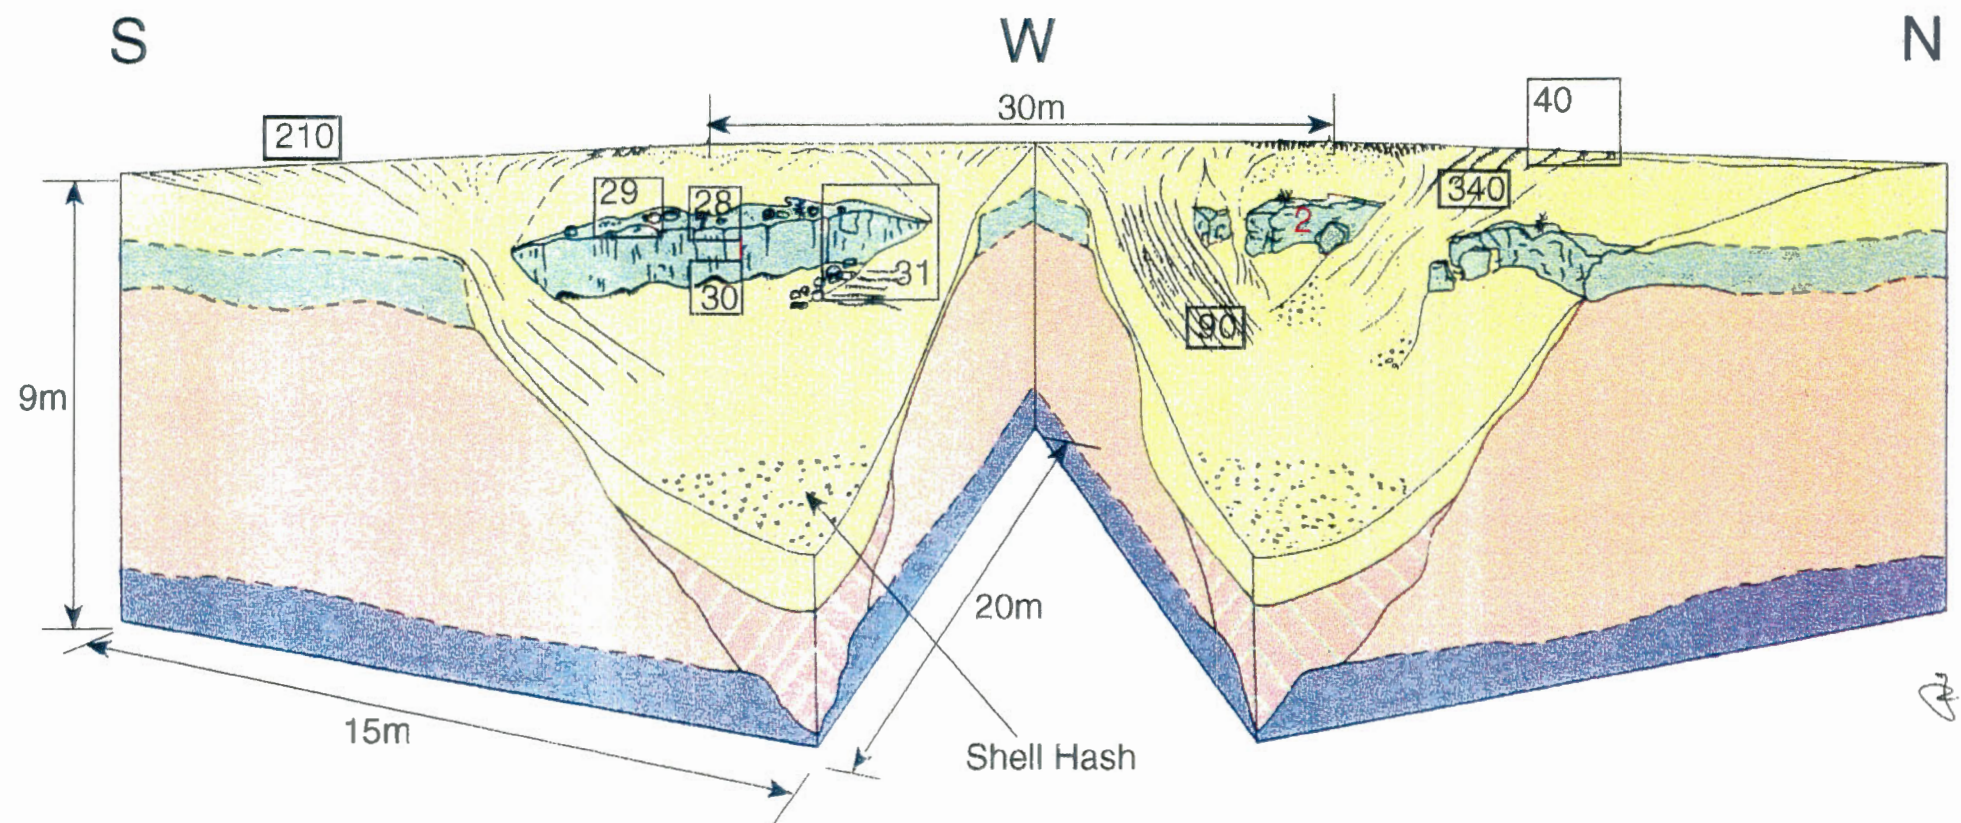
**Figure 27:** Generalized representation of the glory hole almost five years after completion. Hi-8 and VHS colour imagery, visual observations from the manned submersible, SDL-1 provided exceptional resolution and unique insight into the physical character of the exposed sediments.

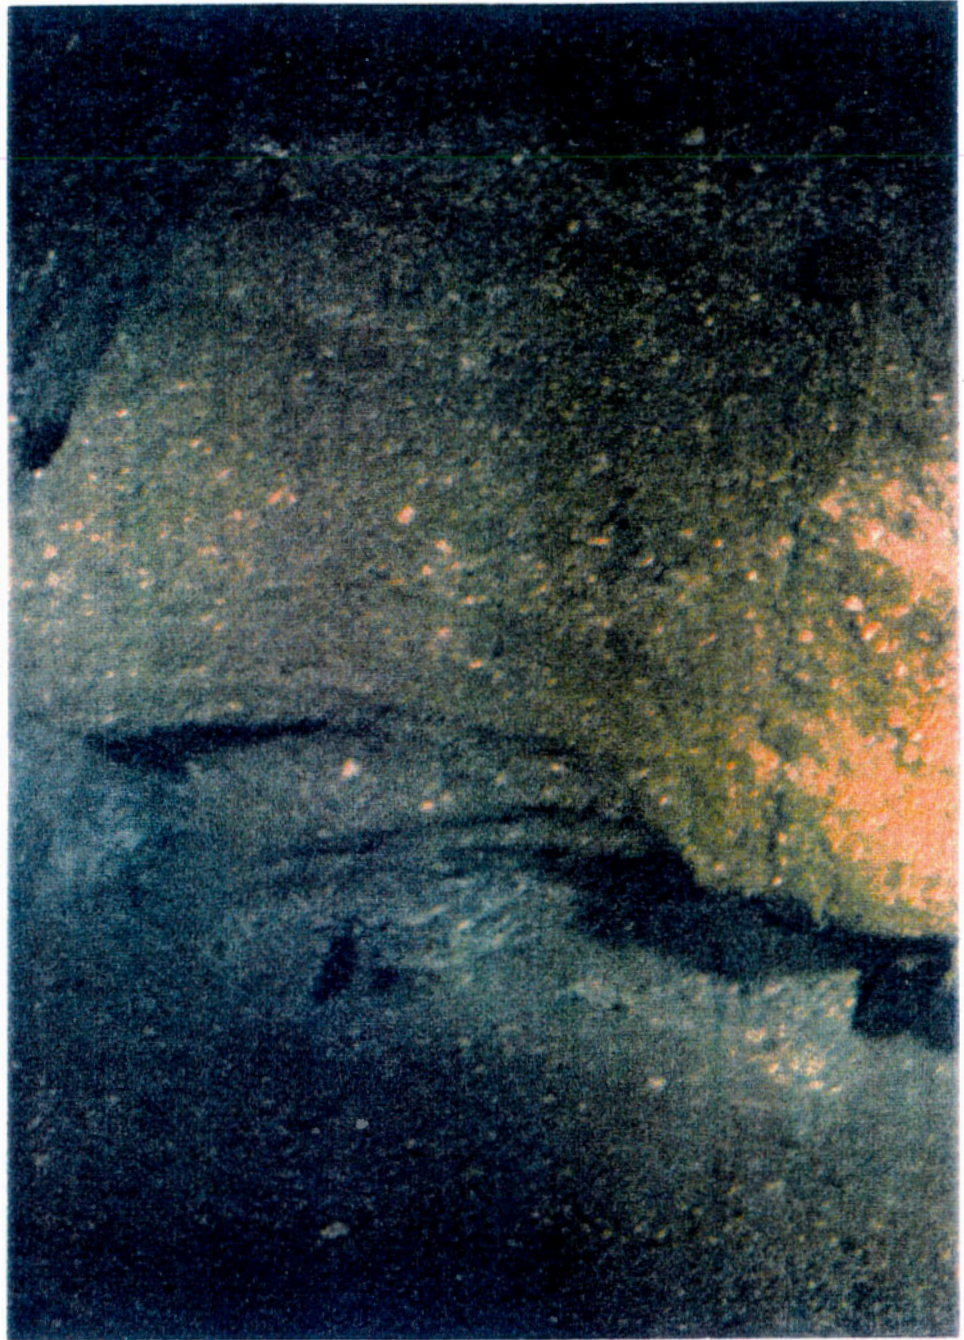
Figure 33

**Figure 33:** Same as figure 30

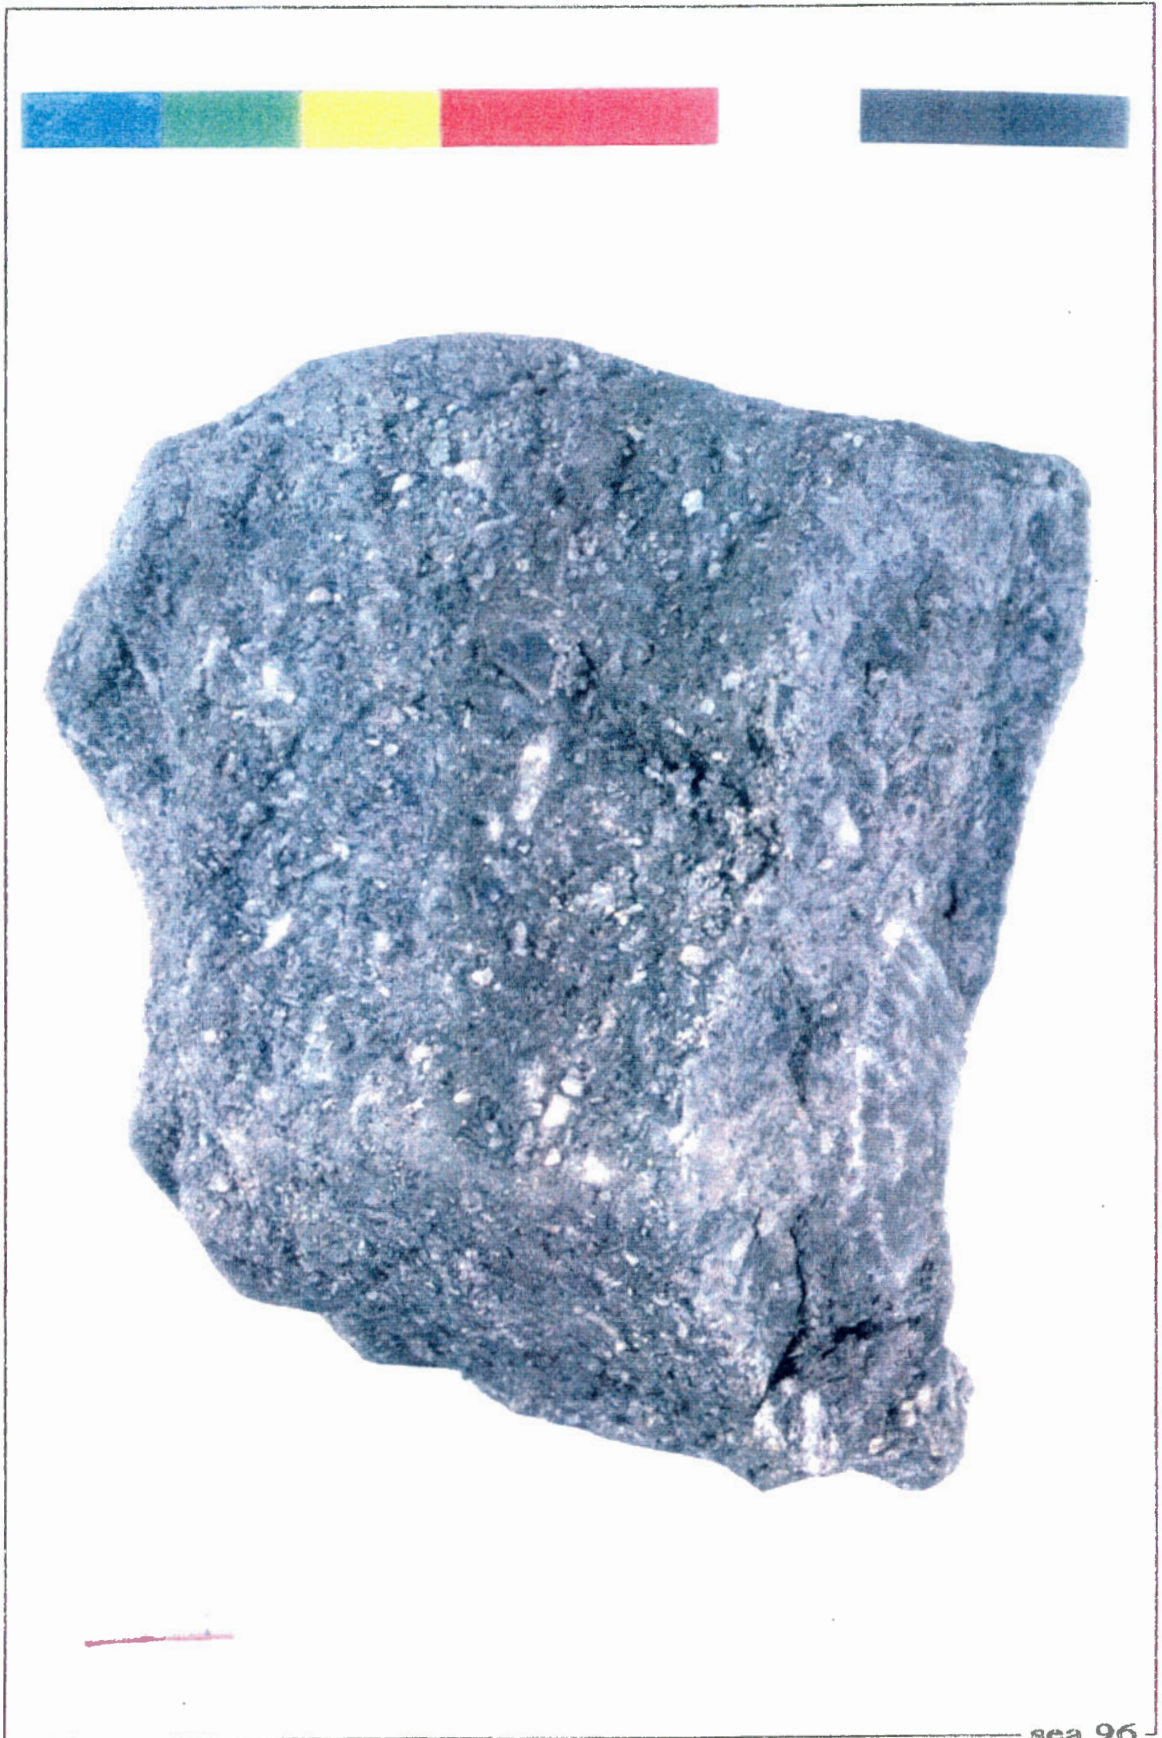
Figure 34

**Figure 34:** "Shelly hardpan" of Unit 2 sample. The block was recovered from the base of Unit 2 (see Figure 31). Scale bar units is in centimetres.

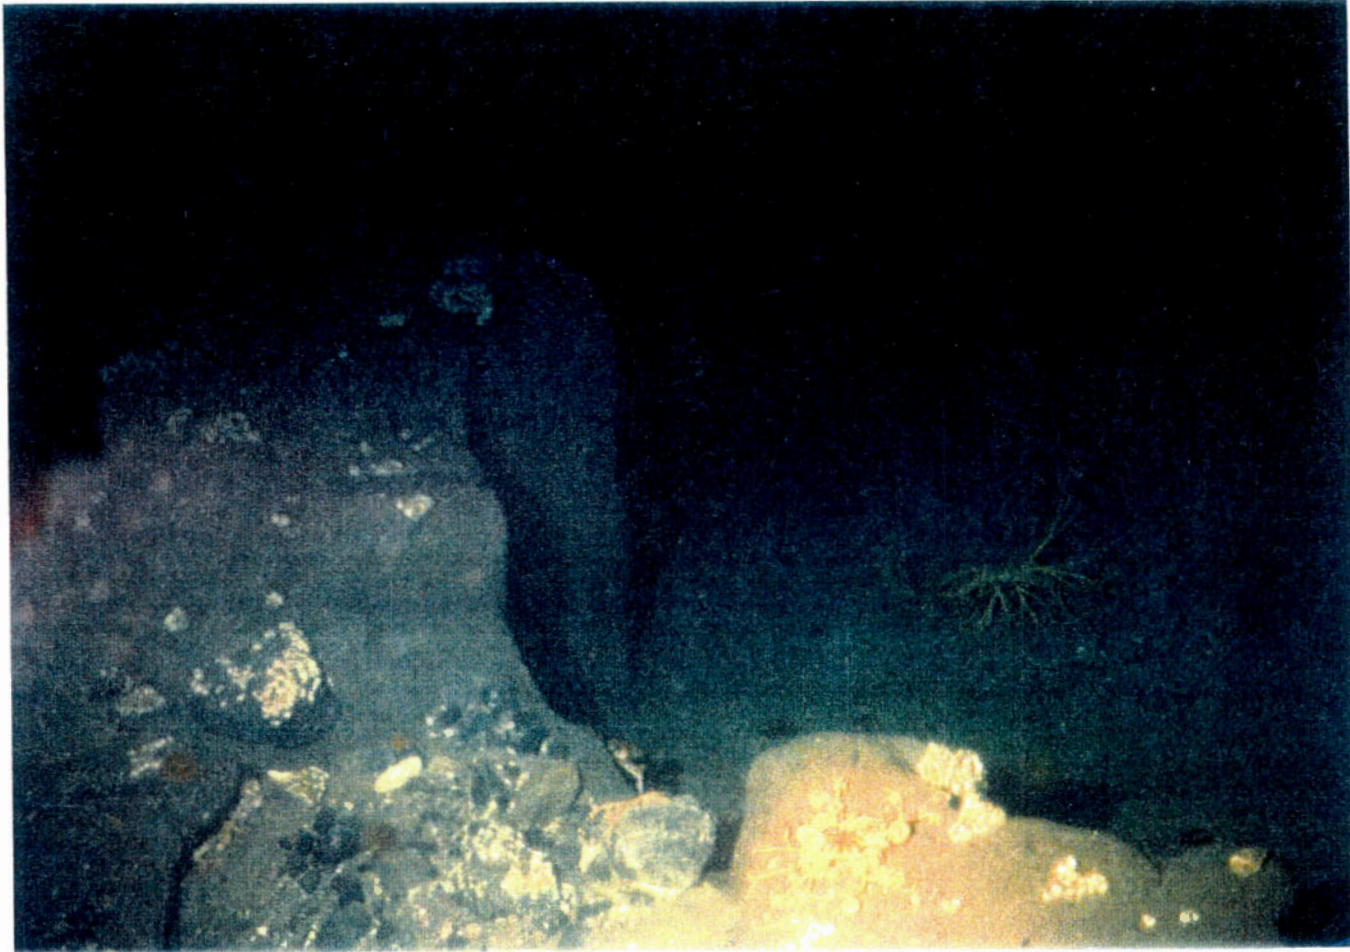
Figure 35

**Figure 35:** View of the sample site on the northwestern edge in Unit 2 at approximately the same stratigraphic level as Figure 30. Note the darker colour, absence of shelly material and the more rounded, massive (degraded) character of the material in comparison to Figure 15. Cliff top was penetrated by sub's hydraulic samplers but mud was too cohesive to remain in sampler. Image collected using the hand-held HI-8 video camera inside the SDL and derived as a frame grab from the original video tape (March, 1995).

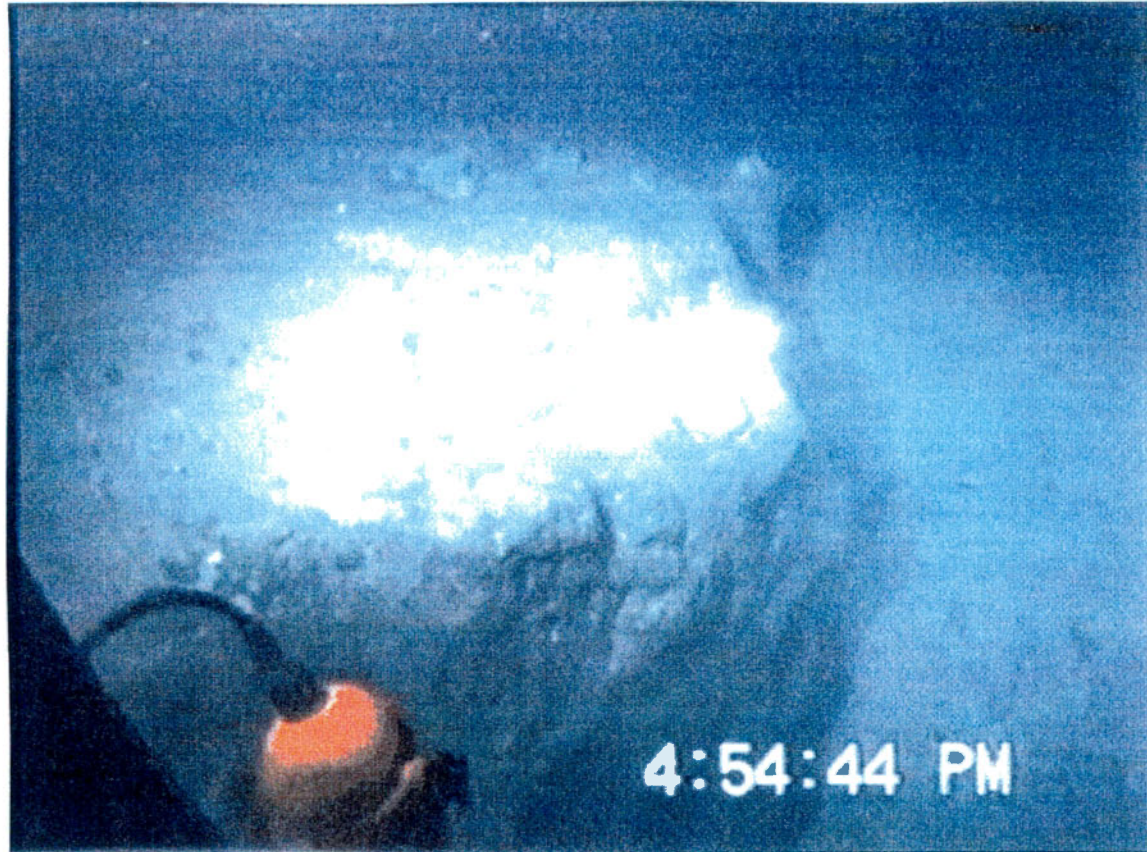
Figure 36

**Figure 36:** Similar view as Figure 35 obtained at the same location but with a 35mm handheld camera from a different angle.

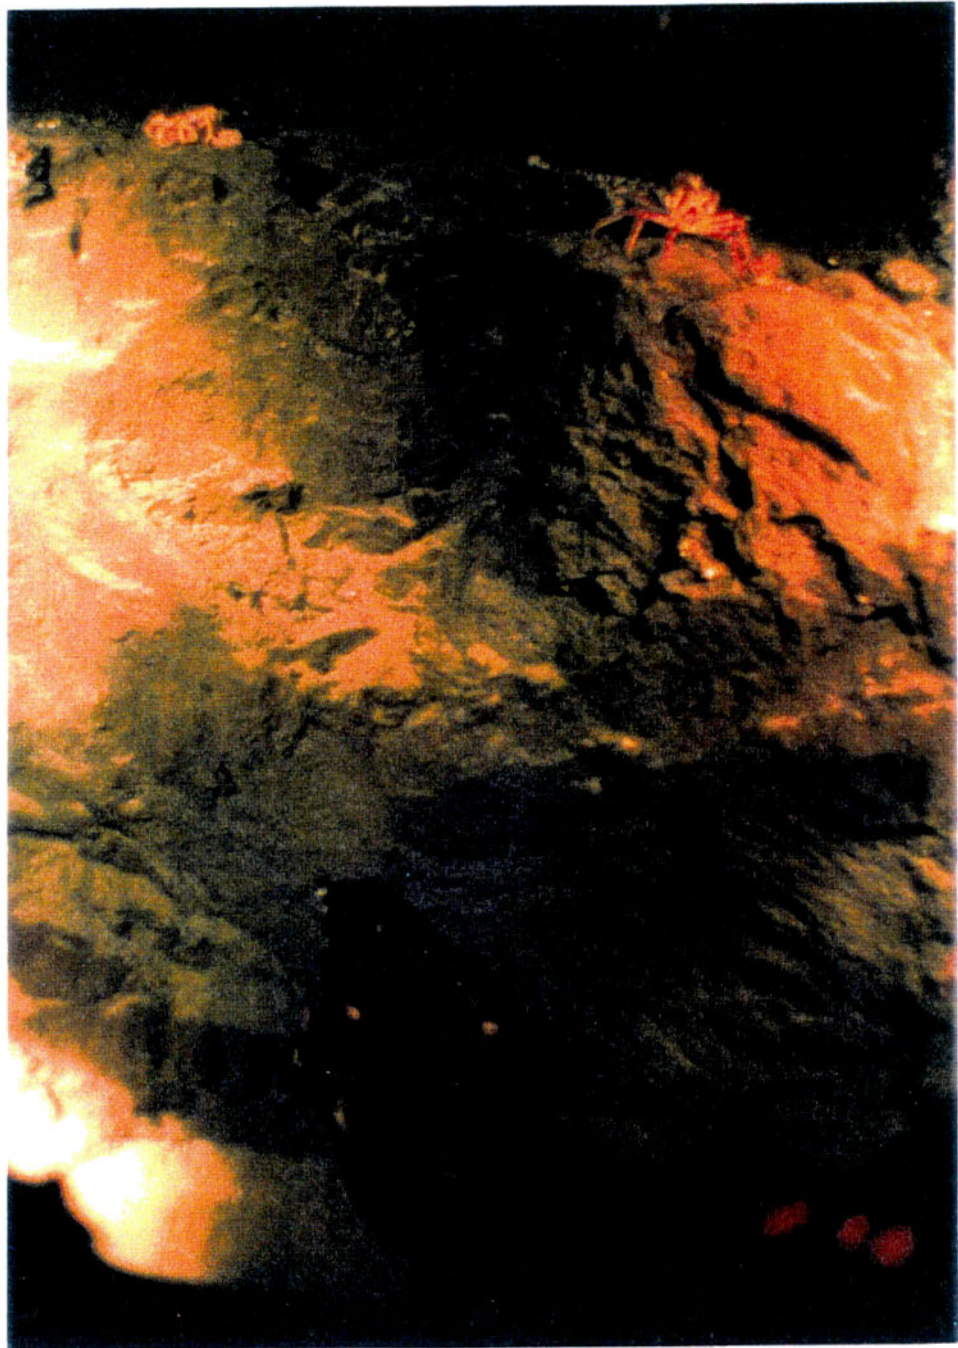
Figure 38

**Figure 38:** Similar view as Figure 37 obtained at the same location but with a 35mm handheld camera from a different angle.
