The East Gate Landslide, Beaver Valley, Glacier National Park, Columbia Mountains, British Columbia

OPEN FILE # 3877

Réjean Couture Eng. Ph.D.

May 2000

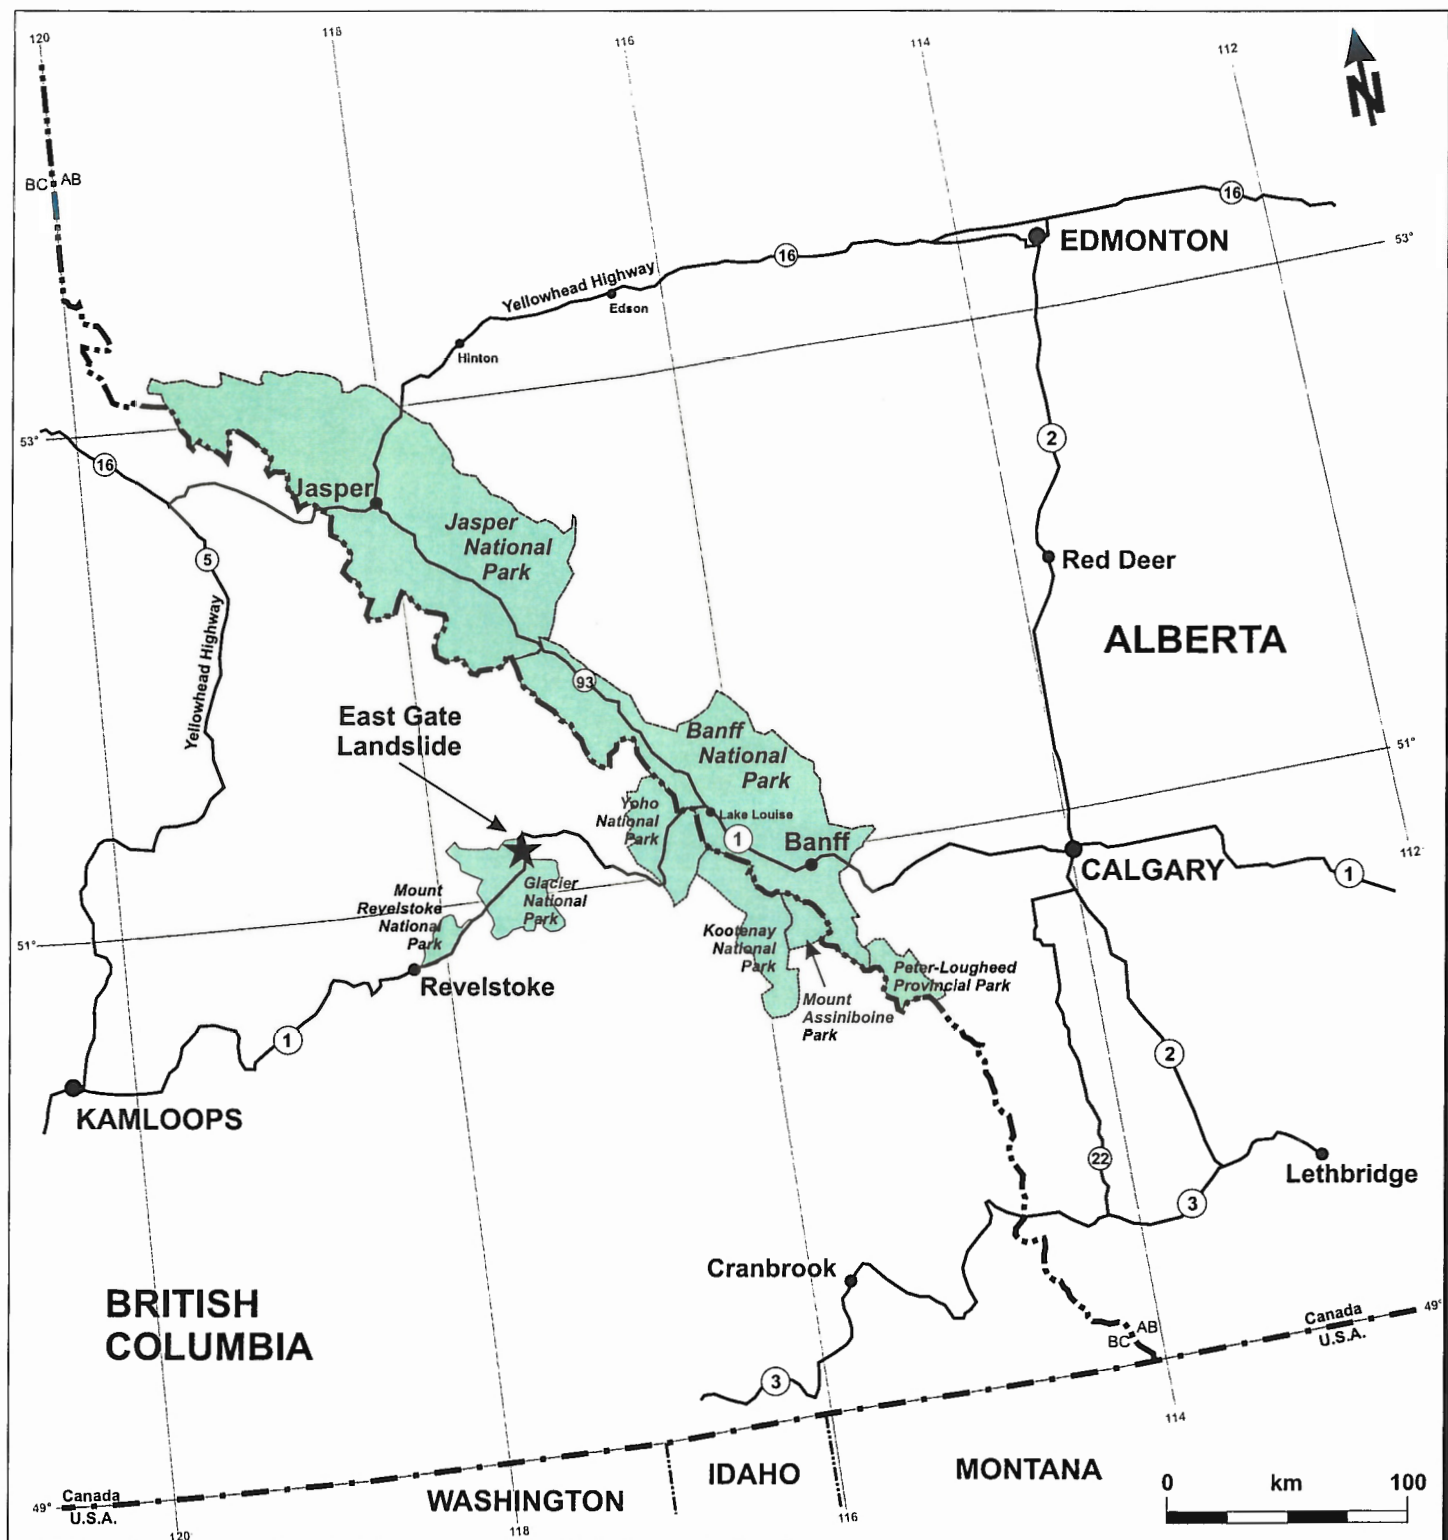
- 1.1 In late May 1999, mudslide debris covered the Trans-Canada Highway 1.5 km north of the East Gate of Glacier National Park in the Beaver Valley, Columbia Mountains, British Columbia (Fig. 1). The debris originated from disintegrating rockslide debris high above the highway in an area of active rock slope failure. On July 15, 1999, Glacier National Park contacted the Geological Survey of Canada (GSC) requesting assistance in the analysis of the landslide and in the development of a monitoring/mitigation program for the geotechnical instability.

Figure 1. Location of the East Gate landslide, Beaver River valley, Glacier National Park, British Columbia.

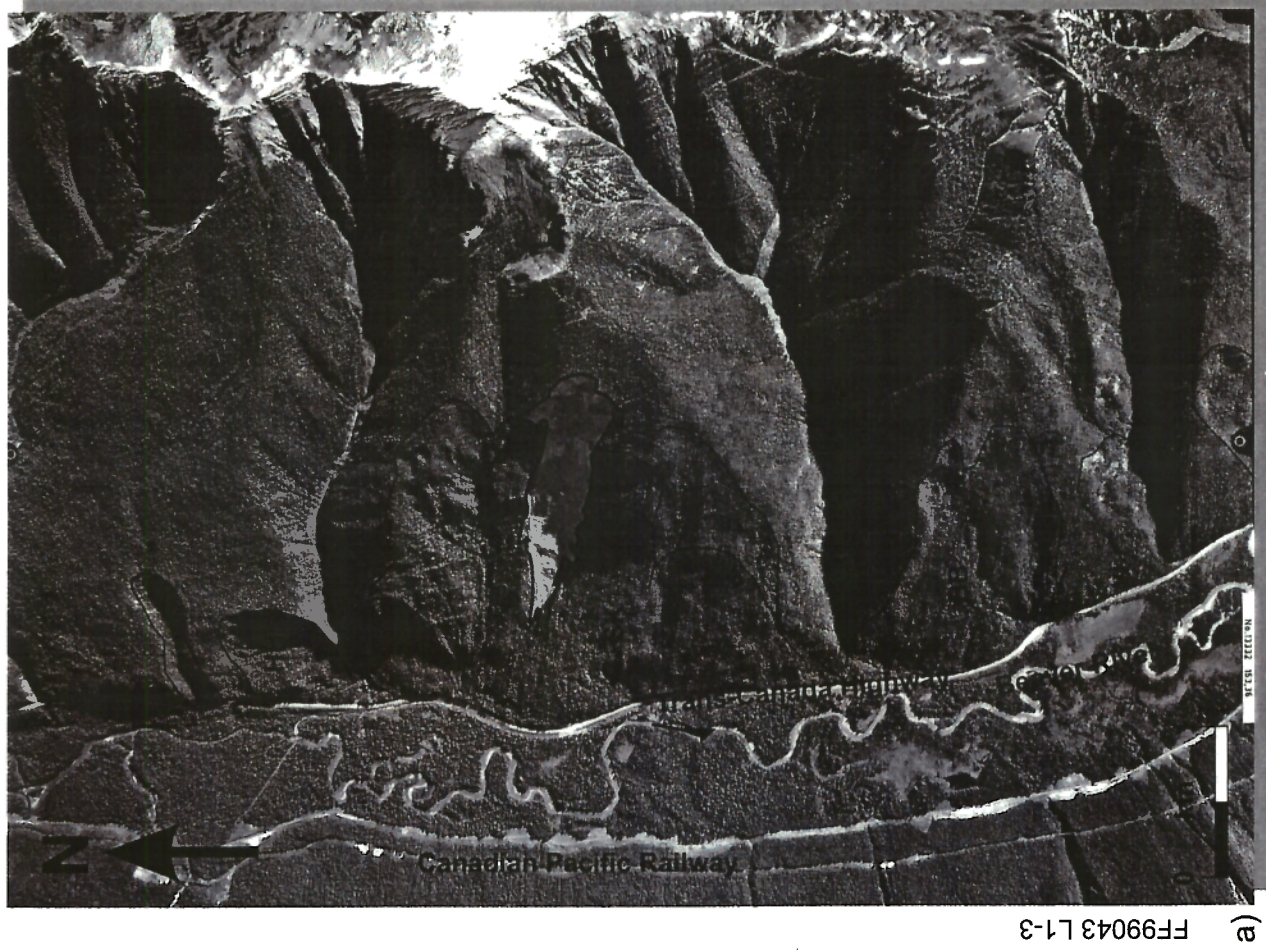
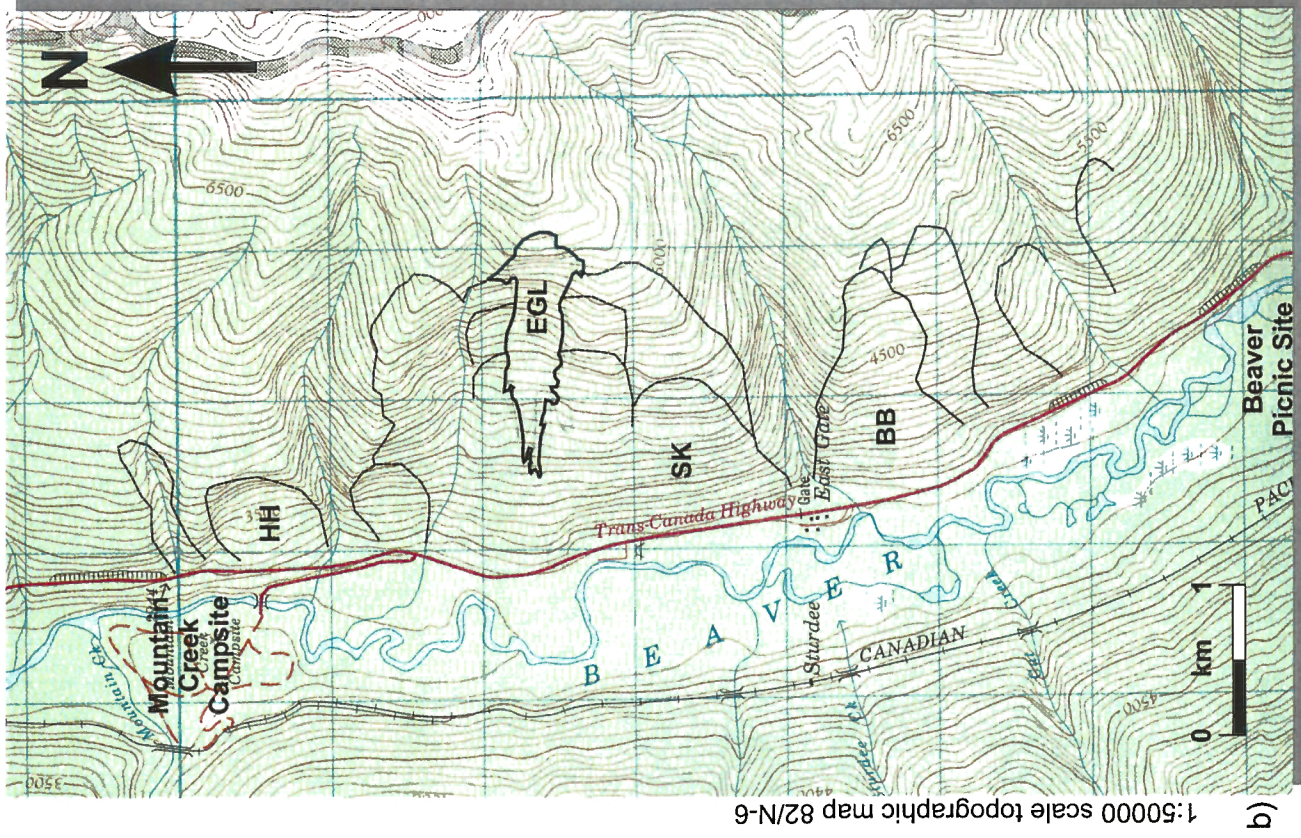
1:50000 scale topographic map 82/N-6

about 1950 m above the valley bottom. However, over a period of 29 years, as seen on 1978 airphotos, the slope did not show any obvious further degradation (Fig. 3). Marked degradation did not take place until noted in January 1997. Photos taken on January 30, 1997 (shown in EBA, 1999) show that the headscarp had retreated to a identified structural lineament (indicated by arrow on earlier photos, Fig. 3) parallel to the slope and two large debris flows had moved downslope to about 1450 m elevation (Fig. 4a).

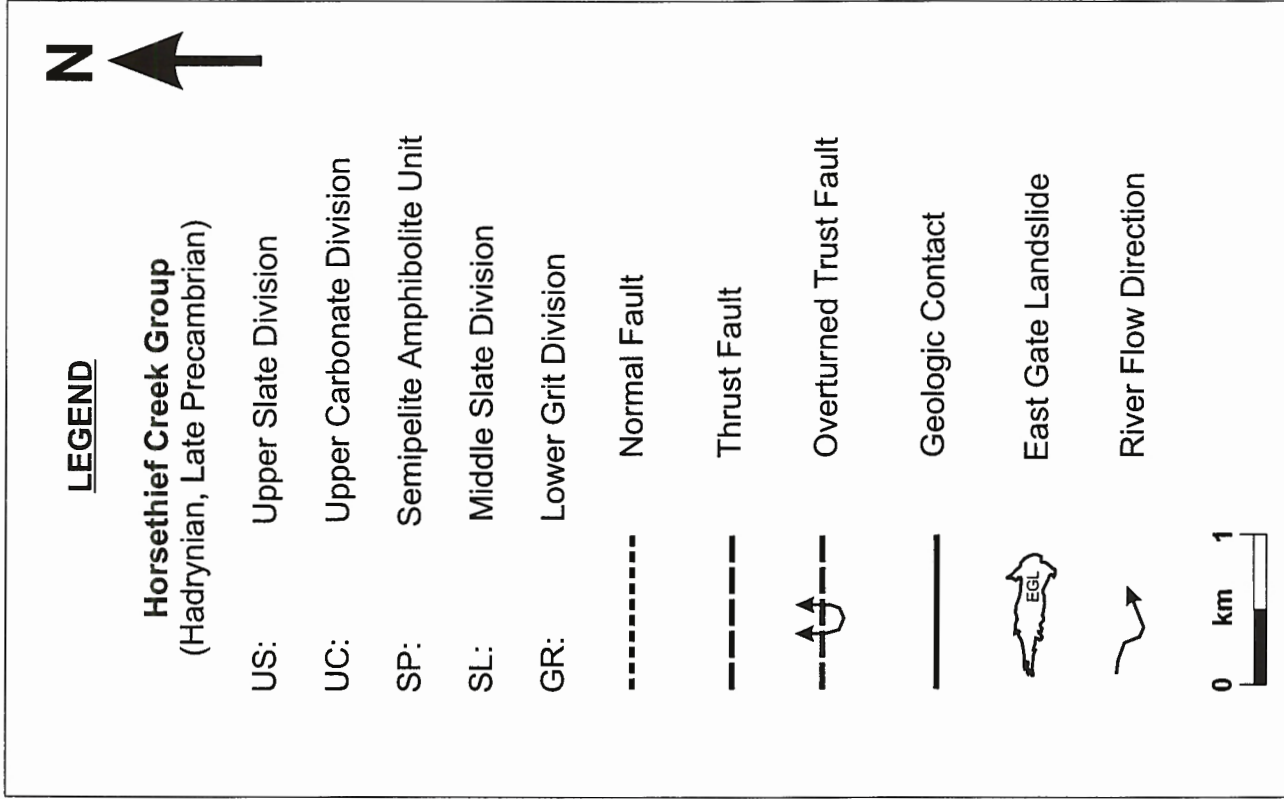
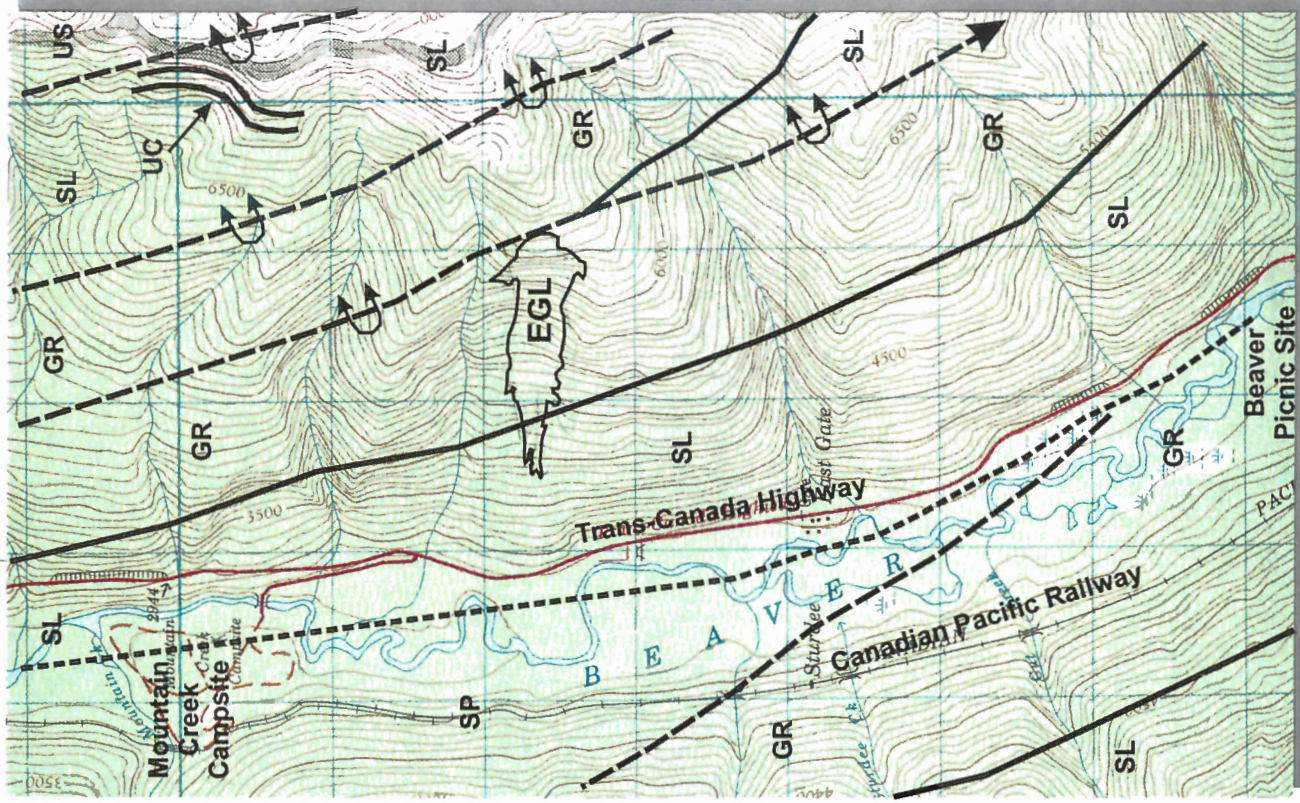
1:50000 scale topographic map 82/N-6

- 3.1.1 The east side of the Beaver Valley is formed in rocks of Hadrynian (Late Precambrian) Horsethief Creek Group (Fig. 5; Wheeler, 1963). The Horsethief Creek Group consists of a Lower Grit Division (GR) successively overlain by a Middle Slate Division (SL), an Upper Carbonate Division, and an Upper Slate Division (Poulton & Simony, 1980). Only the first two divisions (GR and SL) are of concern in the study area (Fig. 5). The Middle Slate Division (SL) is divided into a Semipelite Amphibolite Unit in the Beaver Valley. The East Gate landslide occurs in the Lower Grit Division (GR), which consists “dominantly of coarse- and fine-grained gritty, feldspathic and micaceous sandstone with slate interbeds” (Simony & Wind, 1970). More details concerning the description of rock assemblages are given in Poulton & Simony (1980).

- 3.1.2 The east slope of the valley consists of a series of imbricated thrust sheets. The upper eastern slope of the valley is affected by two overturned thrust faults (Fig. 5). The Hadrynian rocks are complexly folded and exhibiting bedding (So) trending northwestward throughout the valley, dipping steeply east. The penetrative foliation or schistosity (S1), corresponding to a first phase of folding, is virtually obliterated by intense crenulation cleavage (S2), striking northwest to northeast and dipping more steeply than So bedding (Pritchard et al., 1989). The rocks show a phyllitic to schistose texture. The rocks in the landslide have a soapy feel due to the presence of talc (R. Herd, personal communication) which helps to reduce the friction angle of failure planes.

Figure 5. Regional geology map of the Beaver Valley, Glacier National Park, British Columbia (after Simony & Wind, 1970; and Poulton & Simony, 1980).
