Five-Mile Creek Debris Flow

Banff National Park, near Banff, Alberta

August 4th, 1999

OPEN FILE #3876

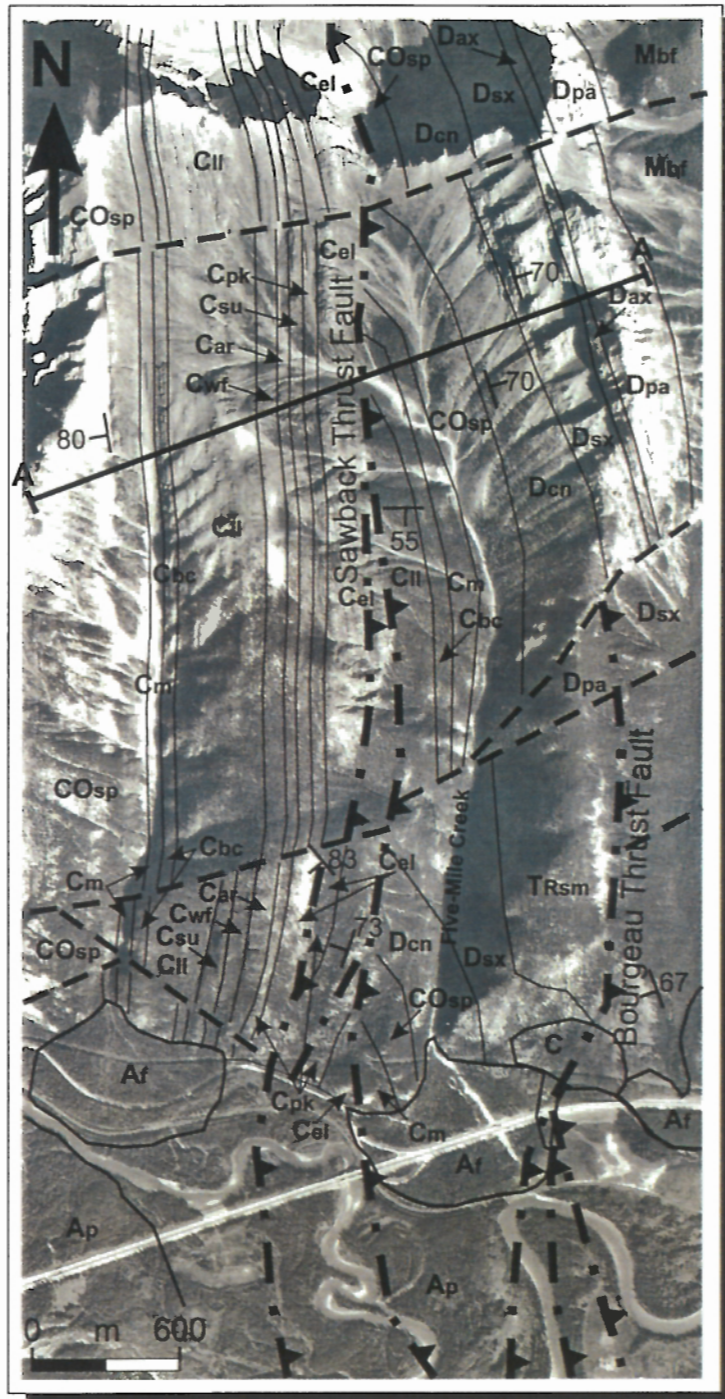
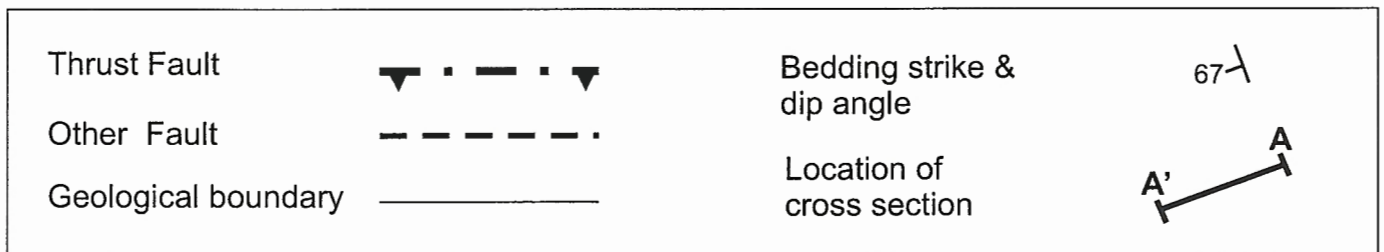
The profile of the Five-Mile Creek valley indicates that the slope angle gradually decreases from about 23° in the source area to 3° at the south tip of the fan (Figure 4.10). The creek profile is also broken by steps, circled on Figure 4.10, corresponding to lithological changes and the intersections with major structural lineaments (Figure 3.2).

Figure 3.2 Air photos of the Five-Mile Creek area , Banff (Alberta) with surperimposed geological boundaries (from Price & Mountjoy 1972). See Figure 3.3 for description of geological units and Figure 3.4 for details on cross section. (Air photo number FF99043-#8, Foto-Flight, Calgary, Alberta).

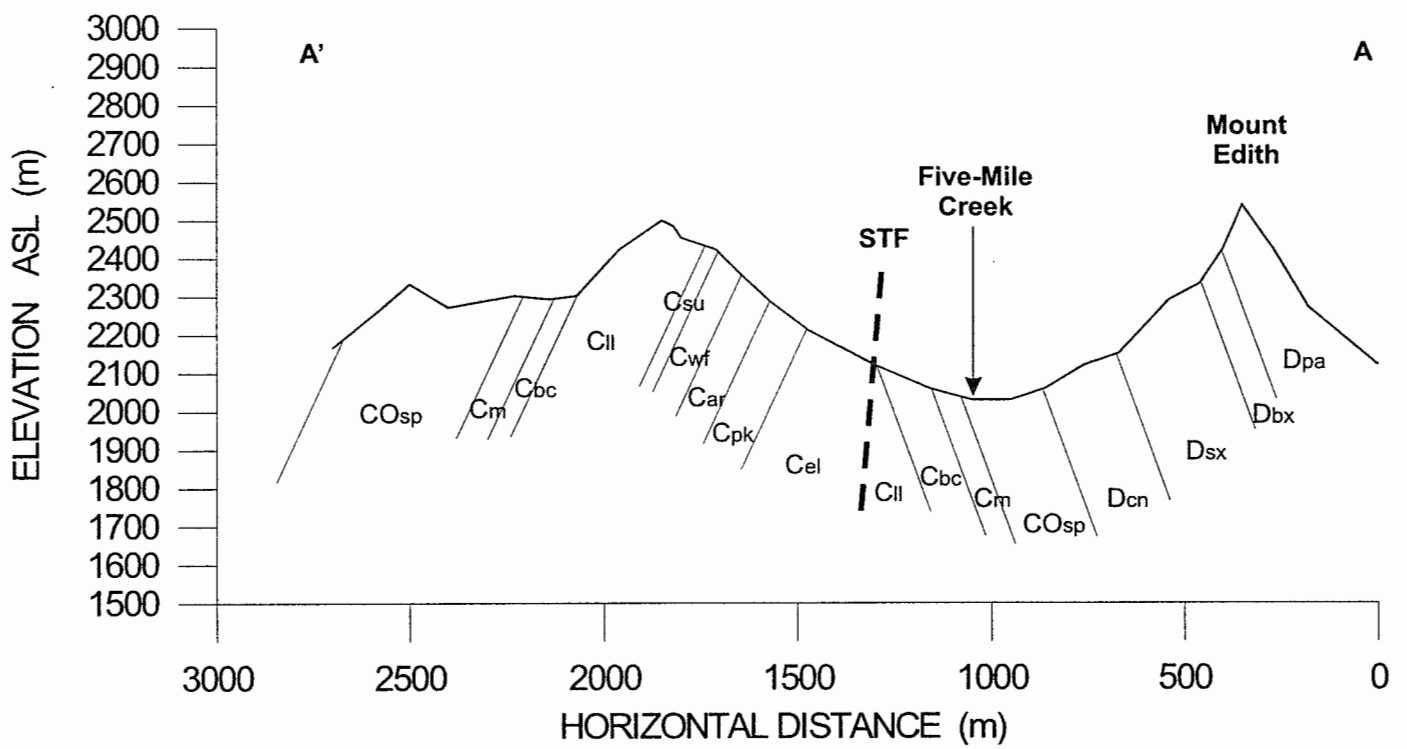
Figure 3.4 Schematic cross section through the upstream area of Five-Mile Creek. STF: Sawback Thrust Fault. See Figure 3.2 for location of cross section and Figure 3.3 for legend (After Price & Mountjoy 1972)..

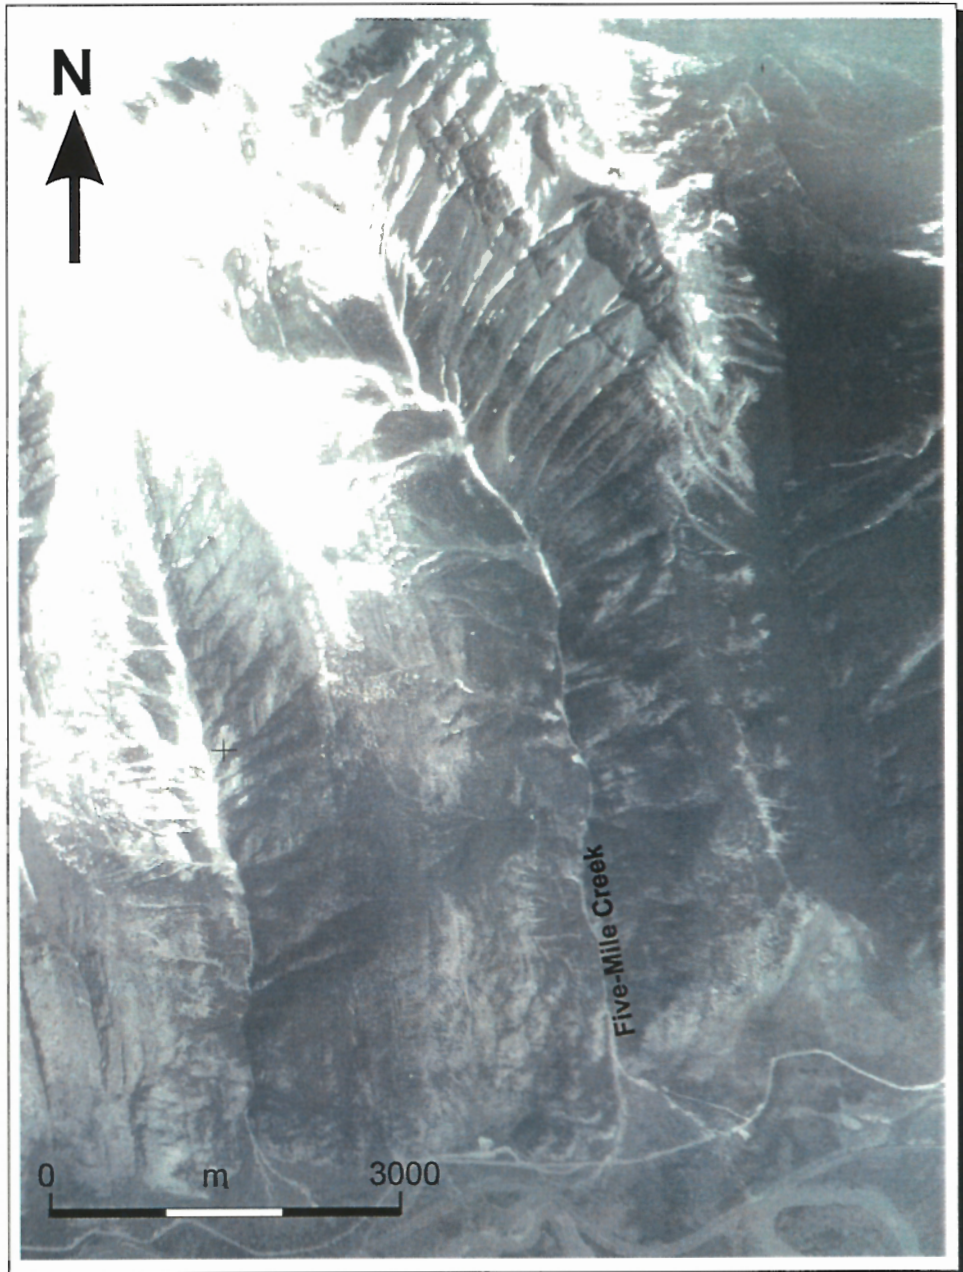
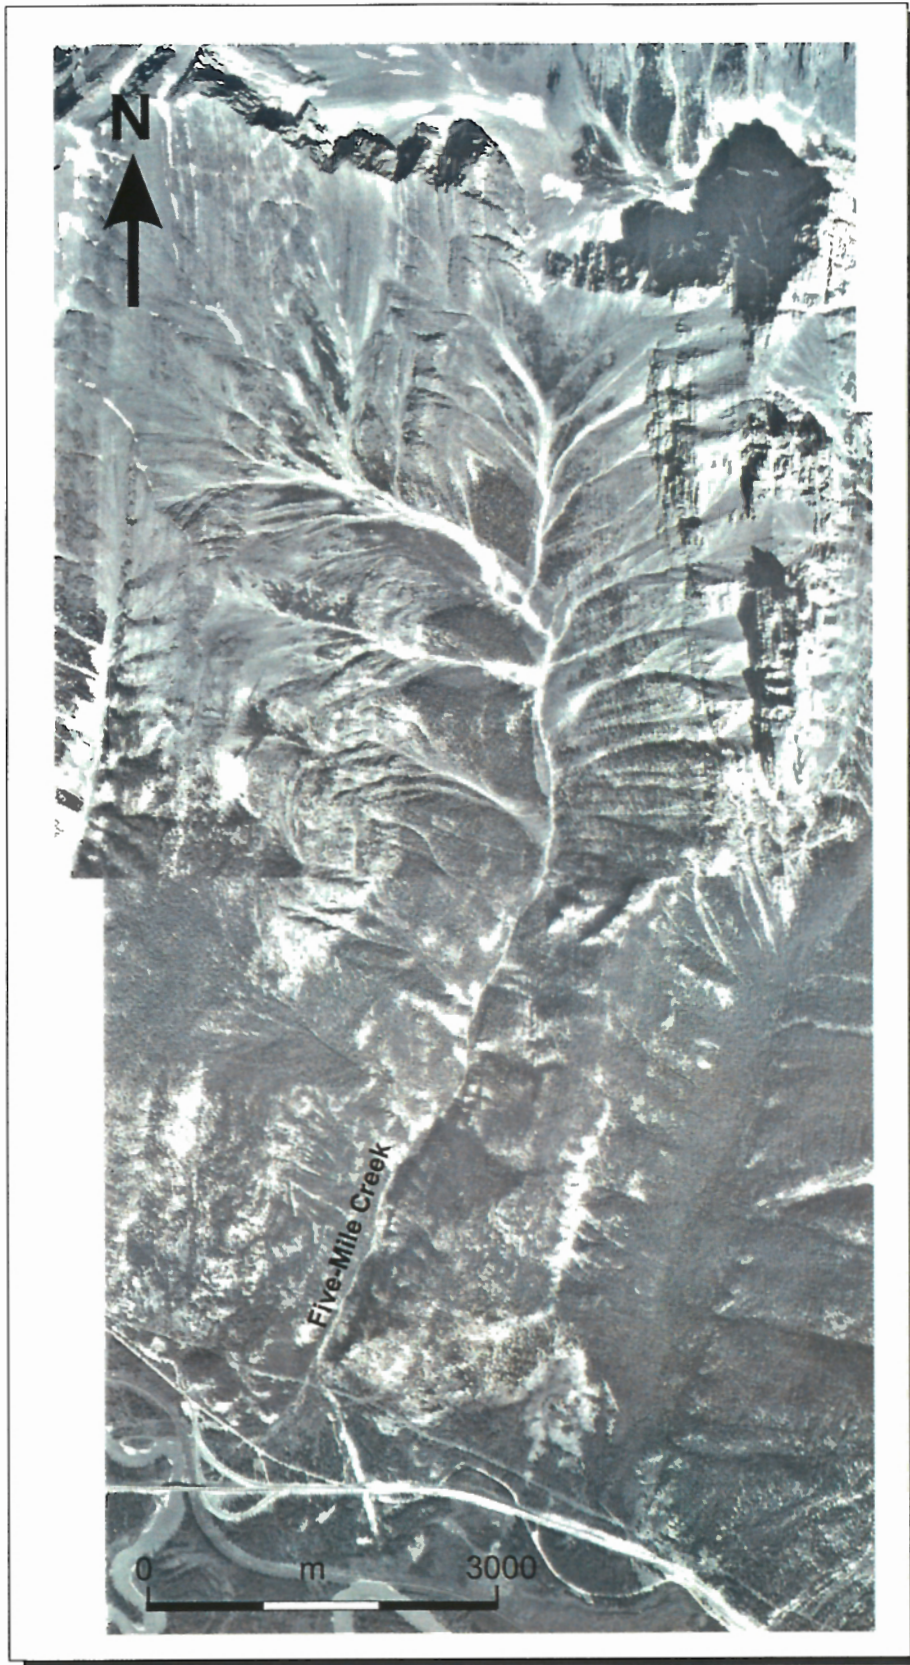
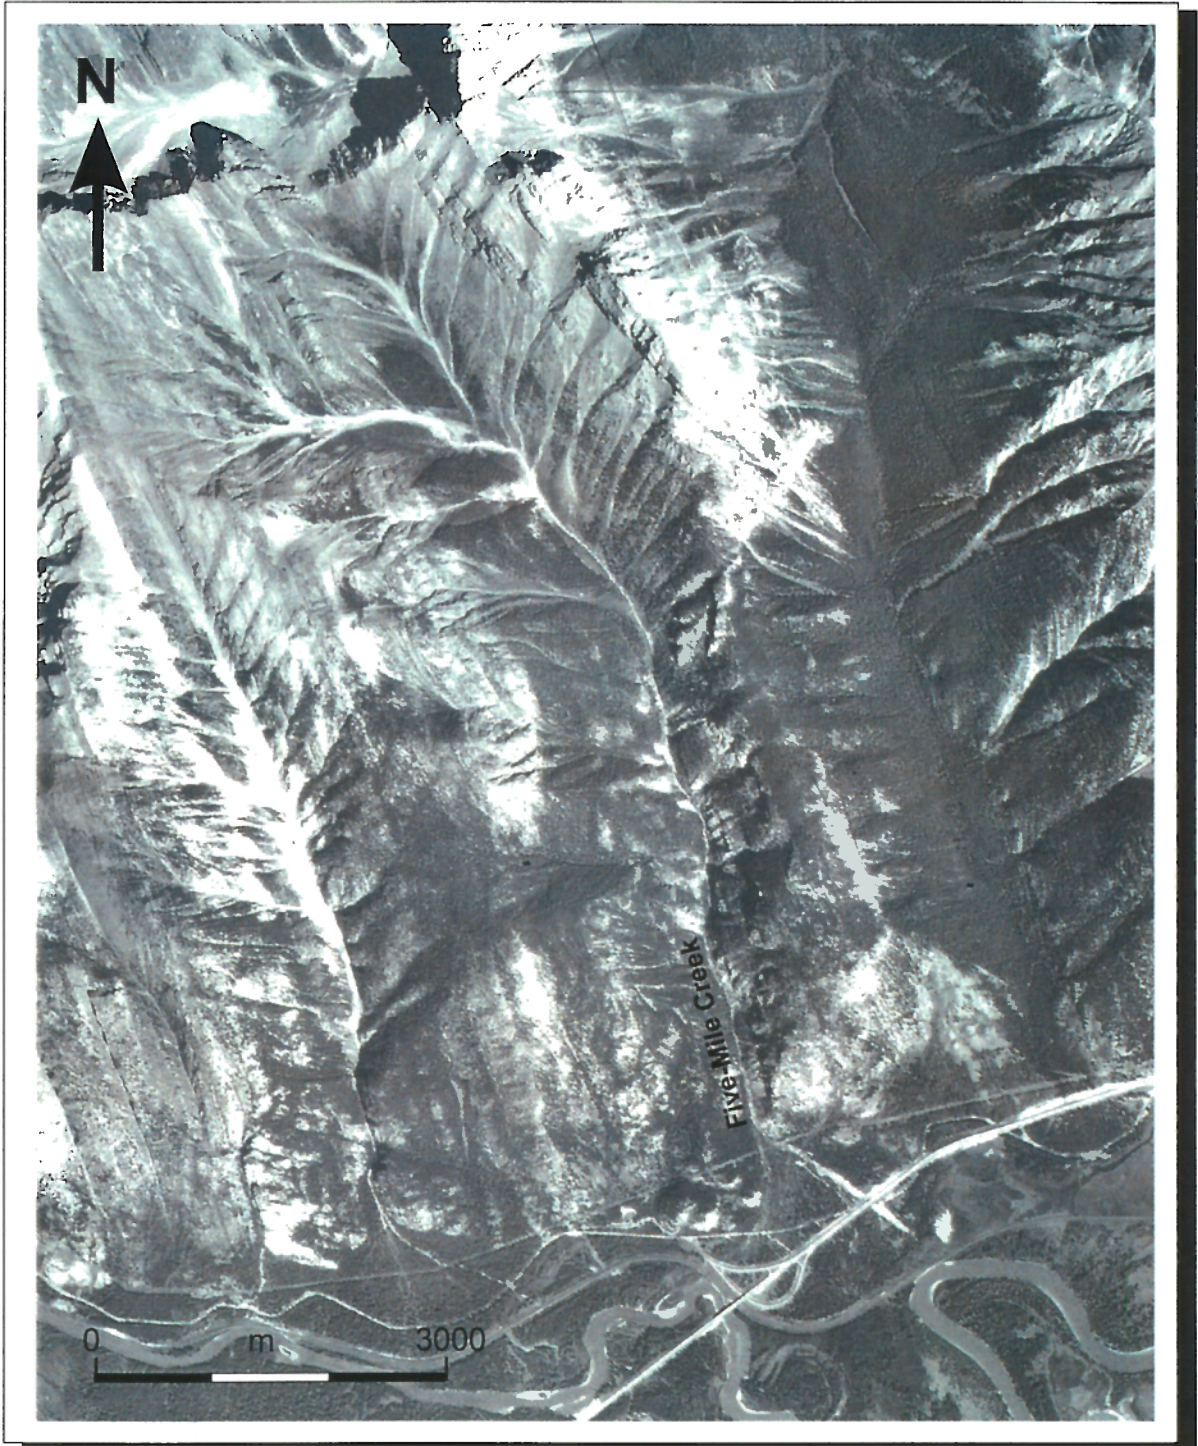
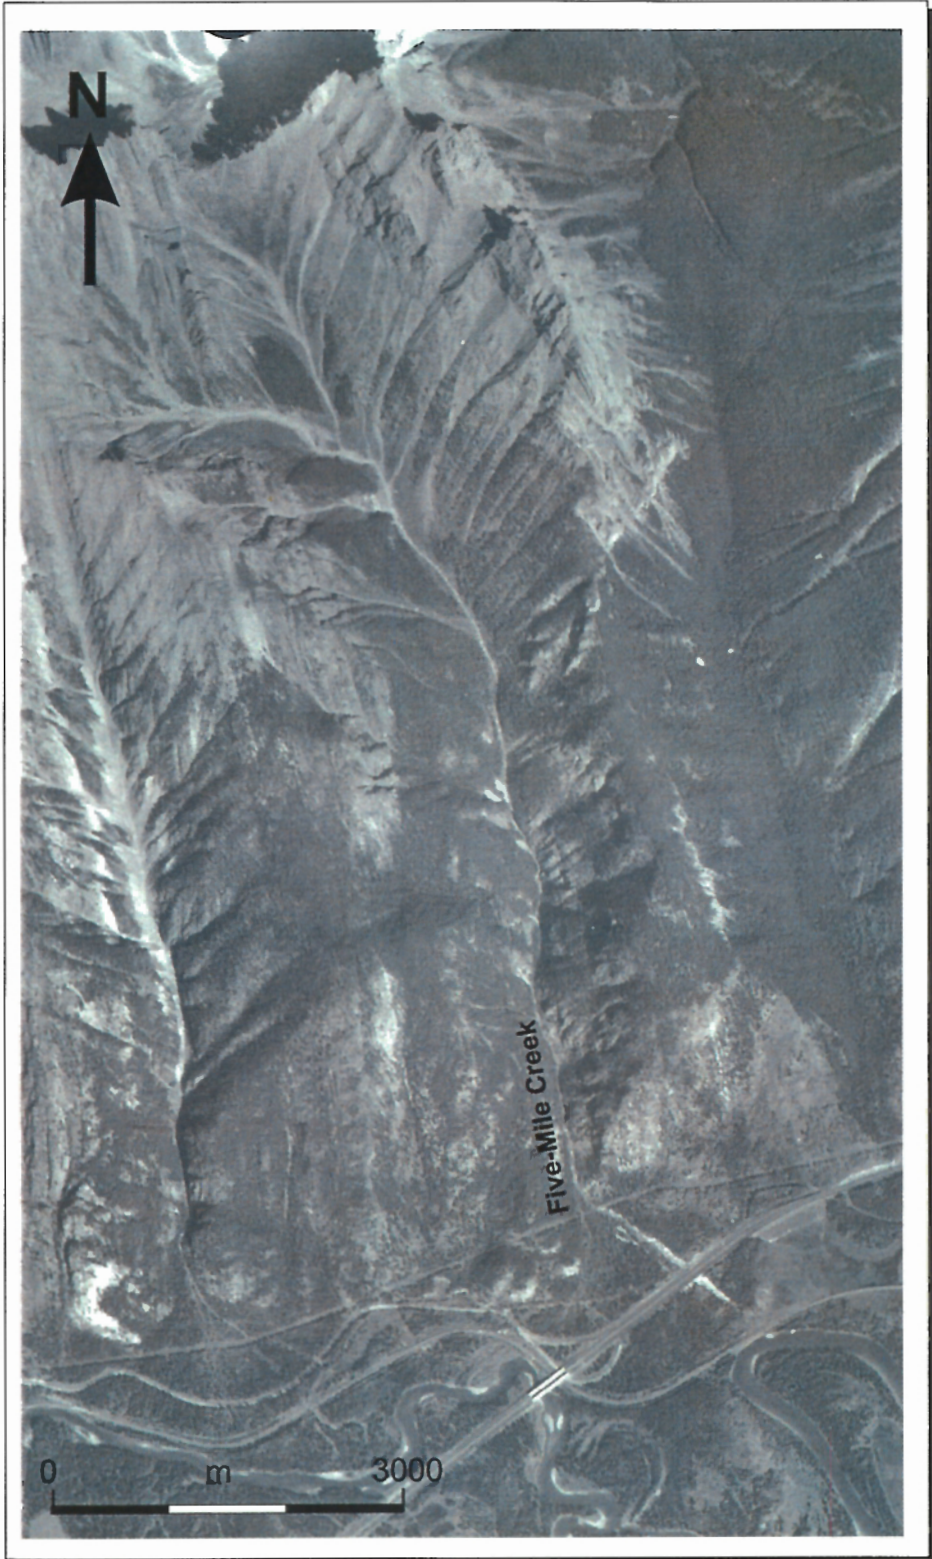
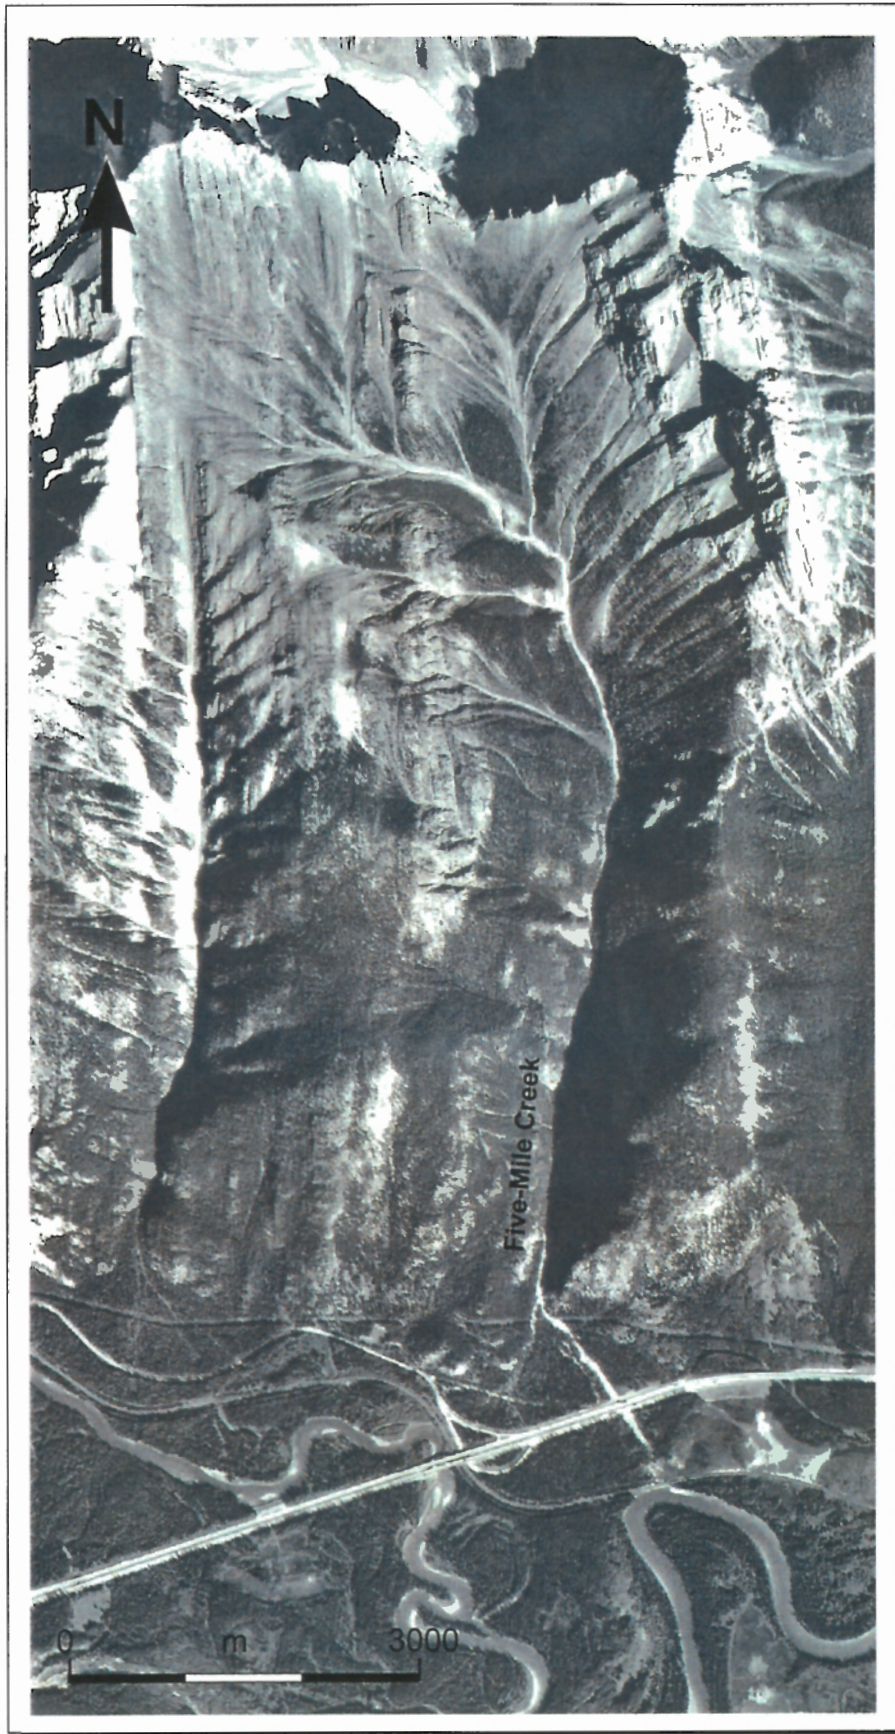
Through the years, the source area and Five-Mile Creek valley do not show any major changes in its morphology (Figures 3.6a to 3.6e). No failure surface is observed along the valley, in the source area, or either side of the valley. Numerous tributary streams feeding Five-Mile Creek also show no change in its path direction, shape and emplacement.

Figure 3.6 Airphotos in the vicinity of Five-Mile Creek, Banff (Alberta): a) 1947

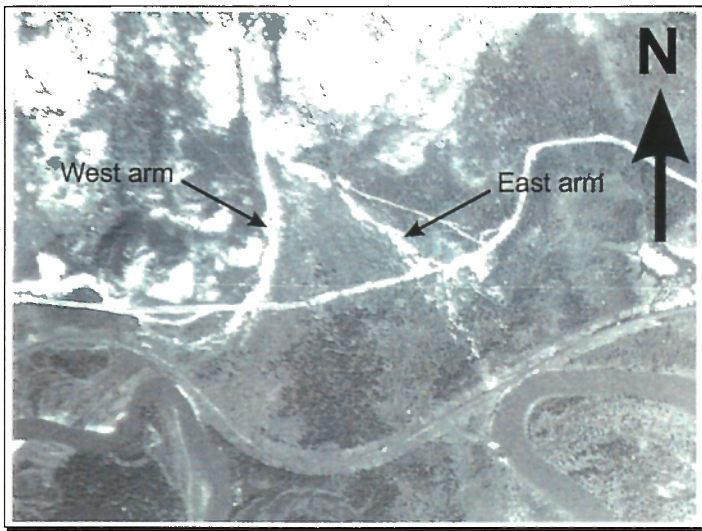
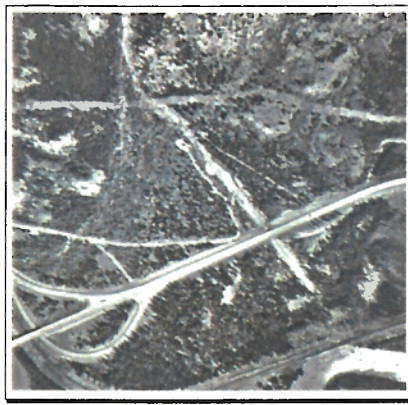
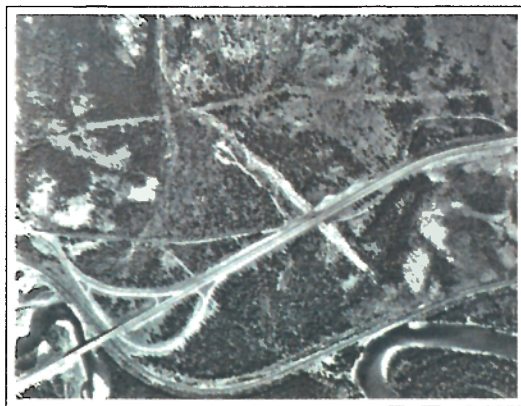
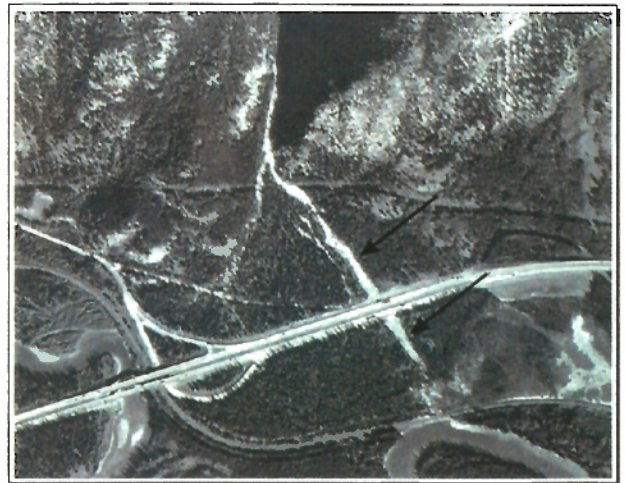
According to a park warden, C. Pacas (personal communication, Banff National Park, the Canadian Pacific Railway installed a small berm at the apex of the fan in the Fifties (encircled in Figure 3.7b), where Five-Mile Creek divided in two arms, forcing the Five-Mile Creek to flow only in the eastern arm. It is the author's understanding that occasional problems to the CP track caused by the creek surges forced the CP authorities to undertake this protective action.

In the Seventies, the small culvert installed in the Sixties through the CP track foundations seems to have been blocked, since the evacuated deposits did not extend any further in the river (arrow in Figure 3.7d), runoff was going towards the Vermilion Lakes.

During the Nineties, Canadian Pacific railway installed two small culverts, west of the culvert installed in the Sixties, to allow water to reach the Bow River while reducing the pore water pressures within the track foundations (C.Pacas, personal communication). It should also be noted that through the last fifty years the Five-Mile Creek does not seem to take a well-defined channel downstream of the highway, except for the human-worked section (Figures 3.7a to 3.7f).

Figure 3.7 Series of aerial photographs of the Five-Mile Creek fan deposits, Banff (Alberta) from 1947 to 1999. Arrows and circle are referred to in the text.

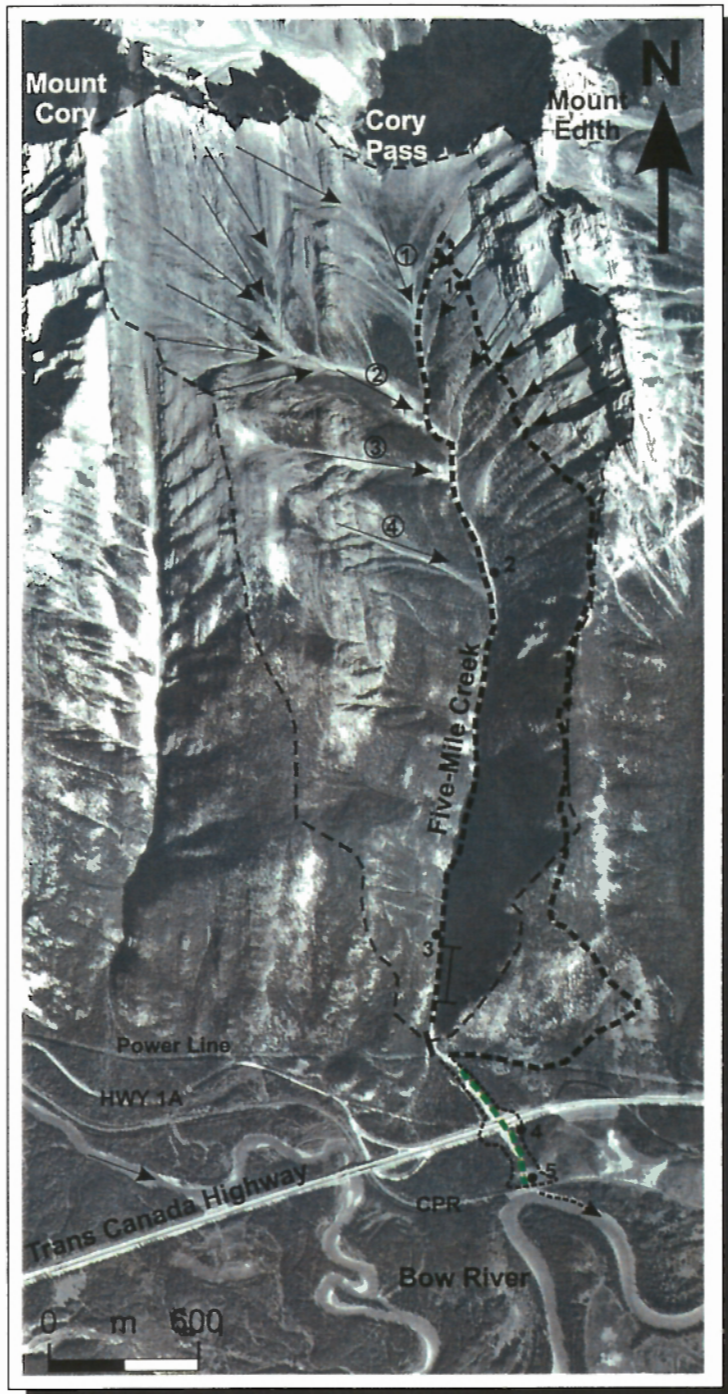
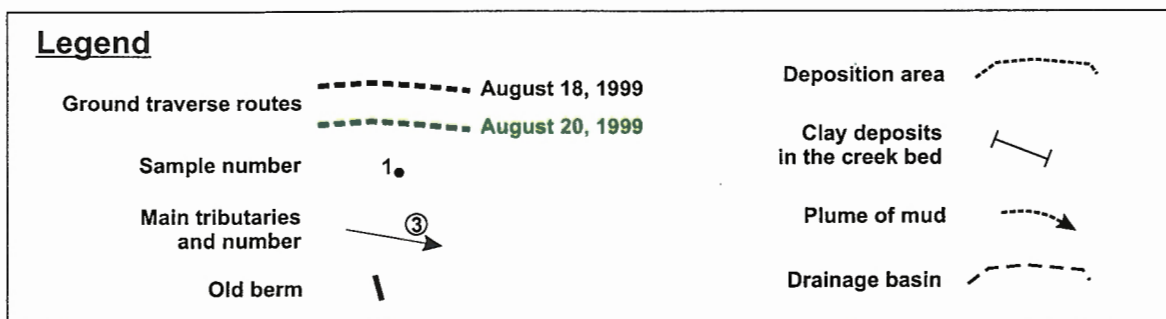
Morphometric details of the 4.5 km² drainage basin as defined in Figure 4.2 are given in Appendix 3. Several streams have carved gullies into the colluvium and bedrock outcrop on both sides of Five-Mile Creek valley (Figure 4.2 & Figure 4.9a). Four main streams in the source area are numbered in Figure 4.2. Adjacent small gullies are indicated by arrows in Figure 4.2. Surface runoff brought a large amount of unconsolidated material to the main stream of Five-Mile Creek.

A second sample of alluvium (sample #2 on Table 4.2), *i.e.* source material, was taken on the east bank of Five-Mile Creek at an elevation of 1715 m (Figures 4.2 and 4.10). The sample consists of gravel, sand, silt and clay at 73.1%, 18.9%, 7.0%, and 1.0%, respectively (Figure 4.8 & Table 4.6). The sample was well cemented by calcium carbonate, probably limited the erodibility of these materials.

Figure 4.2 Major features and location of samples at Five-Mile Creek debris flow, Banff National Park, Alberta. (After 1:30,000 air photos No. FF99043 L2, #6-10, Foto-Flight, Calgary, dated 1999/09/08).

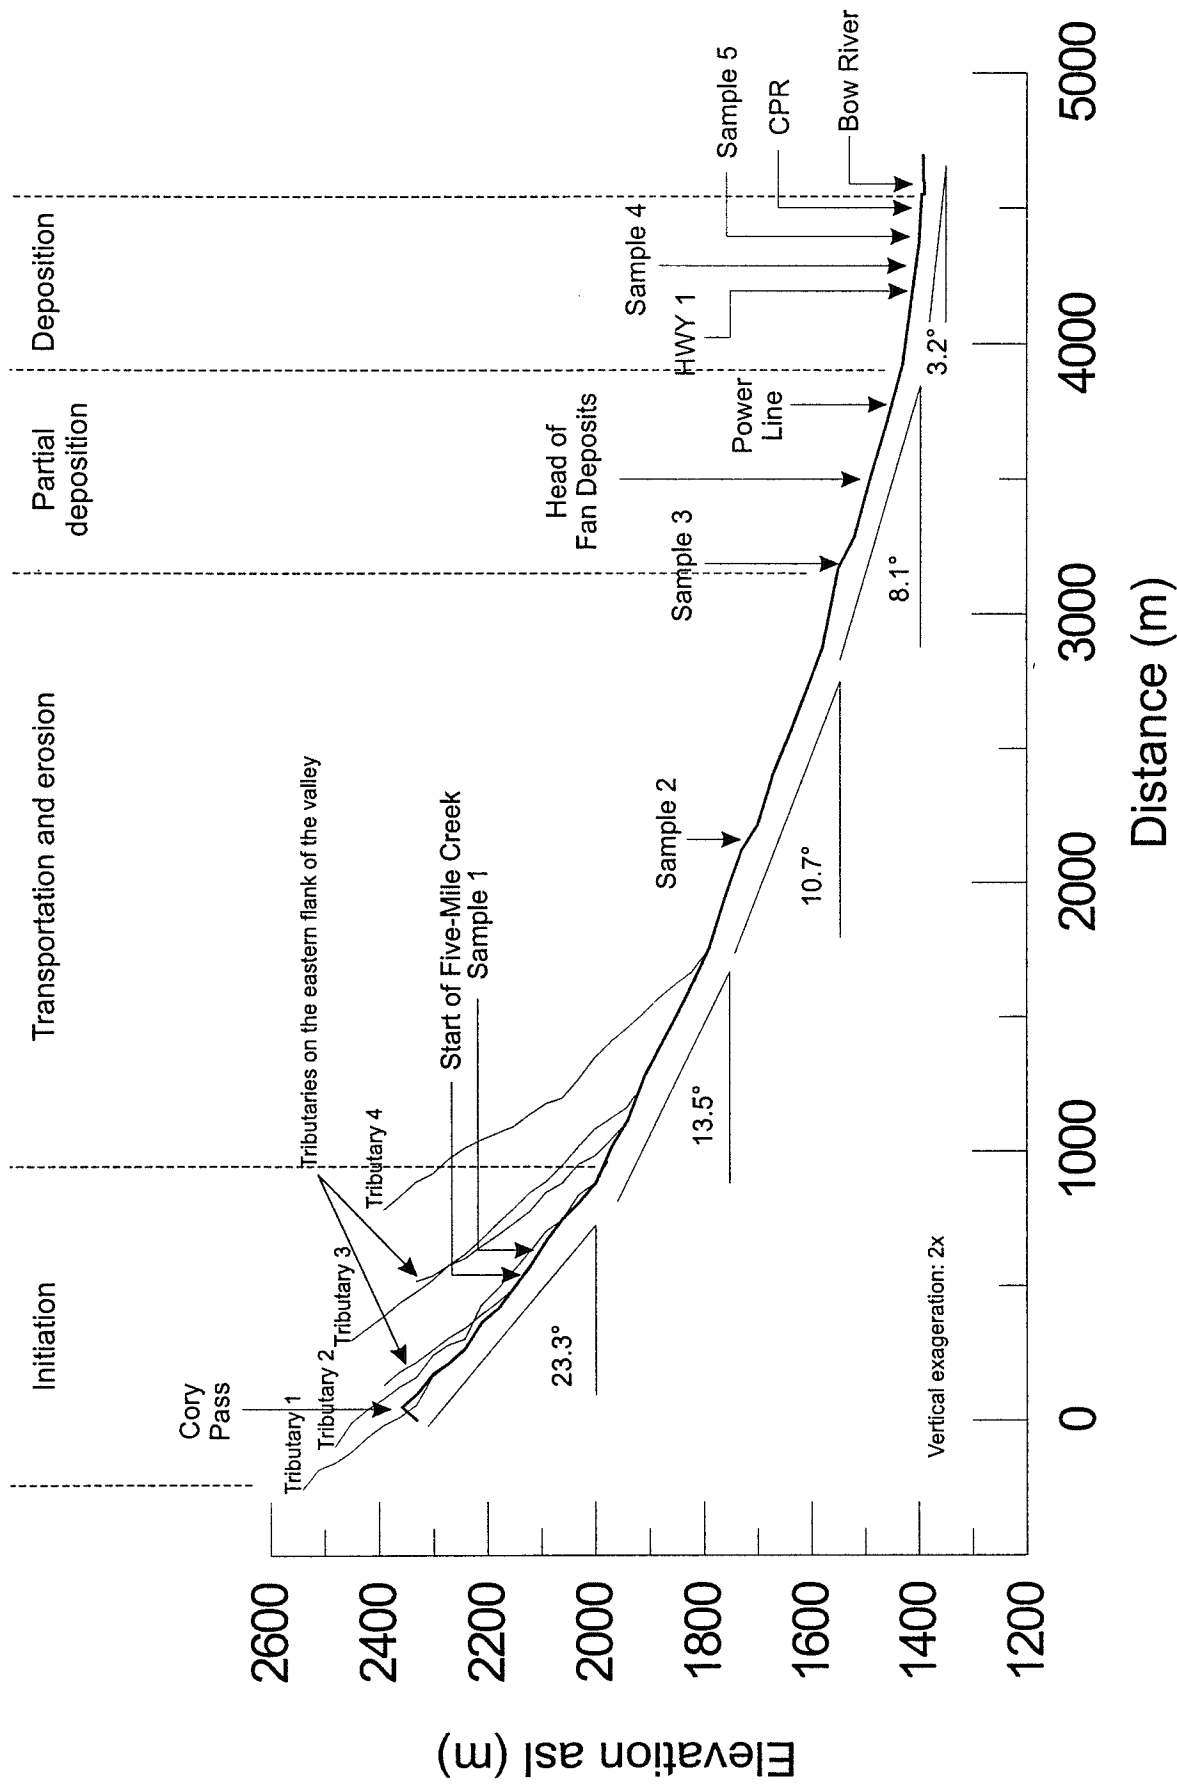
The relatively high flow path gradient ($> 16^\circ$) in the first 2000 m of Five-Mile Creek bed (Figure 4.10) initiated a high flow velocity in the debris. Narrower sections of the Five-Mile Creek gully (Figure 4.11) helped to maintain the high velocity, and lead to higher levels of erosion. The large amount of fines also allowed the transportation of large blocks and debris.

Figure 4.10 Profile of Five-Mile Creek valley from Cory Pass to Bow River. Circles indicate changes in topographic profile associated with changes in geological units.

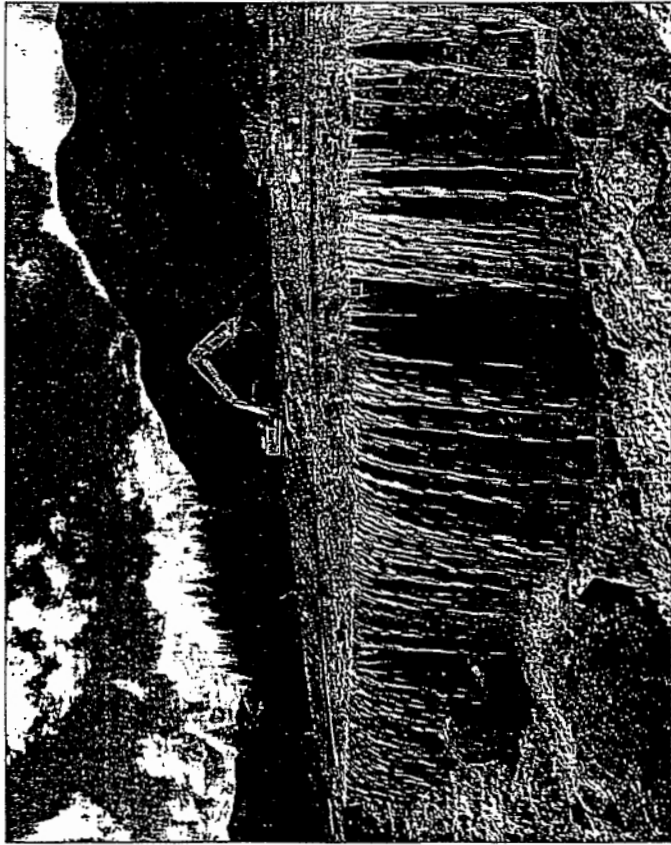
Road crews were busy cleaning up a mudslide that closed a portion of the Trans-Canada Highway eight kilometres west of Banff yesterday morning. A track hoe was clearing a path to drain some water and reopen a blocked drain pipe under the highway.
