THE 1985 MEXICAN EARTHQUAKE - A SITE-VISIT REPORT\*

Ottawa, Canada February 1986

EARTH PHYSICS BRANCH OPEN FILE REPORT NO.: 86-2

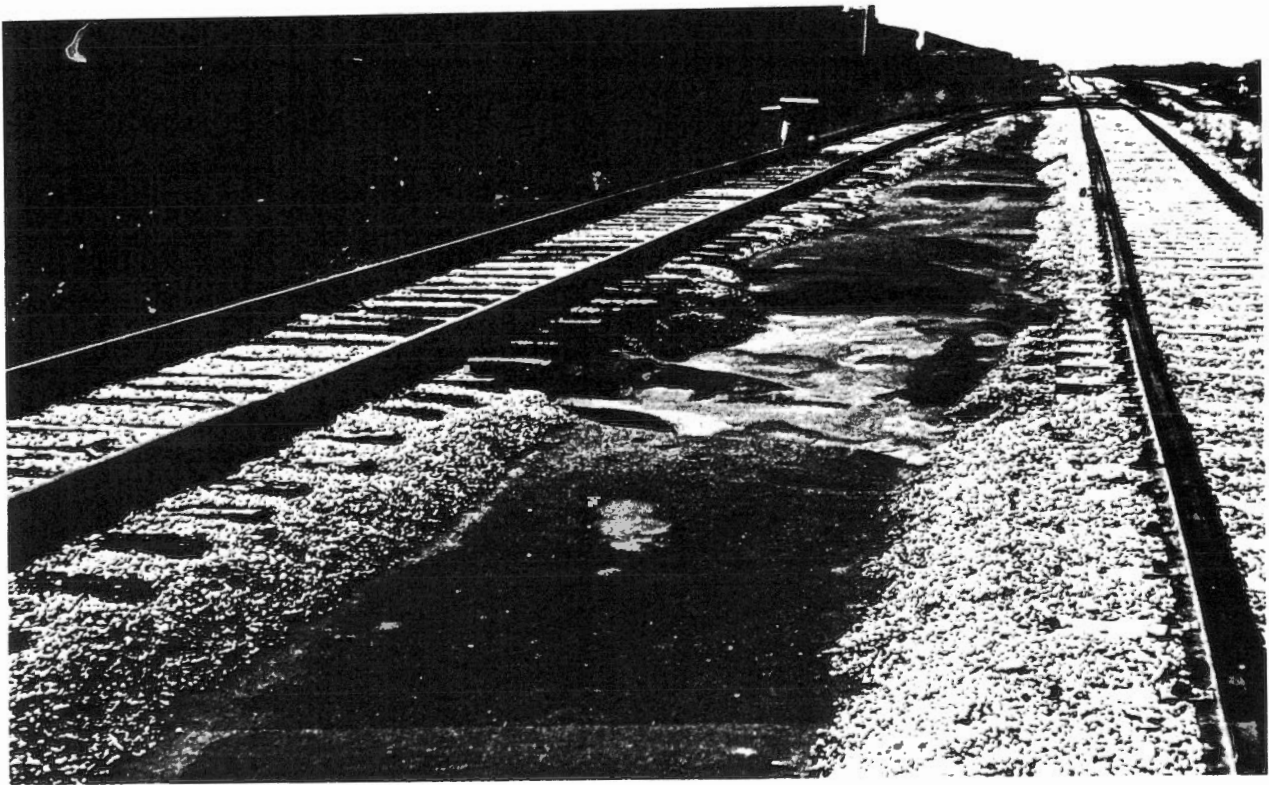
In the Fertimex plant, located on the south tip of the Balsas River delta, evidence for strong ground deformation included: torn or ruptured EW oriented rails (Fig. 3.2); buckled rails, shortened in the NS direction (Fig. 3.3); about half a dozen sand boils, up to 3 m across (Fig. 3.4); buckled flange on 60 cm deep H-columns (Fig. 3.5); and finally a 20 cm thick, 70 m wide concrete slab on grade had buckled resulting in two waves 3/4 m high. The plant was nearing completion, but was not yet in production. Most of the structures were on piles and had survived well, although the ground around them had subsided up to 0.3 m. The plant was designed to California zone 3 (SEAOC zone 3). Plant engineers anticipated that the repair of the damage would only delay opening the plant by a few months.

Fig. 3.4 Sand boil under railway line, in middle distance of Fig. 3.3.

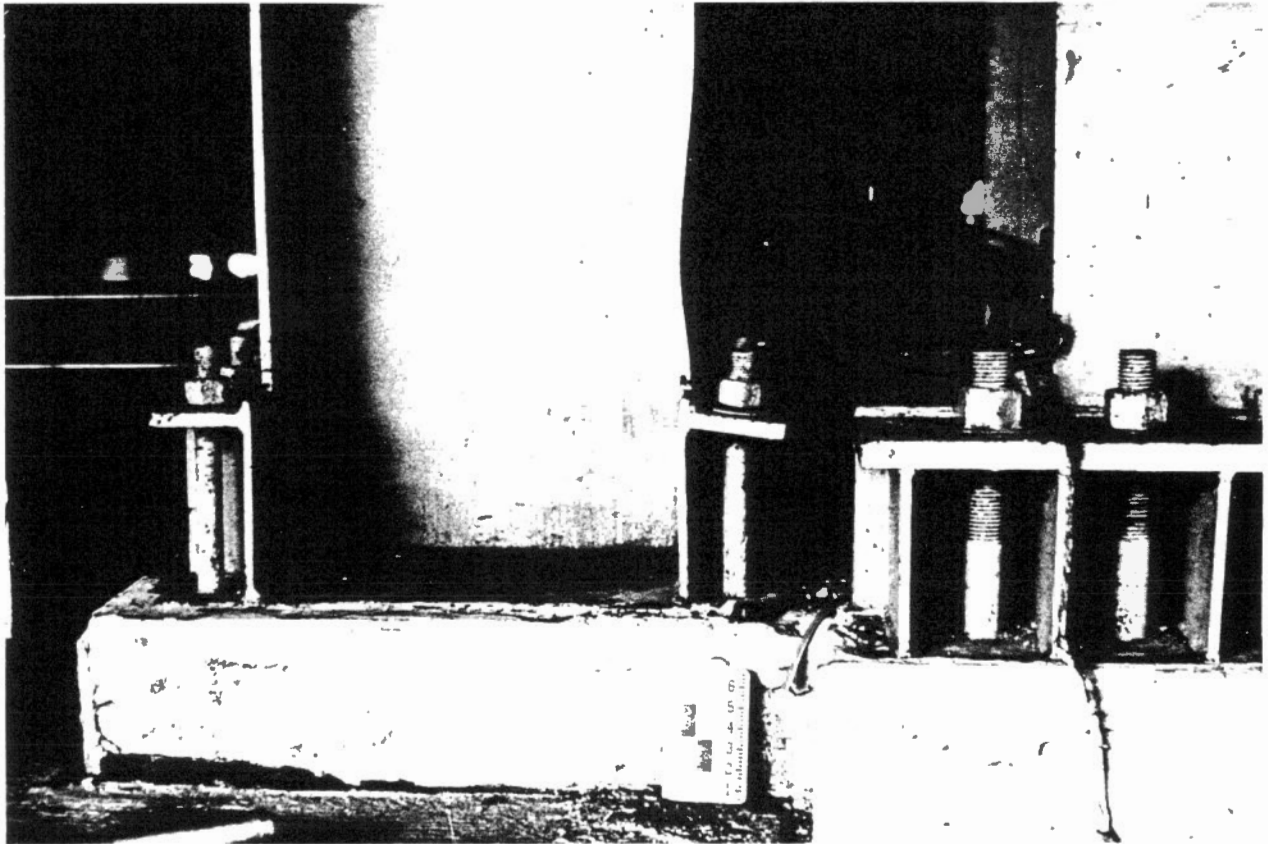
Fig. 3.5 Buckled flange of 60-cm-deep H-column at base of 6-storey steel frame, Fertimex plant. All three columns on this side of the building buckled in the same manner, as did the corresponding three on an identical building a few hundred metres away.

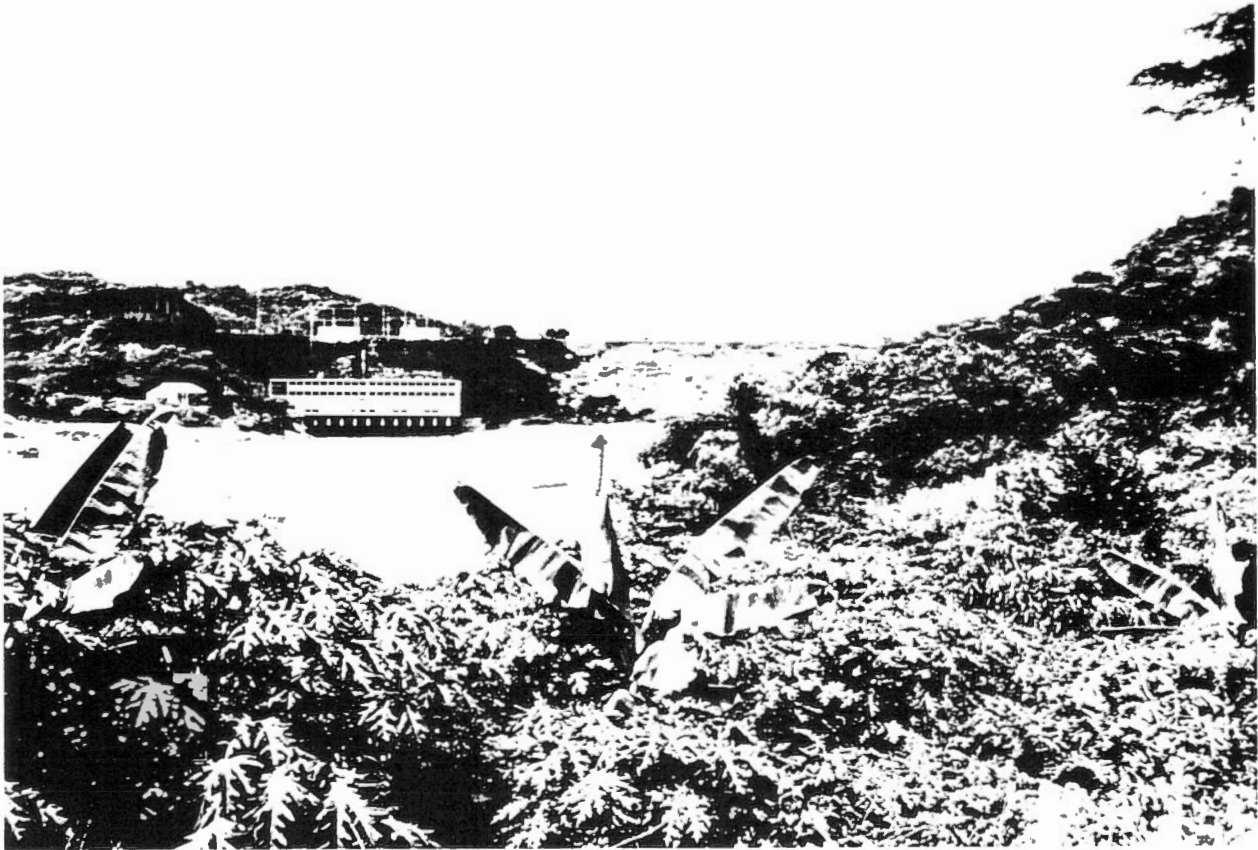
The Morelos dam, a 60 m high earth and rockfill dam (Fig. 3.10), founded on 70 m thick alluvial deposits had minor subsidence at the crest and a few of the concrete barrier panels tipped over (Fig. 3.11). The 304-MW powerhouse and transformer yard showed no damage and we were assured by the operating engineer that none had occurred. At the Infiernillo dam, a 146 m high earth and rockfill dam founded on bedrock and 920 MW powerhouse 55 km upstream from the Morelos received little damage, though 120 mm of settlement occurred on the dam crest together with 100 mm wide longitudinal cracks. Both dams were well-engineered structures and highly instrumented, and we were provided with the latest inspection report containing post-earthquake survey data (Ref. 3.3).

Fig. 3.10 Morelos Dam and La Villita powerhouse, located near the mouth of the Rio Balsas. The earth-filled dam is approximately 60 m high by 300 m long. The large array of high voltage equipment in the station switchyard (adjacent to the dam crest, see Fig. 3.11) was unaffected by the earthquake, even though this type of equipment is often susceptible to seismic damage. The power station is housed in a large steel frame building and consists of four 76 megawatt units, completed in 1973. Mechanical and electrical equipment in the station were undamaged by the earthquake. Protective relays disconnected the station from the power grid during the earthquake (from Ref. 3.2).

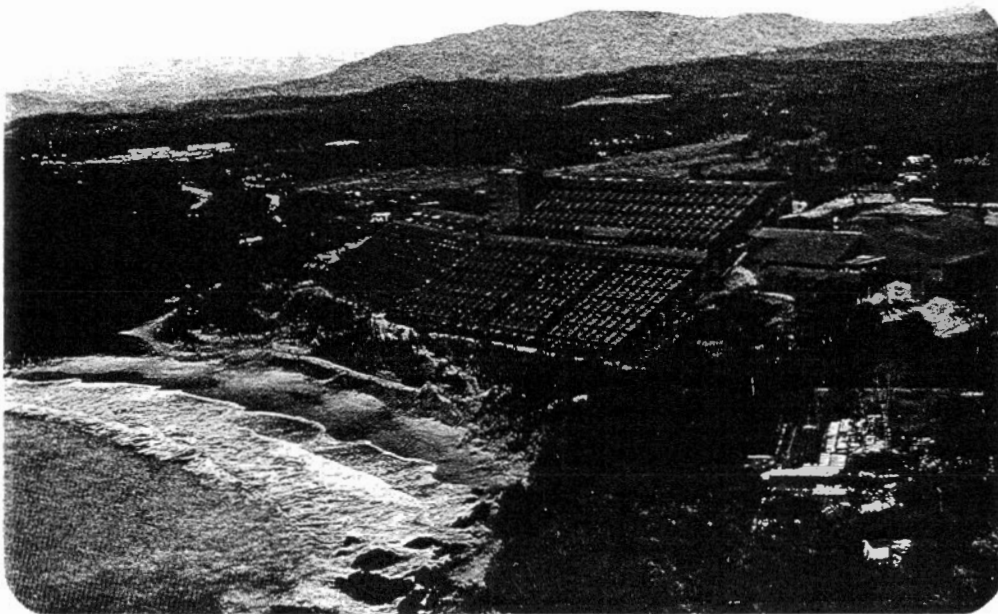
A modern hotel of completely different design is the Camino Real which is built in cascade fashion against rock hill, thus being effectively only one to two storeys above ground level, except for the 6-storey lobby at the top of the slope (Fig. 3.13). This building was said to have suffered no damage during the M 8.1 main shock, but was damaged by the M 7.5 aftershock, in which none of the highrises were said to have suffered further damage. The aftershock was probably richer in high frequencies, perhaps inherent in the source but certainly because of the lower attenuation of high frequencies over the shorter epicentral distance to Ixtapa. Similarly, only the second shock caused slight new damage to a one storey restaurant.

Fig. 3.13 Camino Real hotel, Ixtapa. This modern hotel is built down the hill slope to the beach, thus being effectively only one to two storeys above ground level except for the 6-storey lobby at the top of the hill. It suffered minor damage from the M 7.5 aftershock. The landscape here is typical of the coastal area. Postcard courtesy of Camino Real Hotel.

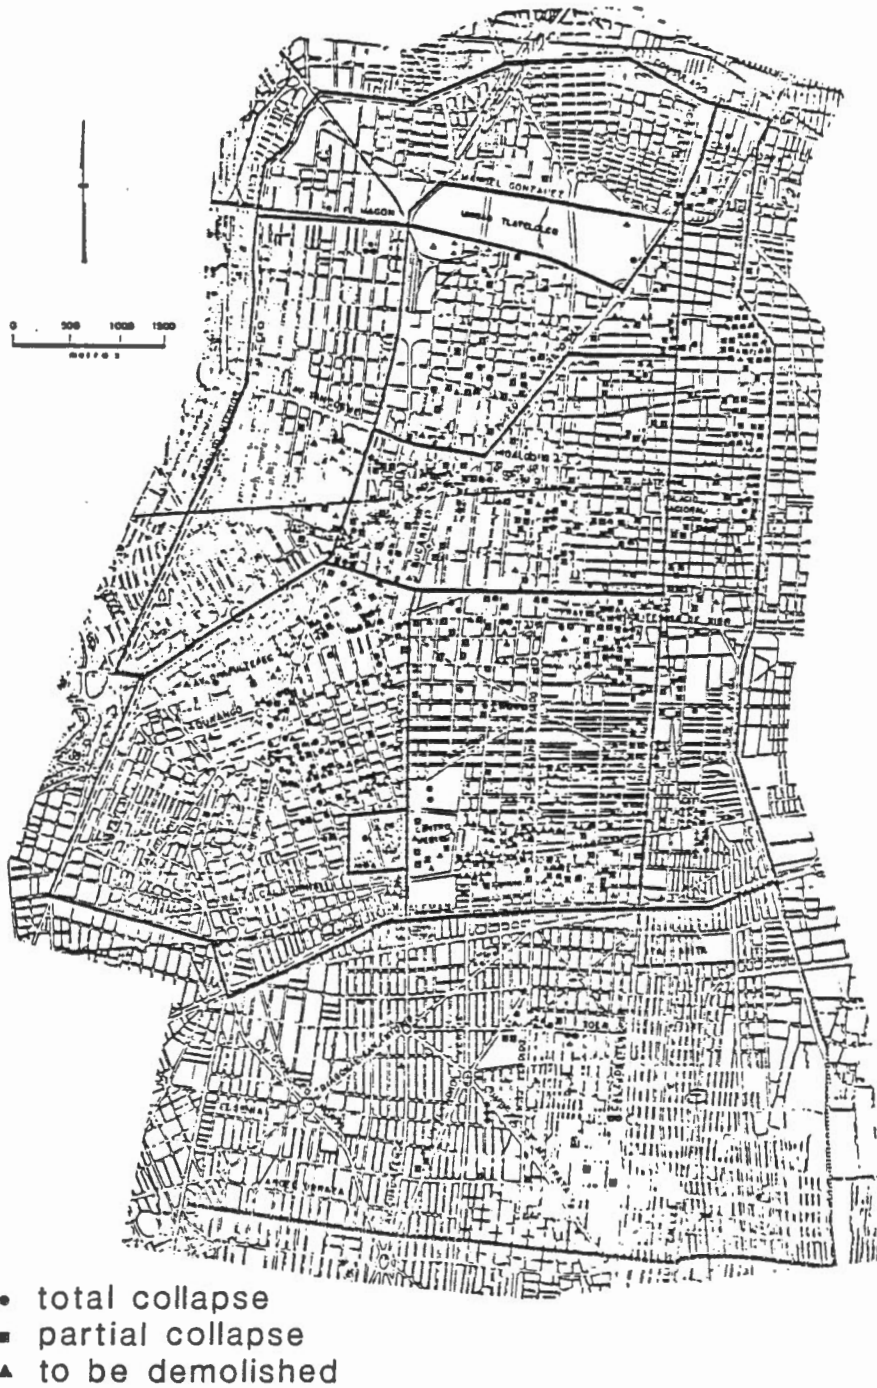
Fig. 4.9 Distribution of Collapsed or Severely Damaged Structures in Mexico City (taken from Ref. 4.3).

Figure 4.9 illustrates the distribution of damage in Mexico City for the structures that suffered total or partial collapse as well as for structures that were severely damaged.

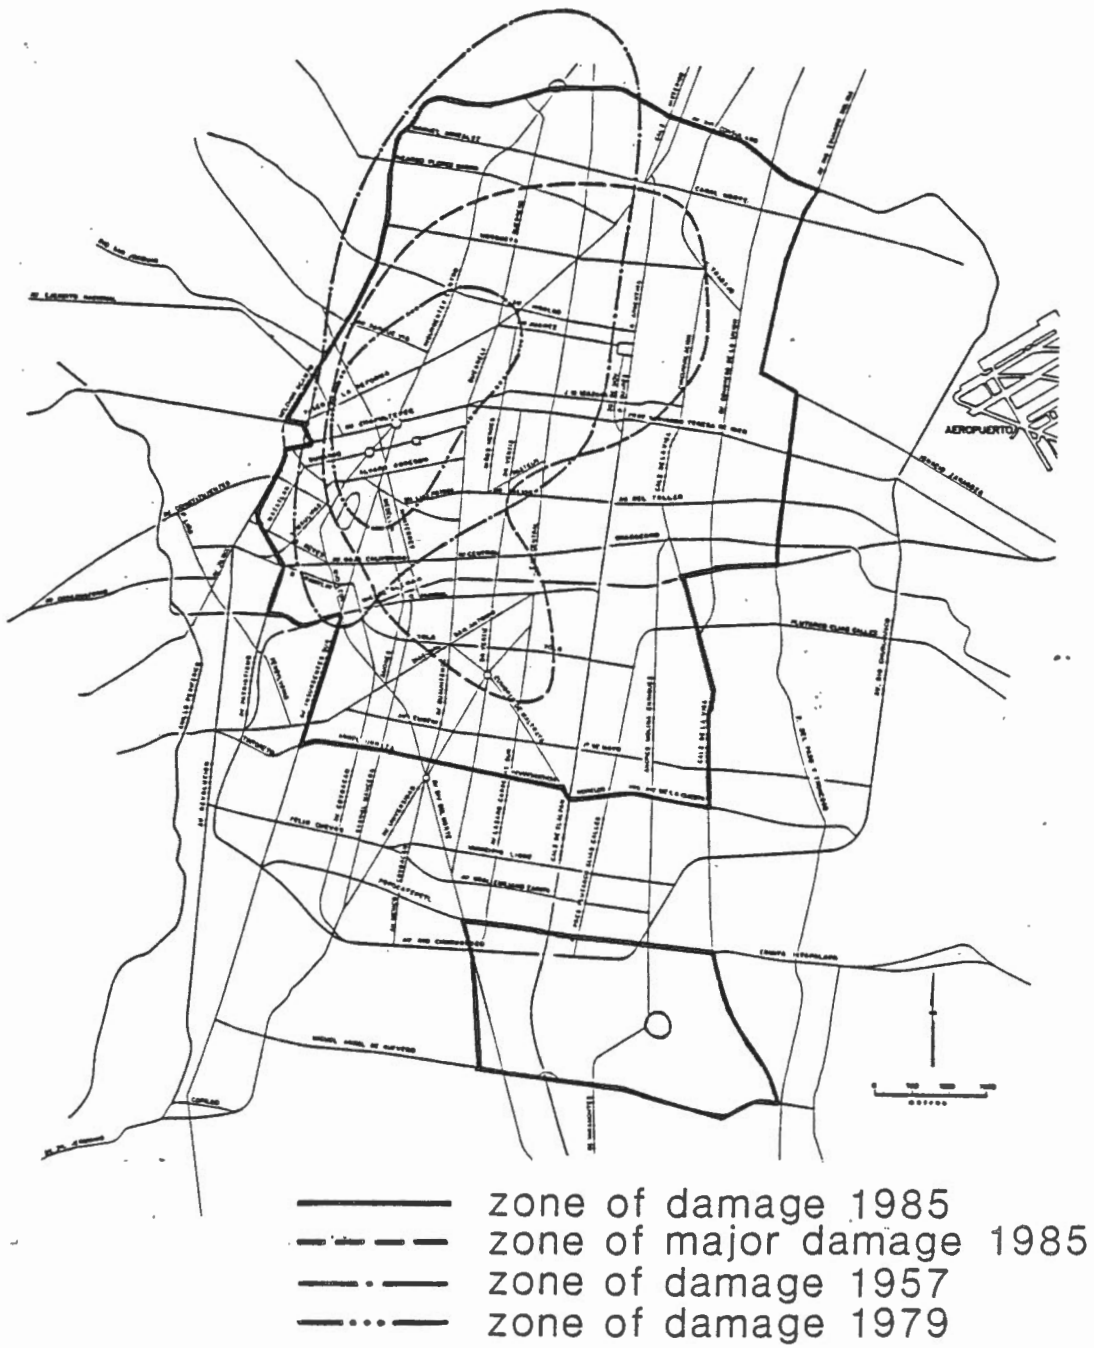
Fig. 4.10 Zones of Damage in Mexico City (taken from Ref. 4.3).

Figure 4.10 shows the region classified as having minor but significant damage which covers an area of 65 km<sup>2</sup>. The area classified as having major damage in the 1985 earthquake (see Fig. 4.10) covers an area of about 23 km<sup>2</sup>. It is interesting to compare the 1985 regions of damage with the regions of damage in the July 28, 1957 and the March 14, 1979 earthquakes as shown in Fig. 4.10. The 1985 damage zones coincide in part with those of the previous earthquakes but extends to cover a much larger area towards both the east and the south.

is compared with Fig. 4.10. The region with the greatest amplification and which suffered the most severe damage is located in the west lake zone where the depth to the first competent layer ranges from 26 to 32 m and the depth to the second competent layer ranges from 30 to 46 m. The ground motion amplification decreased in regions having thinner or thicker lake deposits.

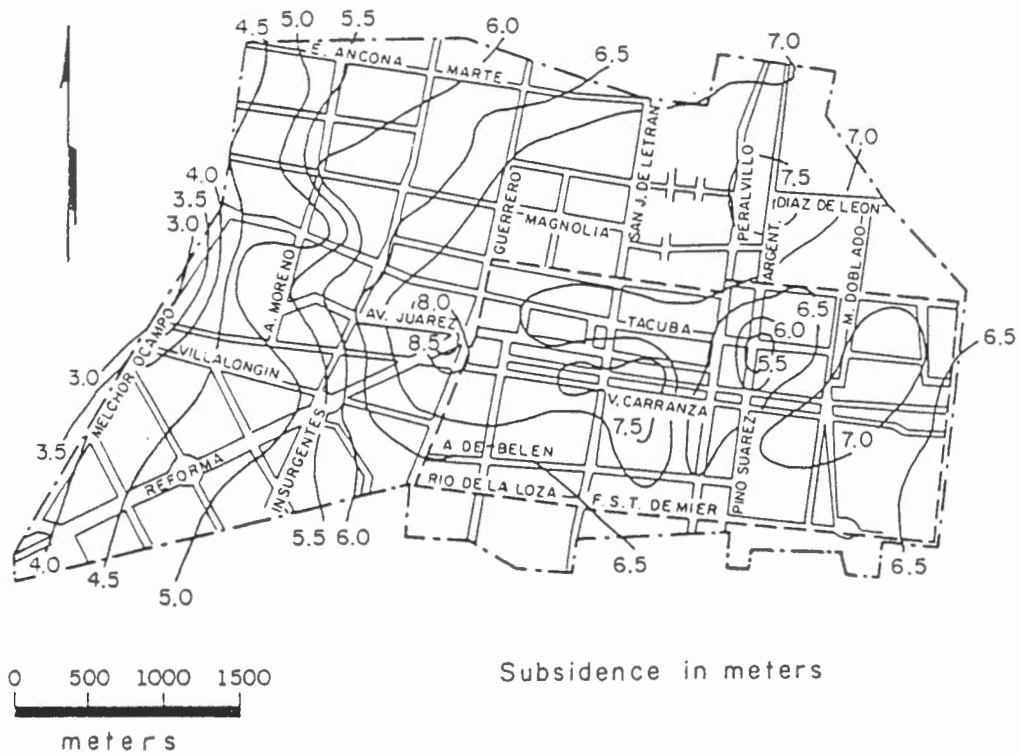
Fig. 4.12 Contours of Equal Subsidence in the Period from 1891 to 1970 (taken from Ref. 4.2).

The withdrawal of groundwater by drainage and by pumping from sand aquifers sandwiched between highly compressible clays has been chiefly responsible for a general irregular subsidence in the lake and transition zones. Landfills and building loads also contributed to about 20% of the total settlements (Ref. 4.2). The effects of the water extraction from well pumping on the lowering of piezometric levels in the aquifers and on the observed ground subsidence were demonstrated by Nabor Carrillo in 1948 (Ref. 4.4). Since then, strict restrictions on the exploitation of aquifers within the urban area has reduced the subsidence rate significantly. Figure 4.11 shows the progression of settlement with time at the Cathedral and at Alameda Park within the old city. As can be seen settlements of 7 m have taken place in a period of 70 years! Figure 4.12 shows the settlement contours in metres over the area of the old city.

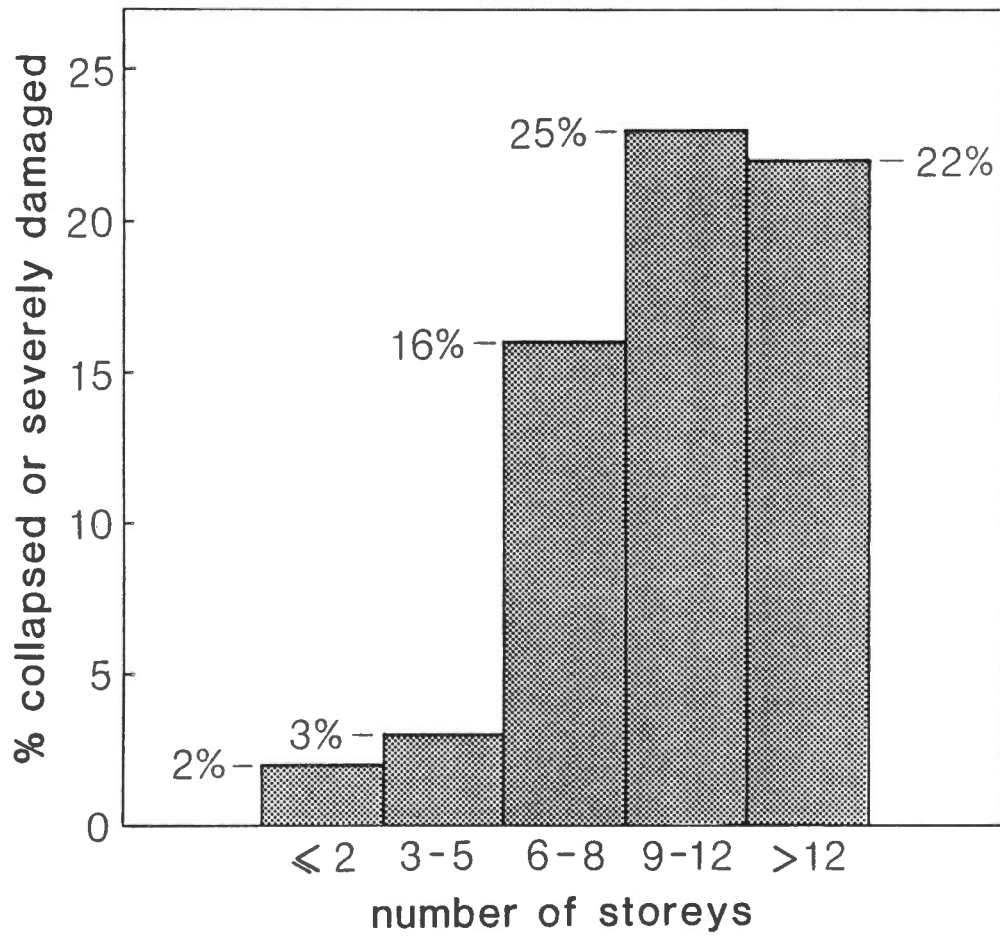
Fig. 6.3 Percentage of Buildings of Various Storey Heights that Collapsed or were Severely Damaged in the Zone of Damage

different heights in the damaged region that either collapsed or suffered severe damage. In all, 3 percent of the structures in this region were damaged with those buildings over 6 storeys in height being most affected.

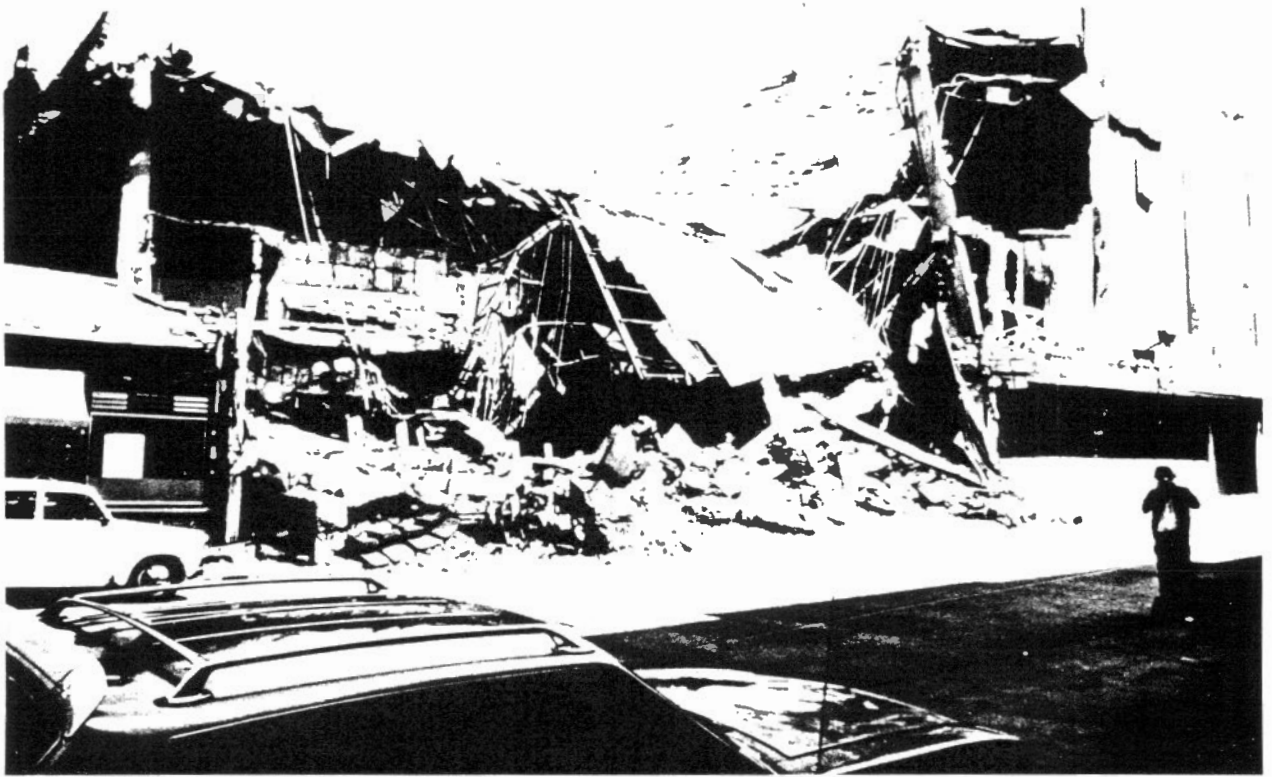
Fig. 6.18 Collapsed Theater Structure

This structure had masonry walls with light steel trusses and a metal deck roof.

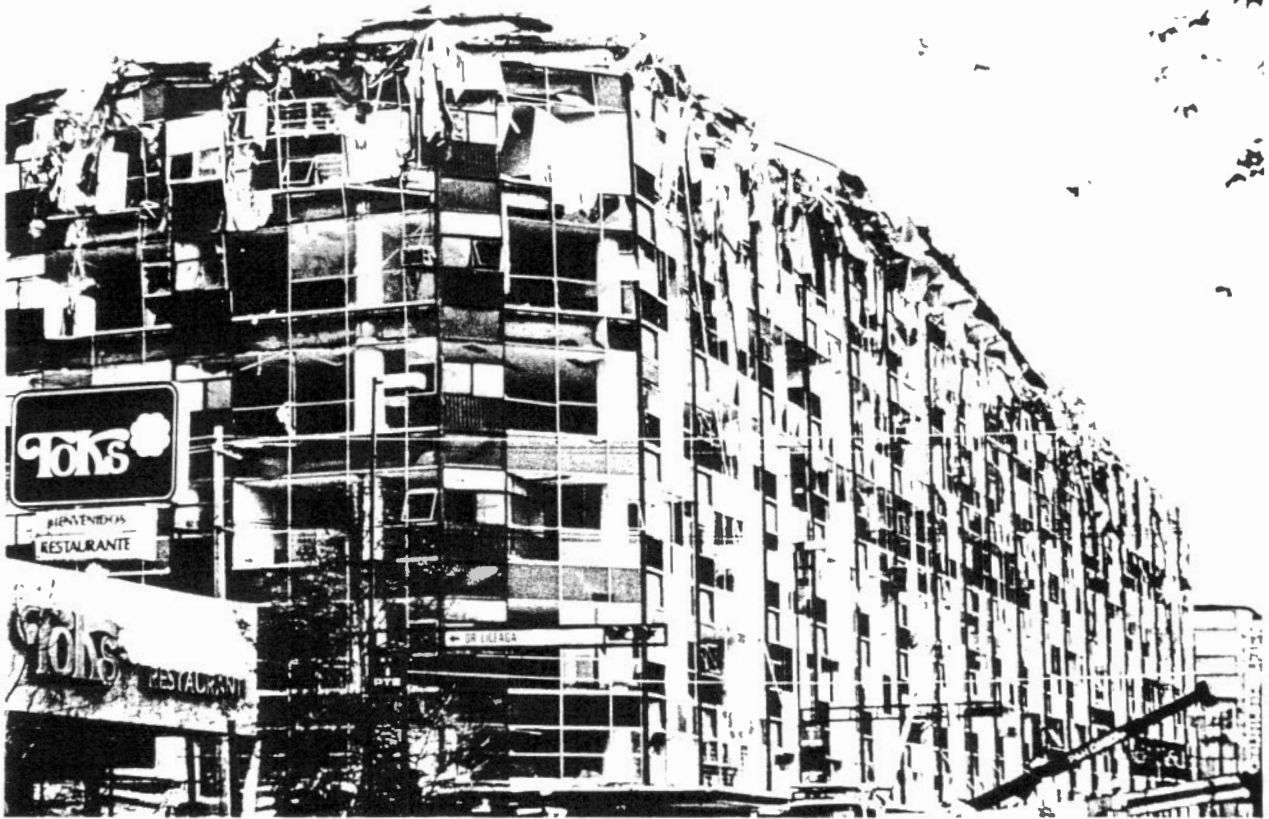
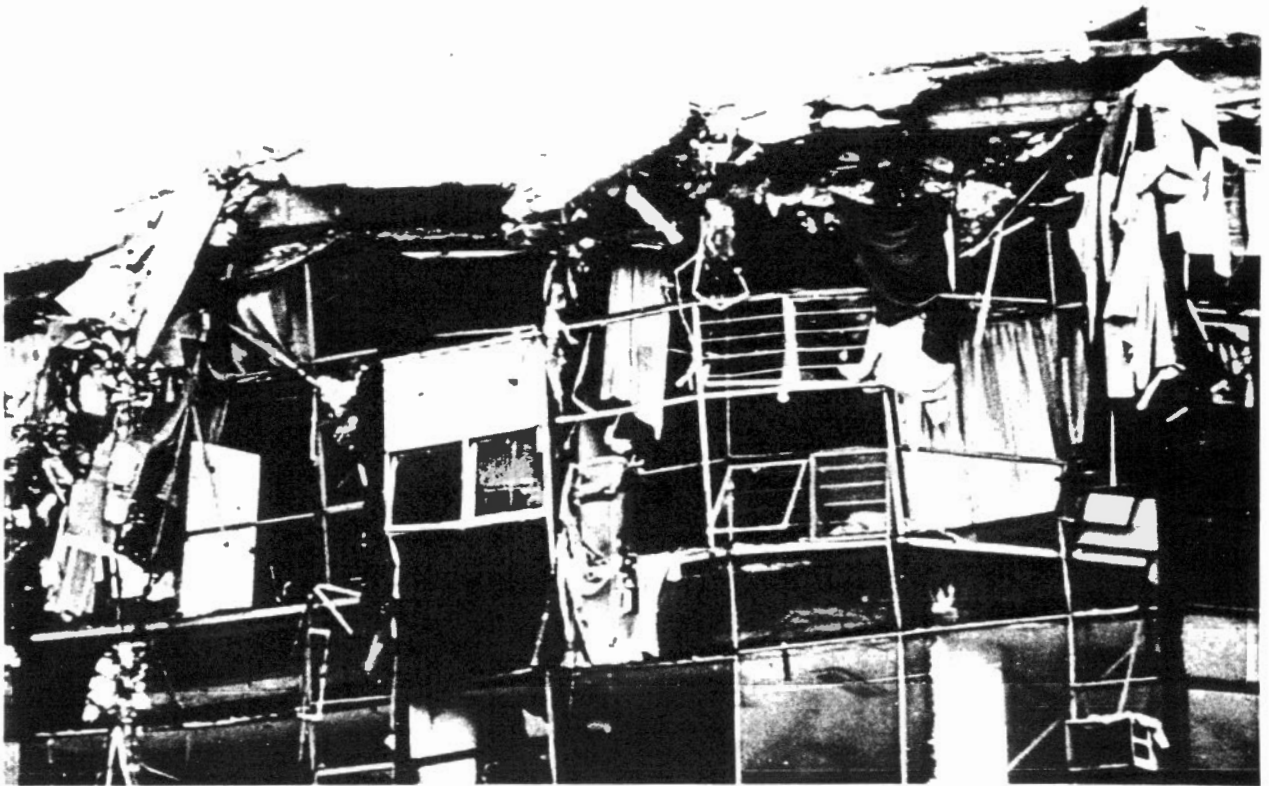
Fig. 6.17a and 6.17b Eight Storey Flat Plate Structure with Collapsed Top Storey

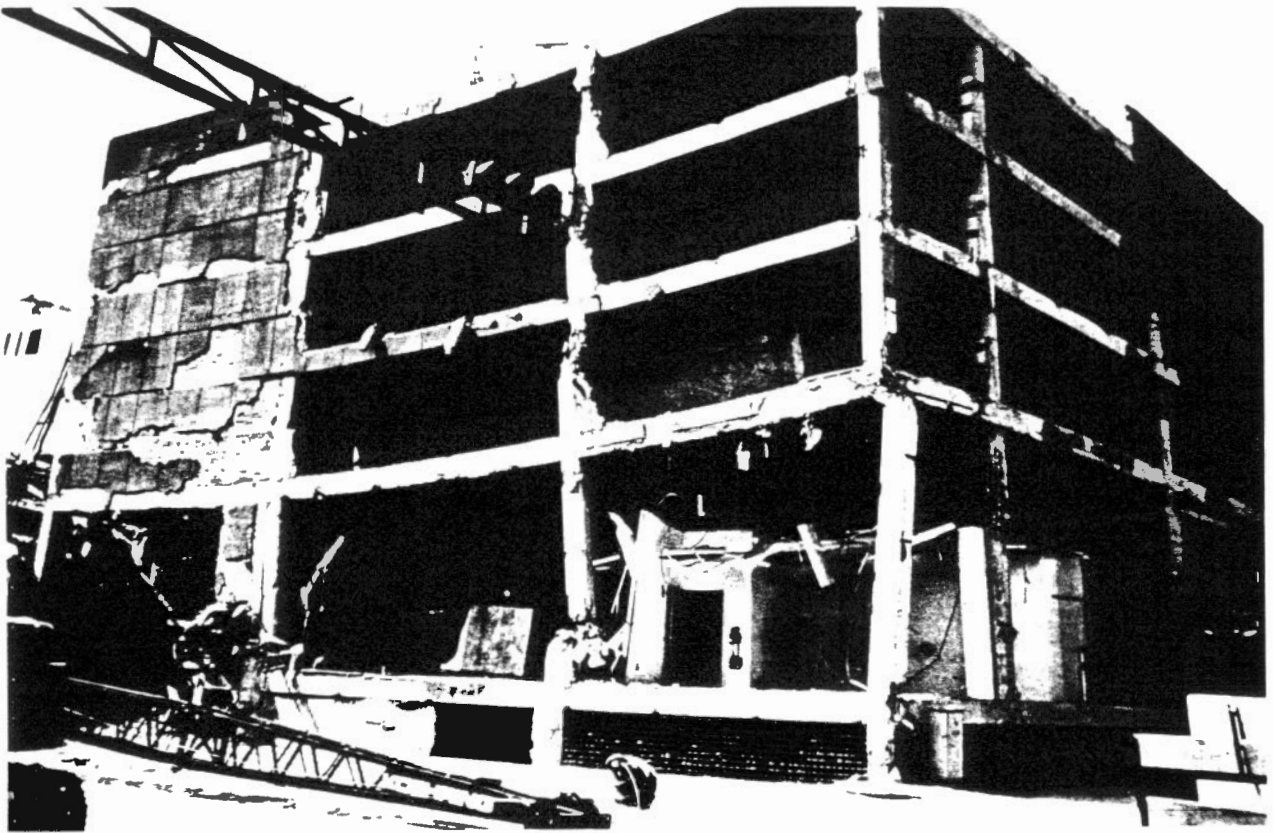
Fig. 6.19a and 6.19b Four Storey Theatre with Reinforced Concrete Frame and Masonry Infilled Walls

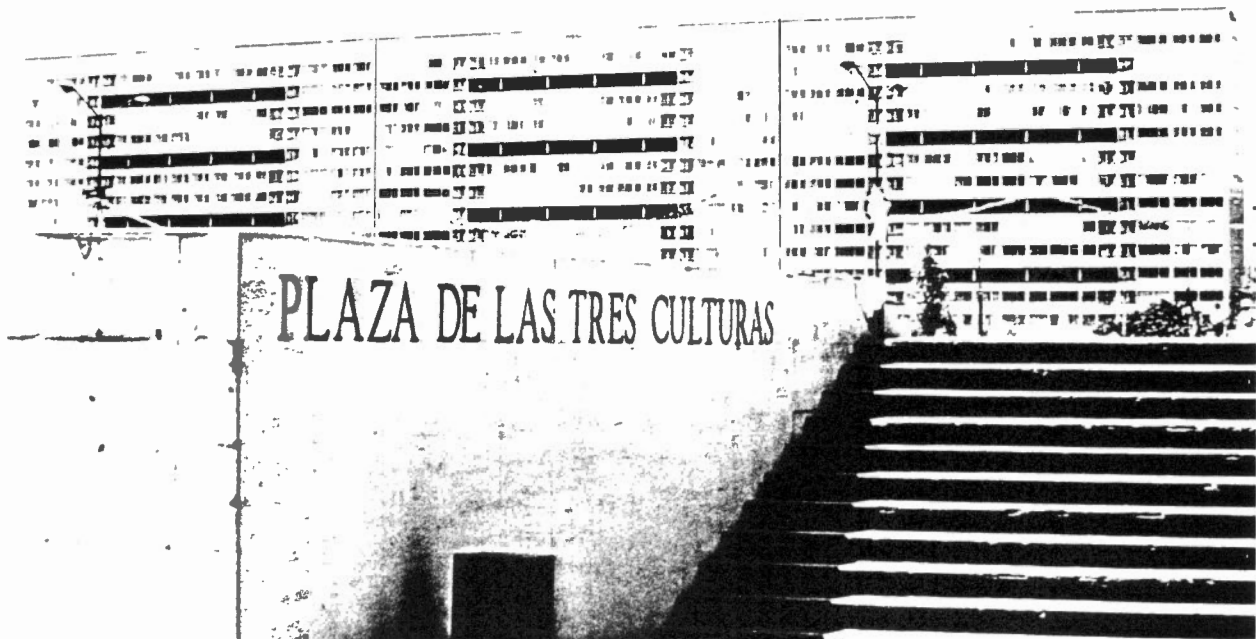
Fig. 6.20 The Tlatelolco Housing Development

The 23 year old Tlatelolco housing development contains 102 apartment and condominium buildings with about 105,000 inhabitants. This development is in the soft soil region close to the transition zone. According to the National Housing Agency only 59 out of the 102 buildings are habitable.

Shown in Fig. 6.20 is the Chihuahua apartment building which is rectangular in plan and is composed of three parts. In the Nuevo Leon condominium complex, which was identical to the Chihuahua structure, 2 of the three adjacent parts had completely collapsed. Details are given in Fig. 6.21 a, b and c.

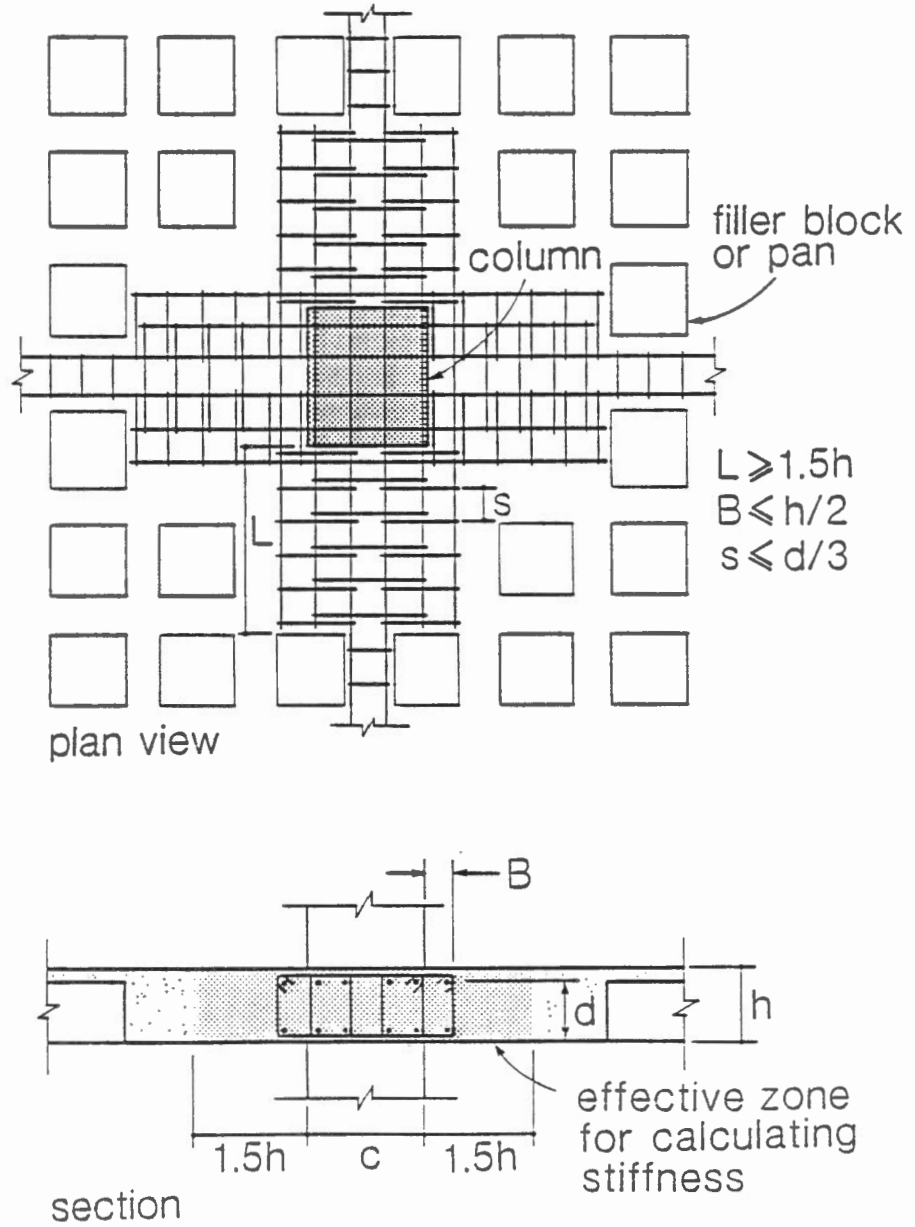
Fig. 7.1 Details of Waffle Slab Required by Emergency Code Changes

ARTICLE 12 In using the equivalent frame analysis for regular slab structures subjected to vertical loads the column stiffnesses should be reduced by one-half. For analysis with lateral loads an equivalent beam width of slab equal to  $c_2 + 3h$  is used [where  $c_2$  = column dimension perpendicular to the direction in which moments are being determined and  $h$  = slab thickness.] At least 75 percent of the longitudinal slab reinforcement necessary to resist seismic loads must pass through the column and the rest of the reinforcement must be within a distance of  $1.5 h$  from the column face. The waffle slabs must contain a solid slab region around the column over a distance of at least  $2h$  from each column face. In the analysis of slabs it is necessary to account for the variation of the moment of inertia of the equivalent beam. The reinforcement of the equivalent beam in the solid portion of the slab around the column must have stirrups having a spacing not exceeding  $1/3$  of the effective slab depth. [The resulting details of a waffle slab are illustrated in Fig. 7.1].
