GEOLOGICAL ASPECTS OF THE BEACH RESTORATION
PROGRAMME IN CHEDABUCTO BAY,
NOVA SCOTIA, 1970.

E.H. Owens

Report to the
Scientific Coordination Team
Project Oil Task Force

September 1970.

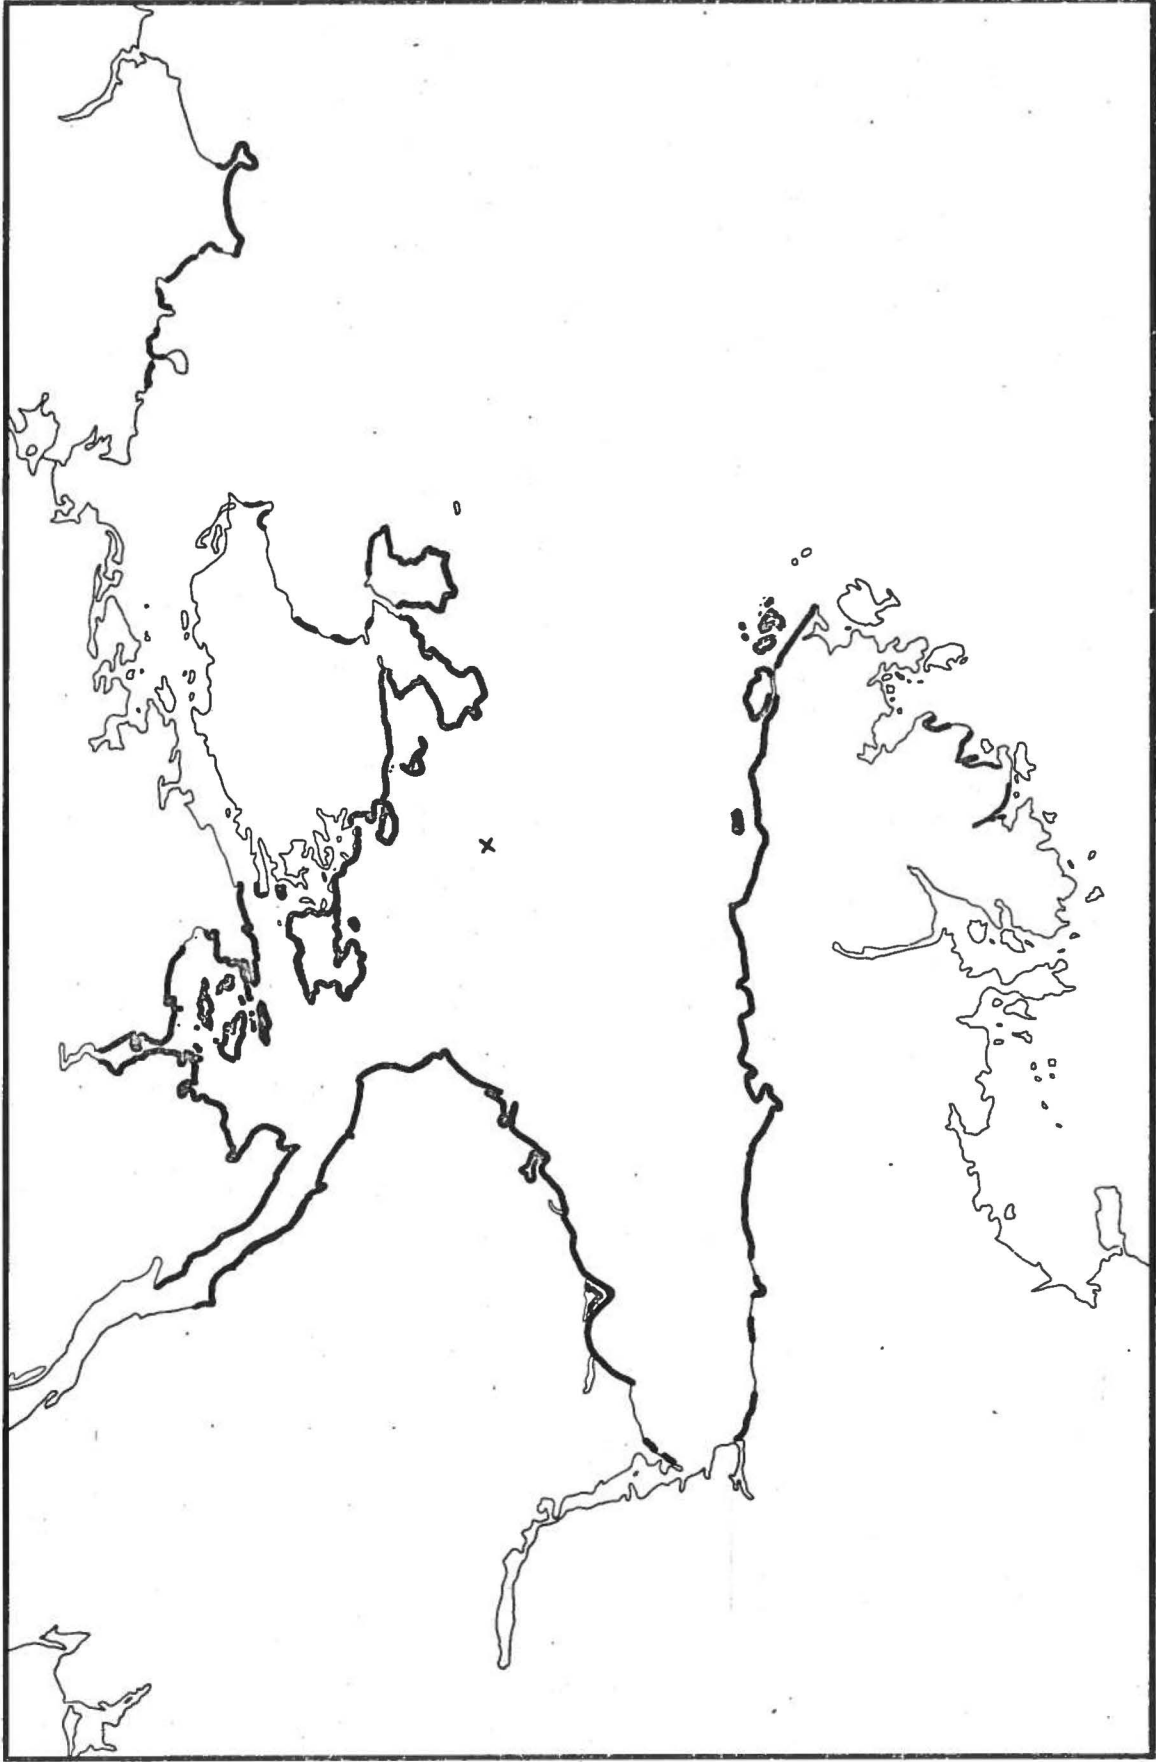
Those coastal areas which were contaminated by Bunker C from the "Arrow" are outlined in Figure 8. This diagram is only accurate for the Bay itself as many of the areas in the north-east and to the south and west of Cape Canso were only surveyed at the reconnaissance level and thus only those areas where oil was actually observed are indicated. The shore affected by oil was more extensive than is shown and it should be noted that contamination extended as far as St. Esprit, on the north shore some 5 miles east of Point Michaud, and Sable Island, which lies over 100 miles south-east of the Bay (Figure 1). The major spills took place in February and March but oil leaked from the wreck throughout the spring and summer.

light and not continuous. The shore of the east section of Lennox Passage was not polluted following the construction of a dam in the middle section.

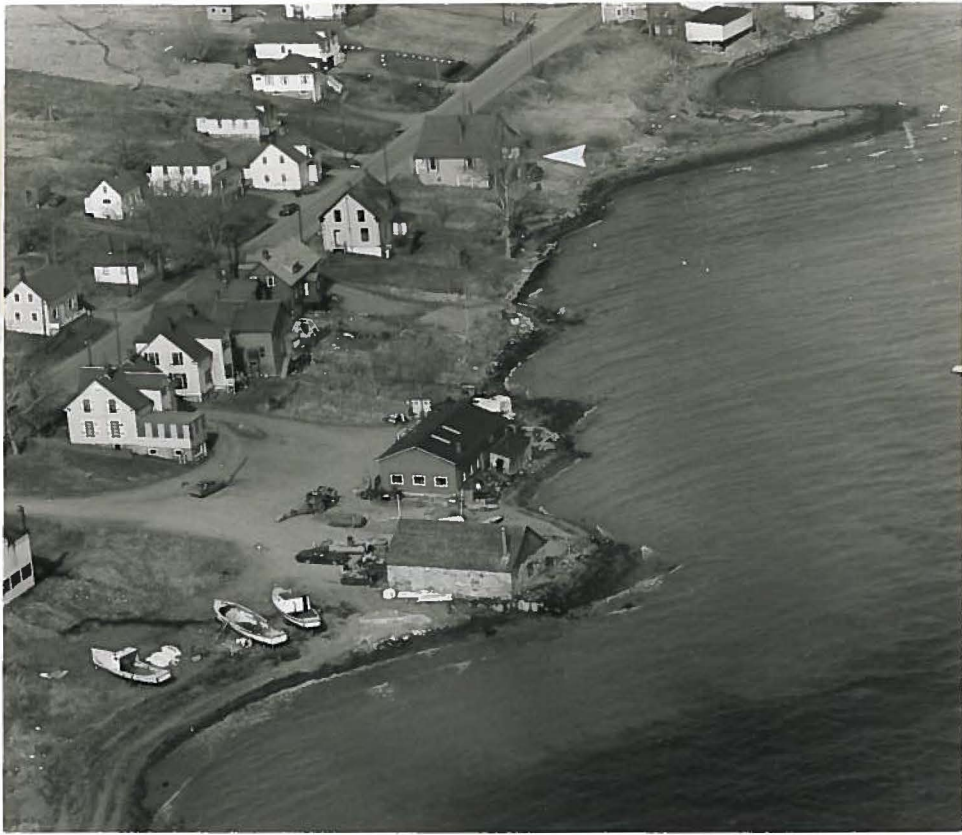
ARICHAT June 9, 1970

4. The east half of the area is made up of a series of three mid-bay bars and low active till cliffs (Photograph 1). The bars have been built out on a shallow platform which has a maximum width of about 60 feet. Sediment accretion on these small bars has deprived the intervening areas of material so that the narrow beaches have not prevented wave erosion of the backshore cliffs. The till cliffs are generally lower than the west section, being between 5 and 15 feet high. Various sections have been riprapped or protected with wood structures to prevent the erosion of property.

Air view of east section at high tide after restoration. Material was removed from the foreland areas but not from the beaches backed by cliffs or crib-work. The arrow indicates the location of a building as a point of reference between photographs 1 and 2.

On May 6 it was decided to remove and replace a section by the Noir Forge which had been excavated to the till bedrock and areas were outlined in the east half of the contract where material should not be disturbed. During May 6 to 10, the areas designated for cleaning in the east section were dealt with by the contractor (Photograph 2) and on May 11 the contractor was released.

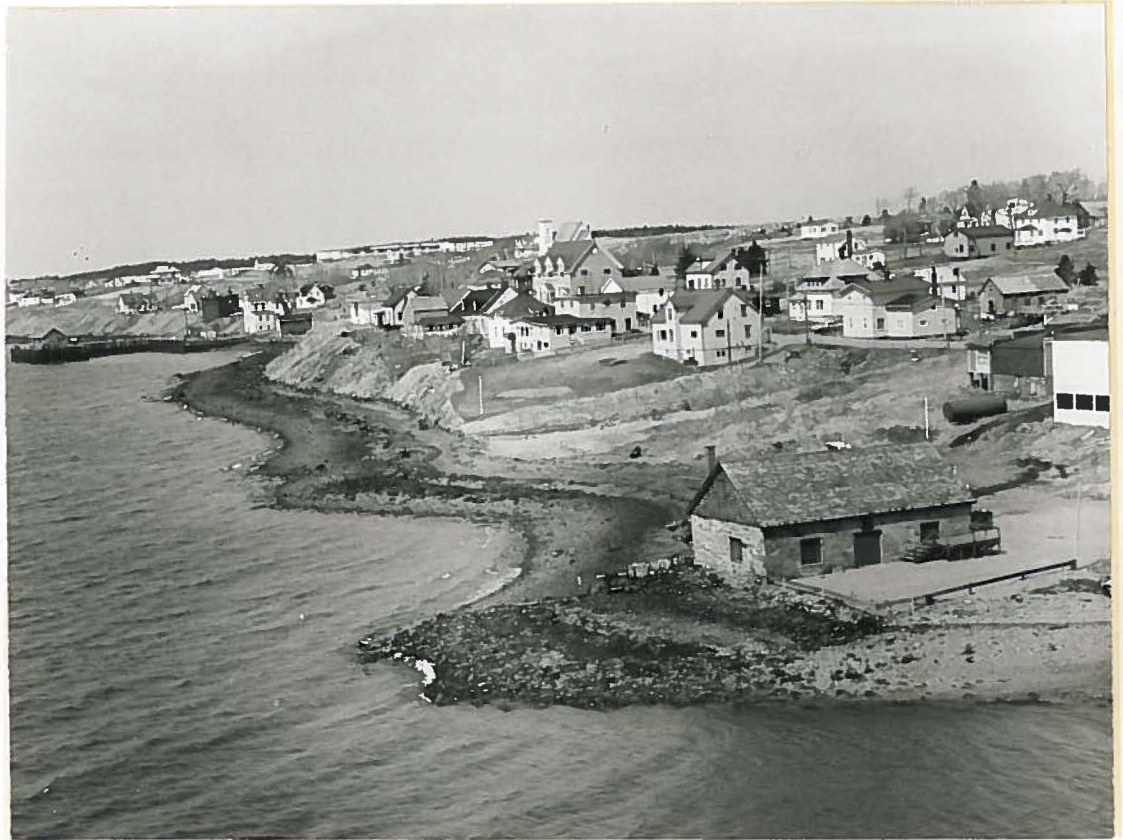
ARICHAT June 9, 1970

2. A small prograding beach, about 100 feet long and 60 feet wide fronts a low backshore in the area immediately west of the Noir Forge (Photograph 3). This appears to have resulted from the prevention of longshore sediment transport by the small headland on which the Noir Forge was constructed.

3. The Noir Forge headland is a till bedrock area which has a beach of till-derived material at its seaward end (Photographs 1 and 3). The two small beaches on either side of the headland are of gravel and are areas of more rapid accretion.

Air view of Noir Forge and west section near high tide after completion of the contract work. The dark line near high water on the west section is the reoiling of the material which was pushed against the cliff base. Boulders have been brought in at the right of the Forge as replacement for some of the removed material. To the east of the Forge certain sections were not cleaned because of the danger of erosion or inaccessability to heavy equipment.

This was the first of the contracts to be issued and work began on April 30. Contaminated material in the intertidal zone just to the west of the Noir Forge was heaped into piles and a "road" was bulldozed along high water mark westwards toward the wharf (Photograph 3). Some concern over the action of the contractor was expressed at the evening meeting and it was decided not to remove any material beneath the cliff west of the Noir Forge. As the "road" had already been bulldozed part of the way the disturbed material on that section would be pushed against the base of the cliff. The contaminated material which had been piled up on the beach adjacent to the Noir Forge would be removed.

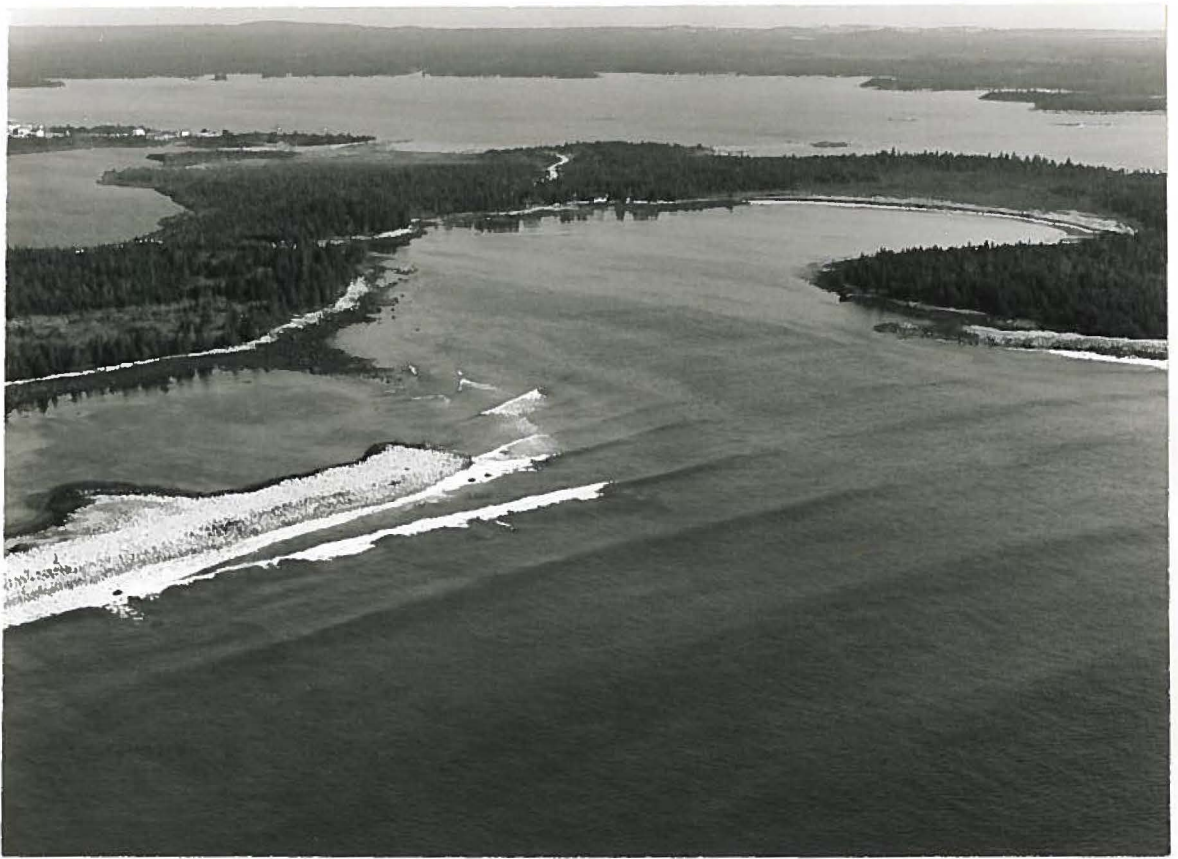
BLACK DUCK COVE July 10, 1970

Drapeau also noted that within one month of contamination gravel bars directly exposed to wave processes cleaned themselves naturally and effectively, whilst in protected areas the beaches remained polluted. This is particularly evident in photographs 5 and 6 of Black Duck Cove. The lagoon remained heavily

The exposed side of the spit has effectively cleaned itself. Traces of oil are still evident in small amounts on the material where it has not been completely abraded. Despite the size of the beach material, this is a very active and mobile beach, during periods of storm waves these sediments were in constant motion.

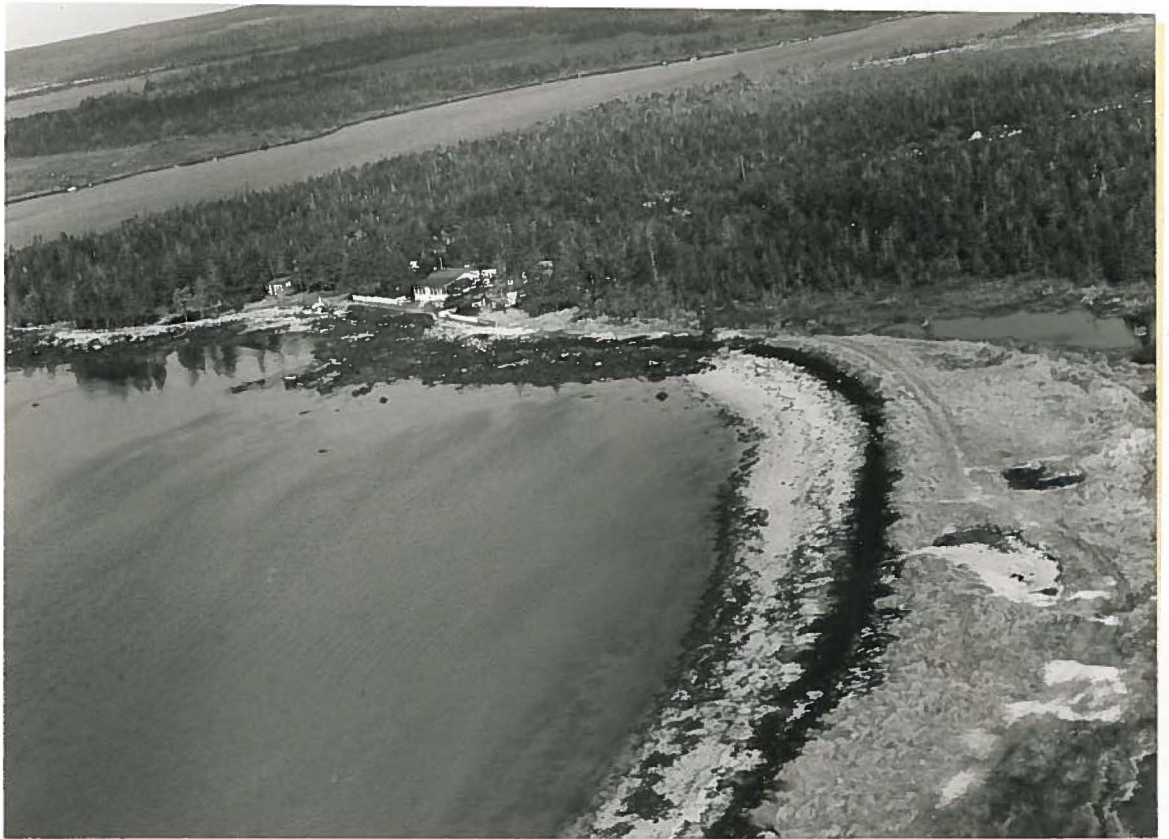
BLACK DUCK COVE May 2, 1970

Air view of beach restoration work at low tide. A bulldozer shoved the contaminated sediments above the high water mark for subsequent removal by a front-end loader. The contaminated material along the edge of the vegetation was removed by the bulldozer scraping backwards down the beach in order to minimize damage to the backshore. For the same reason access to the beach from the backshore was carefully controlled to prevent the development of blow-outs.

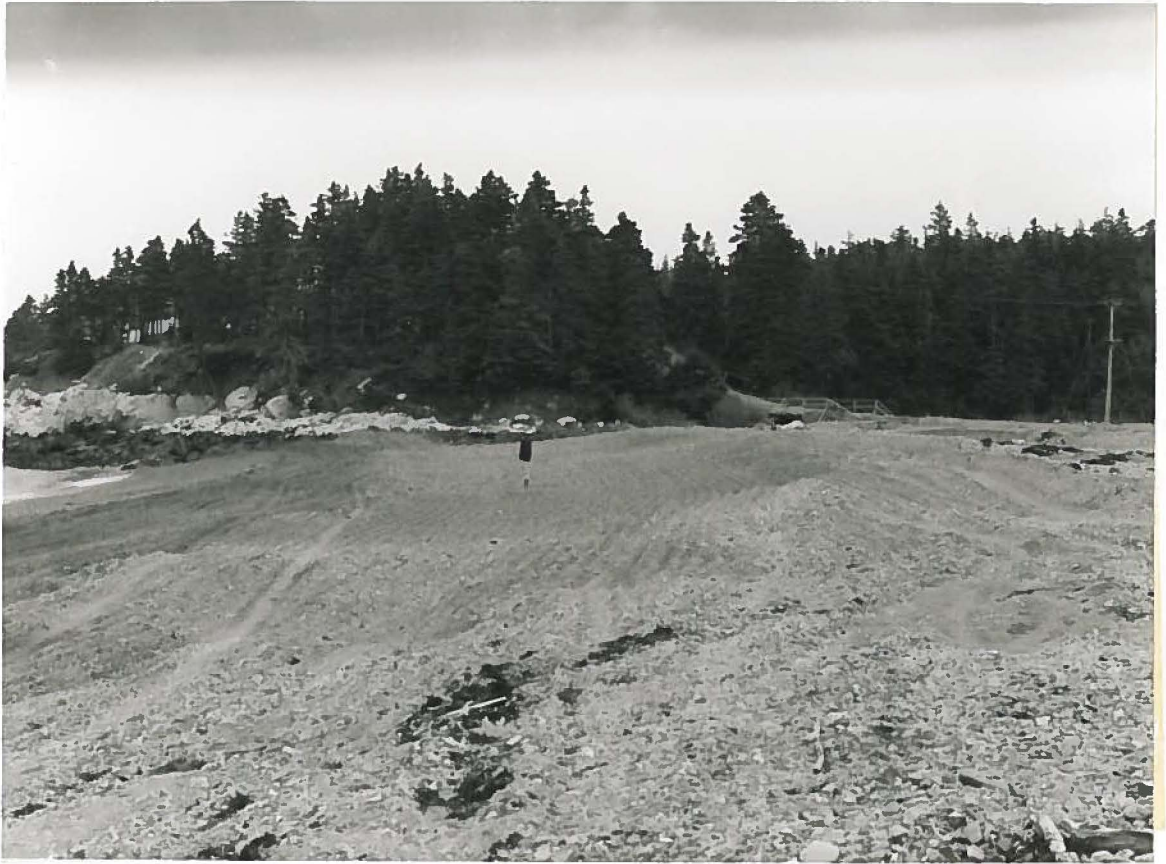
INDIAN COVE May 25, 1970

The same view as above at low tide four days later. The recontamination was from alongshore and the oil was concentrated at the high water mark.

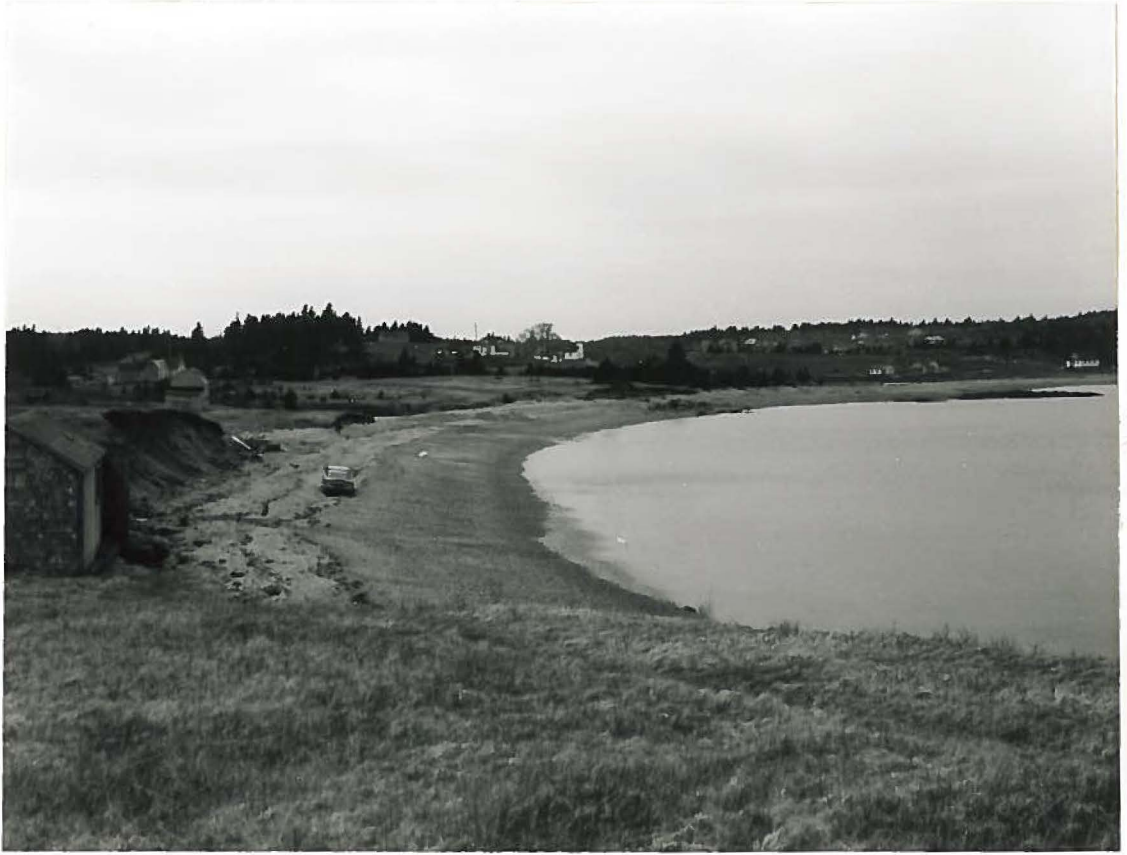
HALF ISLAND COVE June 3, 1970

The same section of beach at low tide after completion of the contract work. The dark patches in the left foreground are contaminated sediments (see photograph 17). This beach exhibits a summer profile gradation of cobbles on the upper part of the beach and a mixture of coarse sand, gravel, and cobbles in the intertidal zone.

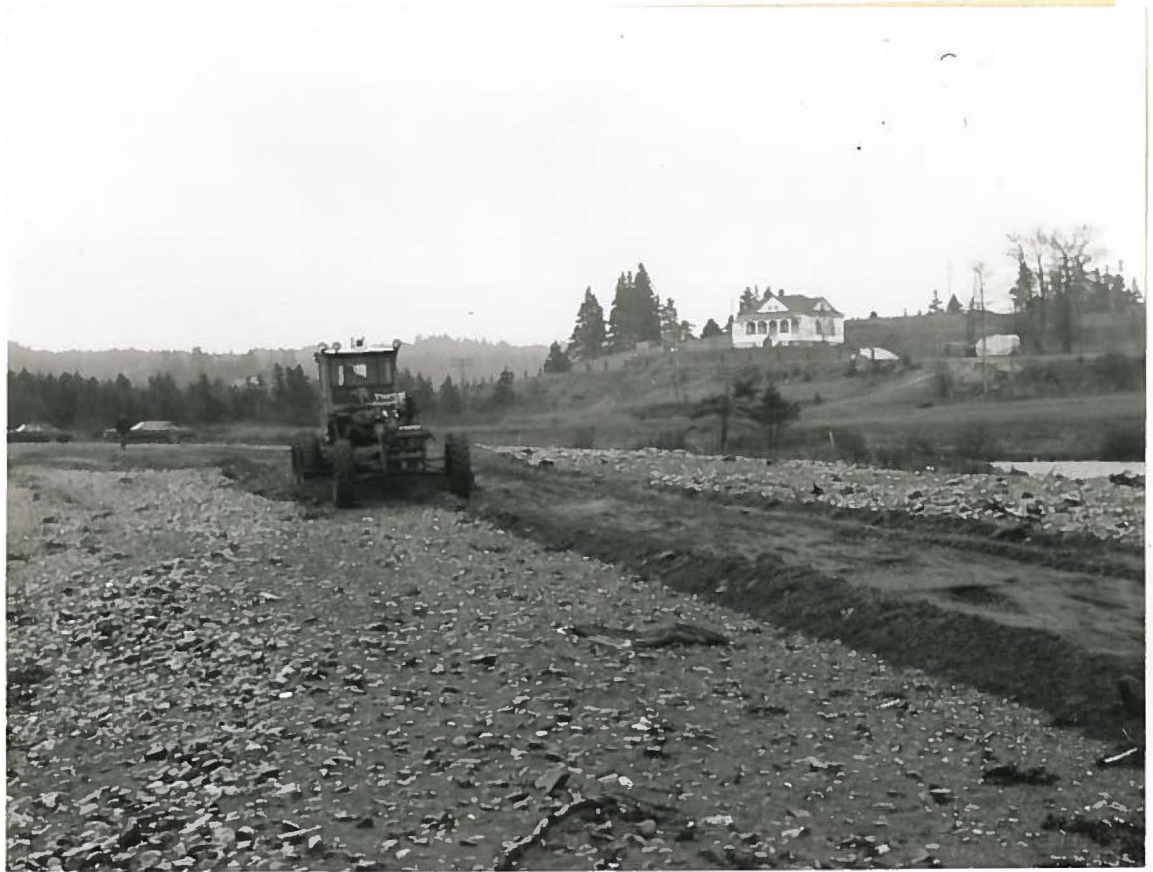
HALF ISLAND COVE May 26, 1970

Effect of a decrease in traction and a non-level surface on the performance of the grader. The machine was almost stuck and churned up the beach to a depth of two feet.

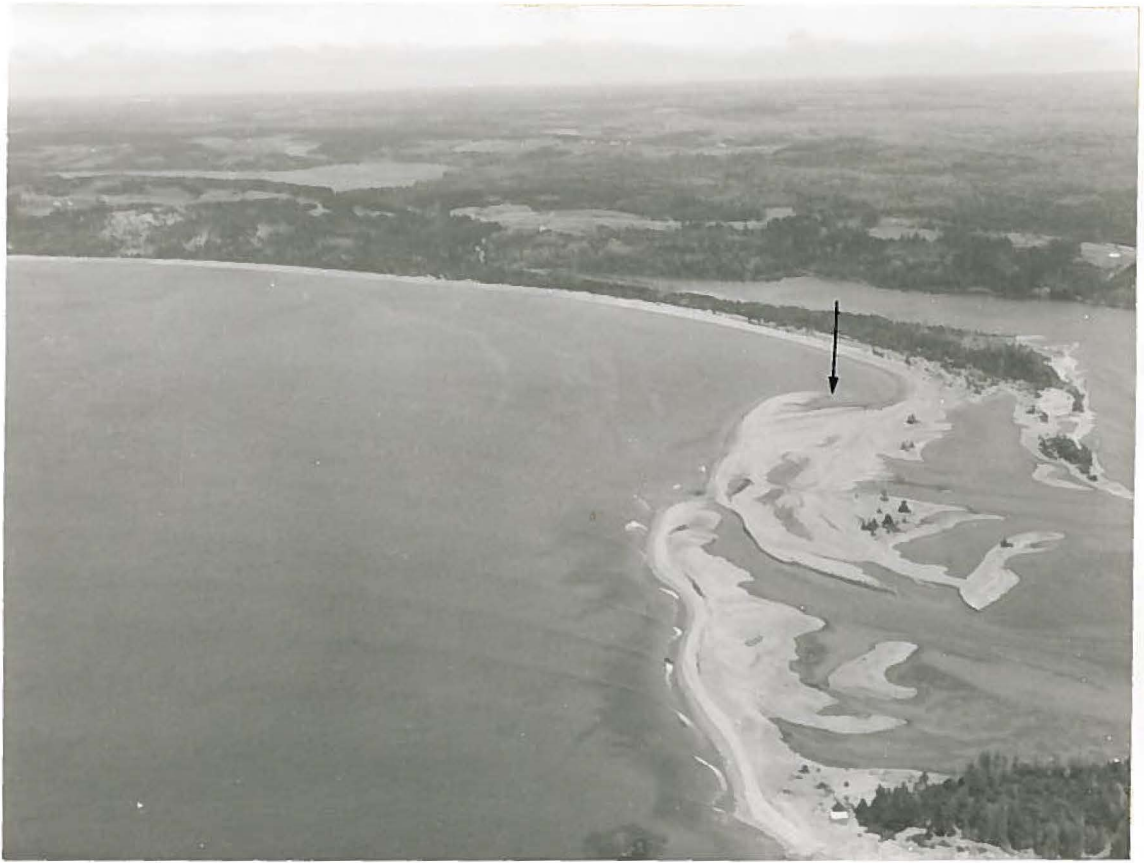
MOOSE BAY June 9, 1970

Air view of the main section of the beach at mid tide before restoration. The main storm ridge is backed by a vegetated swale which in turn is replaced by a higher vegetation sequence. A squad of "slick pickers" is removing contaminated material manually (see also photograph 41), these are located by an arrow. No sections of this beach were paralyzed, although originally heavily polluted most of the oil was buried or removed by normal wave action.

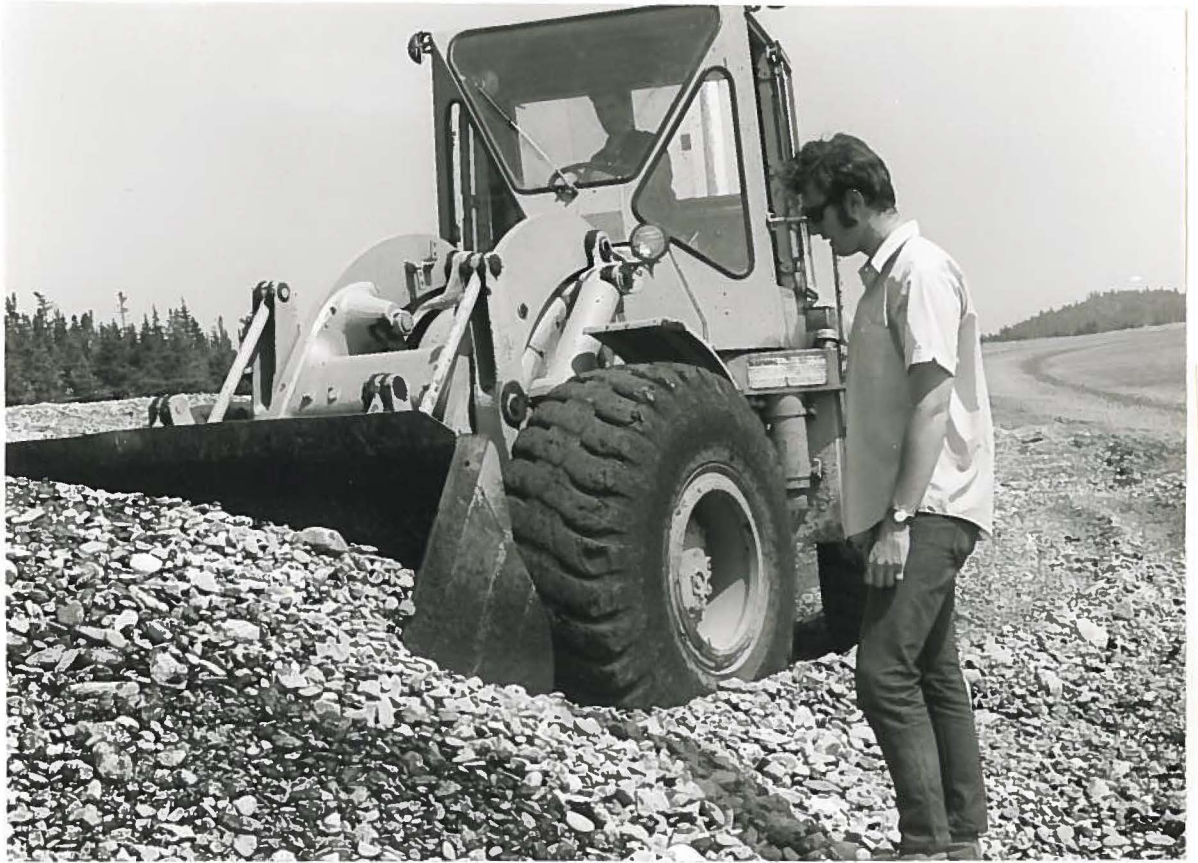
HADLEYVILLE #I June 3, 1970

This is a similar area to Moose Bay though more heavily polluted, it is an active beach which had succeeded in cleaning itself well. Again contaminated material was reworked and this shows the loader attempting to remove a buried layer. This machine is quite efficient if operated well but there is a great deal of spillage from the bucket as it shoves into the beach.

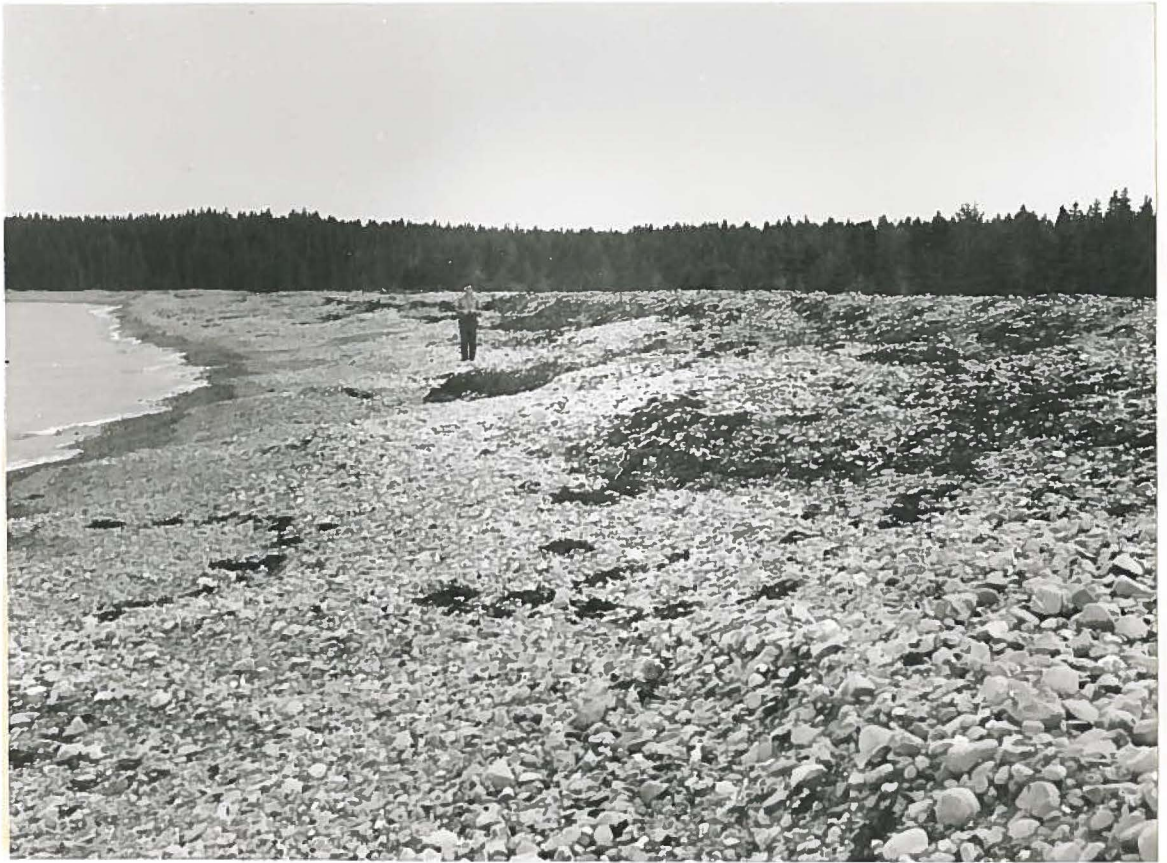
HADLEYVILLE #I. June 13, 1970

The west section after restoration at low tide. Much of the storm ridge has been removed and the beach has a much lower slope than previously. Dark patches are seaweed.

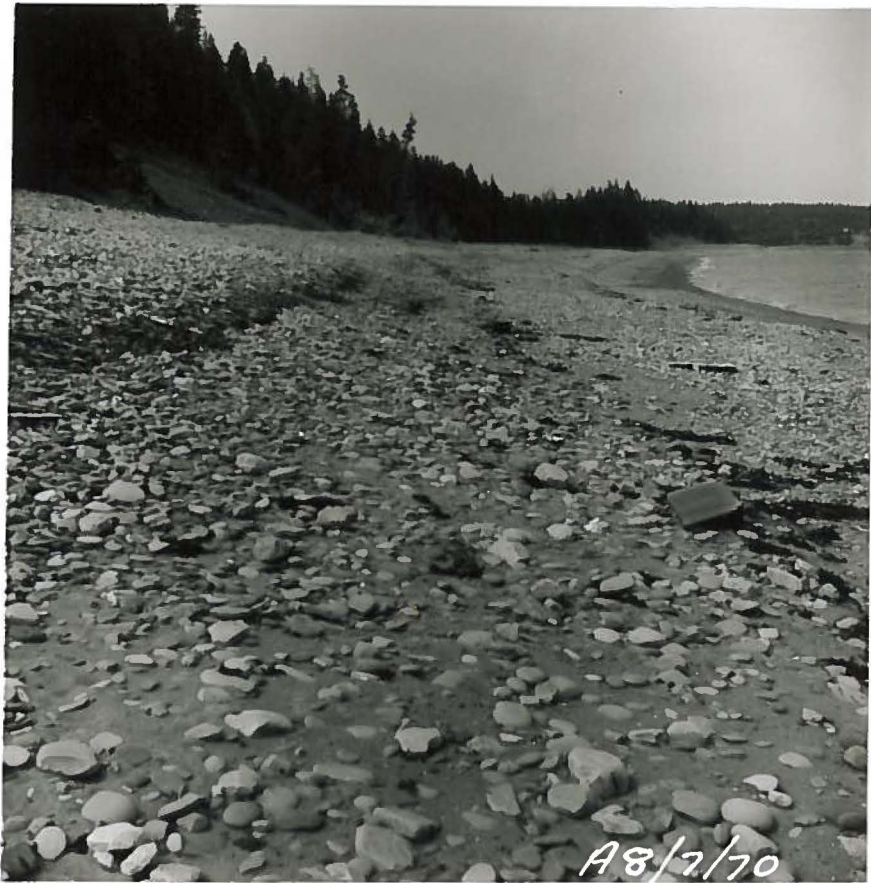
HADLEYVILLE #II. July 10, 1970

The layers of oil, when exposed by wave action, are more resistant to erosion but quickly collapse through sunlight and gravity.

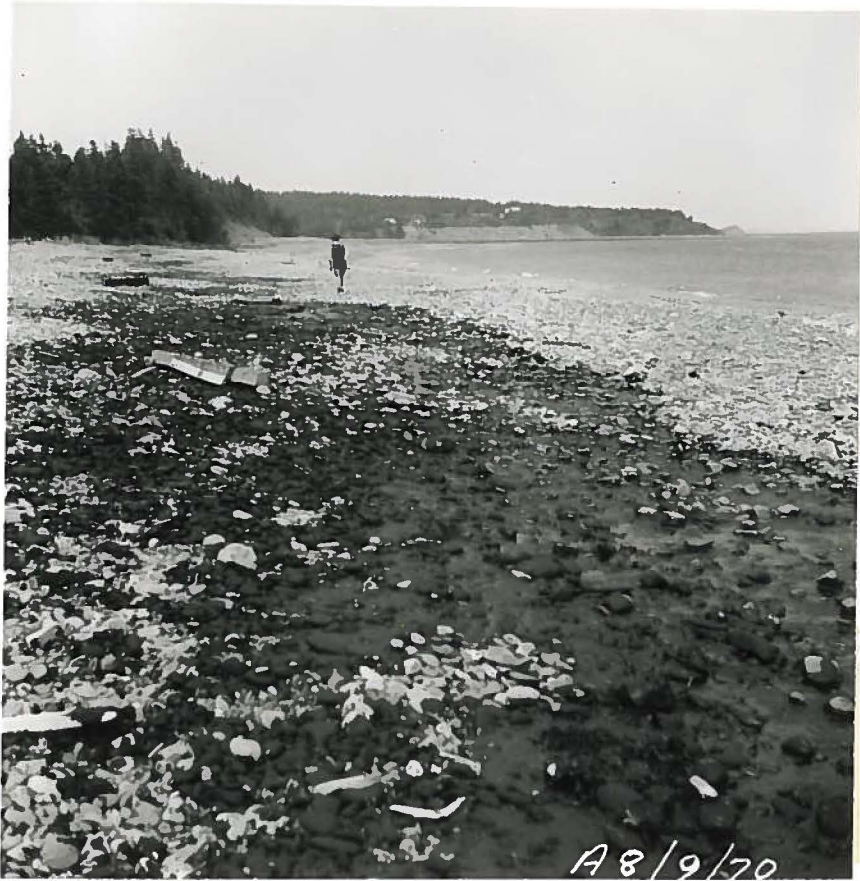
HADLEYVILLE #II. July 10, 1970

The east end of the beach was made up of coarse sand and the oil remained as large pans which had a surface layer of fines or was buried to a depth of several feet. No oil was visible in the intertidal zone.

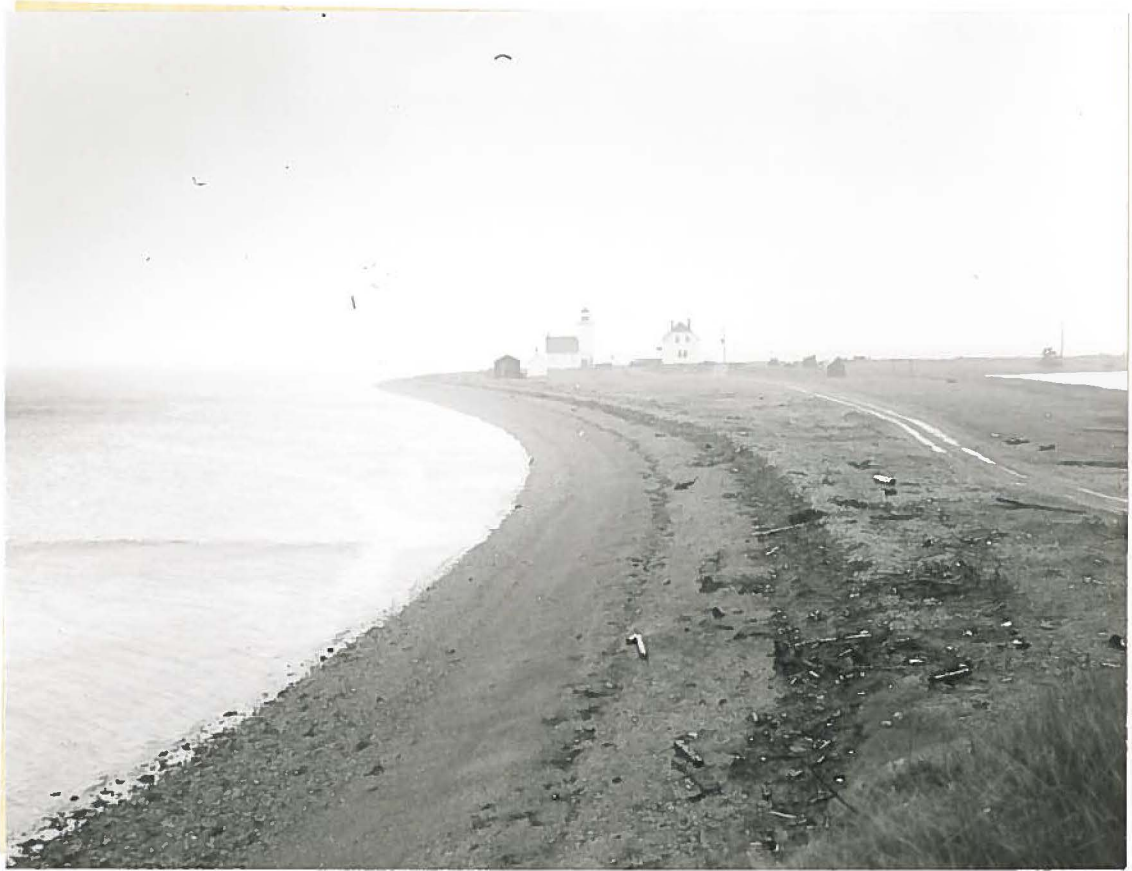
EDDY POINT June 29, 1970

After restoration, at mid tide. Along this north shore clean material was brought in as replacement and deposited at the beach crest to prevent breaching of the bar.

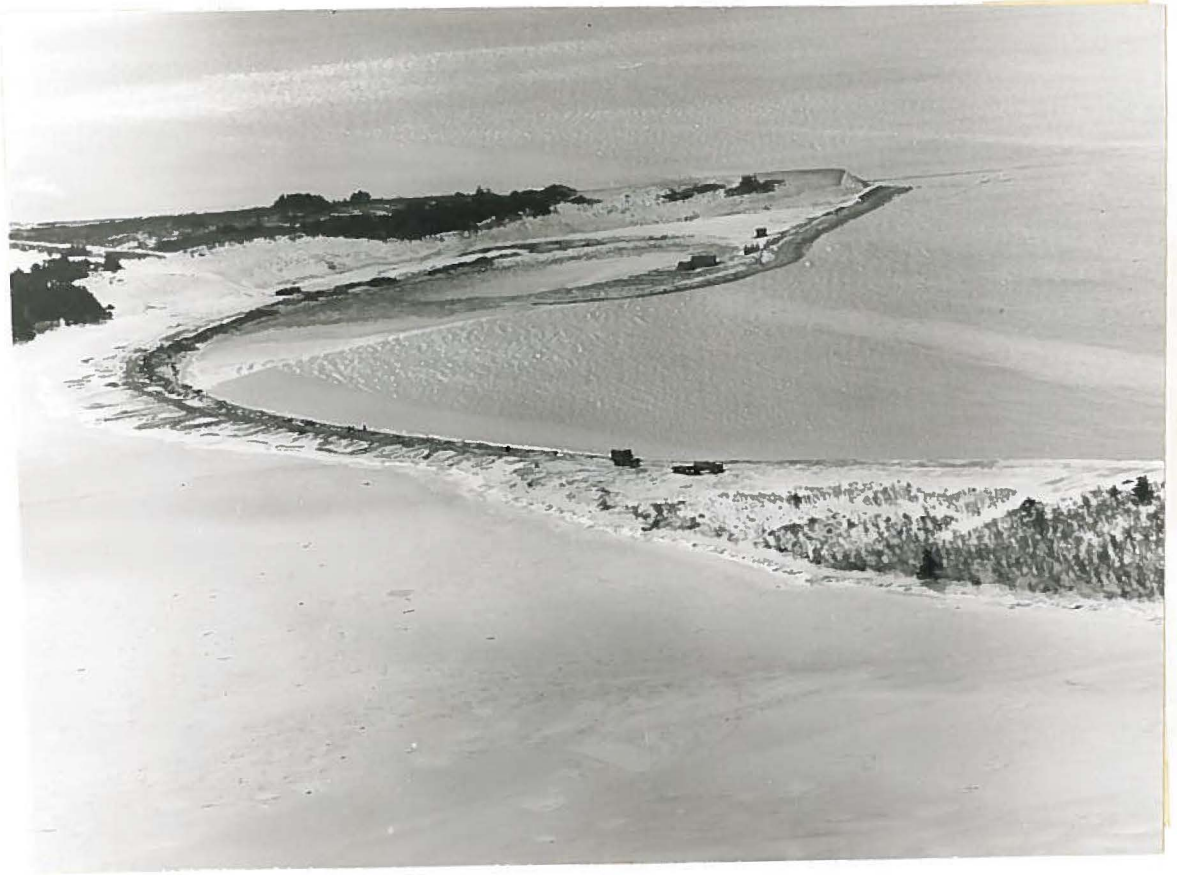
DEEP COVE March 1, 1970

Air view of beach from the south at high tide. This beach was heavily contaminated on frequent occasions and at this time much of the sea ice was covered with oil. In the central section of the beach, near the group of people, the bar is only 100 feet wide, the far side is hidden by snow and ice cover.

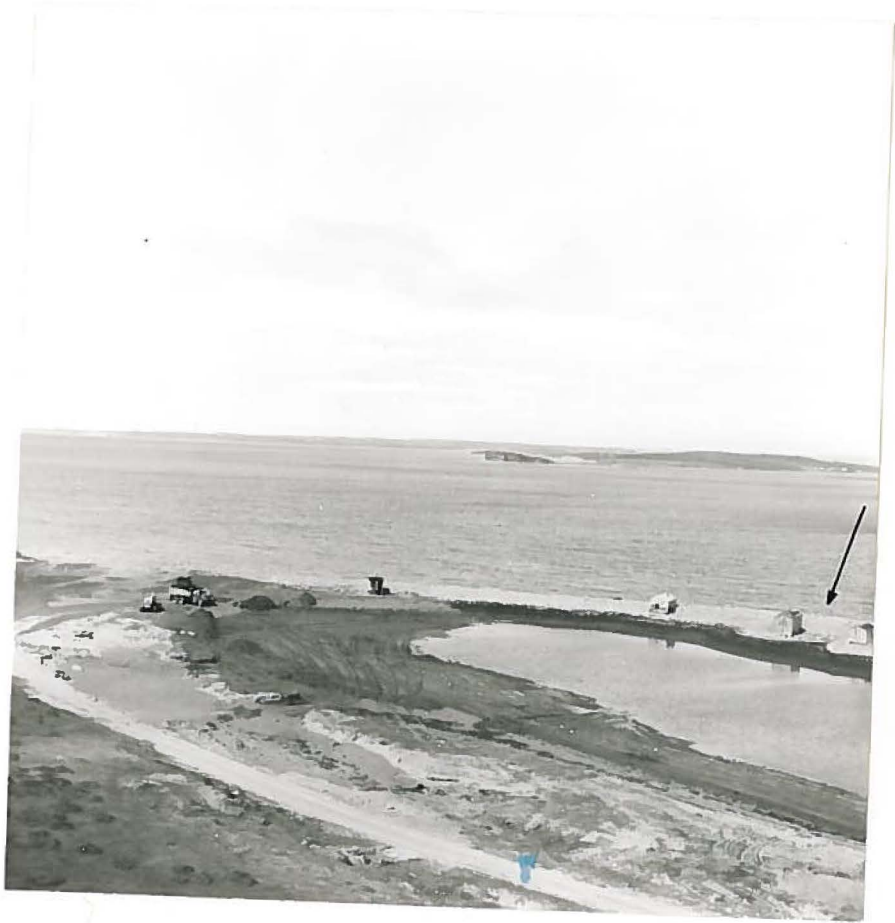
DEEP COVE June 29, 1970

Following the initial work on this beach (see Section 6.1., page 36) further removal of contaminated sediments was carried out in June on the seaward side of the bar and in the lagoon. An angle-blade bulldozer was used in the lagoon area to remove the surface oil (Photograph 36) but the vehicle tracks acted to grind in the oil which had been buried. Although the machine was relatively efficient in scraping the surface it did not affect the oil which was interbedded with the silt and mud except to mix it to a depth of several feet.

As replacement for material removed from the bar the spit was excavated in the centre to a depth of more than six feet. The location of the excavation is shown on photograph 36. The high water mark on the beach is indicated by a line of seaweed. This beach, on the exposed side of the spit, has been cleaned by wave action though it was heavily polluted on several occasions. The lee side is still paralyzed (see above).

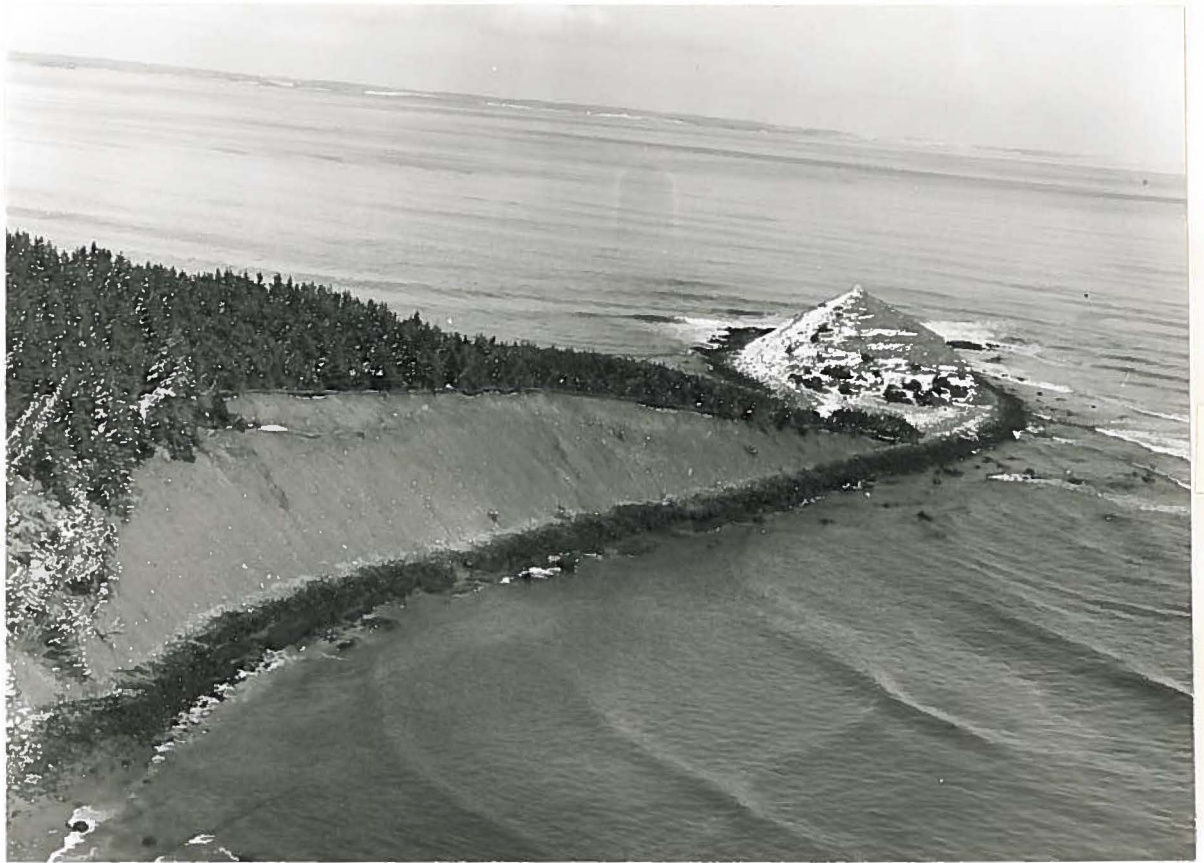
WALKERVILLE June 27, 1970

At the base of till cliffs which are in active retreat there is usually a narrow cobble and boulder beach (Photograph 38). This material is derived largely from the erosion of the free face, which is a limited supply source as most of the till is clay and silt sized material. The retreat of the cliff has led to the development of a small

This beach on the sheltered north shore of Inhabitants Bay has had its thin surface layer of cobbles removed. This has exposed a wet layer of fines about three feet deep. These clean sediments have been thoroughly mixed with contaminated material by the tracked bulldozer and front-end loader.
