Research Report No. 49, "Experimental Zinc Die C	asting	ſ						
Equipment.								
(Preliminary Work on Project Zn-4)"								
ł								
			······	المراجع				
				TENT	5			
	BLE C	JF CO	NTEN	15				
						Page		
Introduction		••		••	• •	1		
Die Casting Machine				• •		2

RESEARCH REPORT NO. 49.

Experimental Zinc Die Casting Equipment

(Preliminary Work on Project Zn-4)

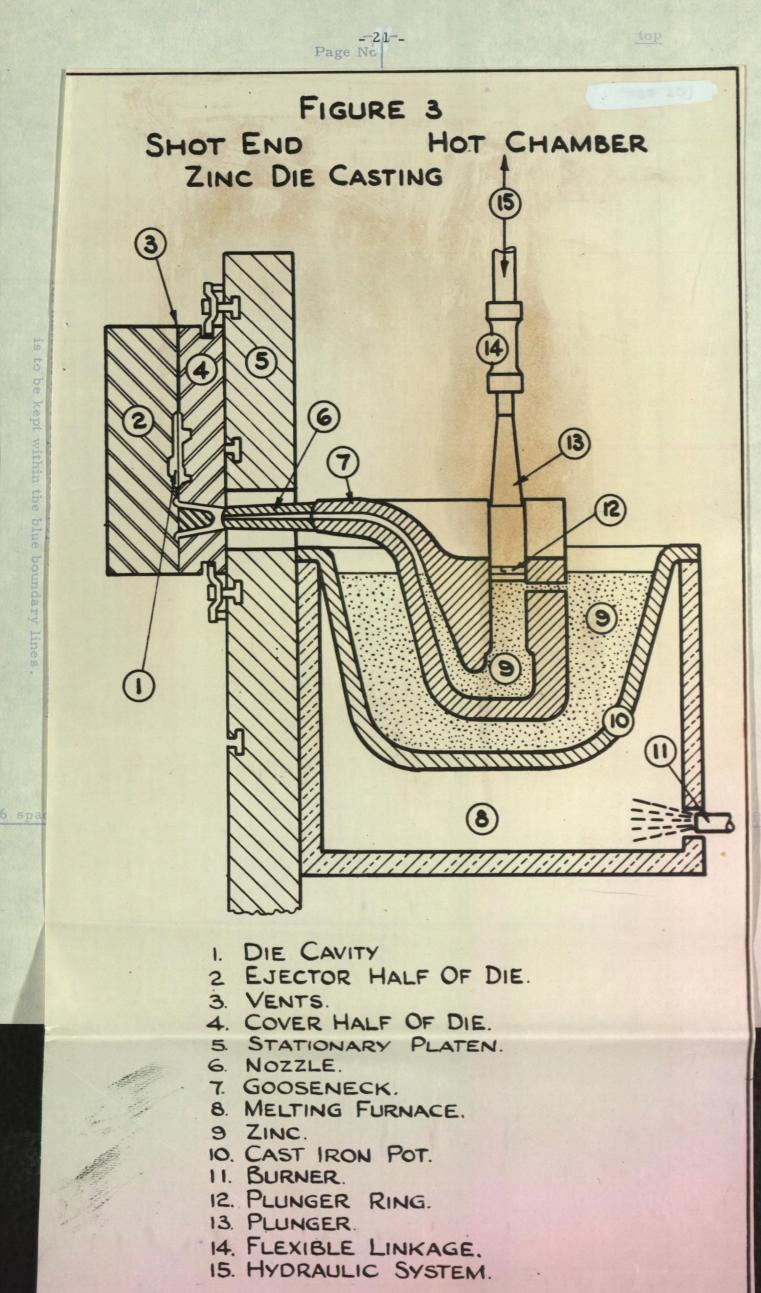
- - 20 --Page No Fig. 2. This sheet is supplied for preparing master sheets for reproduction of paper or metal offset plates by "Xerox" or photography. All material to be reproduced (typed, drawn or mounted) is to be kept within the blue boundary lines. Showing shot end of zinc die casting machine including melting furnace, plunger, and 6 spaces left hydraulic system
