A CASE HISTORY OF SUPPORT AT NACIMIENTO MINE

Ben L. Seegmiller

DECEMBER 1976

MINERALS RESEARCH PROGRAM
MINING RESEARCH LABORATORIES
CANMET REPORT 76-27

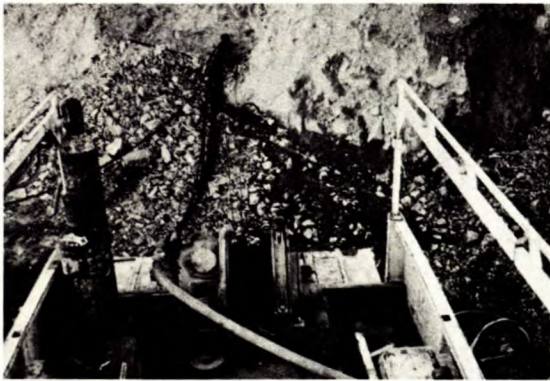
majority of the units, as shown in Fig. 23. Four labourers were required for anchor emplacement in either case.

Fig. 23 - A mechanical tugging to aid anchor insertion

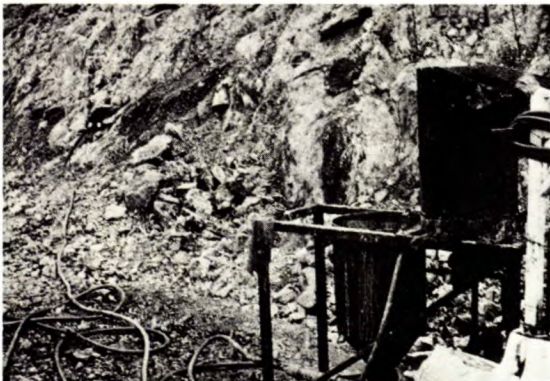
Grouting of the anchorage section is illustrated in Fig. 24. Such grouting was usually done after several anchors had been placed. This enabled the contractor to spend one day grouting several units and another day tensioning the same units after the 14-day curing time.

Fig. 24 - Grouting of an anchorage section

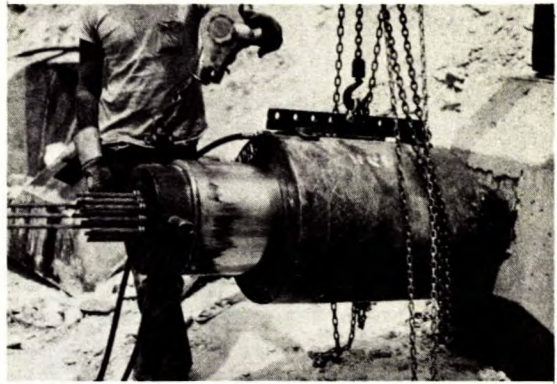
Post-tensioning of anchors was done a minimum of 14 days after both secondary grouting and blockout construction had been completed. The equipment used by the contractor for stressing is shown in Fig. 25 and 26. Stressing was done using a variety of different jacks during the course of the project, ranging from a small hand-held single

Fig. 25 - Stressing a regular anchor with a 500 ton jack

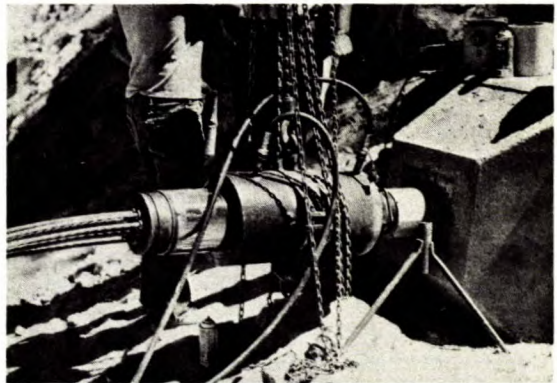
Fig. 26 - Stressing a monitor anchor

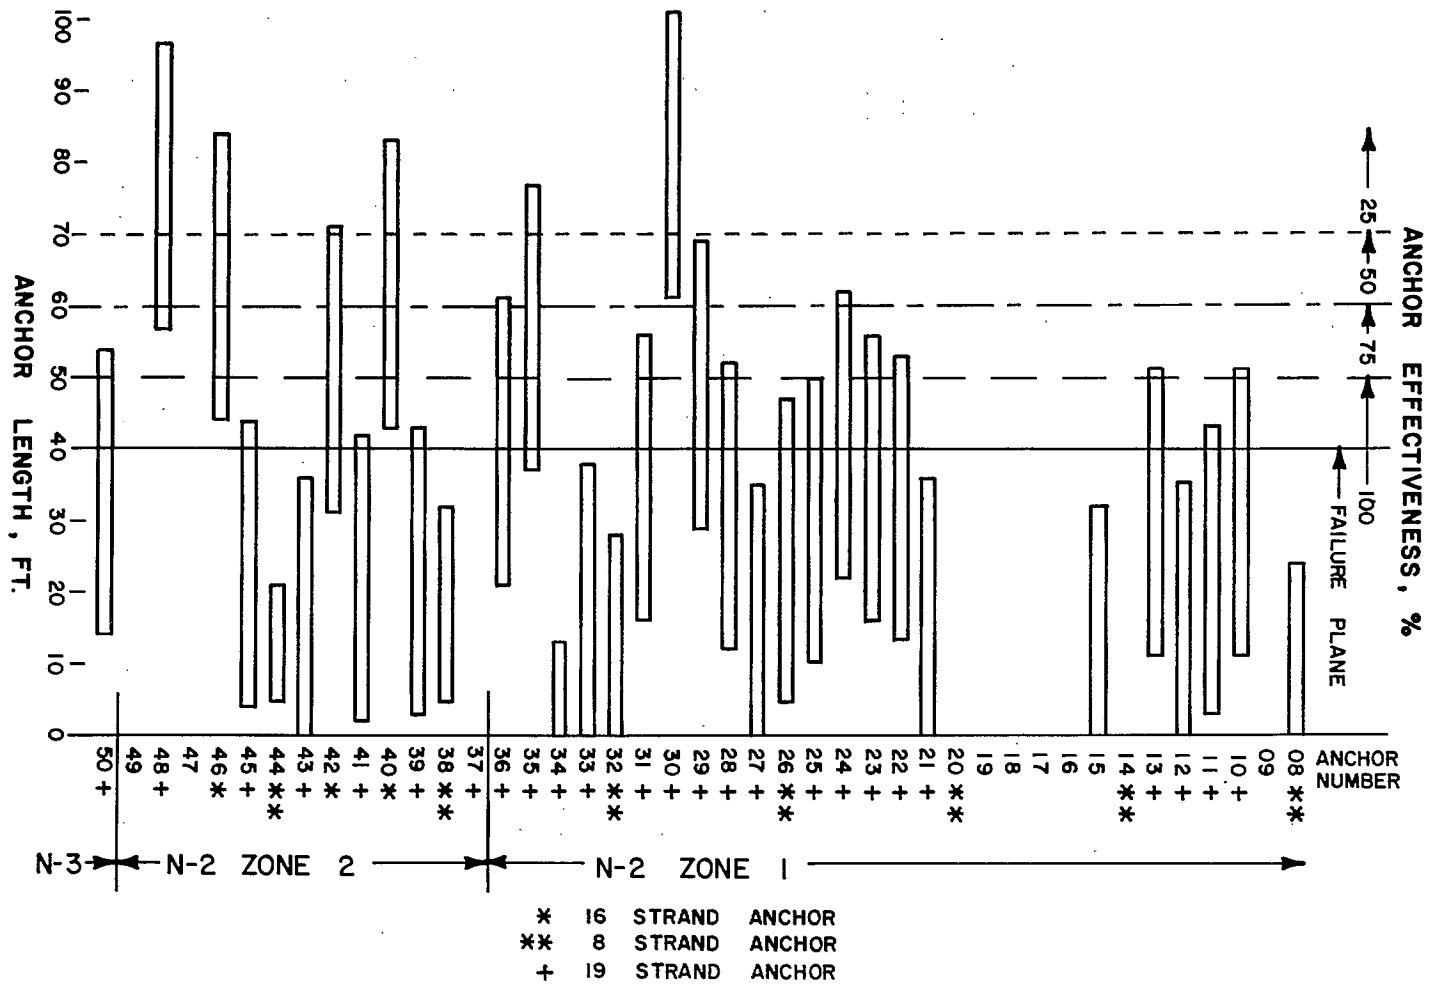
Figure 28 is a schematic drawing showing calculated anchor locations and the assumed anchor effectiveness on the 7600 Bench. A summary by mining bench of the number of stressed anchors and their mean anchorage lengths is presented in Table 8. Mean anchor lengths for regular anchors for various groupings of hole angles and strand numbers are presented in Table 9. The importance of hole angle in achieving effective anchorage sections is shown by the data in Table 9.

Fig. 28 - Schematic of 7600 Bench showing calculated anchor locations and assumed anchor effectiveness

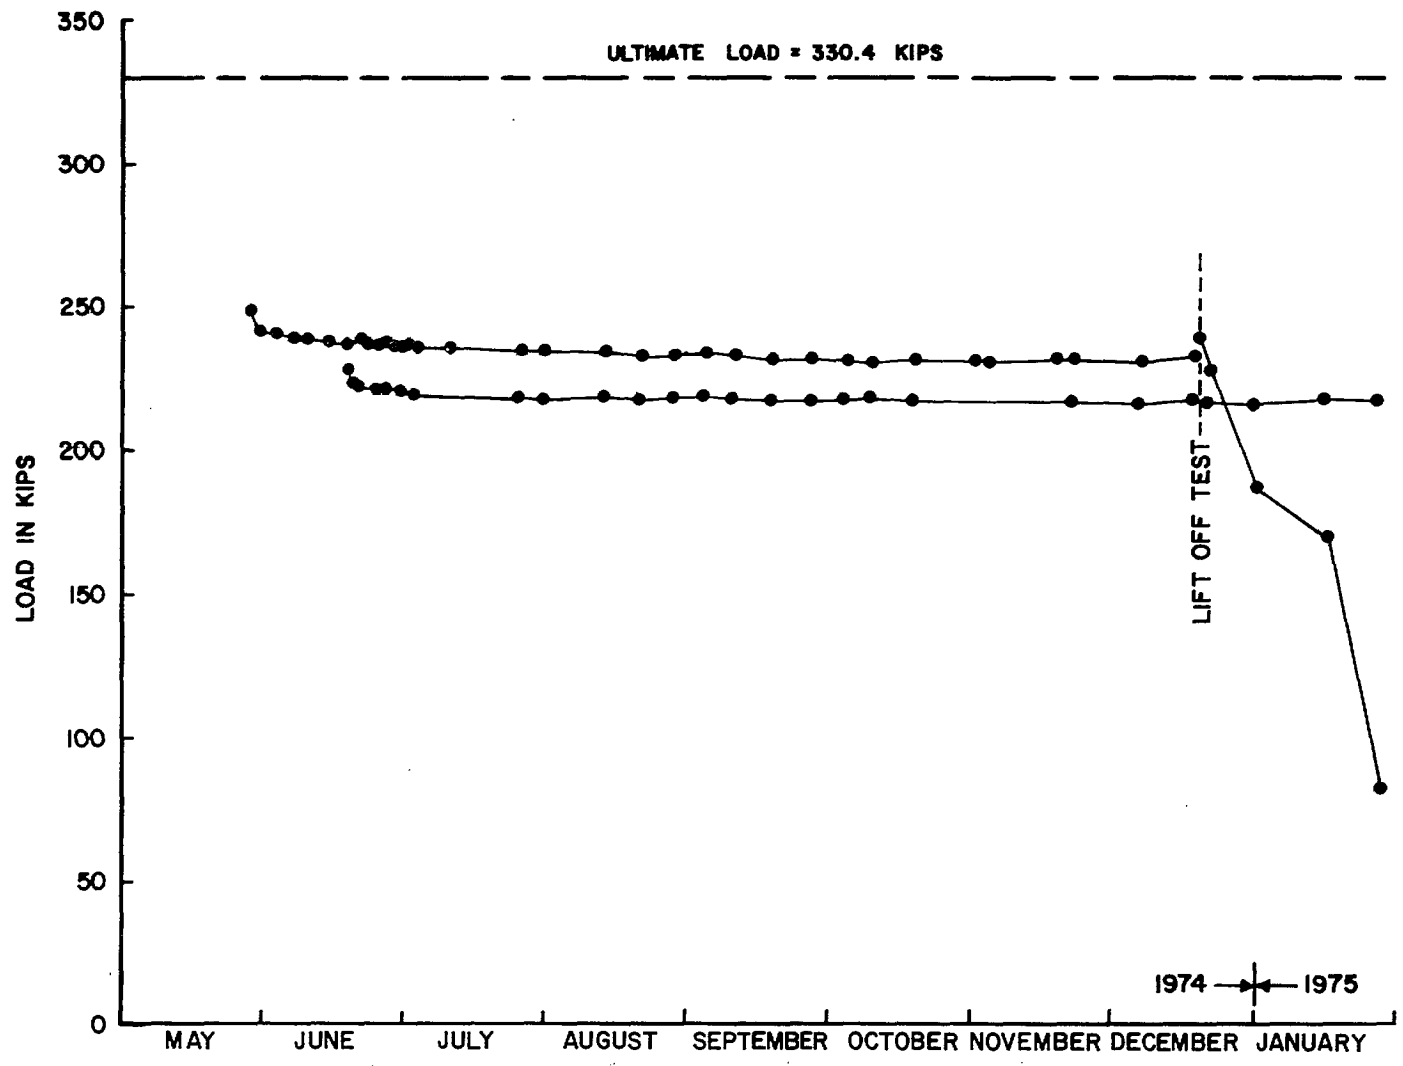
plots for two monitor units are illustrated in Fig. 29. The initial drop in load was due to seating of the anchor wedges and the further decrease reflected creep loss.

Fig. 29 - Typical load cell plot for monitor anchors on 7680 Bench

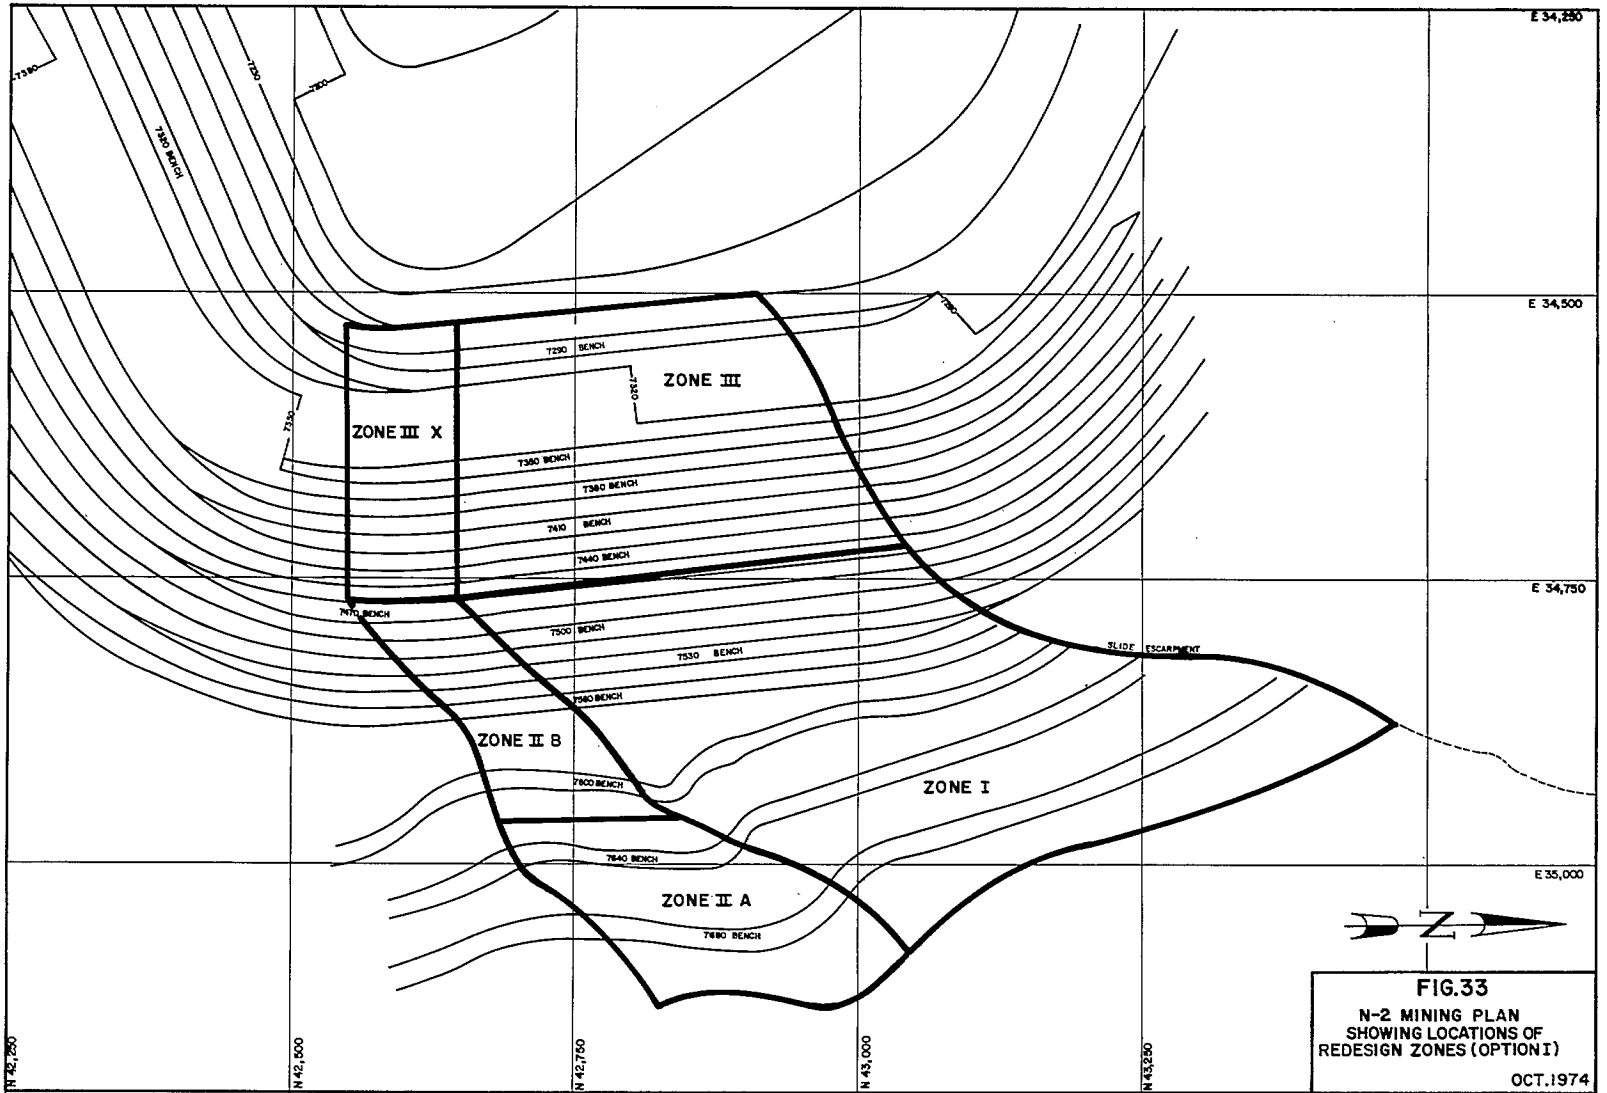
Option I was essentially the same plan as the original design. Shown in Fig. 33 is the plan with the revised design zones. Installation data indicated the potential sliding plane angles for some of the various design zones were probably less than the 28° used for the original design. Following drill hole evaluation of the sliding plane angle, the angles shown in Table 14 were used for the respective design zones shown in Fig. 33.

Fig. 33 - N-2 mining plan showing locations of redesign Zones (option I)

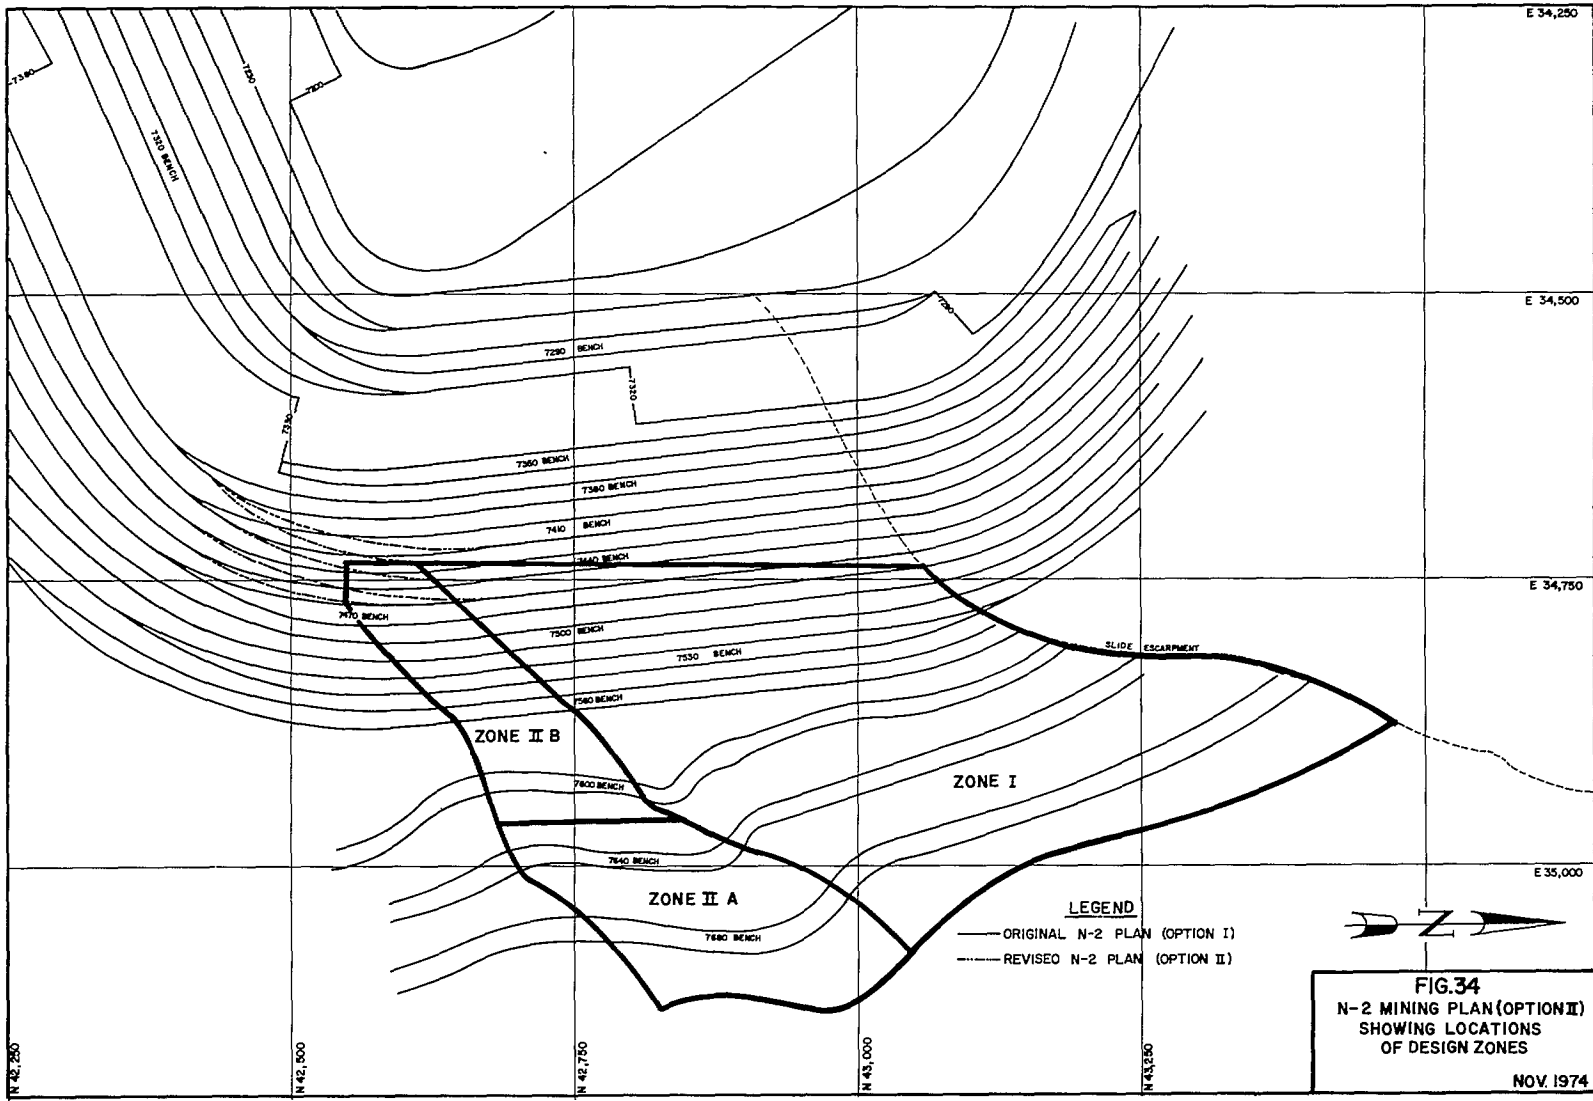
34. Consequently, most of the anchors for Zones III and III X would not be required. All other assumptions for Options I and II were the same and the basic method of analysis was also the same. The design zones were modified to conform with the revised mining plan as shown in Fig. 34.

Fig. 34 - N-2 mining plan (option II) showing locations of design Zones

In Option II, the removal of Zones III and III X created a situation whereby Zones I, II A and II B had to support themselves. In Option I, Zones II A and II B both had an excess driving force indicating that individually each would probably have slipped. However, safety factors for the remaining zones were such that loading from II A and II B would still have resulted in an overall safety factor greater than 1.0. By removing material from Zones III and III X for Option II, Zone I would have had to carry all of the excess driving force from Zones II A and II B for the entire slope to have remained stable. However, Zone I could not have accepted all of the loading because it did not buttress the lower-most portion of Zone II B and, therefore, the lower portion of Zone II B must have had to support itself. Using the same sliding plane angles and other basic assumptions from Option I resulted in the safety factor for Zone I being reduced to 1.002. This was based on a conservative 29° sliding plane angle for Zone II B. If the angle had been 27°, a safety factor of 1.020 would have resulted for Zone I with no addition of anchors. However, assuming a 27° sliding plane angle and the addition of ten 16-strand anchors yielded a safety factor of 1.025 for Zone I.

The total number of anchors recommended for Option II was 334. Spacing and number of anchors in each zone is outlined in Table 16.
