ORE DRESSING AND METALLURGICAL LABORATORIES.

Investigation No. 894.

Report on Comparison of Tools Submitted for
Examination by the Department of National
Defence, Ottawa, Ontario, on August 19th, 1940.

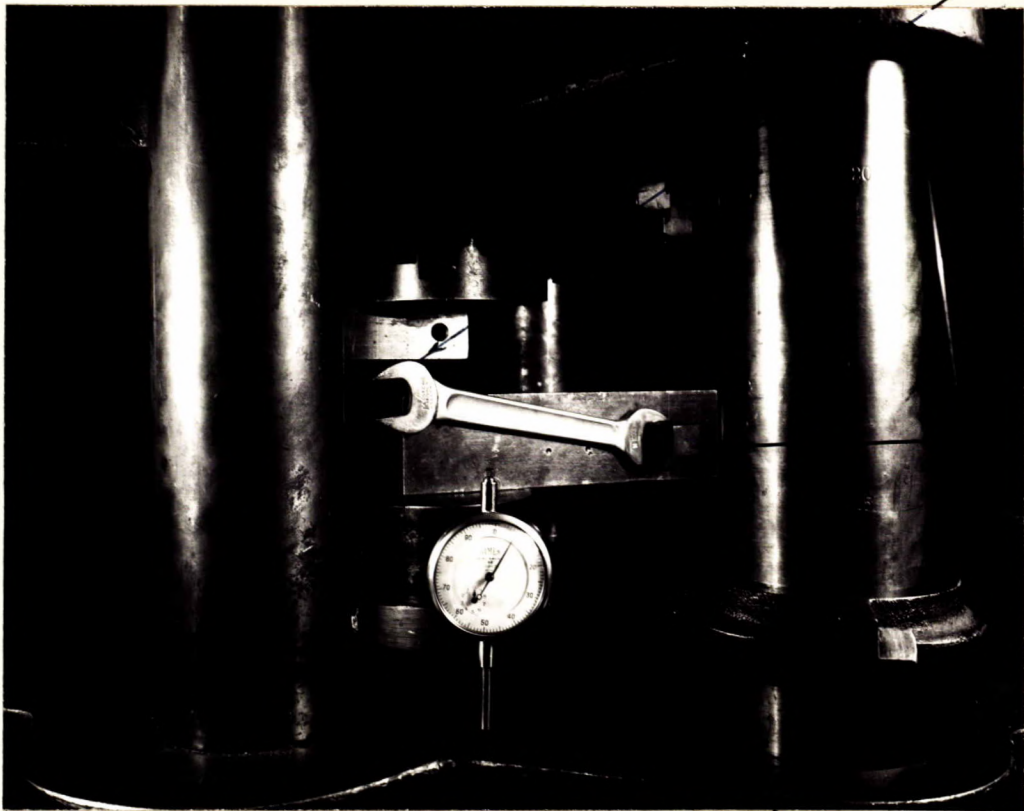
Figure 5.

Wrench-testing fixture:

- (A) Hardened mandrel.
- (B) Point of loading.
- (C) Deformation gauge.

With this equipment it was possible to measure the force and the distance through which it was exerted before failure of the wrench. In order to find out how much energy is required to cause failure in a wrench, the following equation is used:

<u>Tool.</u>		Maximum foot pounds absorbed without any damage to wrench.		<u>Type of failure.</u>
BLUE-POINT	--	34 foot pounds.		Fracture at base of jaw.
MASTER ALLOY, No. 1	--	15 " "		Deformed jaw.
MASTER ALLOY, No. 2	--	11 " "		" "
GRAY DREADNAUGHT	--	7 " "		" "
