Investigation No. 1117.

Examination of a Welded Wing Strut.

R E P O R T
of the
ORE DRESSING AND METALLURGICAL LABORATORIES.

On November 1st, 1941, a welded wing strut was received from G. E. Wallingford, for Chief Aeronautical Engineer, Air Services, Civil Aviation Division, Department of Transport, Ottawa, Ontario. The steel strut, described as "a starboard inner interplane diagonal bracing strut, taken from Fleet Aircraft CF-ANG," had failed in the air, causing collapse of the wing.

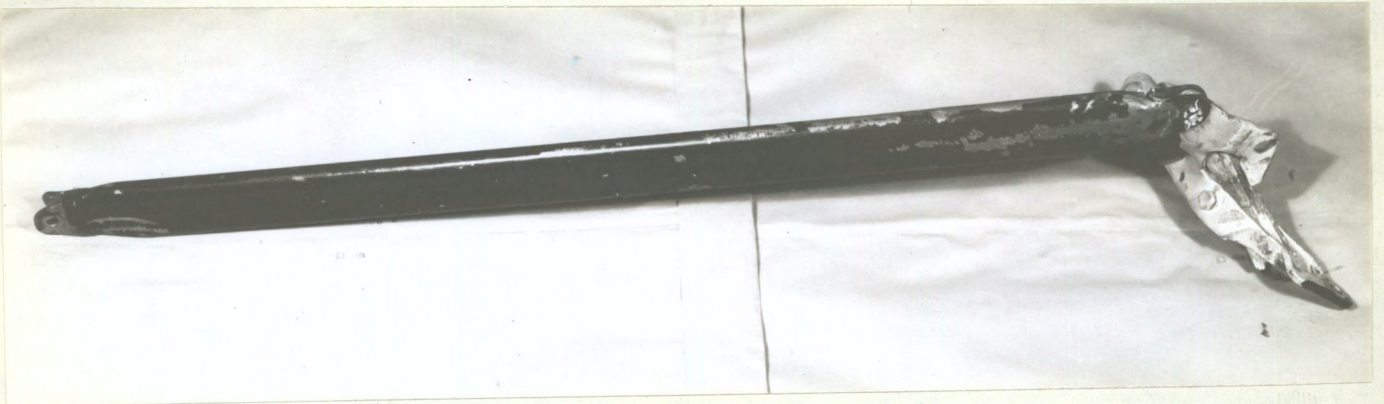
The entire strut assembly is shown in Figure 1. It consists of an S.A.E. X4130 steel streamlined tube, 0.049 x 0.709 x 1.702 in., as depicted in Figure 2. A U-terminal 0.095 inch thick is welded at each end of the tube and forms an anchorage for a bolt. One of these U-terminals, described as attached to the front starboard mainplane spar fitting, was broken at the weld, as shown in Figure 3. Close examination of this part revealed a crack approximately $\frac{1}{4}$ inch long extending from the side of the terminal into the intermediate zone, i.e., the zone adjacent to the weld seam (see location on Figure 4, magnification x5).

Strut assembly, approximately $\frac{1}{4}$ size.

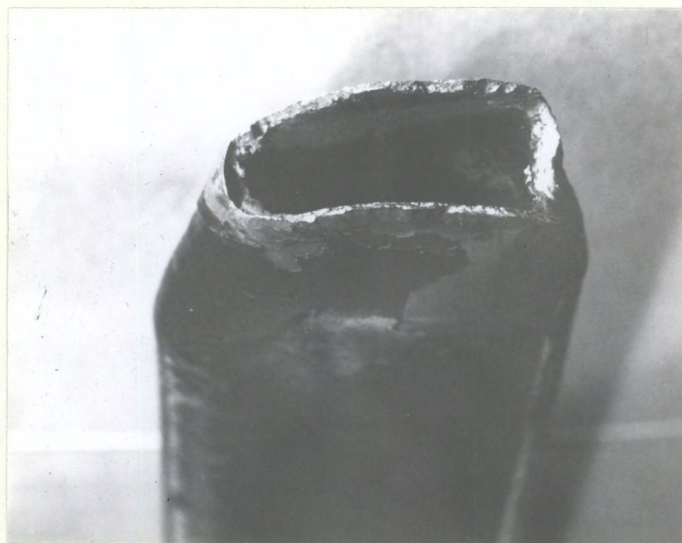
Figure 2.

S.A.E. X4130 steel streamlined tube,
approximately natural size.
