January 10th, 1942.

ORE DRESSING AND METALLURGICAL LABORATORIES.

Investigation No. 1145.

Examination of Material in Spar Member
and Elevator Hinge from Cessna-Crane
Aircraft 7664.

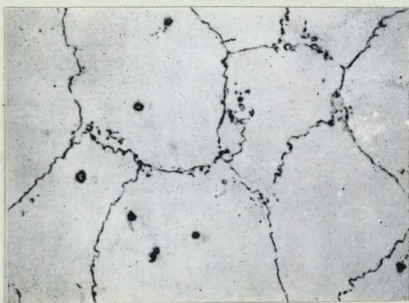
Figure 8.

Figures 8 and 9 show respectively the heat-treated and heat-treated-and-aged structures for an alloy of approximately the same composition as the metal in the hinge, these photomicrographs being taken from A. Beck's THE TECHNOLOGY OF MAGNESIUM AND ITS ALLOYS (London, 1940) - Figures 57 and 60, on Pages 50 and 51.

X200, etched.

SOLUTION HEAT-TREATED.

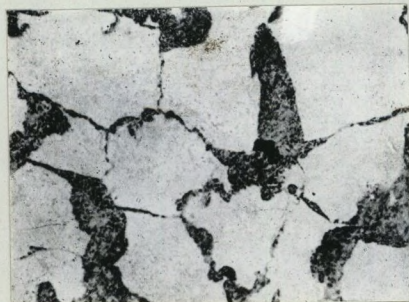
Figure 9.

X200, etched.

SOLUTION HEAT-TREATED AND AGED.
