June 21st, 1943.

ORE DRESSING AND METALLURGICAL LABORATORIES.

Investigation No. 1431.

Examination of Welded Oxygen Cylinders.

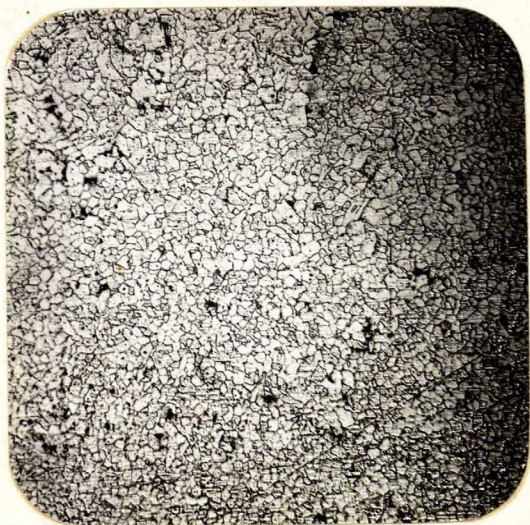
Figure 7.

Figures 7 and 8, photomicrographs at X100 magnification, show the fine-grained structure of the weld and parent metals respectively, after an etch in 2 per cent nital. These structures consist of ferrite (the white etching constituent) and pearlite (the dark etching material). The coarse nature of the pearlite is illustrated in Figure 9, a photomicrograph at X1000 magnification.

WELD METAL.

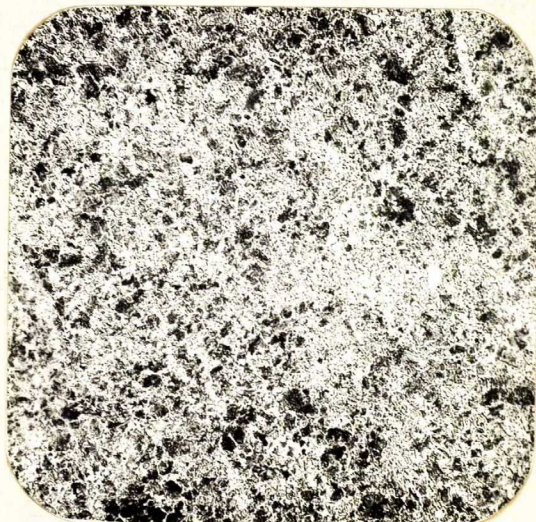
Figure 8.

PARENT METAL.
