CANADA
DEPARTMENT
OF
MINES AND RESOURCES
Mines and Geology Branch

Investigation No. 1463.

Examination of British Maddock Malleable
Iron Universal Carrier Track.

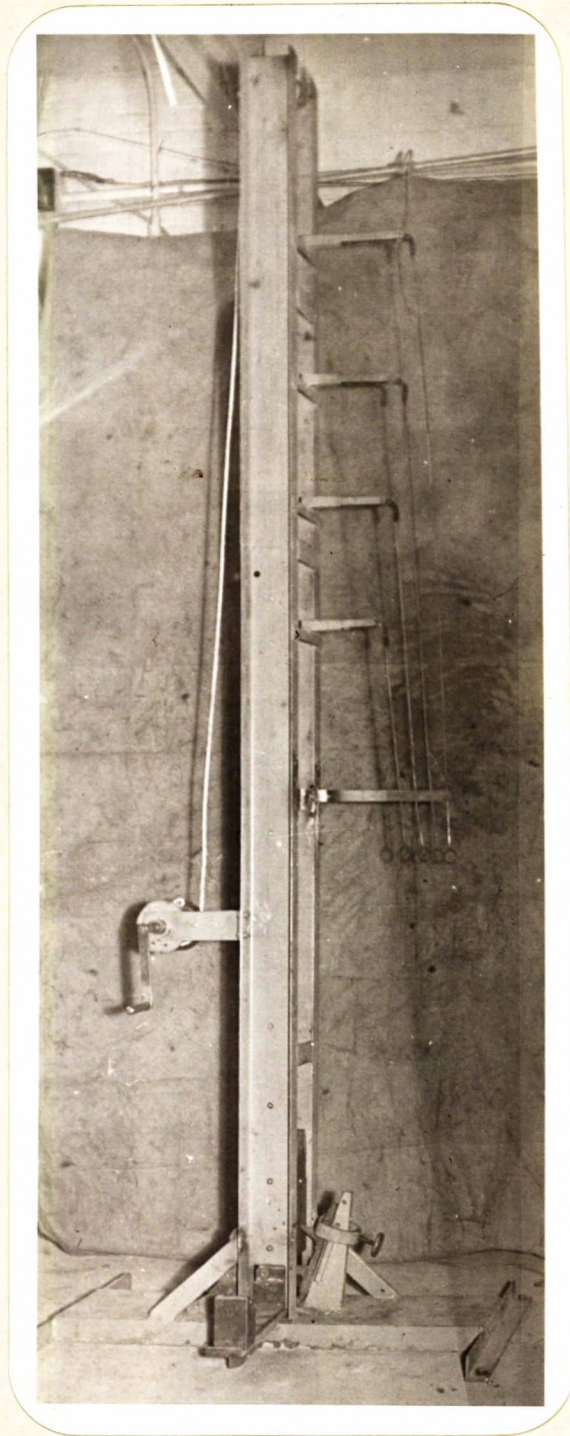
Figure 1.

Impact tests were made on both guide lugs (indicated by (a) and (b) in Table II), and the barrels of five links (lugs facing downward). A 50-lb. weight was dropped from 7 foot (350 ft-lb.) a number of times until failure occurred. Figure 1 illustrates the impact testing machine used. Figure 2 illustrates a link in position for a lug impact test. Table II shows the results obtained. A 400-ft.-lb. impact blow was used for the barrels.

IMPACT MACHINE.

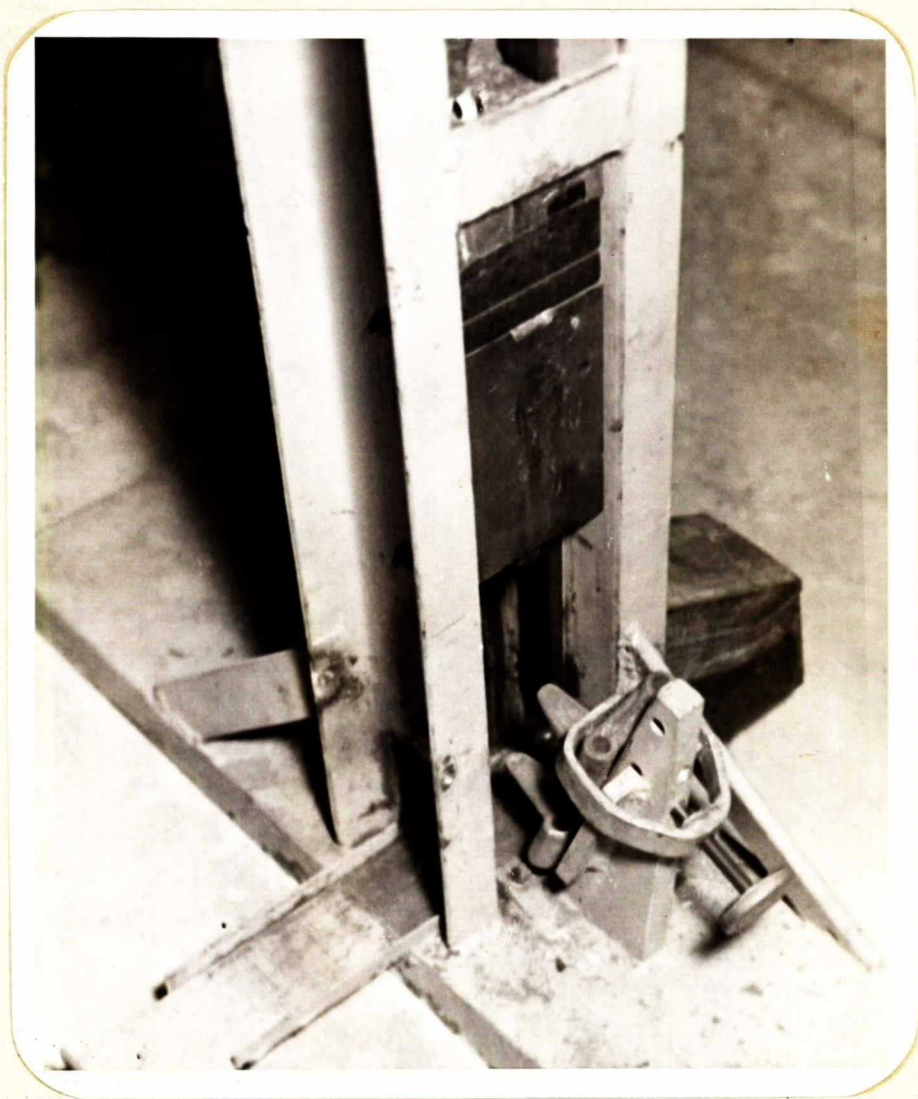
Figure 2.

FIFTY-POUND WEIGHT FALLING ON LUG.

The links have good resistance to impact. Nine guide lugs were tested and only one failed. This test, however, was carried out using a 350-foot-pound blow. The barrels were capable of withstanding 400-foot-pound blows.
