August 30th, 1943.

ORE DRESSING AND METALLURGICAL LABORATORIES.

Investigation No. 1485.

Examination of Snowmobile Bogie Wheel Suspension
Assemblies made by the Bombardier Snowmobiles,
Limited, Valcourt, Quebec.

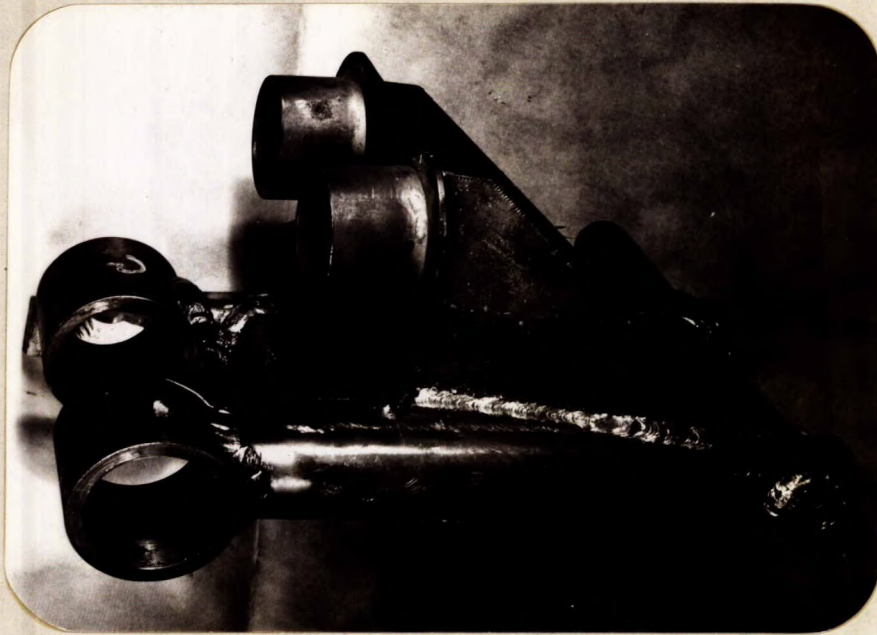
Figure 5.

Assemblies Nos. 1 and 2 (see Figure 5) are of
the type in which the shaft ring is attached to the pipe
frame by means of a fillet weld around the end of the pipe
frame. Assembly No. 4 (see Figure 9) is of the type in
which the shaft ring is attached to the pipe frame by means

GENERAL SHAPE OF BOGIE SUSPENSION ASSEMBLY
AS RECEIVED. ASSEMBLY NO. 1.

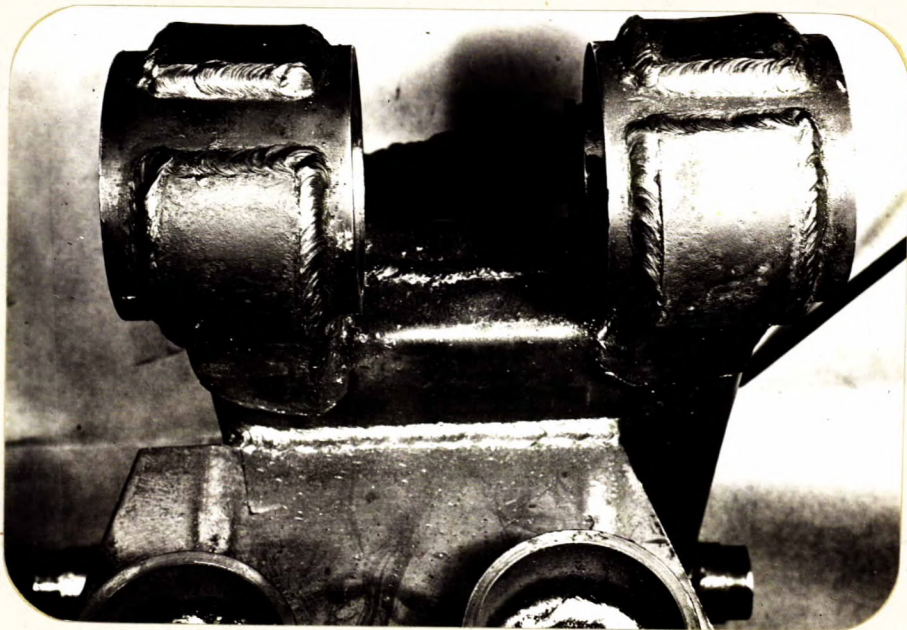
Figure 8.

of a complete strap fillet welded to the shaft ring and pipe frame. Assembly No. 5 (see Figure 8) is of the type in which the shaft ring is attached to the pipe frame by means of a split strap fillet welded to the ring and pipe frame.

shaft rings of Assembly No. 2 showing the fillet weld joining the pipe frame and the shaft rings. Note the width and irregularity of the weld and also undercutting as indicated by the arrow. Figure 7 is a close-up photograph of the opposite side of Assembly No. 2. Note the excessive width of the weld. Figures 8 and 9 show the split strap and complete strap methods, respectively, of attaching the shaft ring to the pipe frame. Figure 10 is a photograph of a fillet weld joining a strap to a shaft ring. Note the severe undercutting typical of all of these welds.

ASSEMBLY NO. 5. - SPLIT STRAP METHOD OF JOINING
SHAFT RING TO PIPE FRAME.

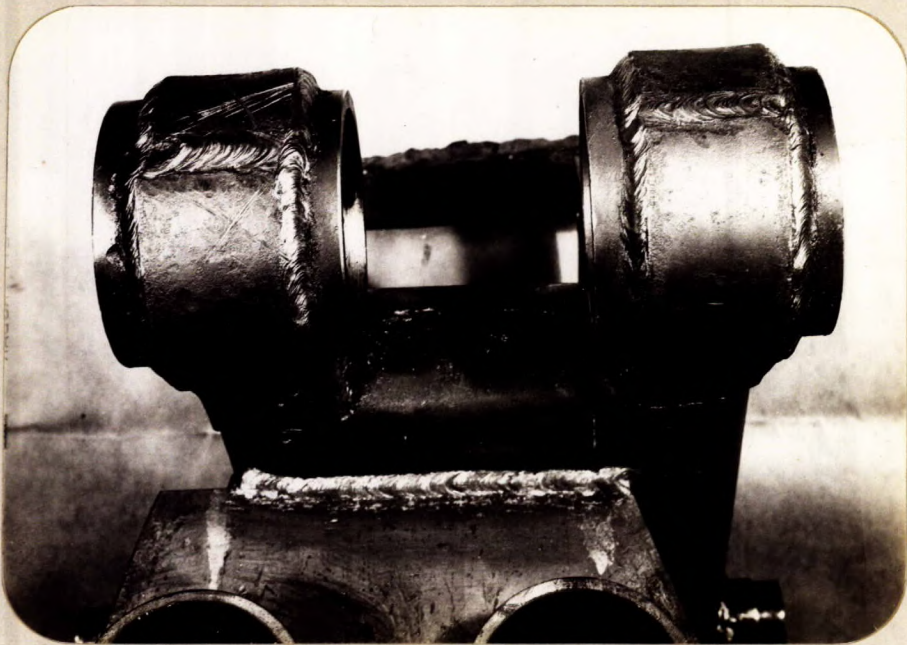
Figure 9.

ASSEMBLY NO. 4. - COMPLETE STRAP METHOD OF JOINING
SHAFT RING TO PIPE FRAME.
