ORE DRESSING AND METALLURGICAL LABORATORIES.

Investigation No. 1550.

Investigation of Three Canadian Dry Pin
Track Pins Which Failed in Field Test.

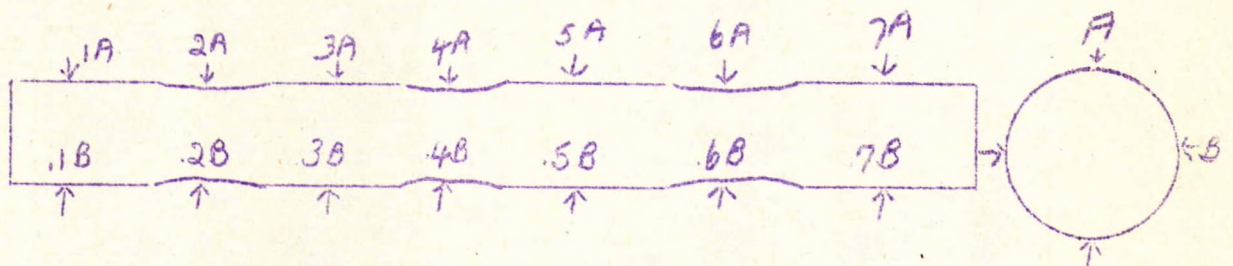
DIAGRAM OF MEASUREMENT POSITIONS.

Measurements were taken of the wear on the four pins. Two readings were made, with a micrometer, at each selected point on the pin. These were at right angles to each other. The following diagram indicates the relative positions at which the pins were measured:
