January 7th, 1944.

ORE DRESSING AND METALLURGICAL LABORATORIES.

Investigation No. 1567.

Examination of Additional Welded Splash Strips.

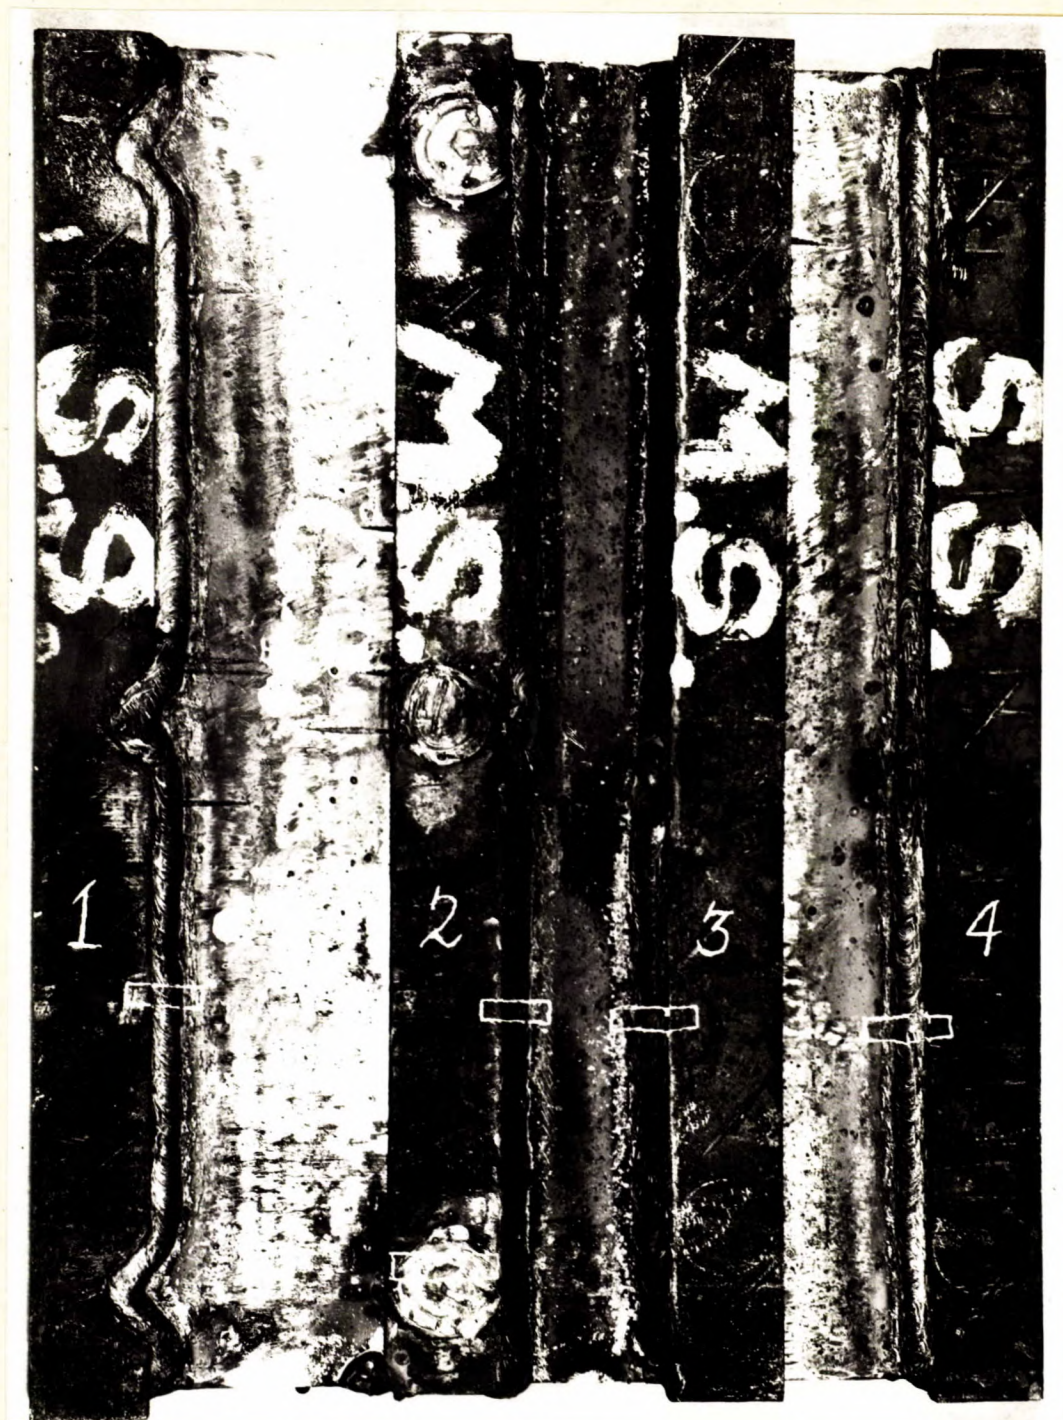
Figure 1.

UNTESTED PLATE AS RECEIVED.

White rectangles indicate areas from which
micro and macro samples were machined.

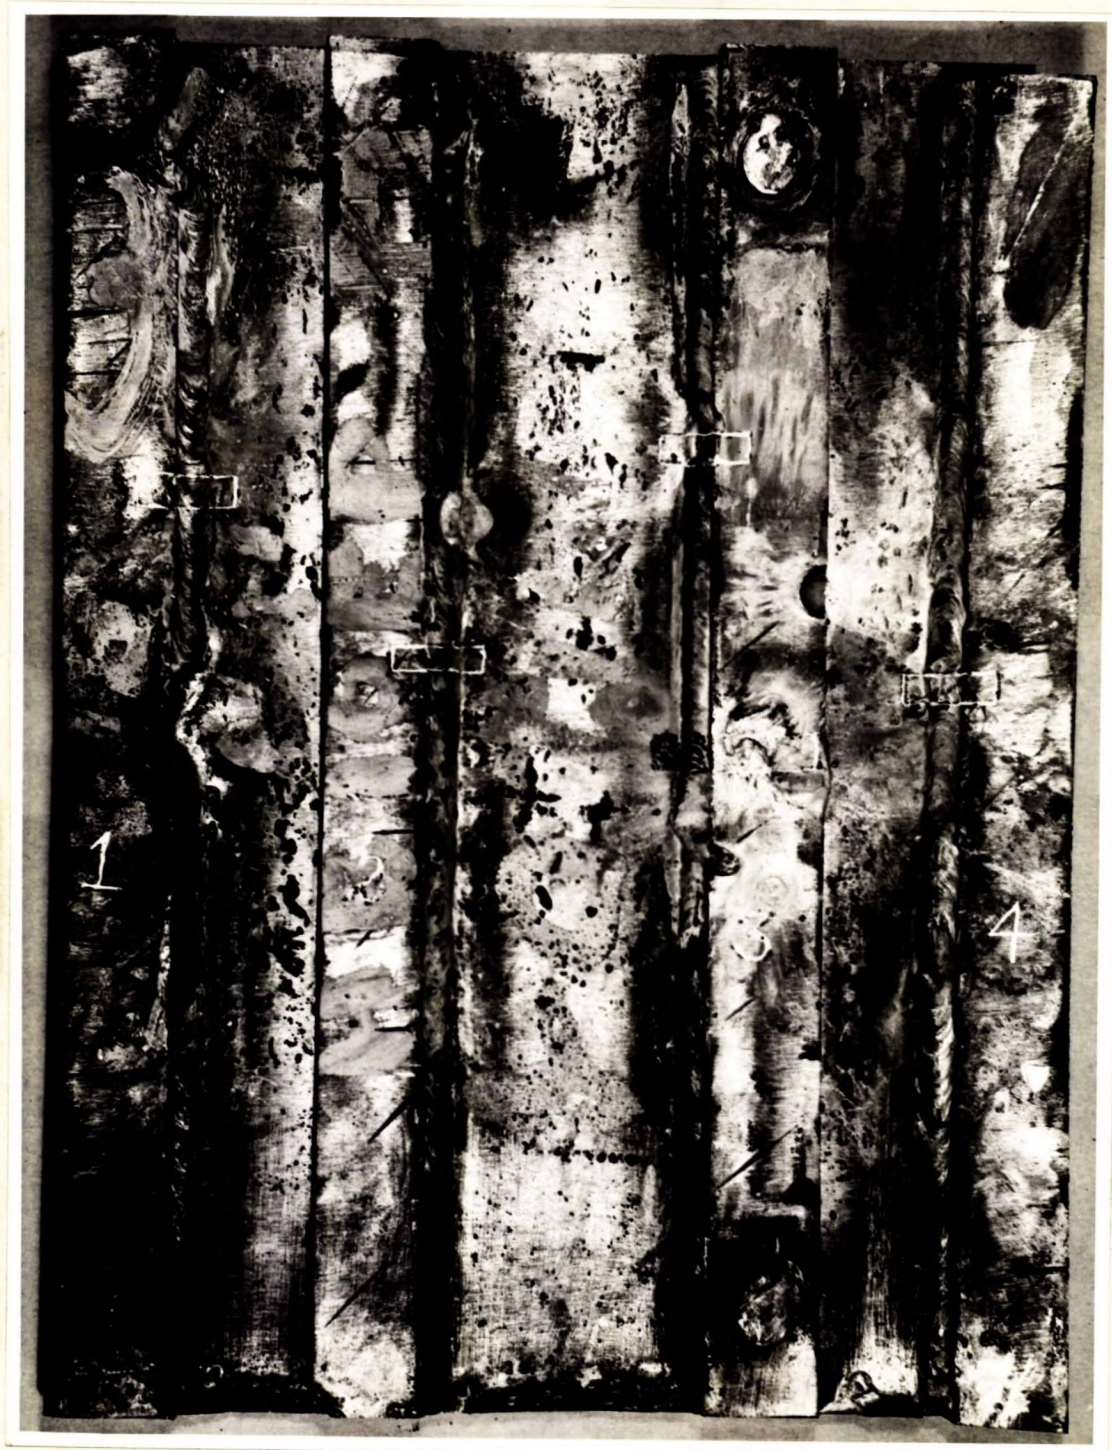
Figure 2.

A visual examination of the test plates indicates that the plates were welded from the outside towards the centre. This is good welding technique in that this reduces locked-up stresses. It is also noted that the location of the welds (see Figure 3 and 4) is irregular in that in some cases the weld metal is washed up to the top of the splash strip and in others only 2/3 of the distance. The areas of impact of the tested sample show only short cracks.

TESTED PLATE AS RECEIVED.

White rectangles indicate areas from which
micro and macro samples were machined.
