February 25th, 1944.

Investigation No. 1604.

Examination of Two Welded Propeller Shaft  
Flange Assemblies for Snowmobiles.

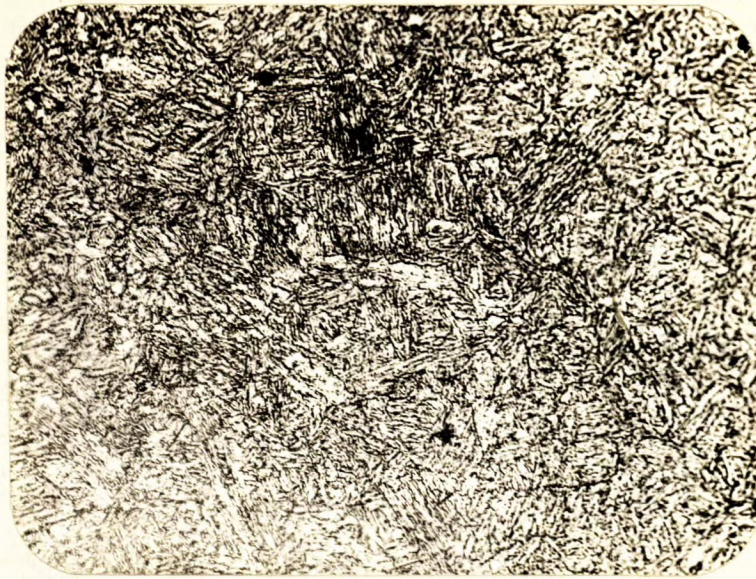
Figure 20.

X500, etched in 4 per cent picral.

NORMAL COUPLING STRUCTURE.

Tempered martensite.

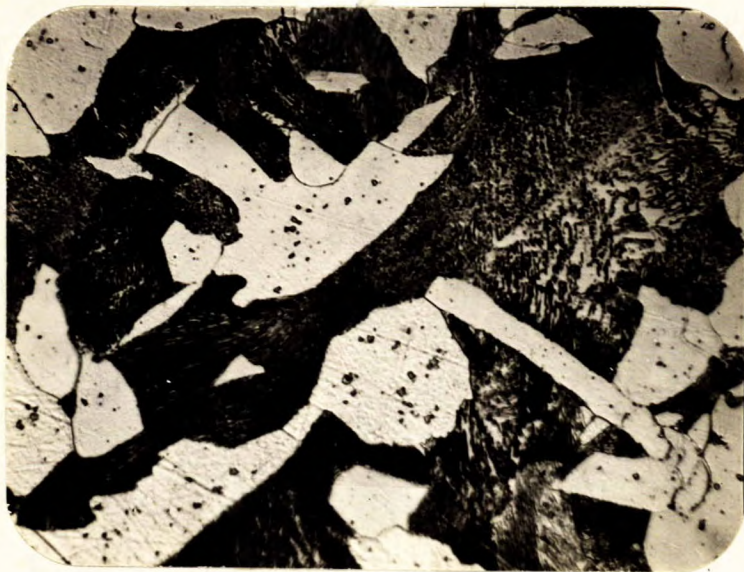
Figure 21.

X500, etched in 4 per cent picral.

NORMAL FACE PLATE STRUCTURE.

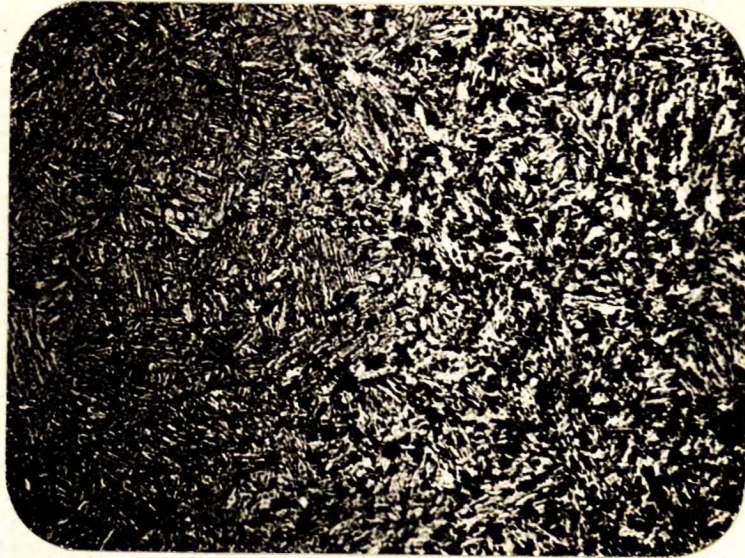
Figure 22.

X500, etched in 4 per cent picral.  
TRANSITION ZONE STRUCTURE OF COUPLING MATERIAL.  
Nodular pearlite in ferrite matrix.

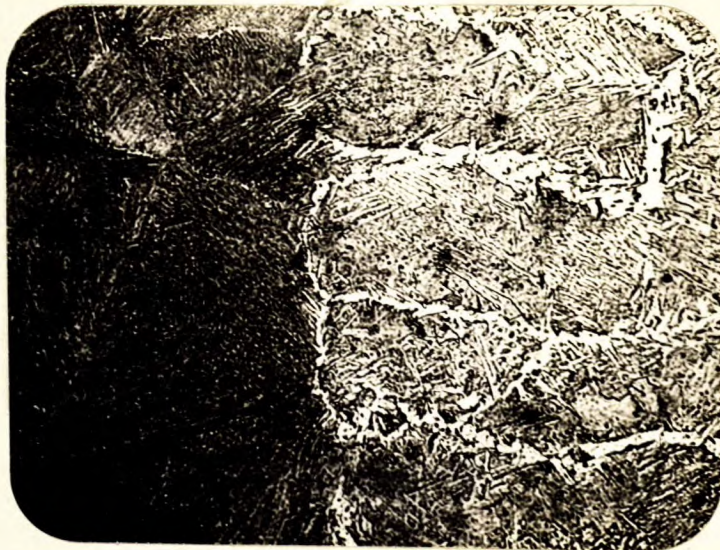
Figure 24.

The hardness tests and the microstructure both reveal the formation of a hard, brittle, martensitic structure adjacent to the weld and point to the necessity of corrective treatment.

X500, etched in 4 per cent picral.  
STRUCTURE AT FUSION LINE OF COUPLING MATERIAL.  
Weld metal above, coupling material below.

1. The assembly should be preheated to 500° F. before welding.
2. The assembly should be stress-relieved at 900° F. for 1 hour after welding.
3. The design of the joint should be changed so that the necessary machining will not weaken the joint. The design recommended above should prove satisfactory.
4. Should the recommended design be approved, an electrode conforming to the AWS E 6030 specification should be used in making the weld.
