Investigation No. 1642.

Metallurgical Examination of Three Sizes of Pivot Mechanisms for Fuge No. 208.

Metallurgical Examination of Three Sizes of Pivot Mechanisms for Fuze No. 208.

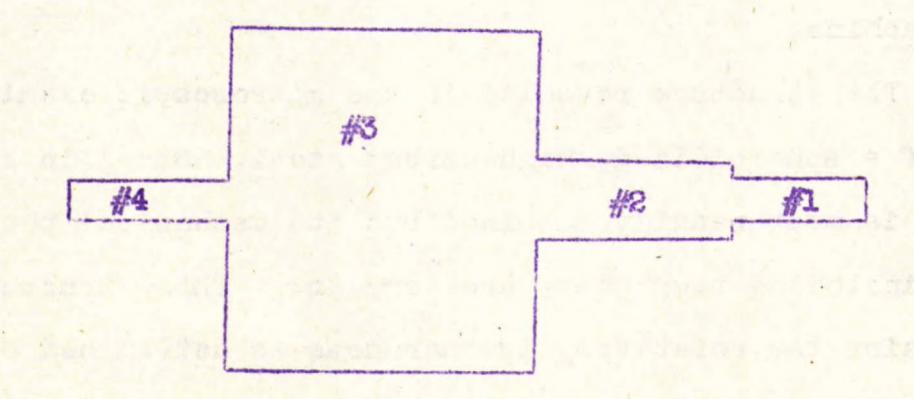
SKETCH TO SHOW SECTIONING OF GEARS FOR MICRO HARDNESS DETERMINATIONS.

Visual examination of all the gears submitted showed that by far the most common location of failure was the breaking off of the short pivot (portion 4, sketch page 3). In most cases the pivot broke off flush with the gear face, but in a few instances it broke so that a very small section remained as a projection from the gear.

the Vickers hardness numbers obtained, by calculation, from the micro hardness results on the various sections of the three sizes of gears. It should be noted that the hardness values are very similar on each size of gear, although there is a slight difference between the various sizes. The results obtained are somewhat lower than those obtained using a Vickers hardness testing machine with a 10-kilogram load. In all cases the hardness of the pivots is similar to the hardness of the gear itself.
