July 3rd, 1944.

Investigation No. 1674.

Metallurgical Examination of Cam Shaft and
Injector Rolls from Cummins Diesel Engine.

Bureau of Mines
Division of Metallic
Minerals
Physical Metallurgy
Research Laboratories

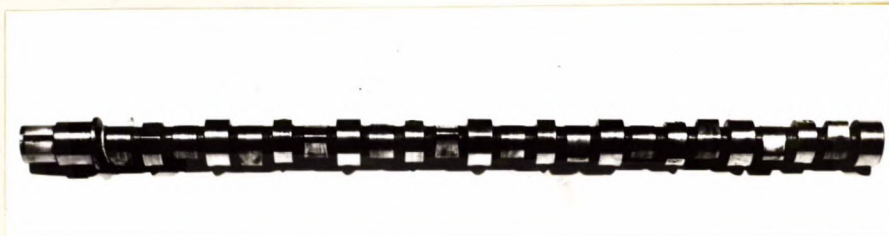
Figure 1.

As the two cam shafts are considered identical, for the purpose of economy only one was sectioned for examination in this investigation. The two injector rolls used were representative of the twelve received. (See Figures 1 and 2).

GENERAL VIEW OF CAM SHAFT.
(Approximately 1/8 actual size).
