August 5th, 1944.

Investigation No. 1695.

Metallurgical Examination of C.D.P. Track Shoe and  
Pin Which Had Been Field-Tested in England.

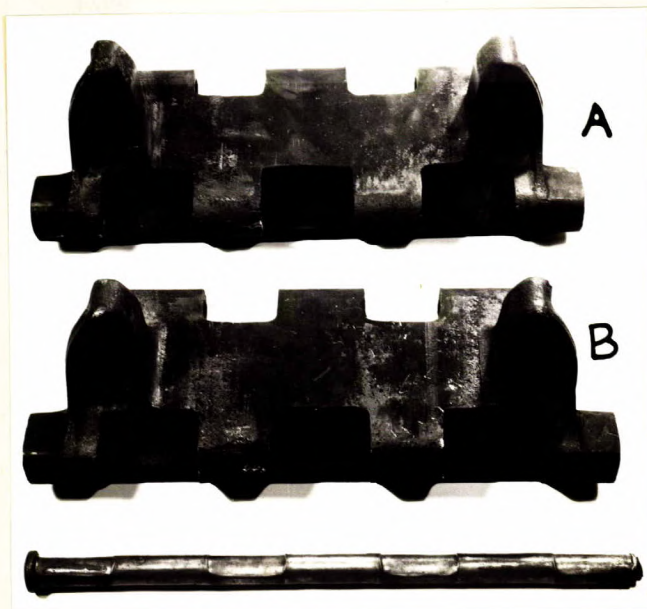
Figure 1.

Photographs of the track shoes and the pin were taken and the less severely worn shoe (B) was immediately returned. Figure 1 shows the two shoes and the pin.

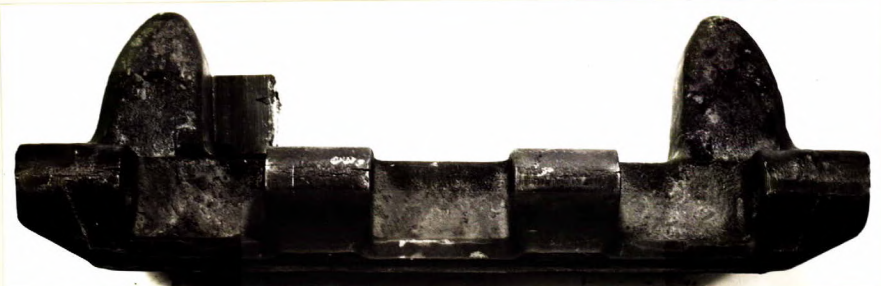
Figure 3.  
TRACK SHOE B.

Figures 2, 3, 4 and 5 show two views of each of the two shoes. It can be seen that Track Shoe A was the more severely worn.

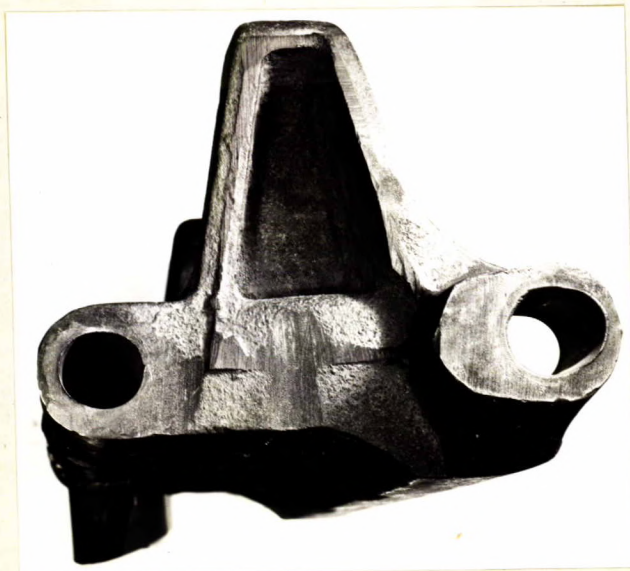
Figure 5.

END VIEW OF TRACK SHOE B.

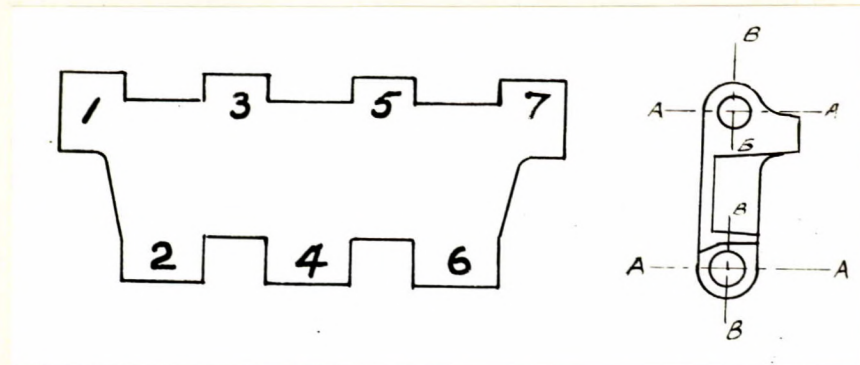
The dimensions of the eye-holes, as submitted by Prof. J. U. MacEwan, are shown in Table I. Measurements were made as shown in Figure 6.

<u>Section</u>	<u>A-A</u>	<u>B-B</u>	<u>Wall Thickness</u>
		<u>- Inches -</u>		
<u>SHOE A:</u>	1	0.866	0.946-0.995	0.201
	3	0.850	1.027-1.081	0.150
	5	0.850	1.007-1.072	0.142
	7	0.851	0.998-1.015	0.190
	2	0.835	0.902	0.252-0.300
	4	0.833	0.892	0.300
	6	0.849	0.902	0.324
<u>SHOE B:</u>	1	0.853	1.045-1.062	0.143
	3	0.853	1.130; Broken.	0.114
	5	0.850	1.162-1.174; Broken.	0.123
	7	0.858	1.078-1.122	0.132
	2	0.875	0.918-0.969	0.295
	4	0.846	0.892	0.320
	6	0.856	0.910-0.924	0.272

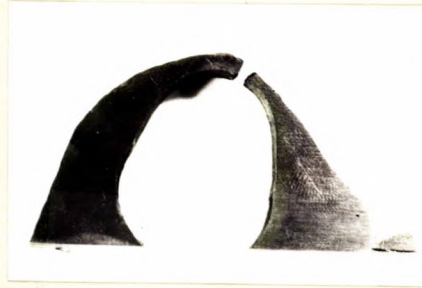
A section was cut from the eye-hole wall as shown in Figure 7. A transverse section was also taken from the grouser.

SECTION FROM EYE-HOLE WALL.

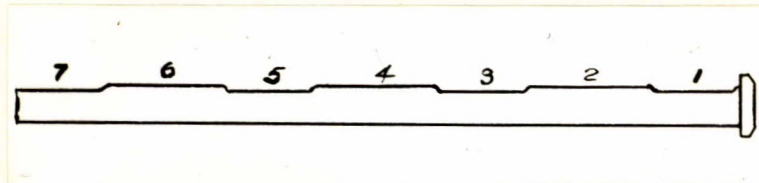
The diameter of the pin was measured by the Army Engineering Design Branch. For purposes of identification the sections of the pin were numbered as illustrated in Figure 12. The diameter measurement results are shown in Table VI. It will

<u>Section</u>		<u>Diameter, inches</u>
<u>1.</u>	-	0.770 .759 .770
<u>2.</u>	-	0.799 .794 .807
<u>3.</u>	-	0.747 .726 .739
<u>4.</u>	-	0.807 .809 .816
<u>5.</u>	-	0.733 .714 .726
<u>6.</u>	-	0.796 .802 .812
<u>7.</u>	-	0.750 .748 .770

Core hardnesses were taken on the two transverse sections cut from the pin. These samples were cut from Sections 4 and 5 as shown in Figure 12. Results are shown below:
