September 14th, 1944.

Investigation No. 1710.

Examination of a C.D.P. Track Shoe and Pin from an
Experimental Lot Which Had Failed in Test.

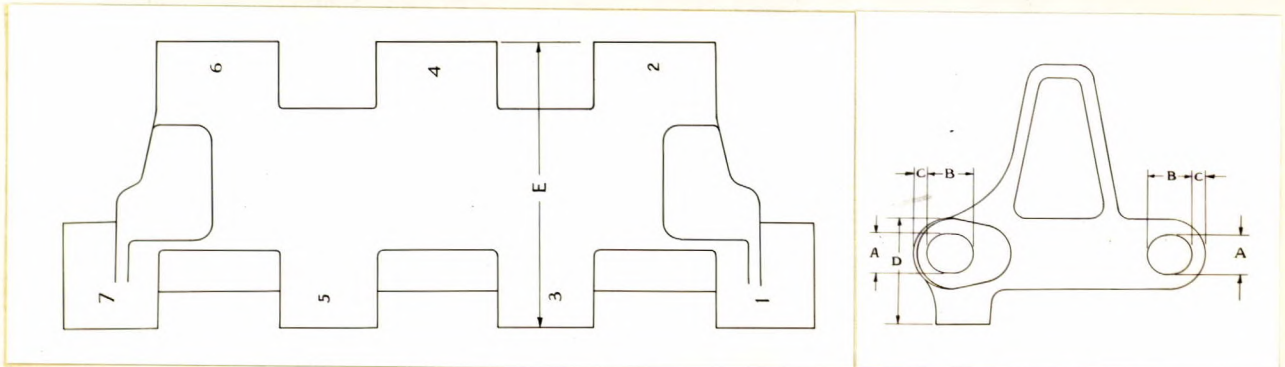
Figure 3.

The high degree of distortion in the hinges made it impossible to measure any dimensions on the three-hinge side of the shoe. The hinges on the other side were measured, however, as was the grouser. The locations of these measurements are shown in Figure 3 and the results in Table I.

LOCATIONS OF MEASUREMENTS.

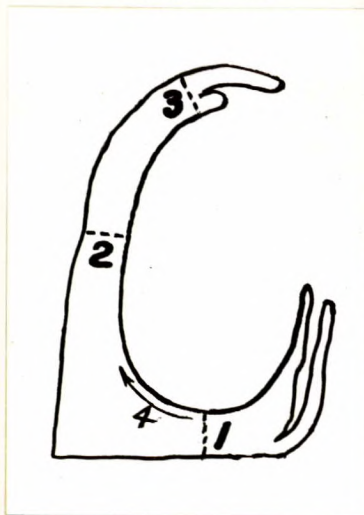
Figure 4.

Hardness surveys across the eye-hole wall were made at three places, in an attempt to discover any variations in hardness. A fourth survey was made around the eye-hole, starting at the bottom of the hinge. These readings were approximately 4 mm. apart. The locations of the surveys are shown in Figure 4 and the results in Table II.

LOCATIONS OF SURVEYS.

at a high temperature. The slight variation in hardness around the eye-hole wall was not sufficiently significant to be attributed to cold work. Severe bending of the wall might have caused the increased hardness in Survey No. 2.
