R E P O R T  
of the  
ORE DRESSING AND METALLURGICAL LABORATORIES.

Investigation No. 2076.

Metallurgical Examination of a Defective  
Cylinder Head Casting.

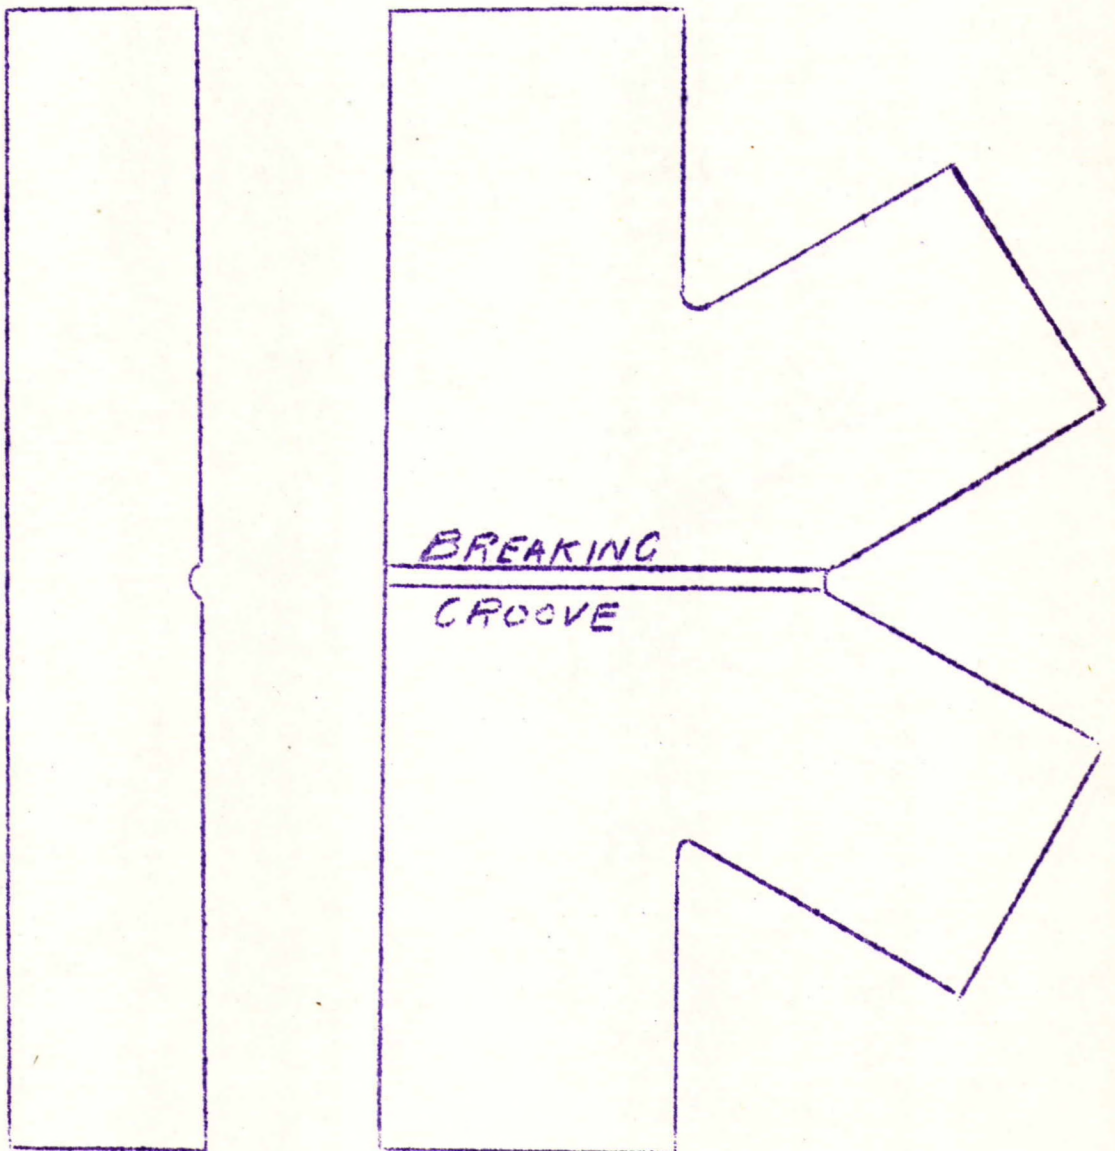
Figure 12.

The tendency of cast iron to form shrinkage cavities can be measured by the "K" casting, a sketch of which is shown as Figure 12 herein.

SHRINKAGE TEST CASTING.
