DEPARTMENT OF MINES AND RESOURCES

BUREAU OF MINES

Investigation No. 2129.

Metallurgical Examination of 20-mm. A/P Shells,
to Determine Cause of Difficulty Encountered in
Hardening.

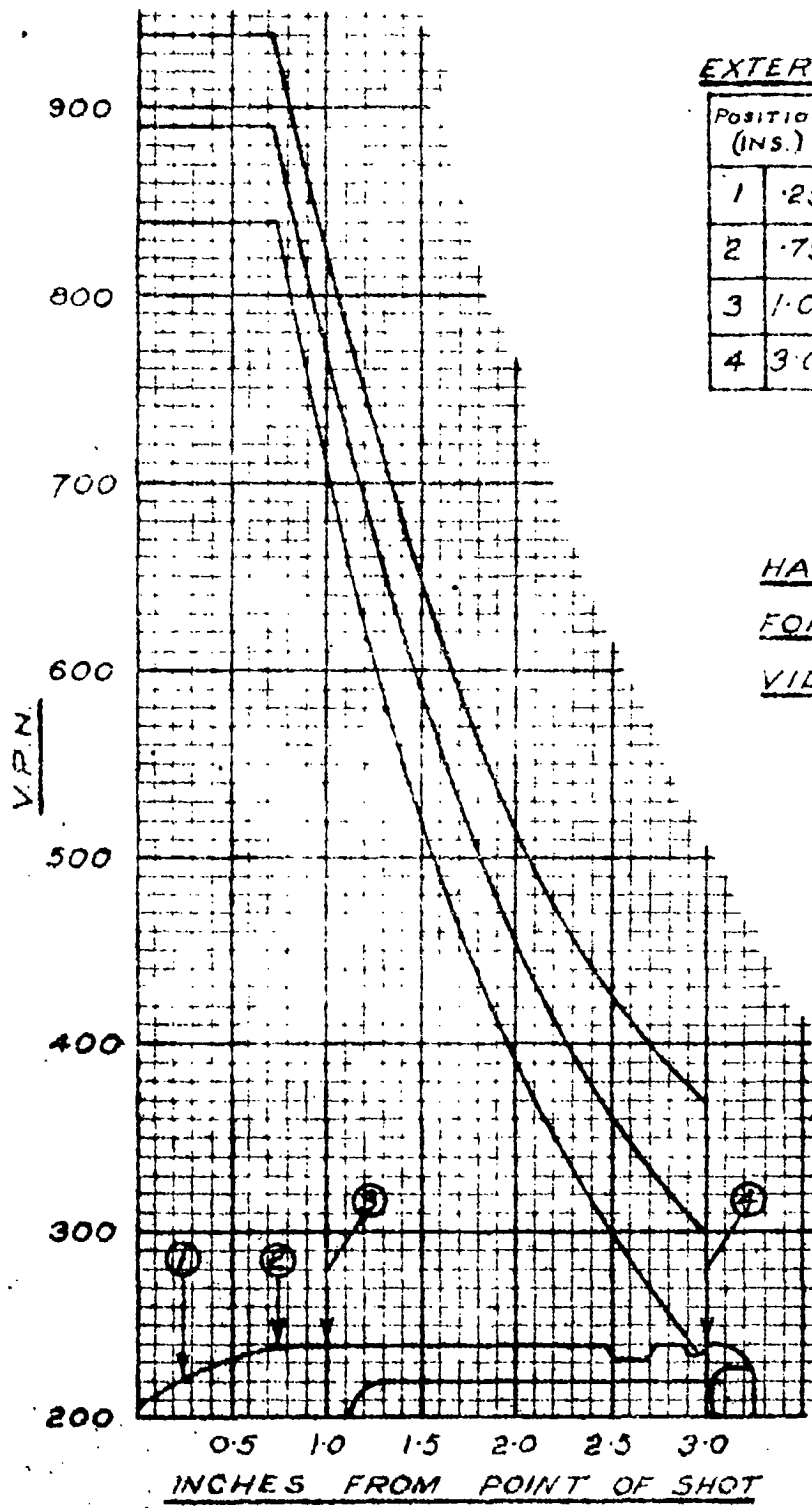
HARDNESS GRADIENTS
FOR 20% AP/T SHOT
VIDE O.B. PROC 25086

HARDNESS CURVE
 THE HARDNESS AT THE .75" POSITION MUST BE MAINTAINED HIGH, AND AS CLOSE AS POSSIBLE TO THAT AT THE .25" POSITION. THE HARDNESS GRADIENT BETWEEN THE .75" AND THE 1.0" POSITIONS SHOULD BE AT LEAST AS STEEP AS THE TARGET CURVE.
