R E P O R T
of the
ORE DRESSING AND METALLURGICAL LABORATORIES.

Investigation No. 1960A.

Distortion in Flame Hardening Naval
Gun Racer Plates.

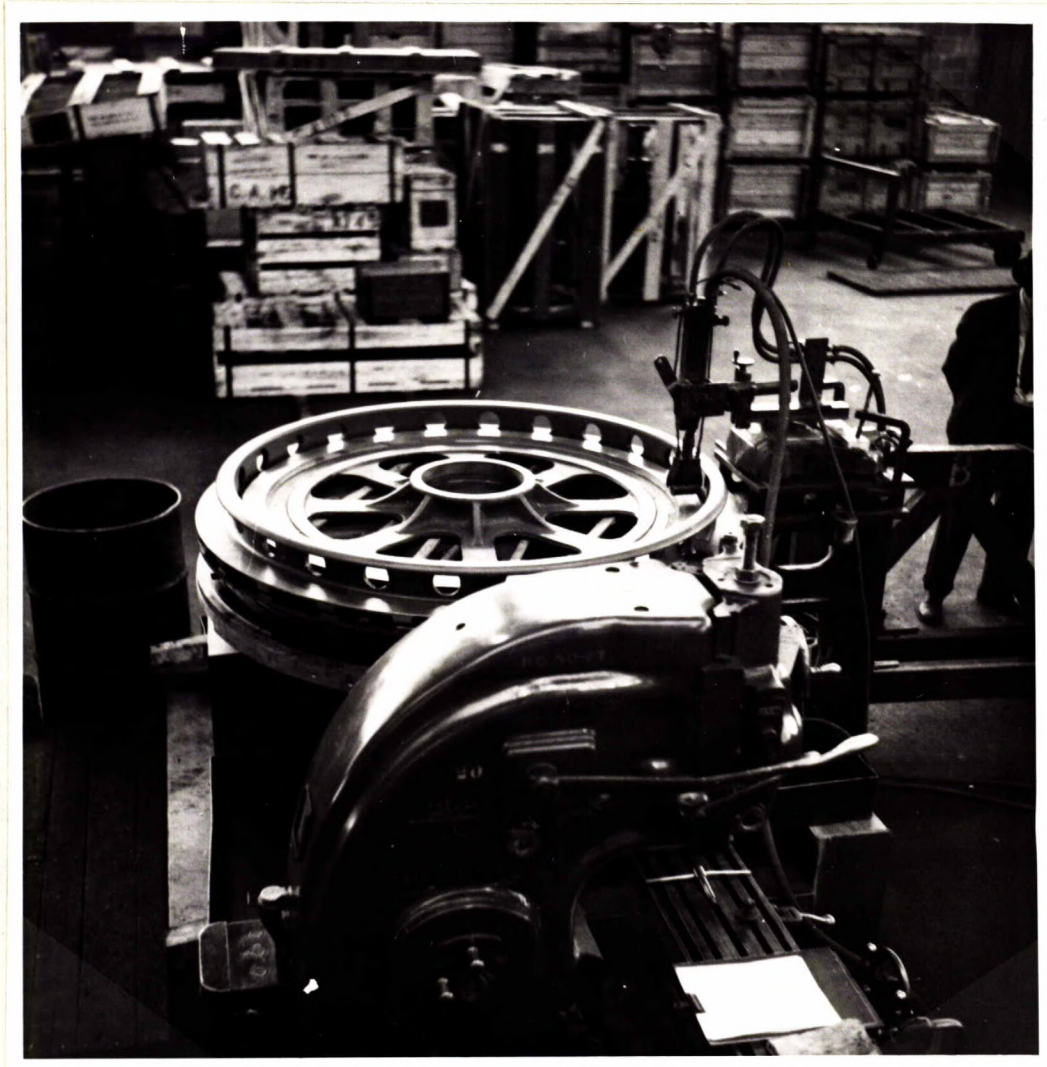
Figure 1.

The flame hardening apparatus (the same as used in the previous investigation) was set up and clamped to an independent set of surface blocks. Water connections were made to the flame head and quenching fixture. The flame head was adjusted at right angles to the racer surface and to provide complete flame coverage of the race without overlapping at the edge. Figure 1 shows the arrangements at this stage of preparation.

ARRANGEMENT OF RACER PLATE AND FLAME-HARDENING
EQUIPMENT FOR FLAME HARDENING.

In foreground is the milling machine which provided
the power to rotate the plate through a dividing
head.
