MINES BRANCH INVESTIGATION REPORT IR 74-9

**EXAMINATION OF A WHEEL AND AXLE ASSEMBLY
REMOVED FROM TANK CAR UTLX 13695**

R. D. MCDONALD AND D. M. NORMAN

PHYSICAL METALLURGY DIVISION

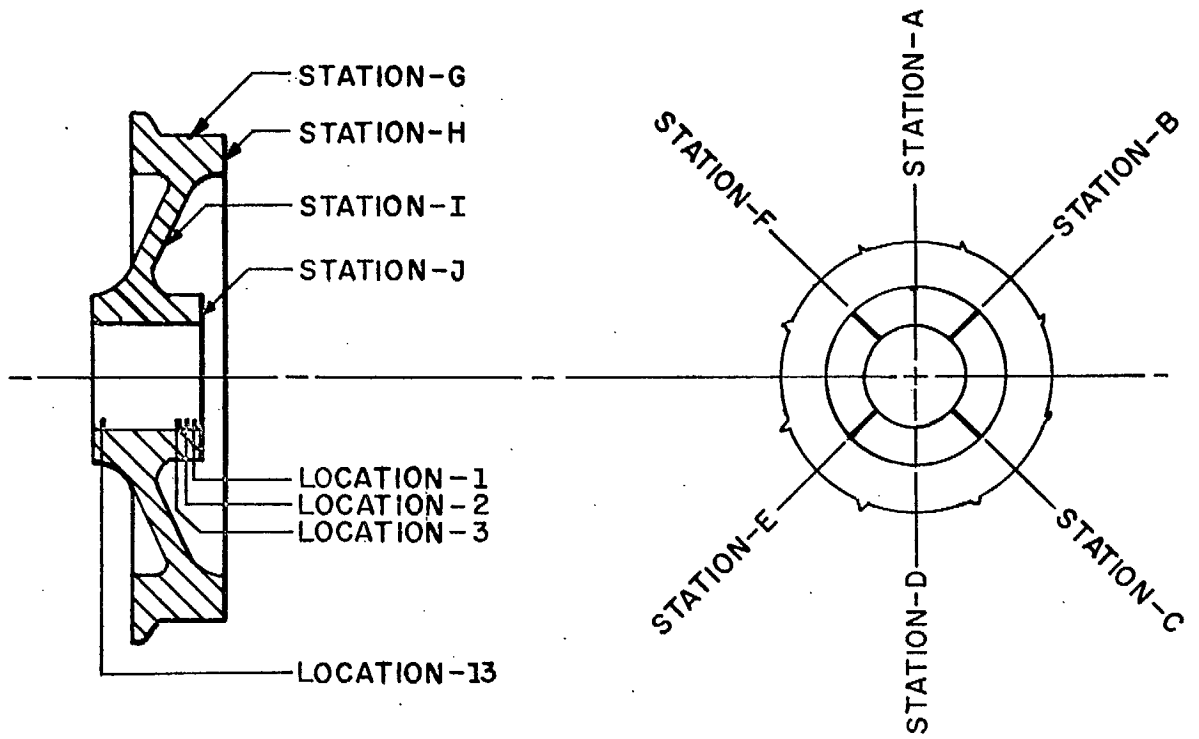
FIGURE 1

In order to provide easy identification of the positions where dimensions would be obtained, a convention was adopted throughout this inspection procedure. Radial positions were designated as alphabetic stations and longitudinal positions were designated as numerical locations. A schematic illustration of the designated measuring positions is shown in Figure 1.

LAYOUT OF MEASURING POINT CO-ORDINATES

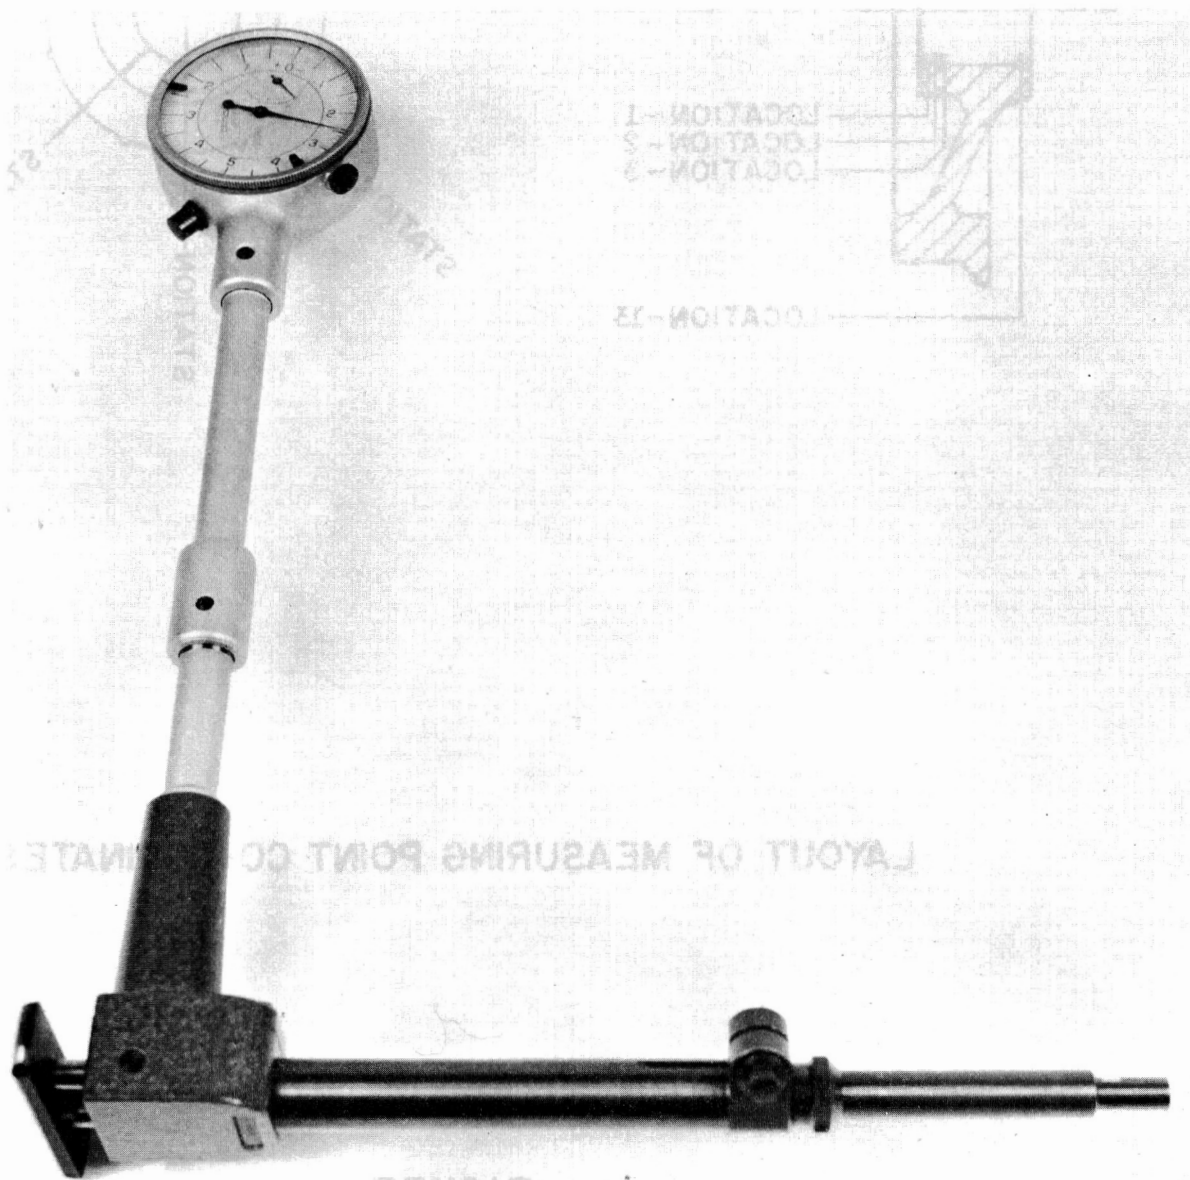
Wheel L1 was then selected and three stations 120° apart were arbitrarily chosen, and the locations starting from the front of the wheel along these three stations were marked off. In order to be able to accurately measure the diameter, a dial-read Alina W08 bore gauge was employed. This gauge is capable of measuring bore diameters from 2 to 12 in. with depths of up to 8 in. The dial gauge is graduated in 0.0001-in. divisions and has a total recordable travel of 0.140 in. There is incorporated in this gauge a spring loaded shoe which causes the gauge to automatically seek the diametrical axis of the hole, and, on rocking the gauge, the smallest reading recorded on the dial is the measure of the bore diameter. A photograph of the gauge is shown in Figure 2. Again, as with the micrometer caliper, this bore gauge was calibrated against a set of gauge blocks. The bore diameters for the L1 wheel are shown in Table 3; although the dial gauge is capable of measurement to four decimal places the diameters shown in the Table are rounded off to three significant figures.

Figure 2. Alina W08 bore gauge.

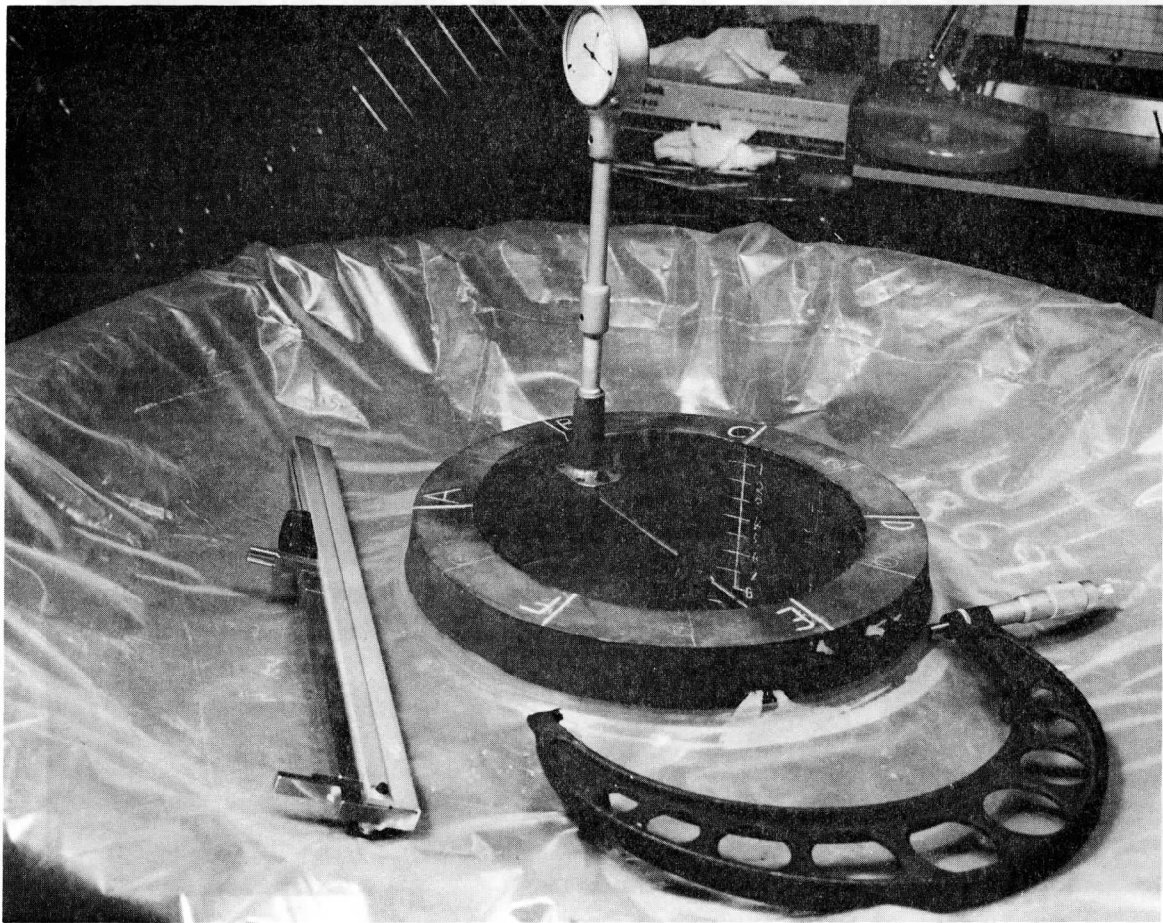
Figure 3. Measurement of R1 wheel bores.

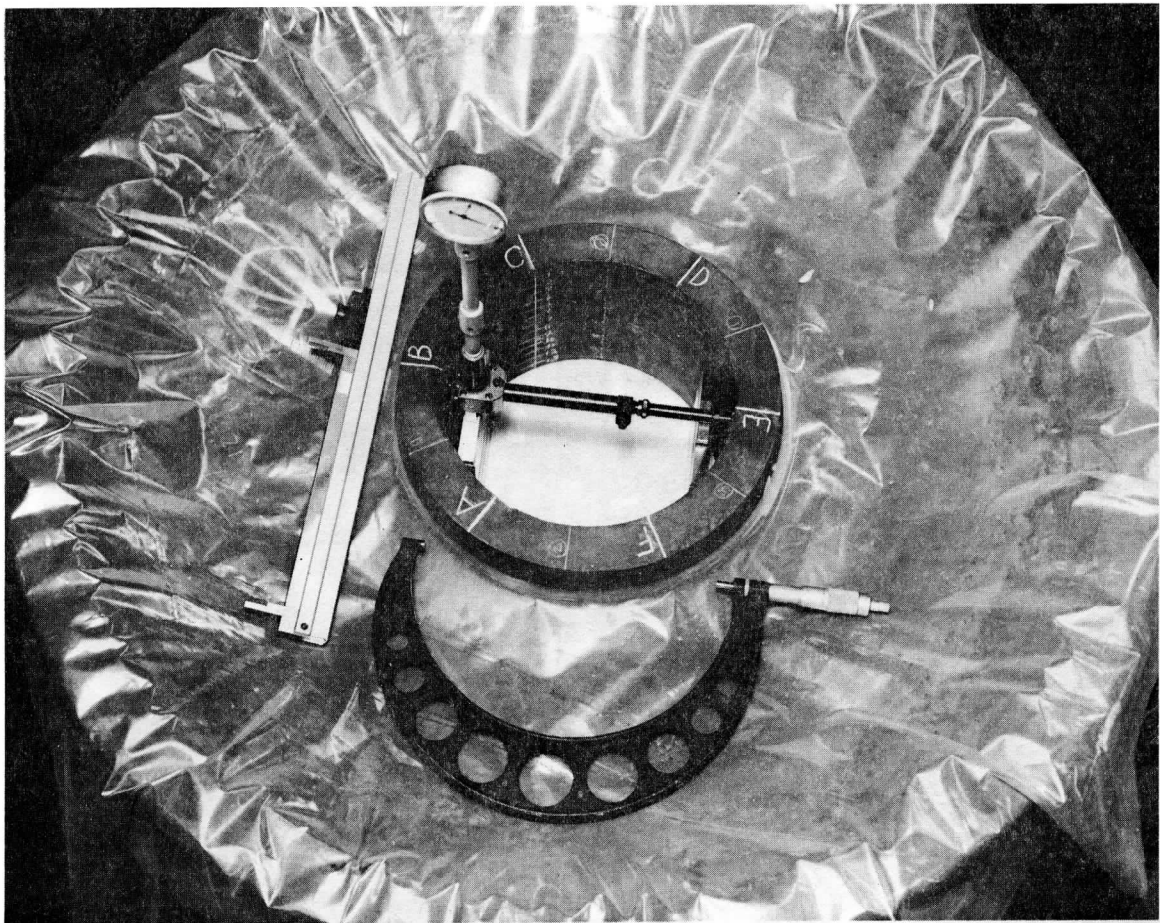
Figure 4. Measurement of R1 wheel bores.

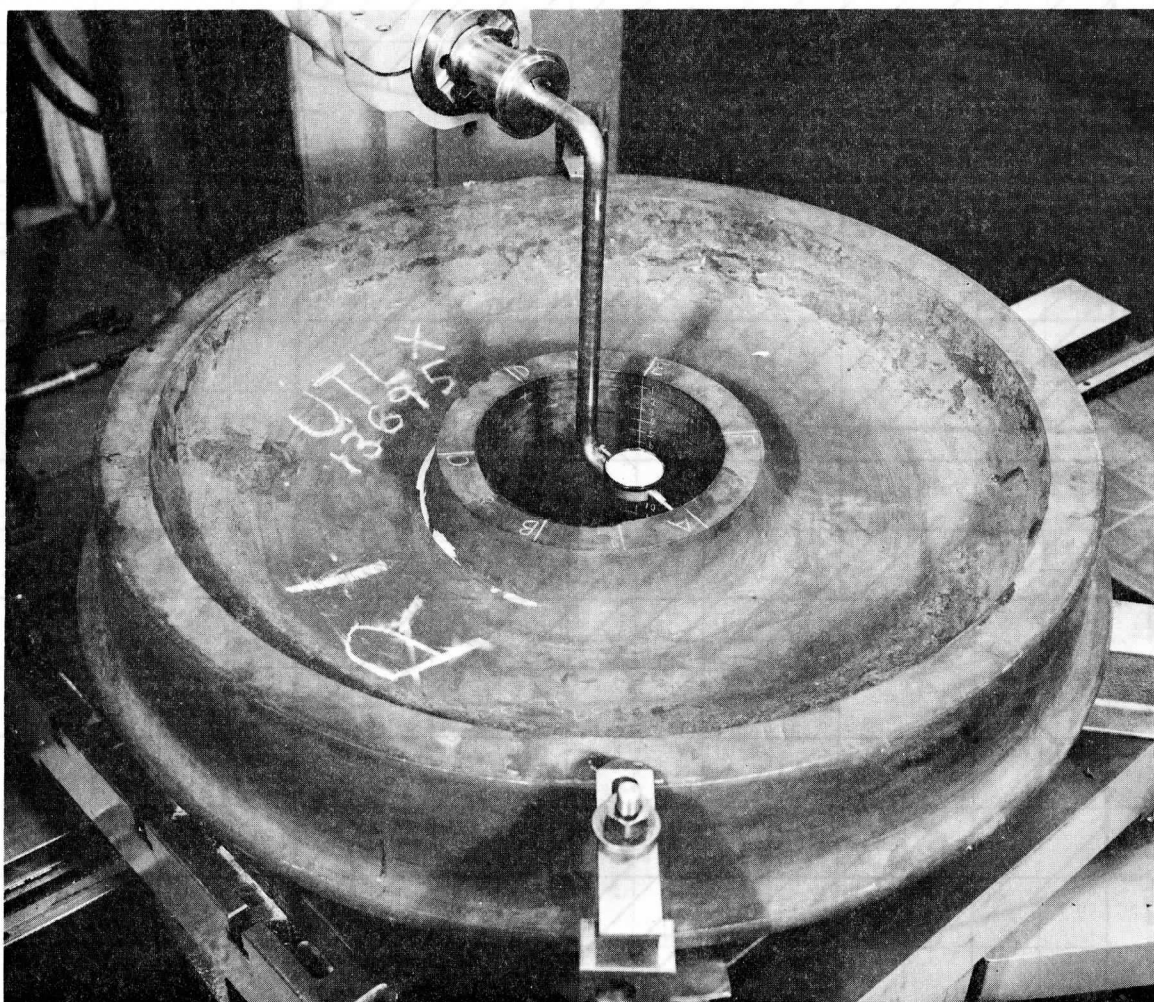
rotary table and a dial indicator with 0.001-in. graduations was mounted in the head of the machine so that TIR measurements of the bore could be obtained to show the bore profile. A photograph of this operation is illustrated in Figure 5.

Figure 5. Measurement of R1 bore radius variations.

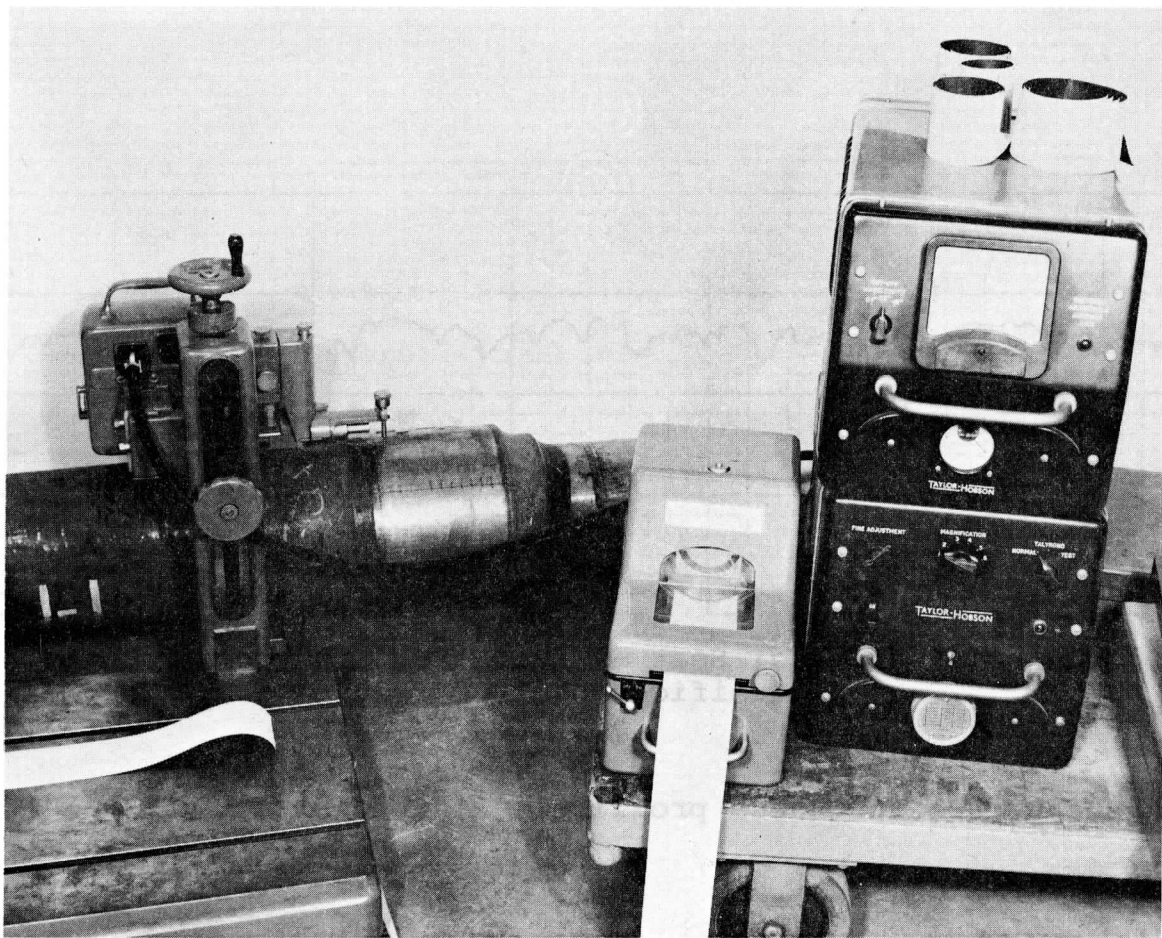
For comparison purposes, surface roughness readings were taken on both the R1 and L1 wheel seats and wheel bores. For this inspection procedure, a Taylor Hobson Model 3 Talysurf Surface Measuring Instrument, as illustrated in Figure 7, was used. During all the series of roughness measurement readings, the calibration of the instrument was checked after each change of range. The stylus of this instrument was set to traverse first across the longitudinal scratch pattern of the L1 wheel seat; this scratch pattern being generated when the wheel and seat were separated. The instrument was then set to measure longitudinally across the machining marks. A graphical recording of the L1 wheel seat produced by the above instrument is shown in Figures 8(a) and 8(b). The magnification on the vertical scale is 1000 and on the horizontal scale 20; this means that each small vertical division represents 0.0001 in. and each

Figure 7. Taylor-Hobson, Model 3, 'Taly Surf'.
