MINES BRANCH INVESTIGATION IR 58-18

METALLURGICAL INVESTIGATION INTO THE FAILURE OF A BEATER ROLL BAR

PHYSICAL METALLURGY DIVISION

FEBRUARY 14, 1958

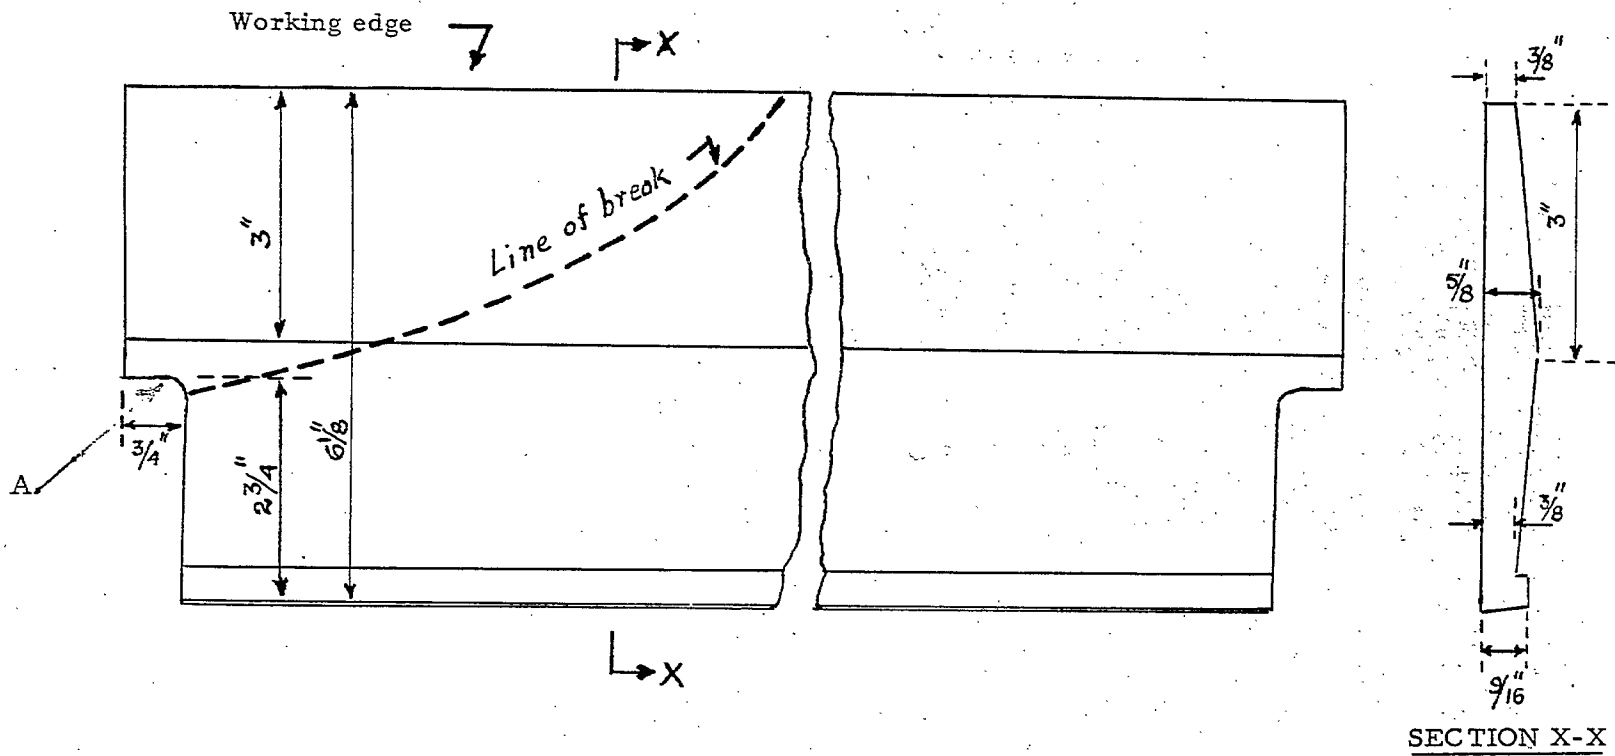
Fig. 1. - Drawing A-85.

In a letter dated January 3, 1958, Mr. K. E. Koreen, Supervisor of Engineering, Port Arthur Shipbuilding Company, Port Arthur, Ontario, requested an examination of the cause of failure of a beater roll bar, broken in service. A rough sketch of the drawing (#A-85) submitted by the company, showing the details of this steel bar, is reproduced in Figure 1.
