MINES BRANCH INVESTIGATION REPORT IR 58-153

INVESTIGATION OF FRACTURE OF 30 IN. WIDE FLANGE I-BEAM FROM WELLAND CANAL BRIDGE NO. 18

D. R. BELL

OCTOBER 14, 1958

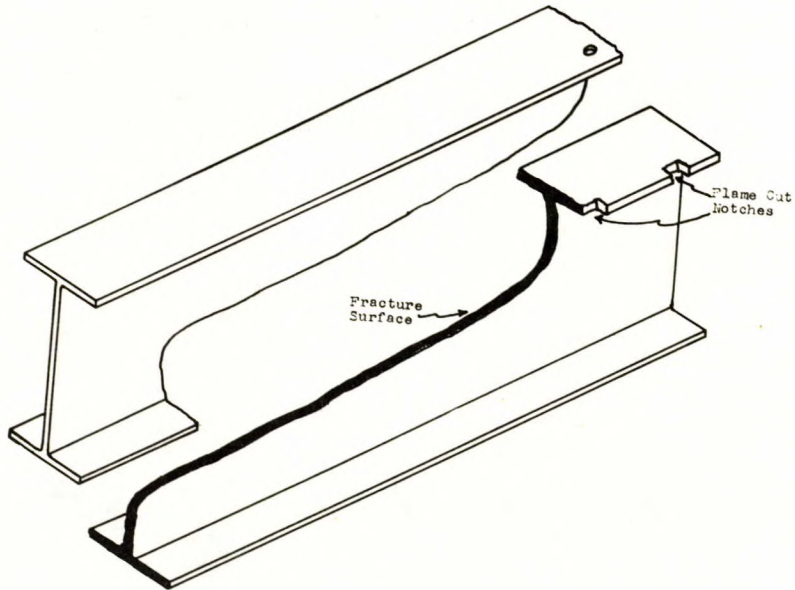
Figure 2. - Sketch of pieces of beam in correct orientation.

the air, a hole was burned in the end of the broken section through which a sling could be fastened, in order that the broken portion could be completely removed and then lowered separately to the ground. The pieces of beam submitted are shown in Figure 1. A sketch of the orientation of the pieces is shown in Figure 2.
