MINES BRANCH INVESTIGATION REPORT IR 60-112

# INVESTIGATION INTO THE STABILITY OF DUFFERIN TERRACE, QUEBEC CITY

A. BROWN AND F. L. CASEY

AUGUST 19, 1960

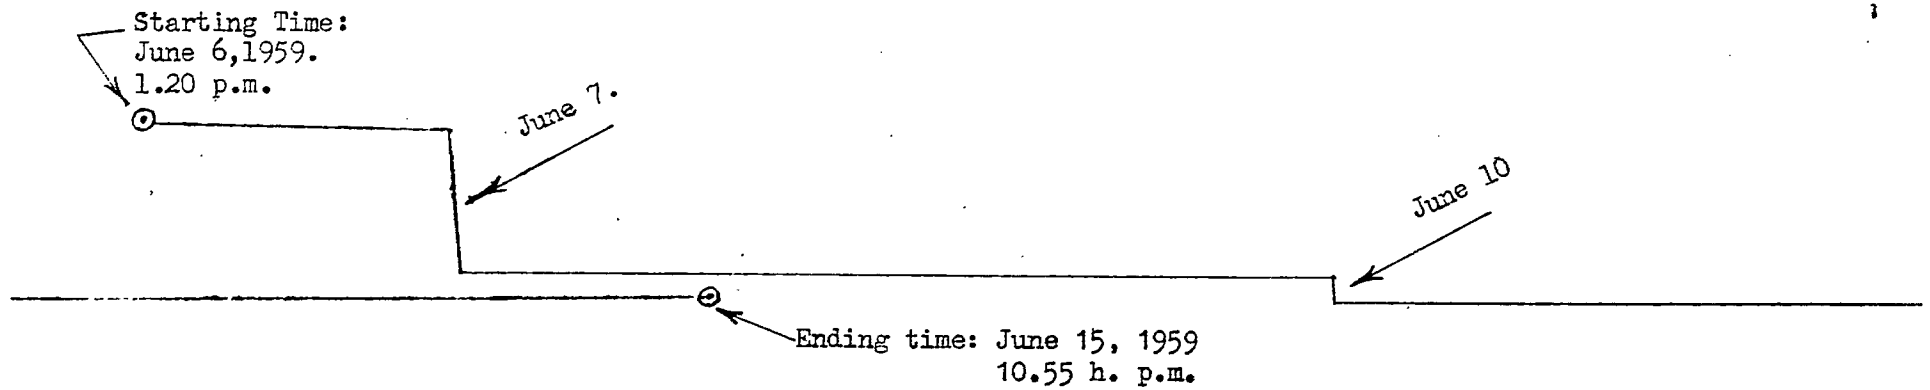
Assembly No 6

The most abrupt movements observed during the investigation occurred at Station 6. A definite convergence was observed in July and August, 1958, amounting to approximately 1/2 inch. Thereafter, until May, 1959, no appreciable movement was observed at this location. In May, 1959, there was evidence of renewed activity, followed by a sudden and quite substantial convergence on June 7 and 10. Figure 15 is a reproduction of the chart taken from the automatic movement recorder that was employed at Station 6. The abrupt nature of the movements is apparent, and it may be mentioned that this type of sudden movement is typical of what has been observed at Dufferin Terrace. Reference to Figure 14 will show that, despite the convergence observed in July, 1958, at Station 6, no changes were observed in the verticality of the main front wall, indicating that it was very likely remaining stationary. This left the possibility that the convergence was caused by an inward movement of the rear wall of the Terrace. Following the more substantial convergence of June, 1959, the rear wall was examined by the Department of Northern Affairs and National Resources, and it was found that the rear wall had cracked at this location and had been thrust forward. It is considered that the break was caused by earth pressure against the wall.

Figure 15. Automatic recorder chart for June 7 and 10, 1959

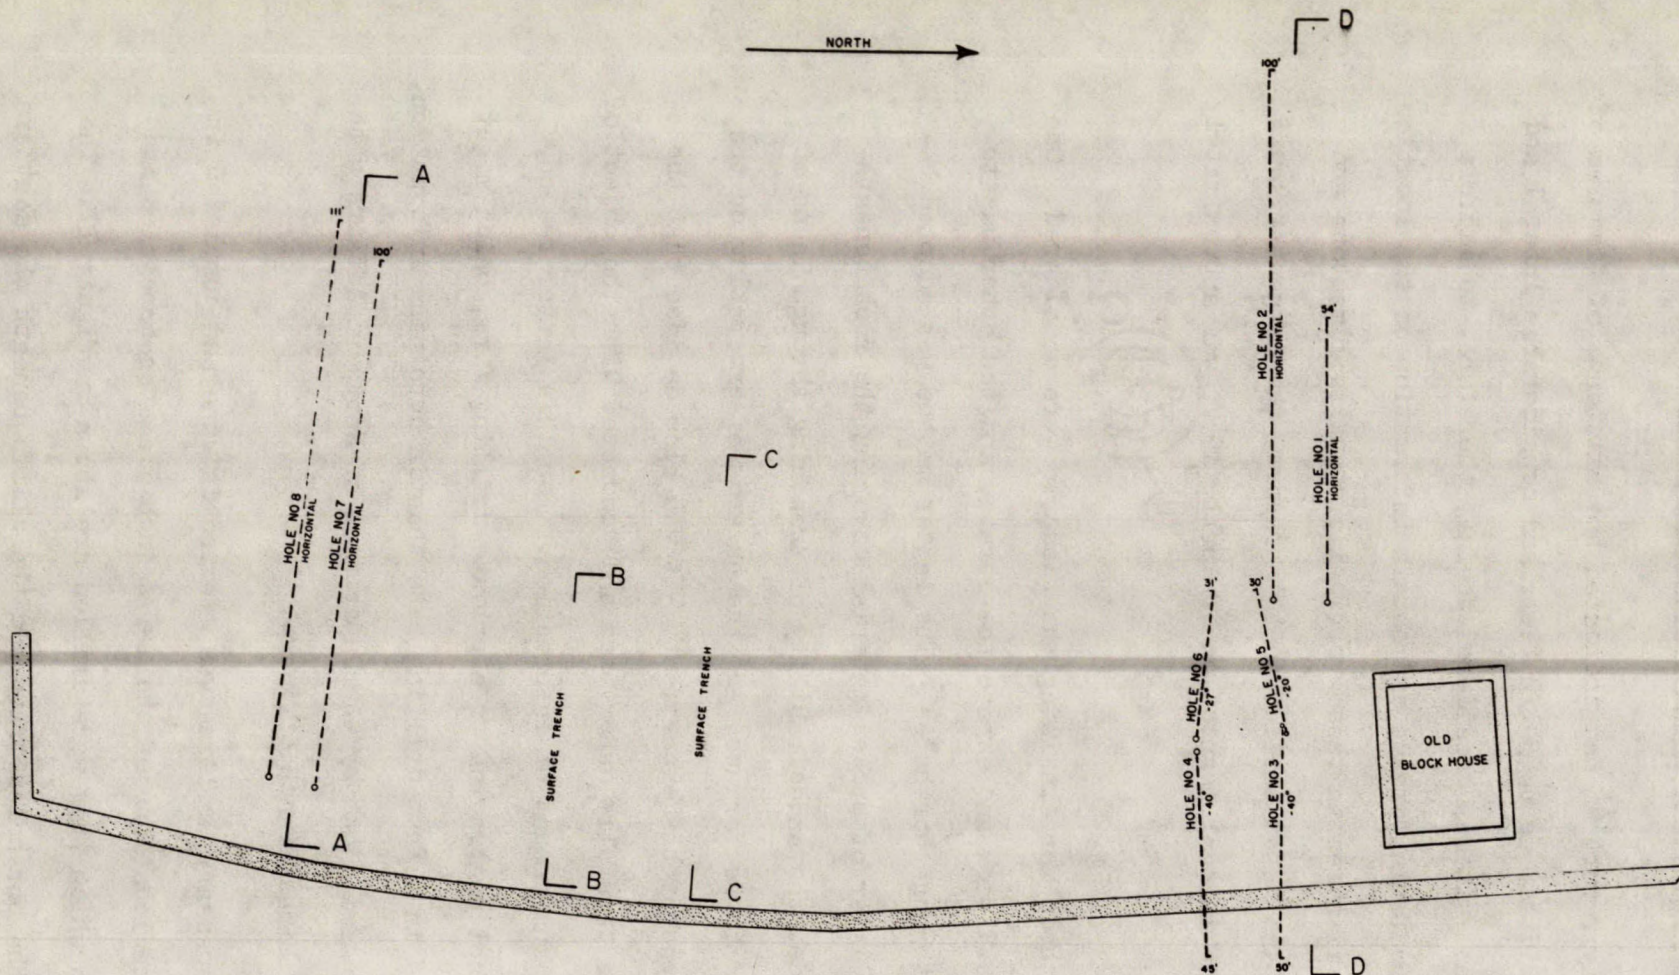
The necessary drilling was started in June and completed in July of 1957. The locations of the 2-1/4 inch diameter boreholes and the directions in which they were drilled are shown in Figure 17. The manner in which the boreholes traversed the cliffs beneath the southern

Figure 17. Exploratory holes drilled at Dufferin Terrace

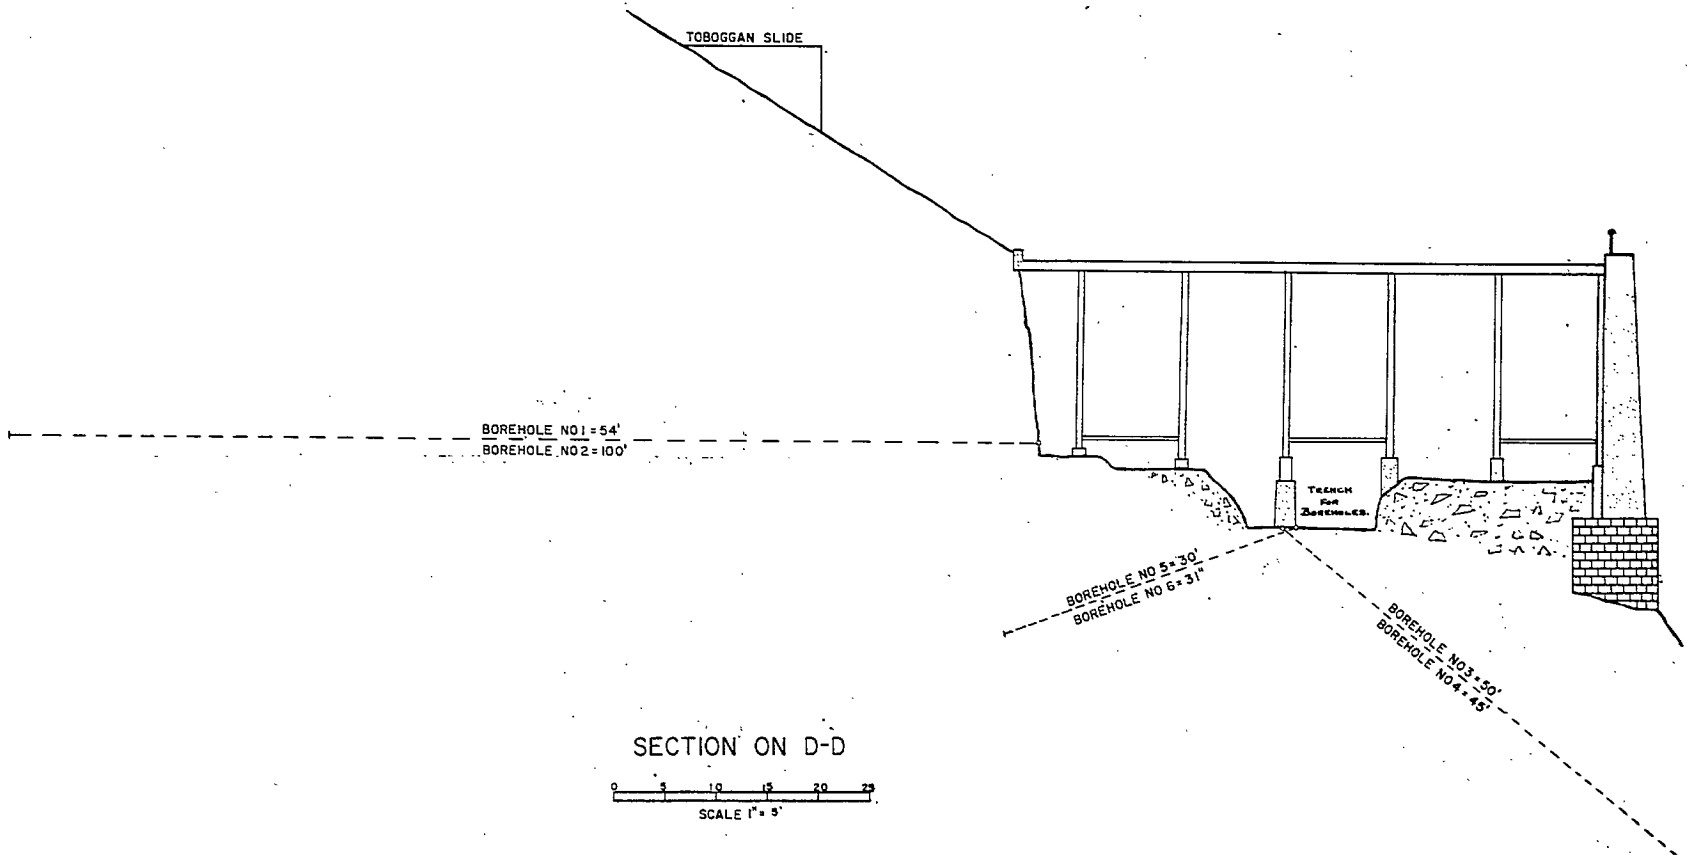
end of Dufferin Terrace is illustrated in Figure 18. This is the area specifically referred to in the Baillaireg  report as being dangerous.

Figure 18. Sectional view through boreholes at Dufferin Terrace
