MINES BRANCH INVESTIGATION REPORT IR 60-114

EXAMINATION OF A FAILED BOILER TUBE

Examination of a section of boiler tube, submitted by the New Brunswick Electric Power Commission showed that failure of the tube was due to overheating of a local area of the tube (hot-spot), combined with erosion, which resulted in reduction of the section and the development of transverse thermal-fatigue cracks.

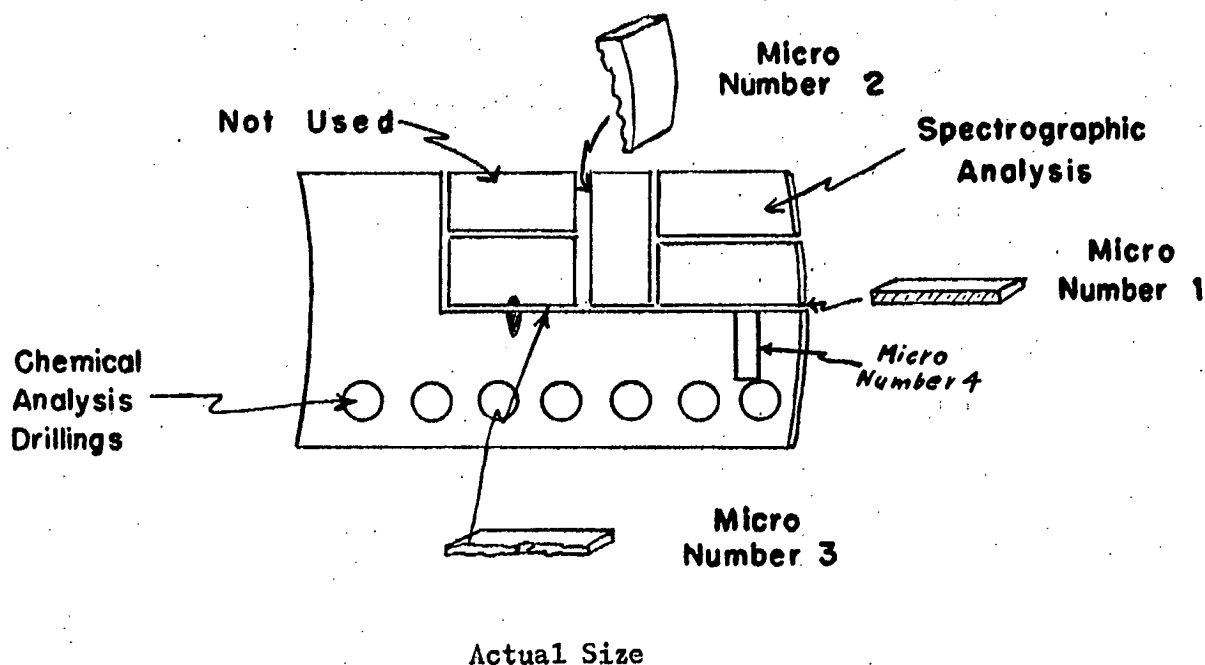
Figure 2. Diagram of Sample of Boiler Tube.

The sample of boiler tube was sectioned as illustrated in this diagram.

Examination of the water-side of the boiler tube (Micro Number 1, Figure 2) showed the entire surface to be covered with a uniform layer of oxide. The cracks were seen to be blunt-ended and filled with corrosion product (Figure 3).
