MINES BRANCH INVESTIGATION REPORT IR 61-132

EXAMINATION OF CARBIDE-TIPPED BURS

Mines Branch Investigation Report IR 61-132

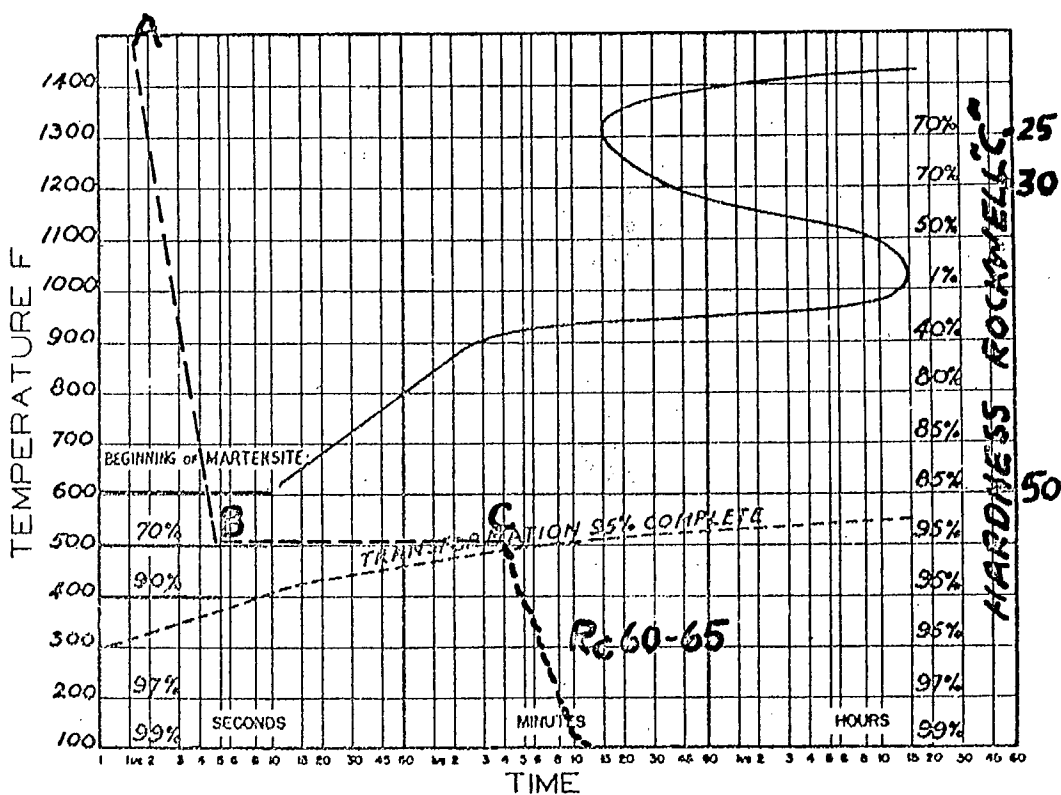
Figure 1 illustrates a TTT diagram for a steel having similar chemical composition to that used for the burs. The line, ABC, illustrates the cooling curve for the bur sample austenitized at 1700°F and marquenched from a 515°F salt bath, (Sample W-1700-515)

Figure 1. TTT Diagram for a Steel having the Composition C 0.50%, Cr 1.25%, V 0.20% and W 2.75% *(Atha Pneu Steel).

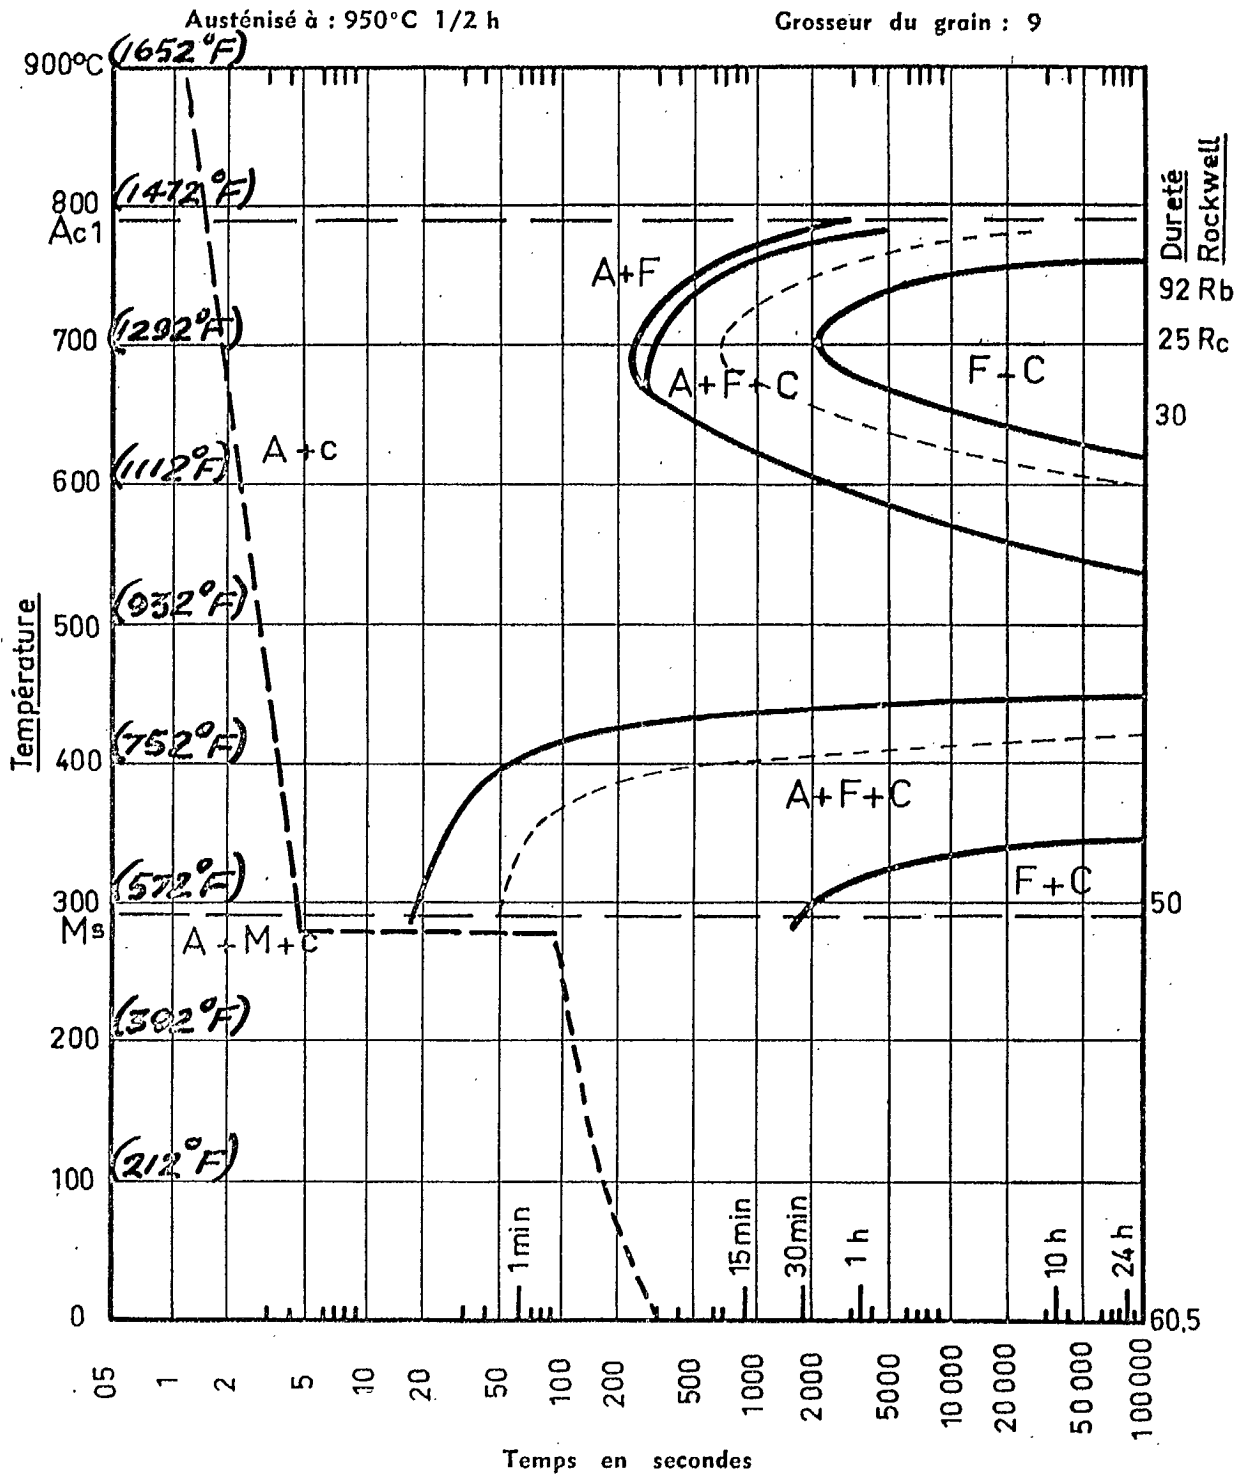
Figure 2. TTT Diagram for Steel 45 W C 20-04

The cooling curve shown in Figure 2 corresponds to the post-weld heat treatment W-1700-515. The present marquench temperatures (500°F or 515°F) appear to be below the M_s temperature for this steel. High hardness (R_C 62 to 65) is developed in the bur by the marquenching heat treatment. If marquenching is used as a post-welding heat treatment, tempering will be required to reduce the hardness to R_C 42 to 48. At present, the microstructure consists of untempered martensite and is brittle. Alternatively, an isothermal austempering treatment could be used with the temperature selected to give a hardness of R_C 45 to 50 (possibly 575 to 600°F). This treatment would avoid the necessity of tempering.

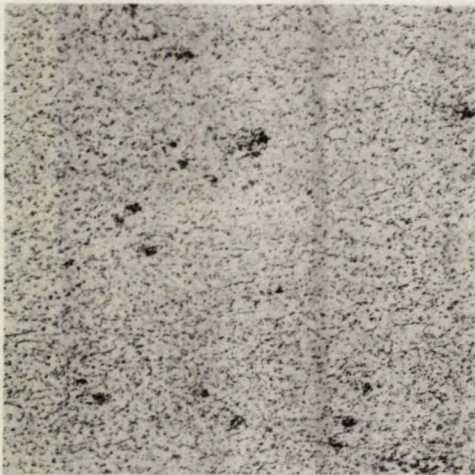
(a)

The microstructure of both wires consisted of ferrite and spheroidized carbide with occasional massive particles which probably contained tungsten. The appearance of the as-received wire for the two heats is illustrated in Figures 3(a) and 3(b).

Figure 3. Transverse Section through Wire from Heat 59. (59AR)

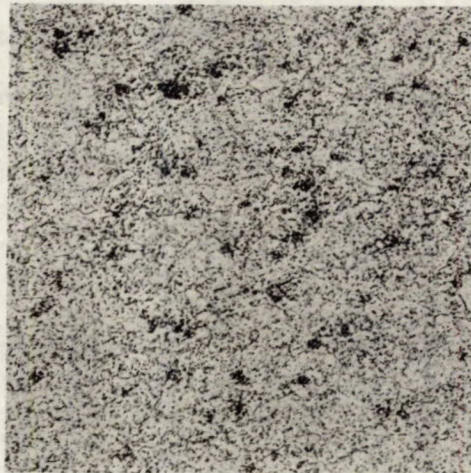
(b)

No significant difference was observed between heats 59 and 60 with respect to the initial spheroidized microstructure or to grain-coarsening tendency at 2000°F. For the particular sample examined, heat 60 appeared to be slightly dirtier than heat 59, but this difference was not believed to be significant.
