MINES BRANCH INVESTIGATION REPORT IR 62-106

**EXAMINATION OF SAMPLES CUT FROM
CCGS JOHN A. MacDONALD SPARE
PROPELLER BLADES**

D. E. PARSONS

JANUARY 3, 1963

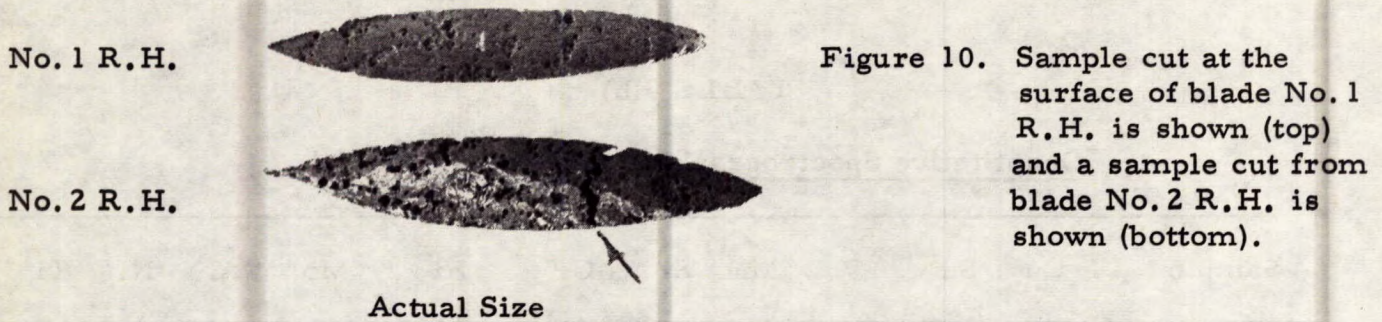
The appearance of the surface of the boat samples at higher magnification is shown in Figure 10.

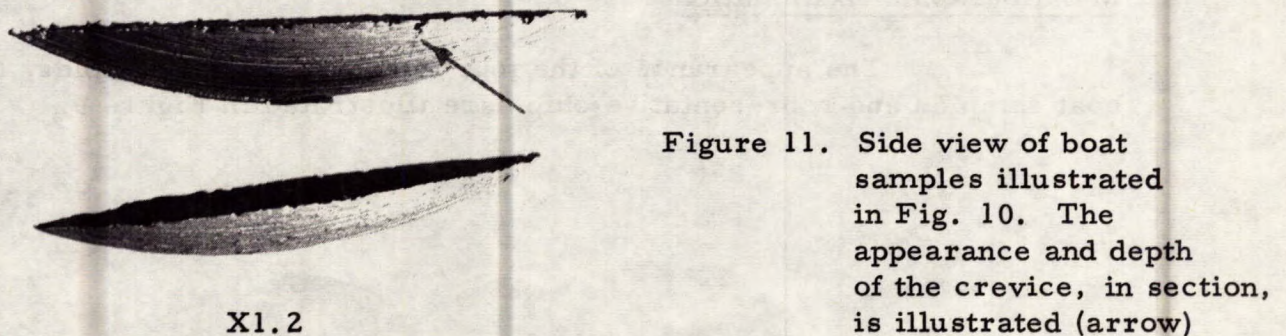
The appearance of the boat samples, viewed in elevation, is shown in Figure 11. The appearance of the crevice on the cut section is marked by the arrow.

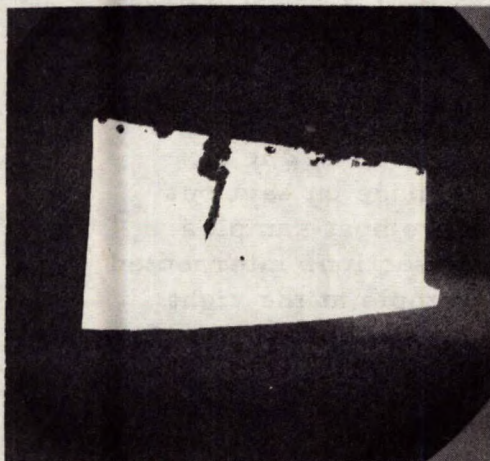
The appearance of a section cut to intersect the crevice illustrated in Figures 10 and 11 and polished for metallographic examination is shown in Figure 12.
