MINES BRANCH INVESTIGATION REPORT IR 63-5

**DETECTION AND ANALYSIS OF
METALLURGICAL DEFECTS IN STEAM
TURBINE ROTORS**

R. D. McDONALD

JANUARY 25, 1963

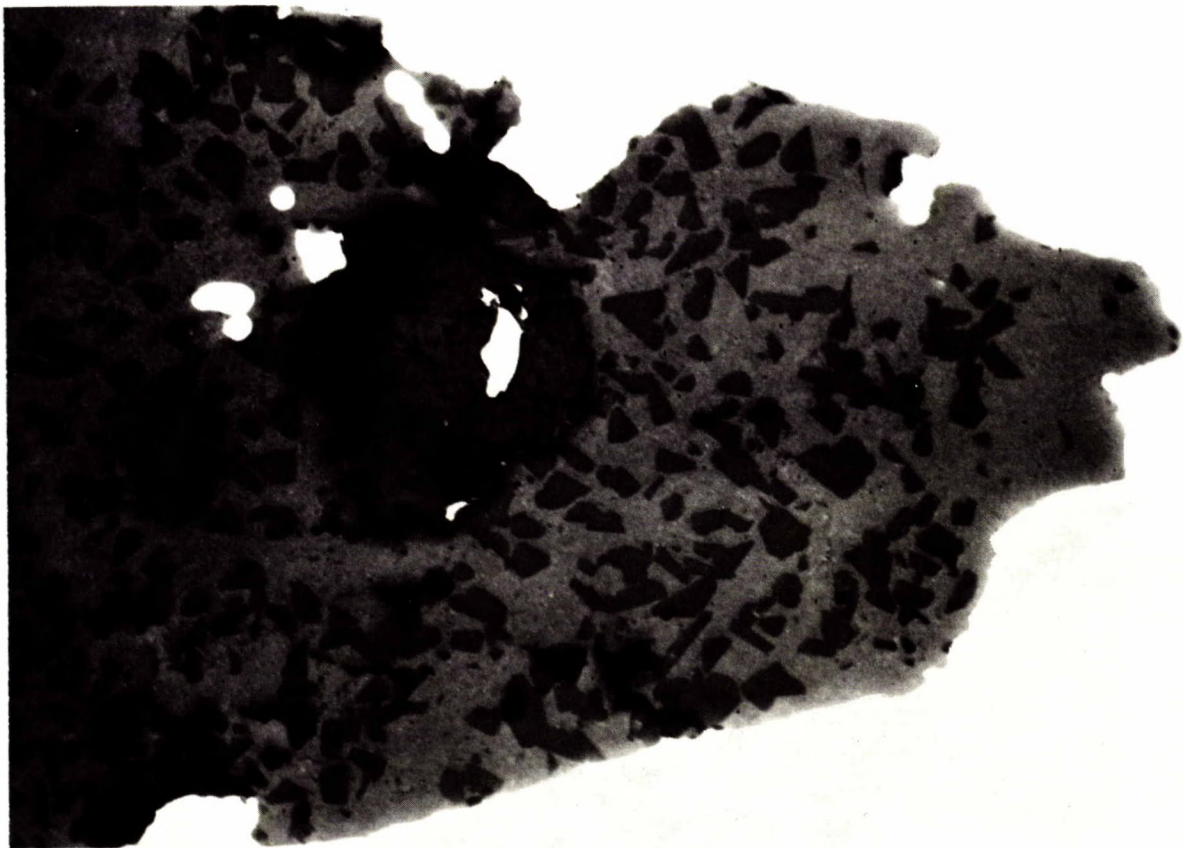
Figure 8. The second of the two large inclusions shown in Figure 6.

This inclusion was used for X-ray diffraction tests.

In the petrographic examination, a diffuse X-ray powder diffraction pattern of the inclusion shown in Figures 6 and 8 was obtained, and one of the major constituents was identified as α -tridymite (high temperature SiO_2). A few extra lines on the pattern indicated that some material was not identifiable. A microscopical examination of a powder of the inclusion in immersion oils confirmed the X-ray results. Polished section studies showed that a few very small grains of a metallic mineral are also present in the inclusion and have optical properties resembling those of jacobsite ($\text{MnO} \cdot \text{Fe}_2\text{O}_3$) or magnetite (Fe_3O_4).

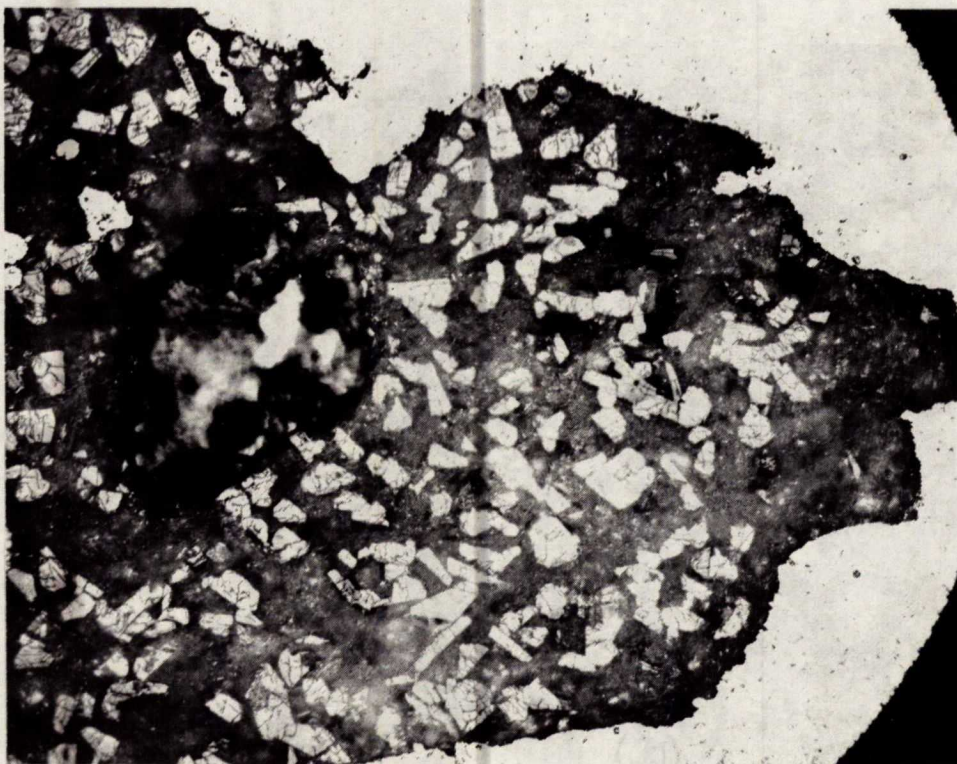
Figure 13. Same as Figure 12, after etching in a saturated solution of stannous chloride in alcohol for 10 minutes.

Additional pitting attack throughout indicates the presence of compound (FeMn) oxide. The dark-grey crystals and matrix show strong resistance to the etch.

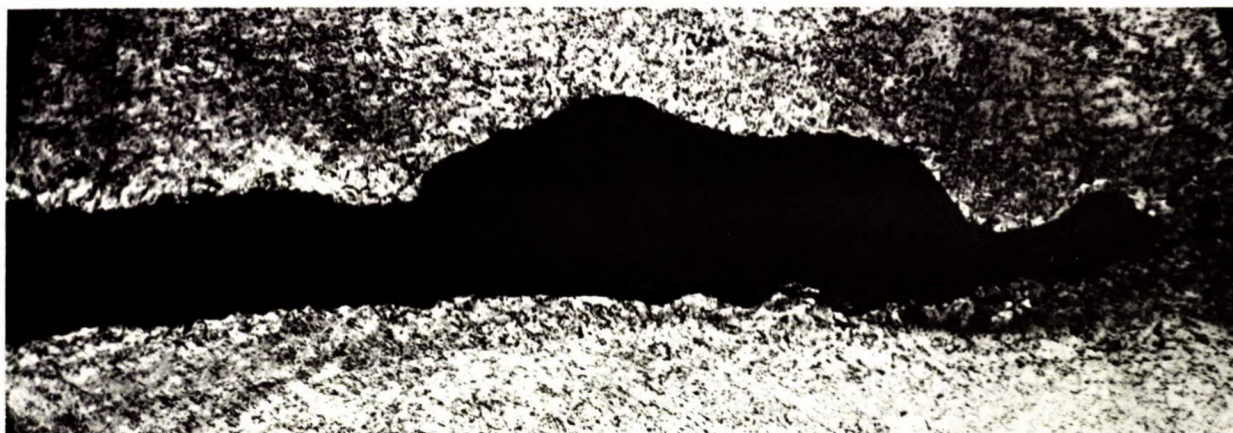
Figure 20. Same as Figure 19, after etching in 10% solution of chromic acid in water for 5 minutes.

The remaining grey globular inclusions were attacked, showing that they consist of FeS-MnS rich in MnS. Some staining has occurred on the lower half of the inclusion.

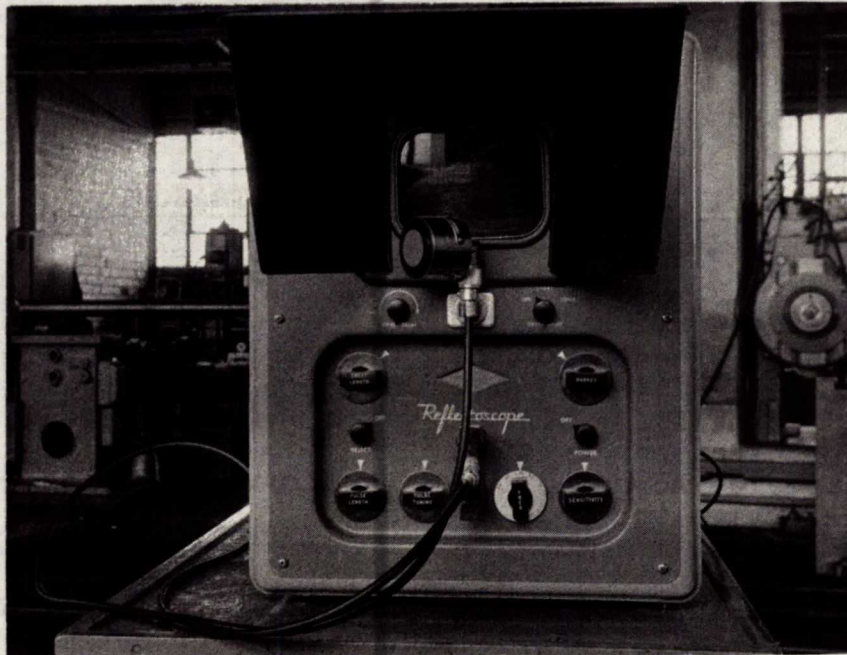
Figure 22 illustrates the front panel of the Reflectoscope. The tuning controls, the screen of the cathode ray tube and a $2\frac{1}{4}$ Mc single-type search unit are all visible.

Figure 22. Front panel of Reflectoscope.

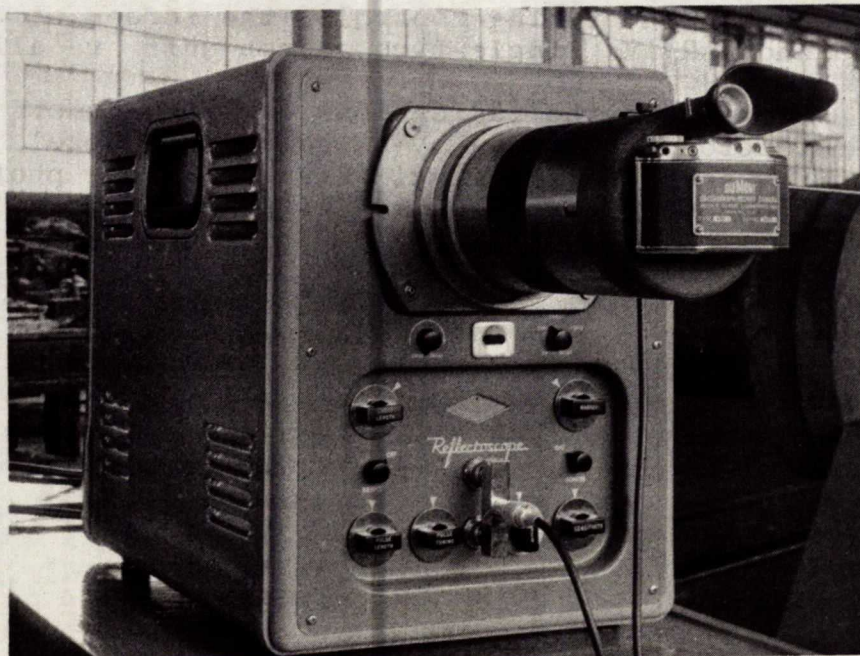
To record the indications, a 35 mm camera was attached to the reflectoscope screen by an adjustable bezel. The adjustment permits accurate focusing. Figure 23 is a photograph of the Reflectoscope with the camera in position.

Figure 23. Reflectoscope with camera in position.

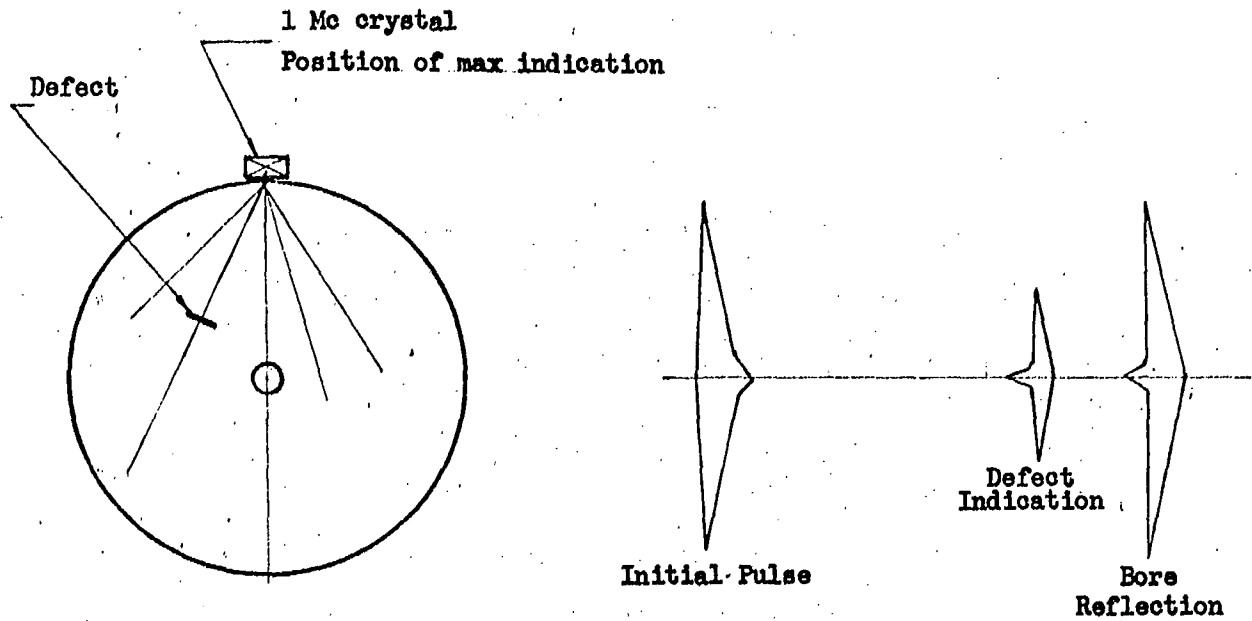
- (a) Locating the 1 Mc crystal position from which the maximum indication from the defect is obtained. The location coincides with the point where some part of the beam is normal to the defect. See Figure 24.
- (b) Locating the 5 Mc crystal position where the maximum loss of bore reflection, due to the defect, occurs. The most radial portion of the beam is responsible for the bore reflection; therefore, when the greatest loss of bore reflection occurs, the defect is in direct radial line (minimum distance) with the defect. See Figure 25.
- (c) Plotting the results of steps (a) and (b) on a cross-section of the rotor. See Figure 26. From the plot shown in Figure 26, the exact location of the defect is given by the 5 Mc data, and the plane of the defect is given by a line constructed at right angles to the line joining the defect location and the 1 Mc crystal location.

Figure 24. Step (a) in ultrasonic pinpointing to locate rotor defects.

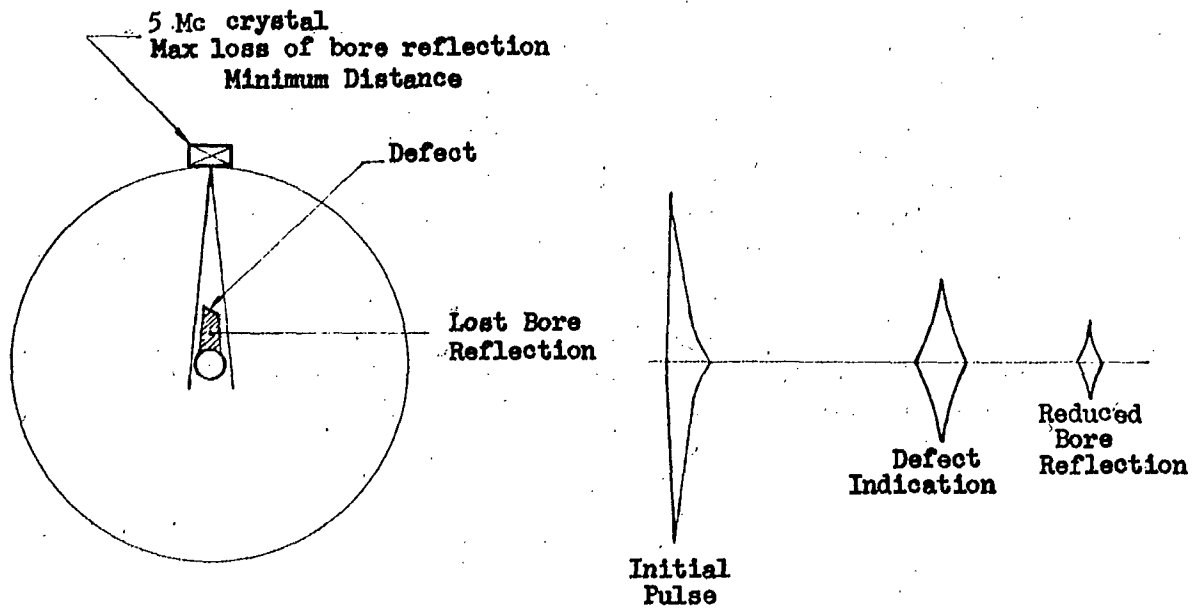
Figure 25. Step (b) in ultrasonic pinpointing to locate rotor defects.

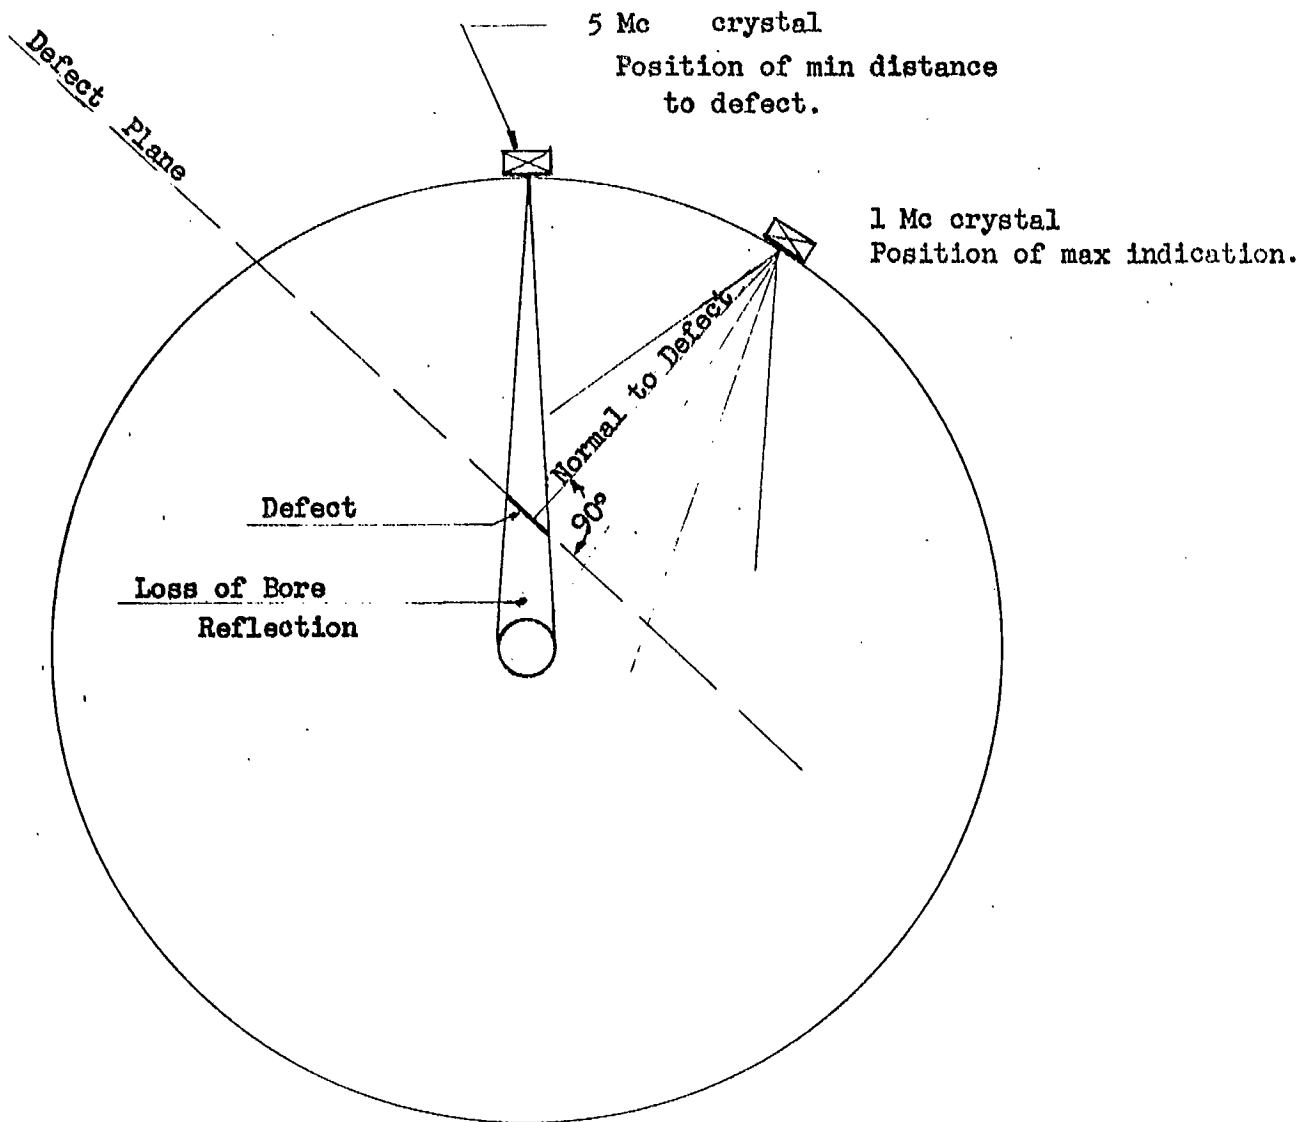
Figure 26. Step(c) in ultrasonic pinpointing: plotting results of steps (a) and(b) to obtain location and plane of defects.

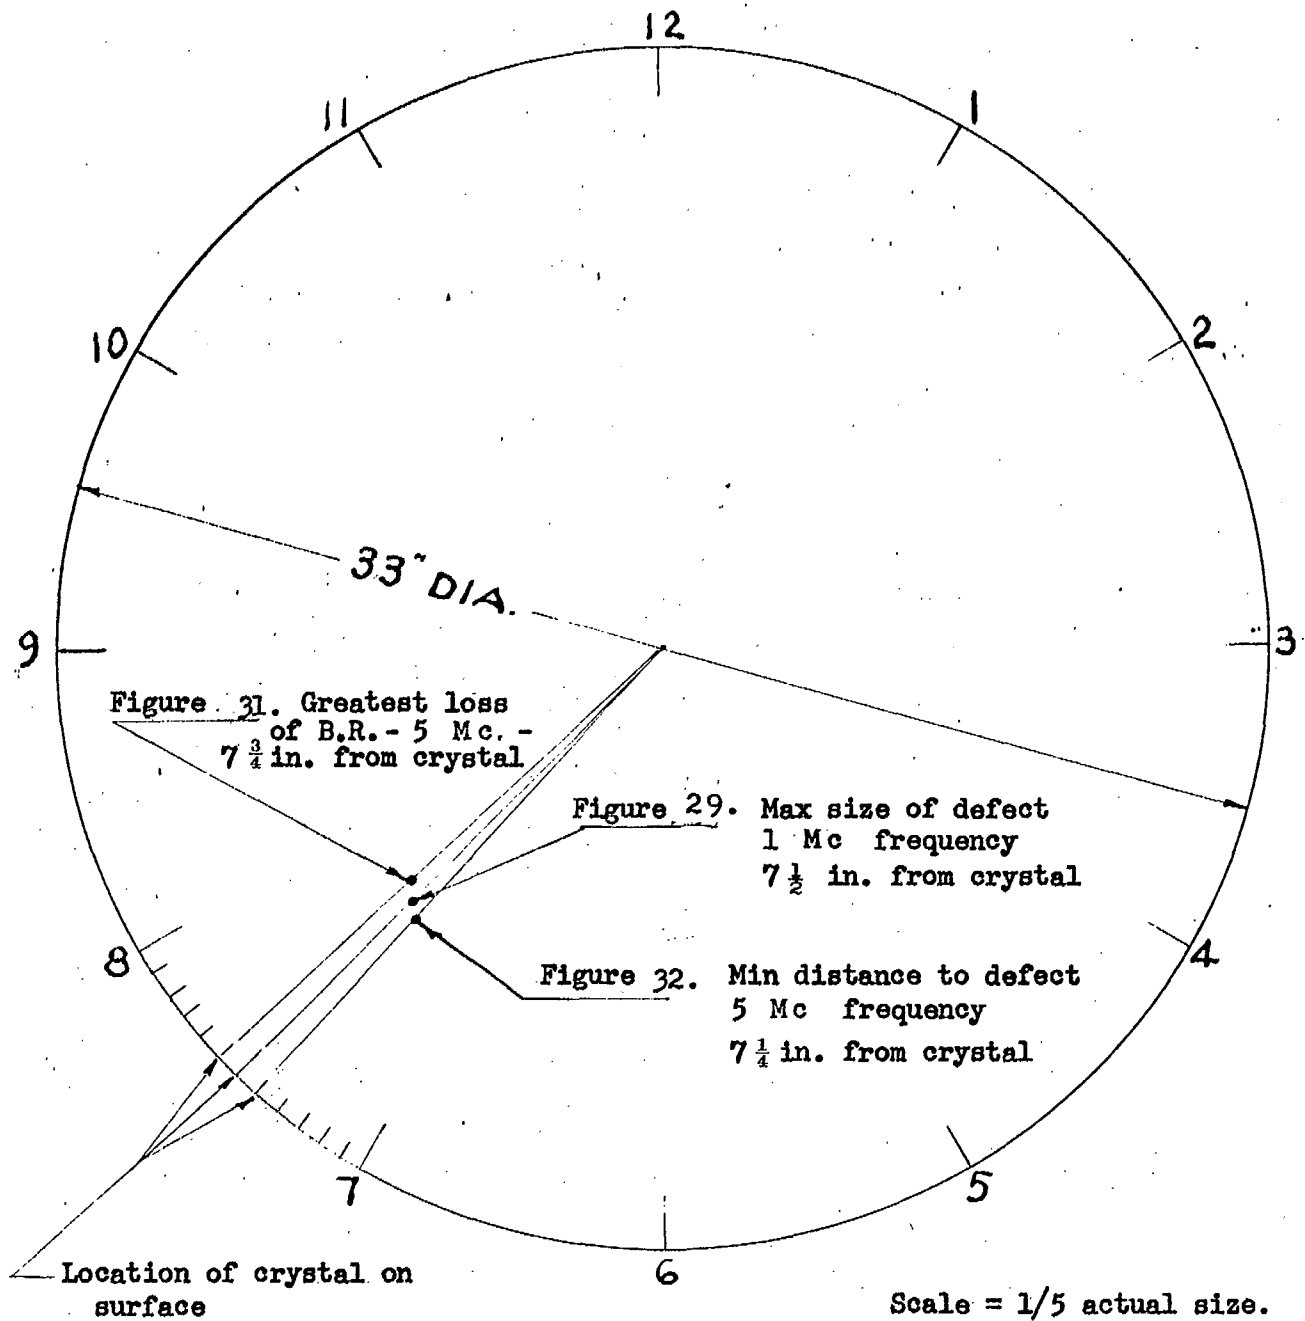
of the pinpointing are shown in Figure 27. A series of reflectograms was made, illustrating the appearance of the indications at the various locations in the pinpointing procedure. The reflectograms are shown in Figures 28 to 32 inclusive. Since the three search unit locations were all practically coincident, it was concluded that the defect did not have any radial orientation.

Figure 27. Cross-section of rotor, located $16\frac{1}{2}$ in. from top end of 33 in. diam.

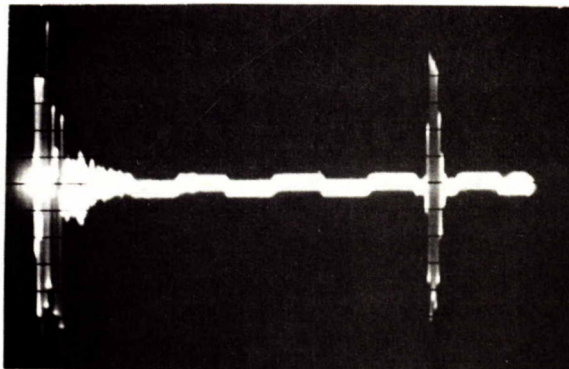
Figure 28. A defect-free area in the 33 in. Ø section.
1 Mc Frequency.

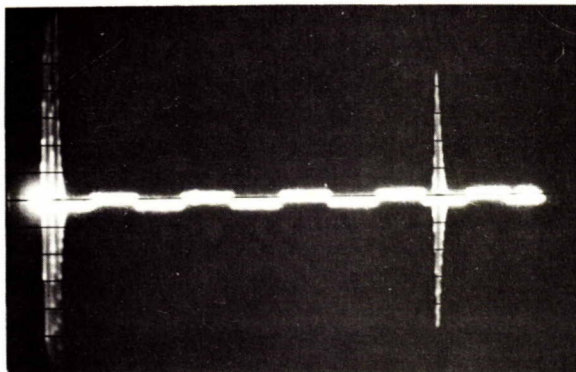
Figure 30. A defect-free area in the 33 in. Ø section.
5 Mc Frequency.

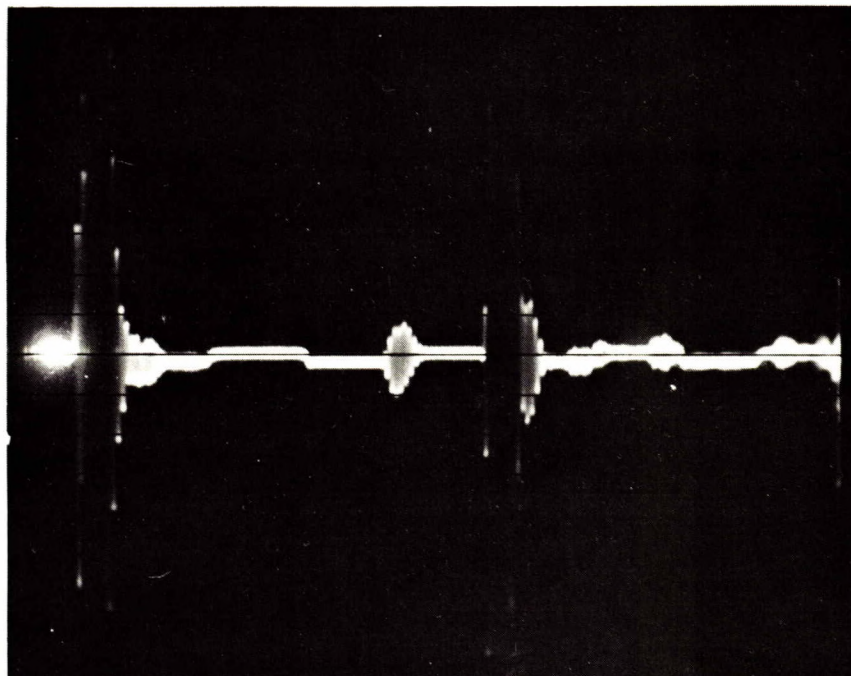
To provide a means of assessing the size of the three defects, Figure 39 may be used. This is a reflectogram illustrating the size of indication produced by a $1/16$ in. diameter flat-bottomed hole when located 3 in. from the search unit, all other conditions being equal to those used for the reflectogram in Figure 38.

Figure 39. Reflectogram illustrating indications from a rotor test block containing a $1/16$ in. diam. flat-bottomed hole 3 in. from the search unit. $2\frac{1}{4}$ Mc setting as for Figure 38.
