MINES BRANCH INVESTIGATION REPORT IR 63-20

EXAMINATION OF BROKEN SHAFT FROM PRETORIA AVENUE BRIDGE OTTAWA, ONTARIO

PHYSICAL METALLURGY DIVISION

FEBRUARY 21, 1963

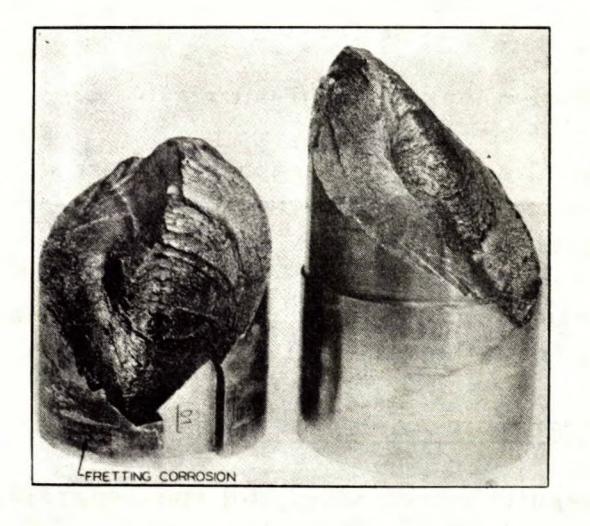
Figure 4. Textbook Fracture. Typical fracture due to alternating torsion as illustrated by M. Hetenyi. (See also references 2 and 3).

Part of the text, by Hetenyi, pertaining to alternating torsion and to the fracture illustrated in Figure 4, was as follows:-"A fatigue crack generally follows a path dictated by the normal stress field, hence one would expect alternating torsion cracks to follow a path 45 deg to the axis. It is almost a certainty that a crack of approximately 45 deg helix found in service is due mainly to alternating torsion. Although there are cases where torsion produces other results, it can be said that bending or axial stresses do not, in practice, produce the diagonal crack which is uniquely characteristic of torsion failure.

A mathematical analysis has indicated that, with failure starting at a small localized stress concentration, a helical crack is to be expected as a result of alternating torsion. This is completely confirmed in all cases of torsion tests of a shaft with a transverse hole, regardless of material.
