MINES BRANCH INVESTIGATION REPORT IR 63-107

EXAMINATION OF TWO BROKEN ICEBREAKER STUB PROPELLER BLADES

D. E. PARSONS

NOVEMBER 1, 1963

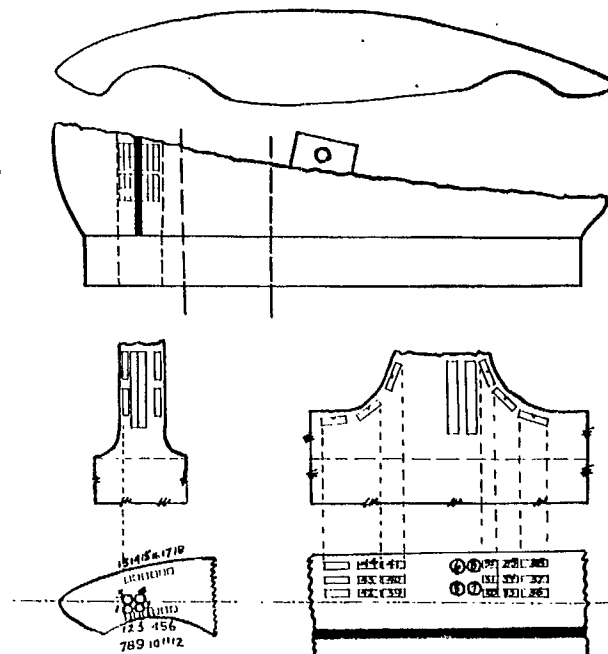
The blades were sectioned, as shown in Figure 3, to obtain transverse sections through the thick and thin parts of each stub. These slices were subsequently inspected by magnetic particle and deep-etch methods. Chemical analyses were made on metal from thin and thick sections from each casting. A 1½ in. slice from each section was surface-ground and was deep-etched for 20 min in 1:1 HCl: water at 71 to 83°C (160-180°F). The remainder of each block was used to provide 0.505 in. diameter tensile and Charpy V-notch bars for determination of the tensile properties in the thin and thick sections and for determination of the Charpy V-notch impact transition temperatures.

The location and identity of the test specimens is shown in Figure 3. Test bars from similar locations in each casting were given the same code number prefixed by the letters "S" or "R".

Figure 3. Sectioning procedure, location and identification of test bars.
